**In-Flight Separation of Vertical Stabilizer  
American Airlines Flight 587  
Airbus Industrie A300-605R, N14053  
Belle Harbor, New York  
November 12, 2001**

**NTSB/AAR-04/04**

**NTSB/AAR-04/04  
PB2004-910404  
Notation 7439B  
Adopted October 26, 2004**

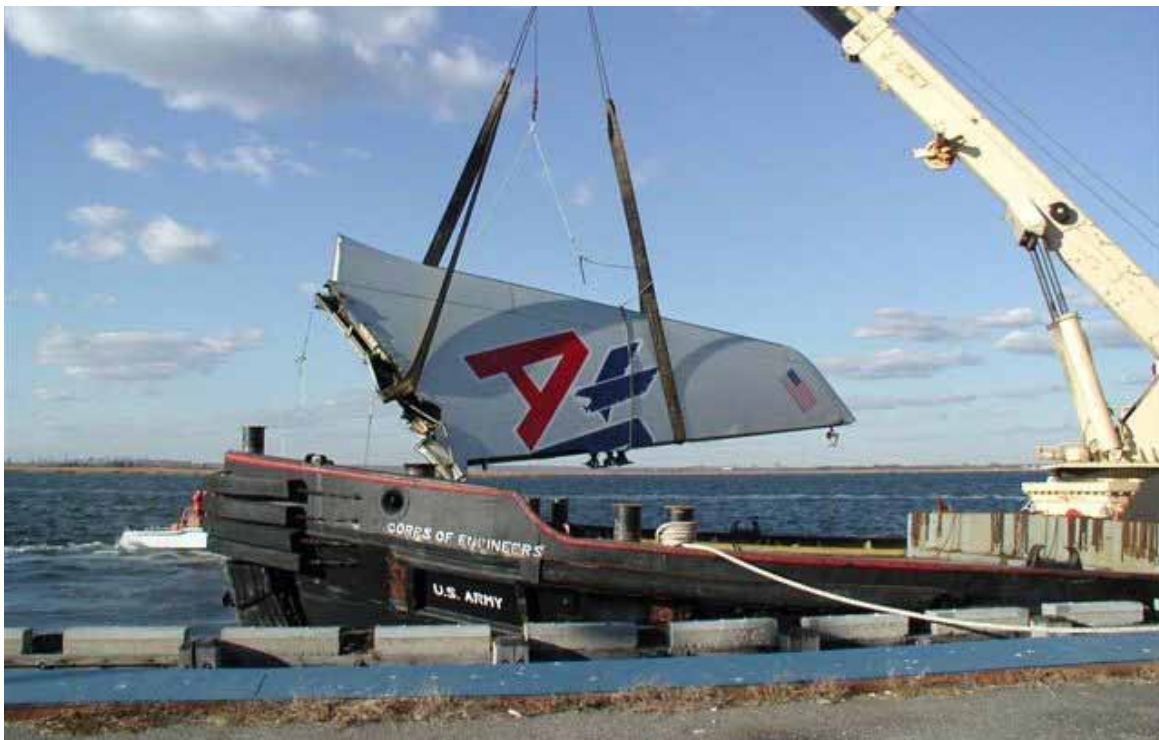
**Figure 11.** Vertical Stabilizer After Recovery From Jamaica Bay

The vertical stabilizer was mostly intact. The left and right skin panels did not exhibit any significant damage, but the six main attachment fittings and the three pairs of transverse load fittings were fractured.

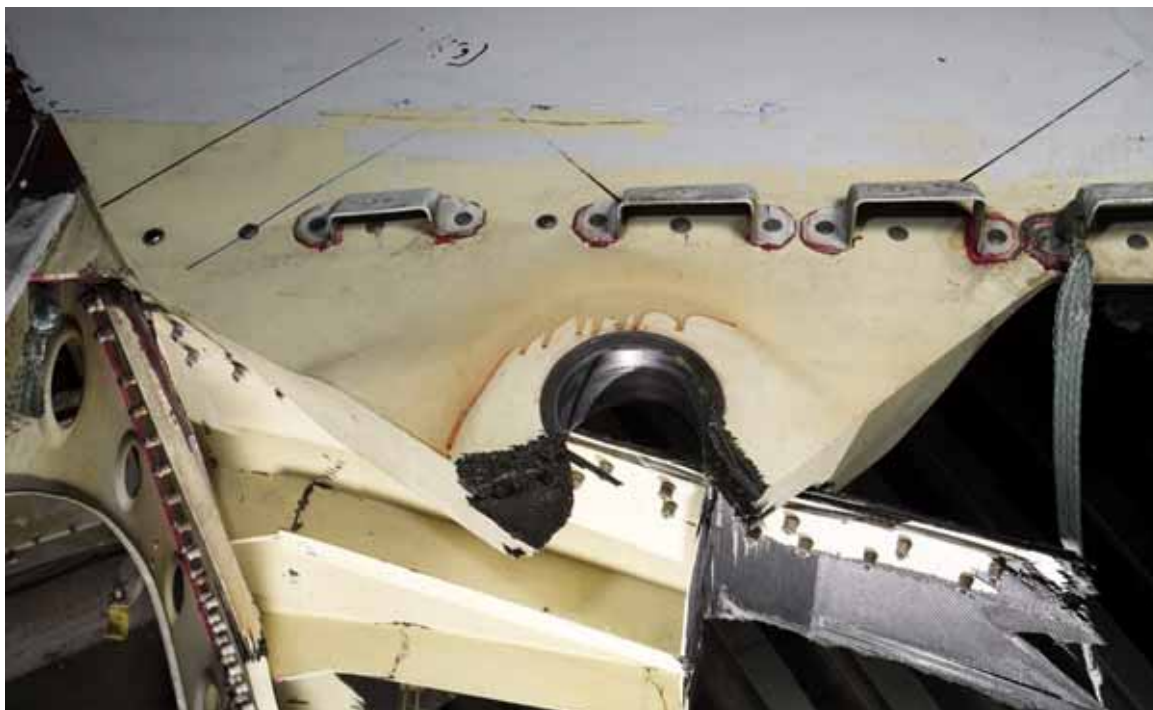
**Figure 12.** Right Rear Main Attachment Fitting

The right rear main attachment fitting fractured at the lughole (see figure 12). The right center main attachment fitting remained attached to the aft fuselage but separated from the vertical stabilizer when it fractured just above ribs 1 and 4 and the skin/stringer interface. The right forward main attachment fitting fractured at the lughole. The left rear main attachment fitting assembly (that is, the inboard and outboard fitting assembly halves and the lug portion of the skin laminate) fractured from the vertical stabilizer but remained attached to the aft fuselage. The left center main attachment fitting separated from the vertical stabilizer at the fastener line along the rib 1 attach angle. The left forward main attachment fitting fractured at the lughole, but the lower part of the fitting remained attached to the aft fuselage.<sup>88</sup>

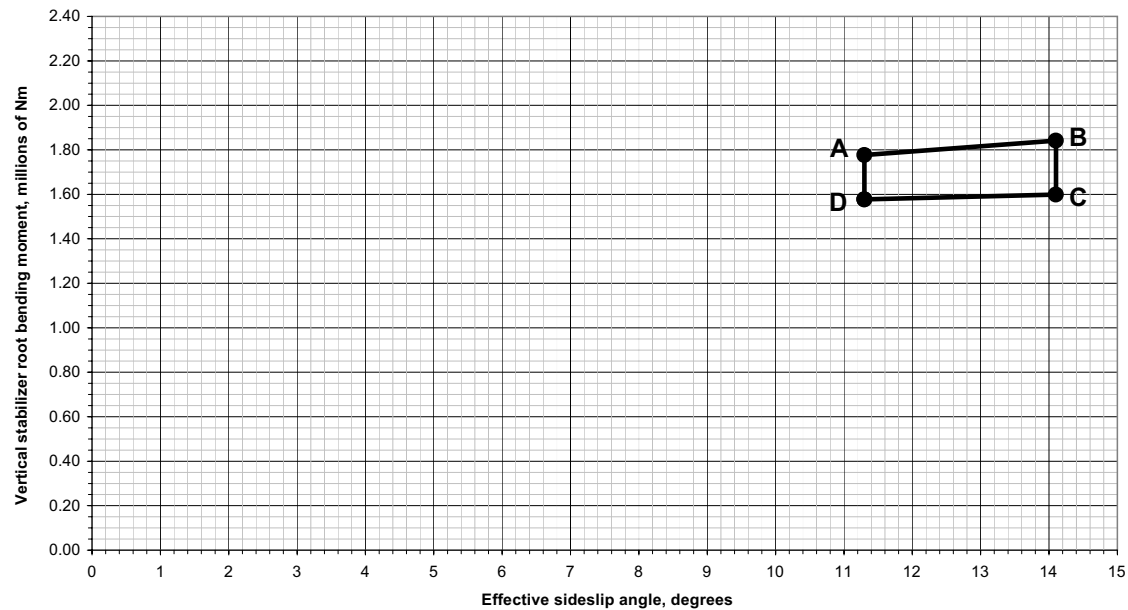
**Figure 14.** Bending Moment Load Range at the Time of Vertical Stabilizer Separation

Note: The calculated range of the root bending moment is defined by points A through D, which are described in addendum 2 to the airplane performance study. See the public docket for this accident for more information.

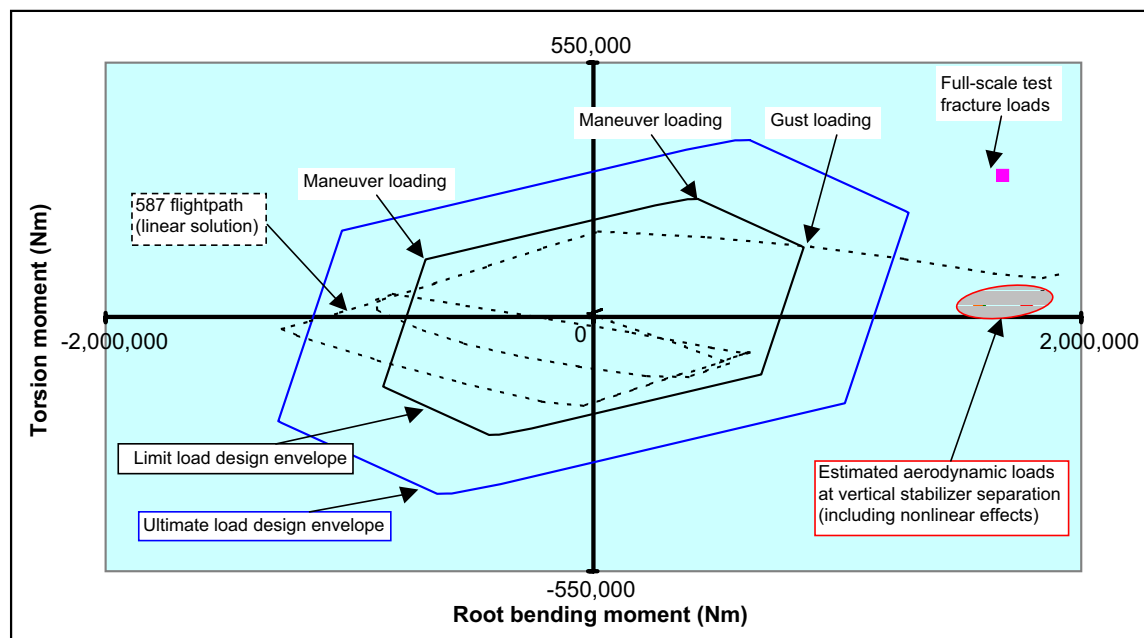
**Figure 15.** Estimated Aerodynamic Loads in Relation to the Torsion Versus Bending Correlated Shear Force Diagram

Note: The four triangles correspond to the four points in figure 14. Specifically, the red triangle is point A, the gray triangle is point B, the green triangle is point C, and the orange triangle is point D.

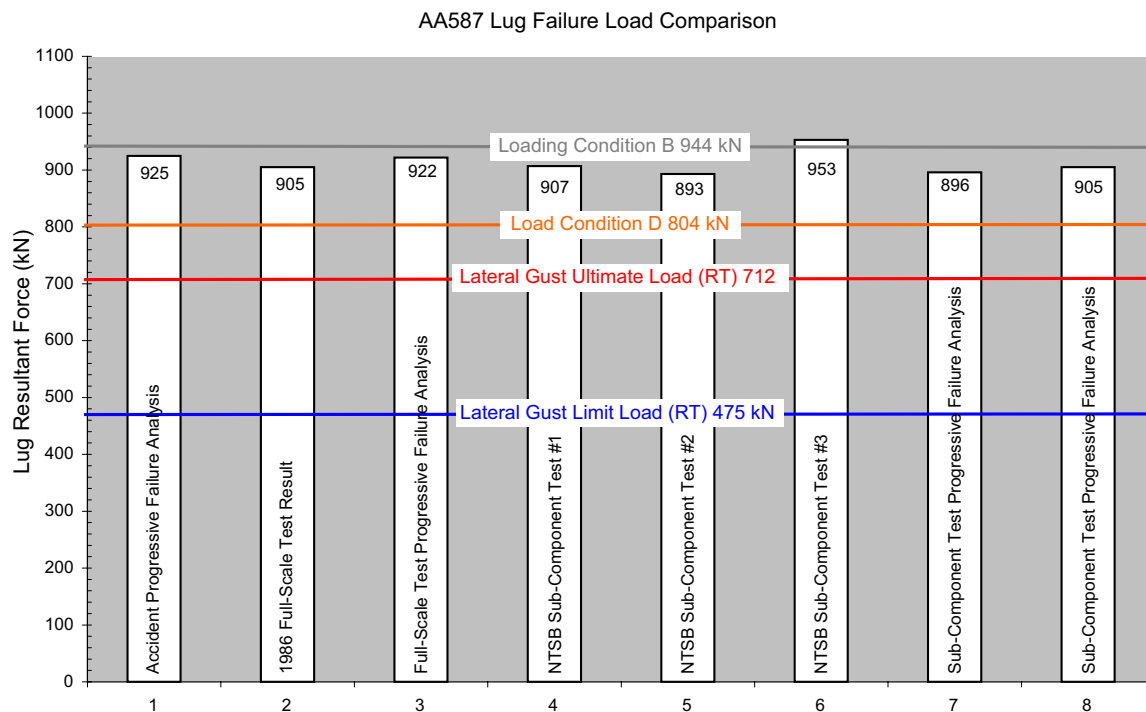
**Figure 16.** Comparison of Lug Forces at the Time of Fracture

NASA's and Airbus' FEA models determined that failure of the right rear main attachment lug was the most probable initial failure. The FEA models and NASA's PFA model also determined that the failure initiated at the final observed maximum vertical stabilizer root bending condition during the accident flight, when the vertical stabilizer

was subjected to a global root bending moment of more than two times the value defined by the limit load design envelope. (As previously stated, for certification, the vertical stabilizer is only required to support loads of 1.5 times limit load without catastrophic failure.) The structural analyses showed that the large aerodynamic loading produced by the accident scenario would result in the right rear main attachment lug experiencing reaction forces and associated stresses that were equivalent to those that produced lug fractures in the Airbus full-scale certification test (lateral gust condition) and the Safety Board's static lug tests. Figure 16 compares the resultant lug forces at the time of fracture for the tests and analyses that were pertinent to the flight 587 investigation.

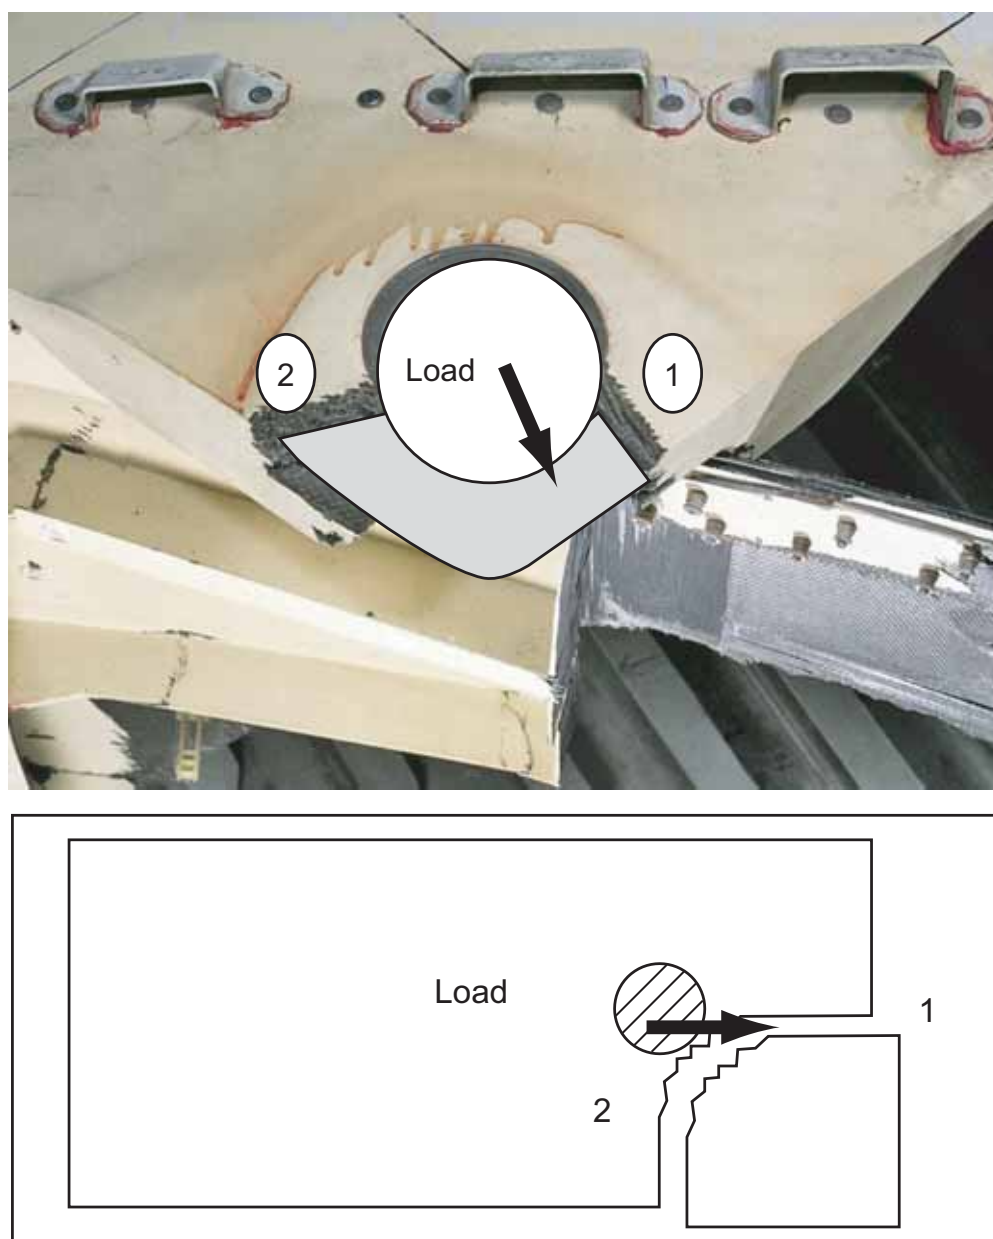
**Figure 17.** Load on the Flight 587 Right Rear Main Attachment Lug and a Depiction of the Cleavage-Tension Failure Mode

The stresses developed exceeded the strength values for the CFRP material used in the manufacturing of the lugs; thus, the accident lug and the tested lugs fractured because of a tensile static overload. The physical evidence and the structural analyses showed that the accident lug's and the tested lugs' fracture features were consistent with a cleavage-tension failure observed in composite-bolted joints. Figure 17 shows the load on the flight 587 right rear main attachment lug and a depiction of the cleavage-tension failure mode.

Note: Number 1 is the initiating fracture, and number 2 is the secondary fracture. The circle indicates the location of the pin and bushing, which were missing from the lug when it was found in the wreckage.
