Investigation Report of the Aircraft Accident Investigation Bureau

to aircraft AVRO 146-RJ100, HB-IXM,

operated by Crossair under flight number CRX 3597,

on 24 November 2001

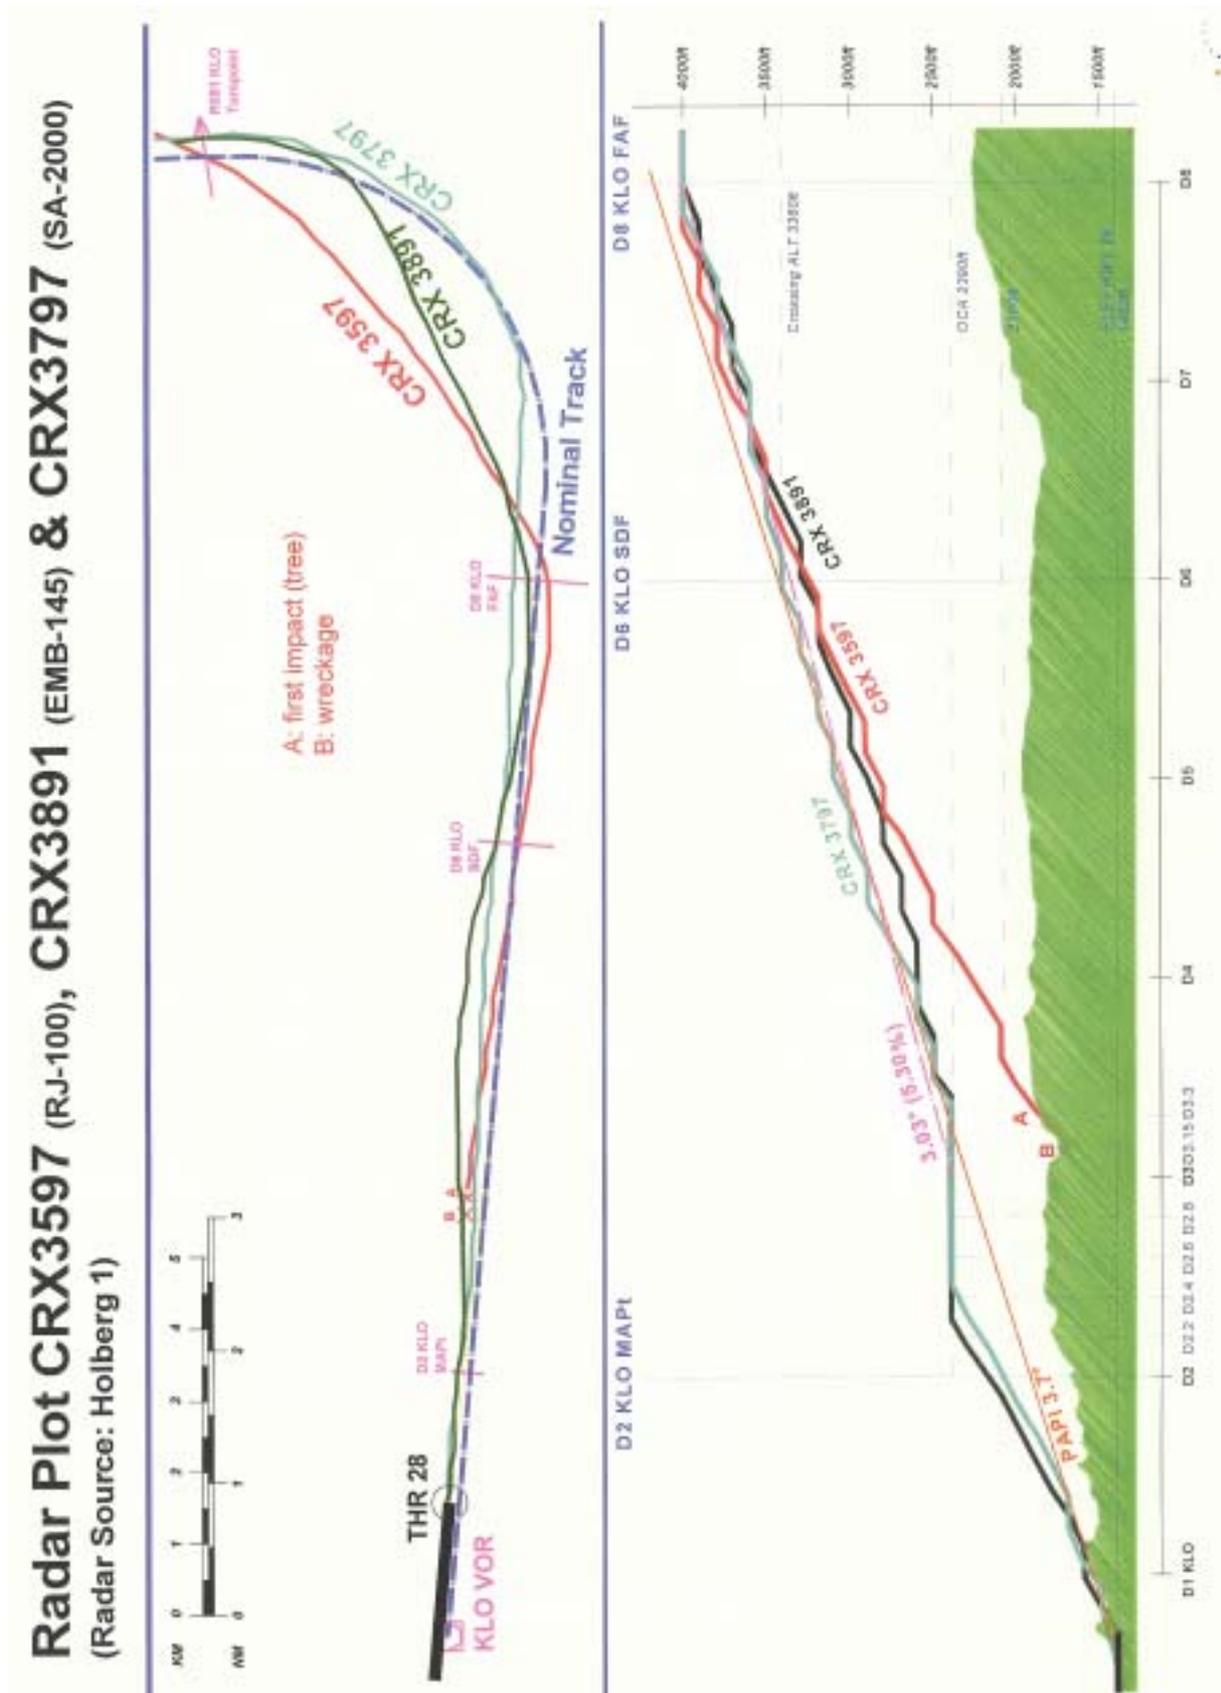
Appendix 4: Approach Profile of Flight CRX 3597

The accident is attributable to the fact that on the final approach, in own navigation, of the standard VOR/DME approach 28 the aircraft flew controlled into a wooded range of hills (controlled flight into terrain – CFIT), because the flight crew deliberately continued the descent under instrument flight conditions below the minimum altitude for the approach without having the necessary prerequisites. The flight crew initiated the go around too late.

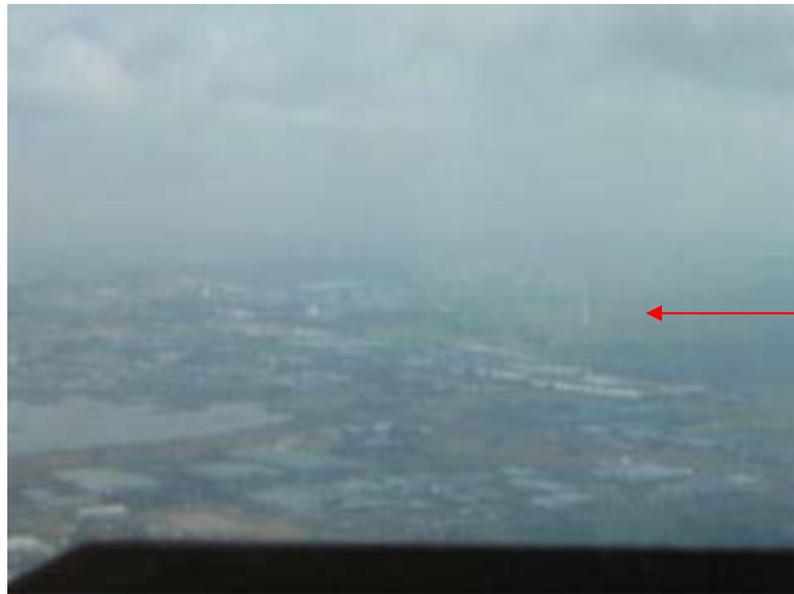
The following picture was made in reality. The aircraft was located as well approx. 1000 ft (MDA) above the threshold elevation on a three degree approach path. The meteorological conditions were as follows: Broken 2000 ft with a visibility of 5000 m.

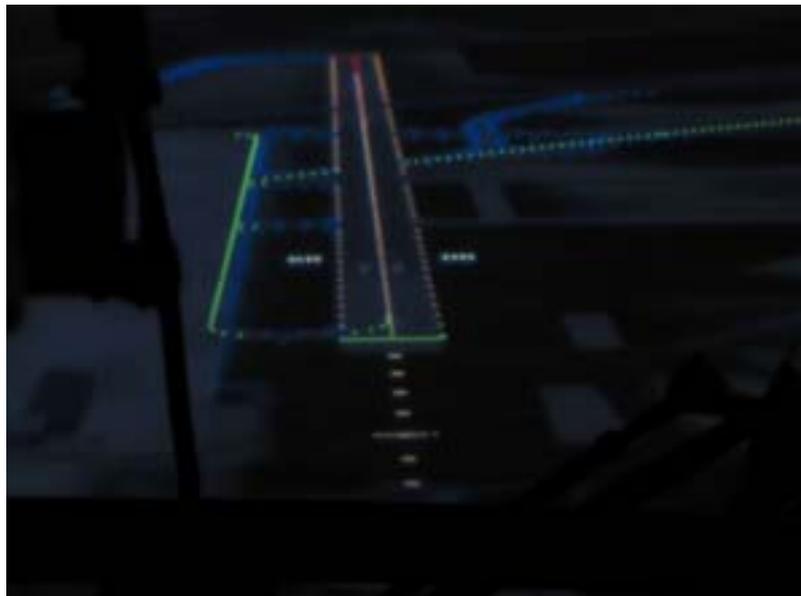
The picture below shows the visual situation as seen by the pilot of an aircraft being at the minimum descent altitude, and approaching the missed approach point with a visibility of 10 km. More or less out of this situation the two preceding traffic CRX3891 (at D2.2 KLO) and CRX3797 (D2.4 KLO) started their final approach descents for landing.

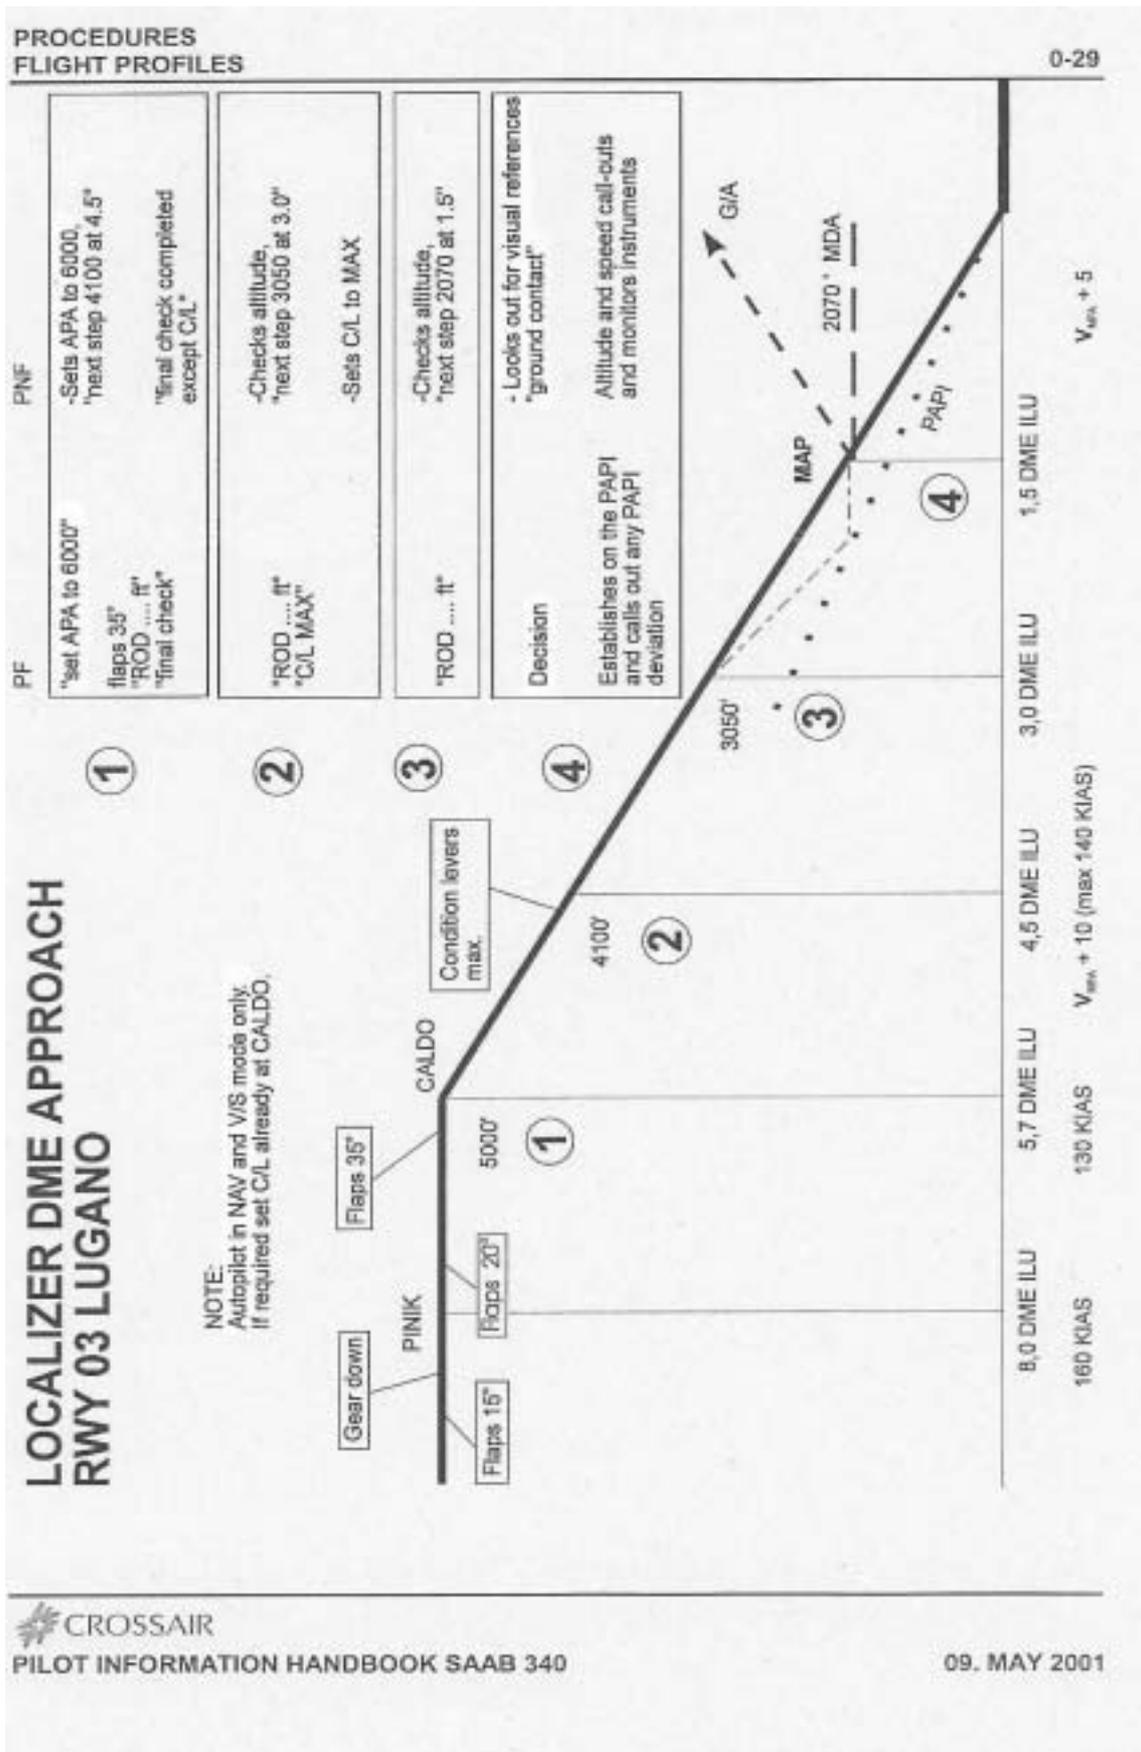
Appendix 6: Localizer DME Approach to Runway 03 in Lugano (today IGS Approach Rwy 01)

According to the statement of the copilot involved, in December 1995 the commander was carrying out an approach to Lugano airport as pilot flying, at night and under instrument flight conditions. Shortly before the Saab 340 reached the PINIK waypoint at an altitude of 7000 ft QNH, the aircraft was configured for the landing, i.e. the landing gear was lowered and a landing flap setting of 35° was selected. For the descent, the commander used the autopilot's vertical speed mode and selected a rate of descent of 4000 ft/min. Since rates of descent of less than 2000 ft/min are usually used for this approach, the copilot asked for the reason for the increased rate of descent. The commander explained that one could implement the procedure in this way. During the descent, which continued unchanged to a radar altitude of 300 ft RA above the lake, the speed of the aircraft increased from 135 to more than 200 KIAS. When the aircraft changed over to horizontal flight at 300 ft RA, part of the lake shore and the mountainside could be seen. The aircraft then flew at this altitude in the direction of Lugano aerodrome until the runway finally came into view and the aircraft was able to land.

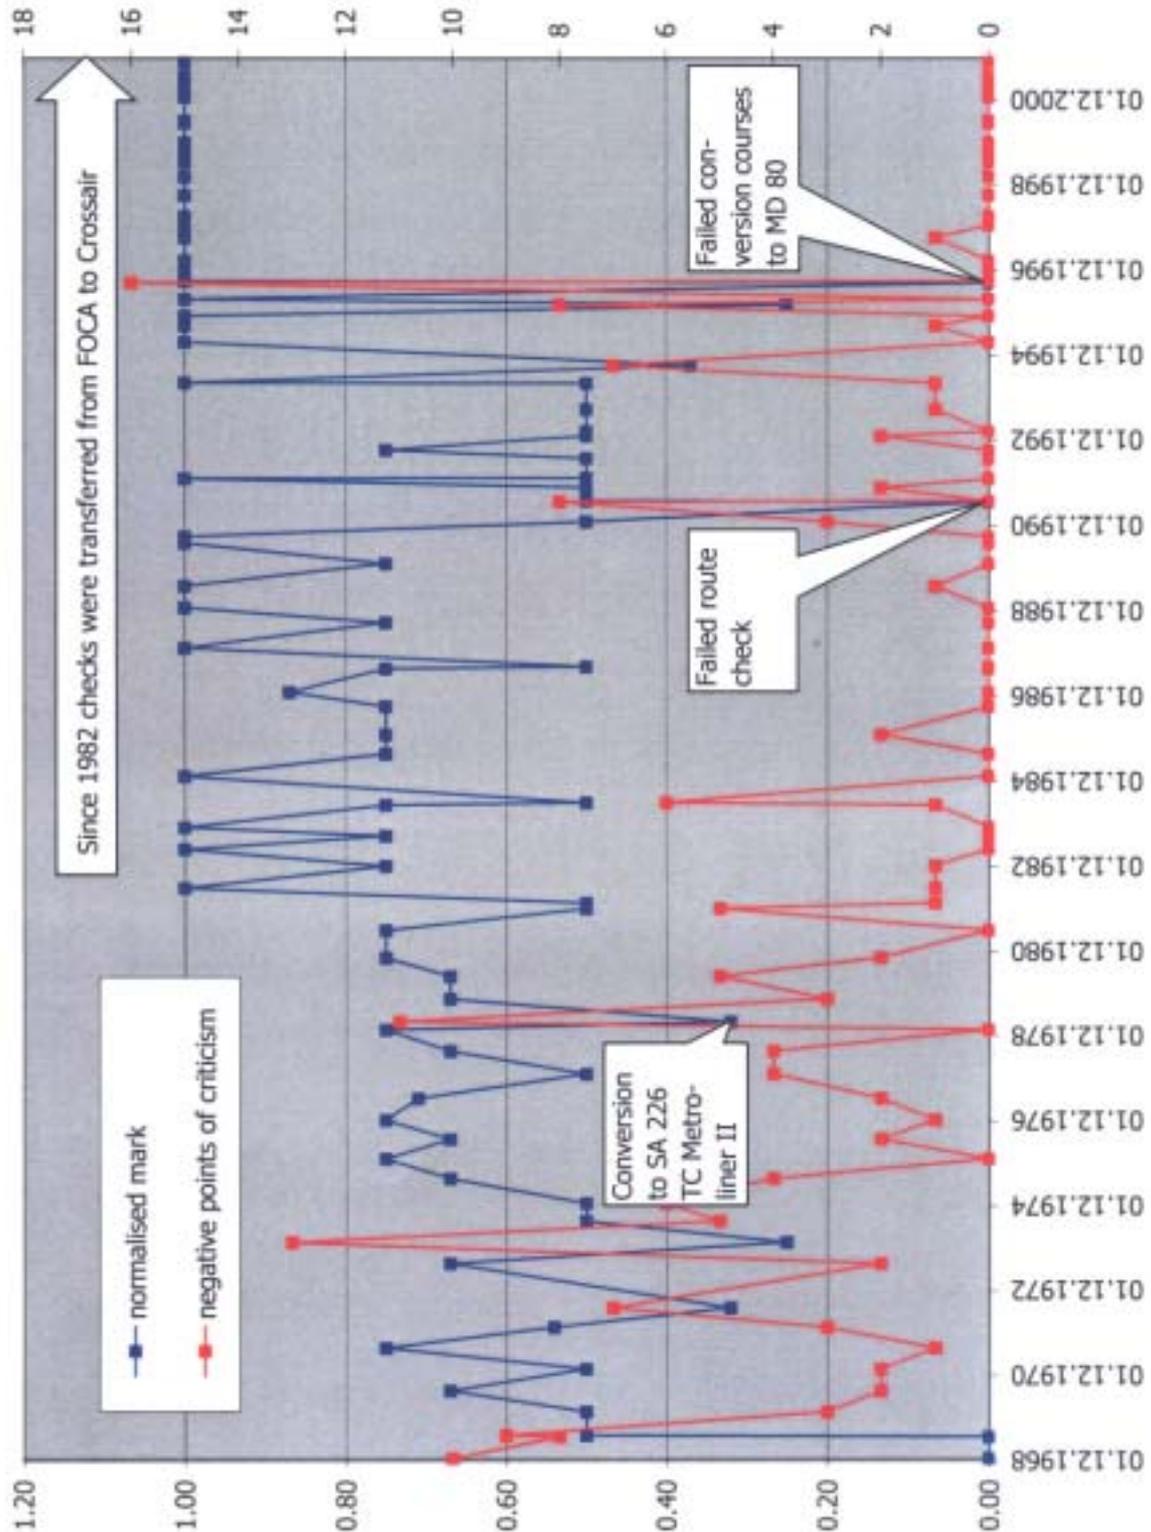
Appendix 9

Graphical compilation of the results of the commander's line, route and simulator checks. Since the marking scale varied over time, the marks were normalised so as to make direct comparison possible (blue data series). A value of 0.5 therefore corresponds to average performance. The number of negative points of criticism mentioned on the checksheets has also been entered (red data series).

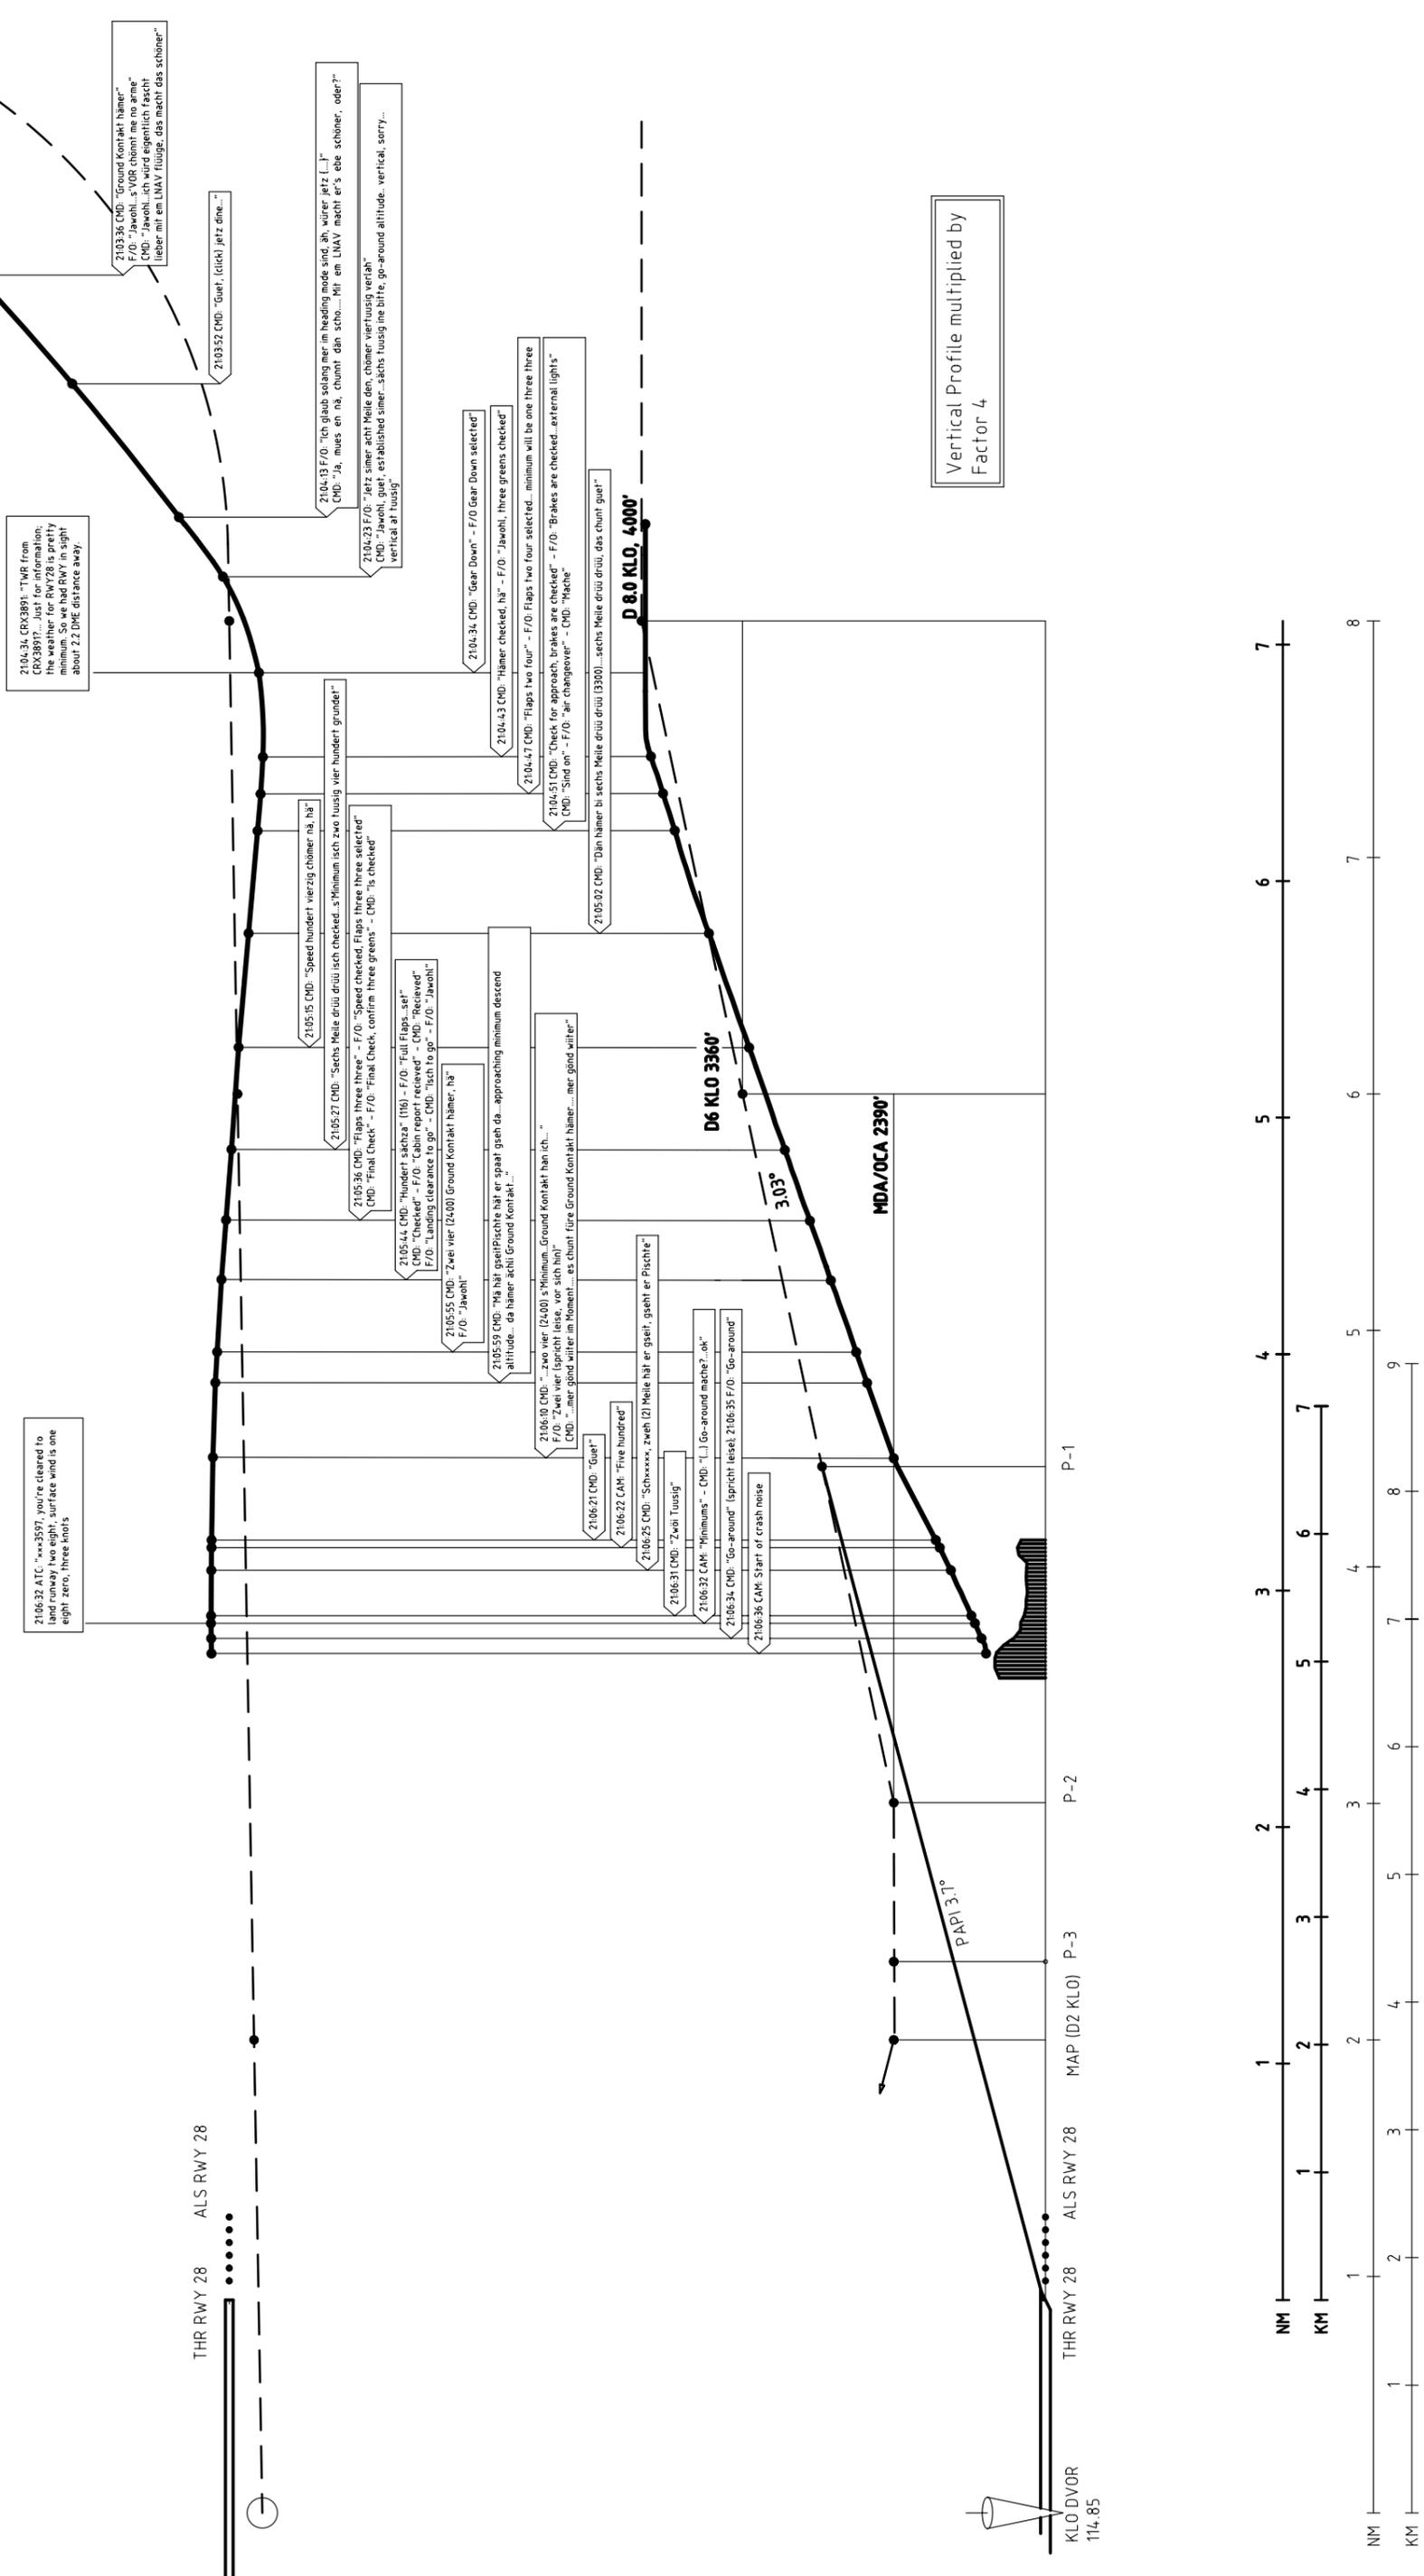
Appendix 10: Detailed Approach Profile of Flight CRX3597

As the aircraft approached the minimum descent altitude (MDA) for the approach, the commander mentioned at 21:05:55 UTC that he had noted this and explained that he had certain visual ground contact: "Zwei vier, ground contact hämmer, hä" – Two four (2400), we have ground contact". The copilot answered: "Yes". At 21:05:59 UTC the commander stated: "Mä hät gseit, Pischte hät er spaht gseh da... approaching minimum descent altitude... da hämmer ächli ground contact..." – Someone said he saw the runway late here ... approaching minimum descent altitude... here we've got some ground contact. At 21:06:10 UTC the aircraft reached the MDA of 2390 ft QNH and the commander said: "...zwo vier, s'Minimum... ground contact han ich... mer gönd wiiter im Moment... es chunnt füre, ground contact hämer... mer gönd wiiter..." - ...two four (2400), the minimum ... I have ground contact ... we're continuing at the moment ... it appears, we have ground contact ... we're continuing on At the same time, the copilot said quietly to himself: "Two four". The descent continued unchanged below the MDA. At 21:06:22 UTC the synthetic voice of the ground proximity warning system (GPWS) announced the radio altimeter reading 500 feet above ground. Immediately thereafter, the commander stated: "Sch*****, zwee Meile hät er gseit, gseht er d'Pischte" – Sh*****, two miles he said, he sees the runway. At 21:06:31 UTC the commander mentioned that 2000 feet had been reached: "Two thousand". In addition, one second later the synthetic voice gave the "minimums" GPWS message, which was triggered by the radio altimeter reading at 300 feet. At 21:06:32 UTC aerodrome control ADC 1 gave flight CRX 3597 the landing clearance. During this radio conversation, the commander said quietly: "...go around mache?" – ...make a go around? At 21:06:34 UTC the commander instructed a go around and an acoustic signal indicated that the autopilot had been switched off. A few fractions of a second later, the copilot likewise expressed the intention to go around. The recordings of the digital flight data recorder prove that the crew pushed the power levers towards the take-off thrust position and the engines' RPM increased. One second later, the CVR began to record the sounds of an impact. A short time later, the CVR recording broke off.
