Investigation Report of the Aircraft Accident Investigation Bureau

concerning the accident

to the aircraft Cessna CE 560 Citation V, HB-VLV

on 20 December 2001

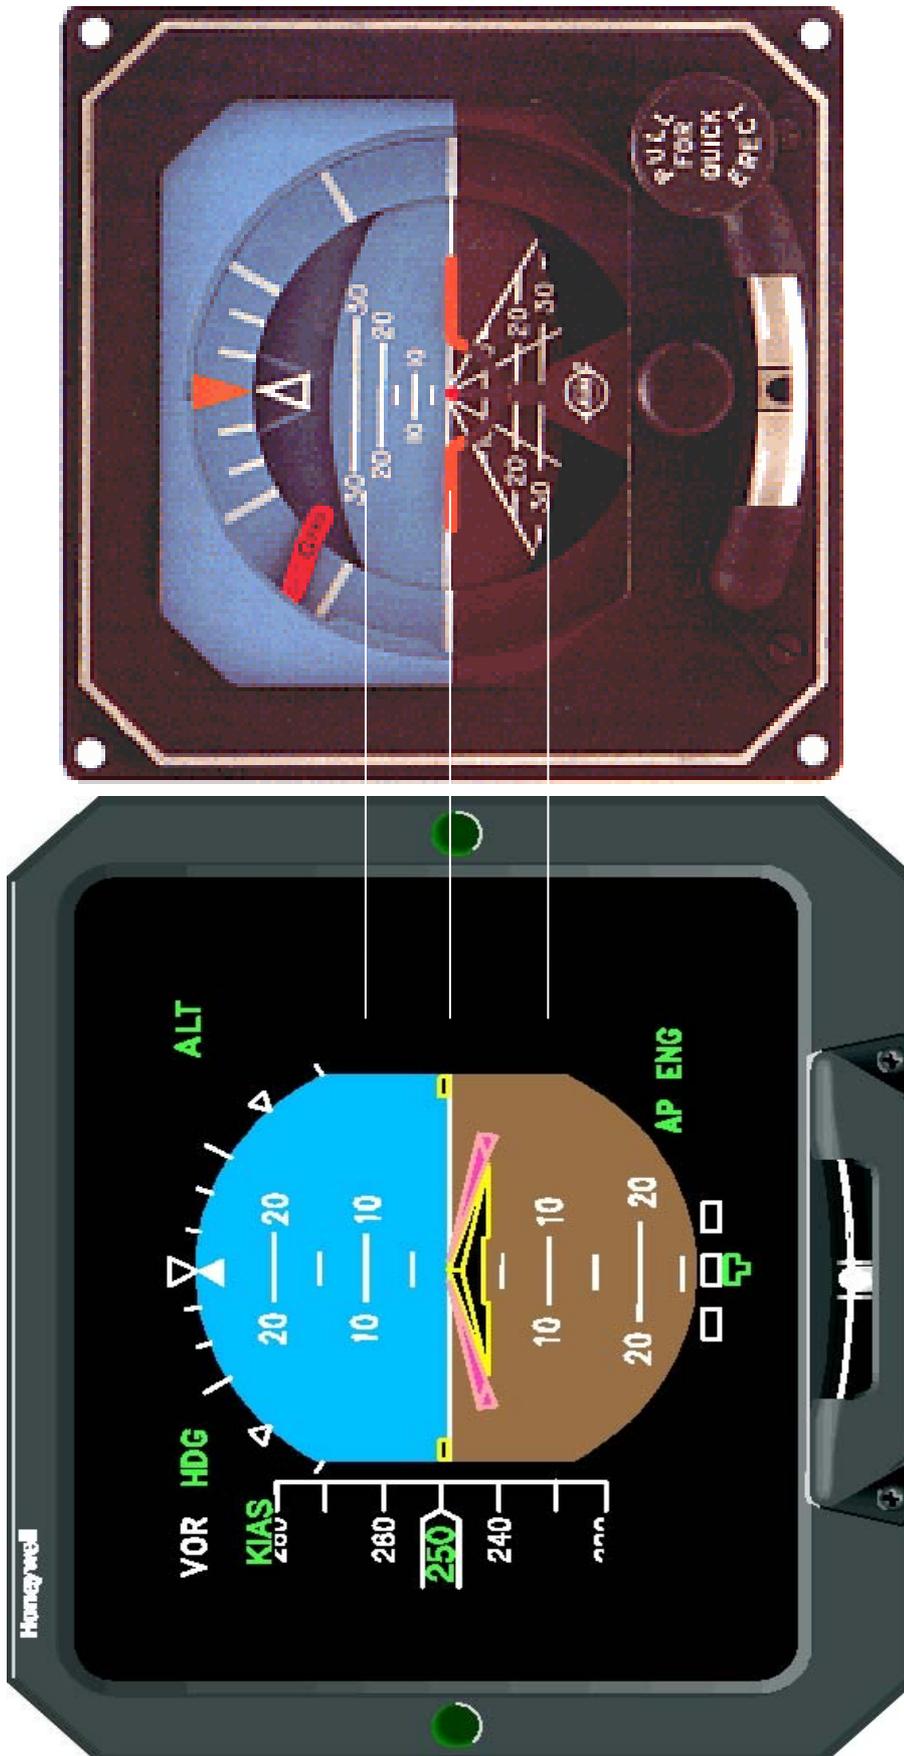
5.1 Comparison EADI and AI, scale 1:1

AI – AIM Horizon

EADI – Honeywell ED600

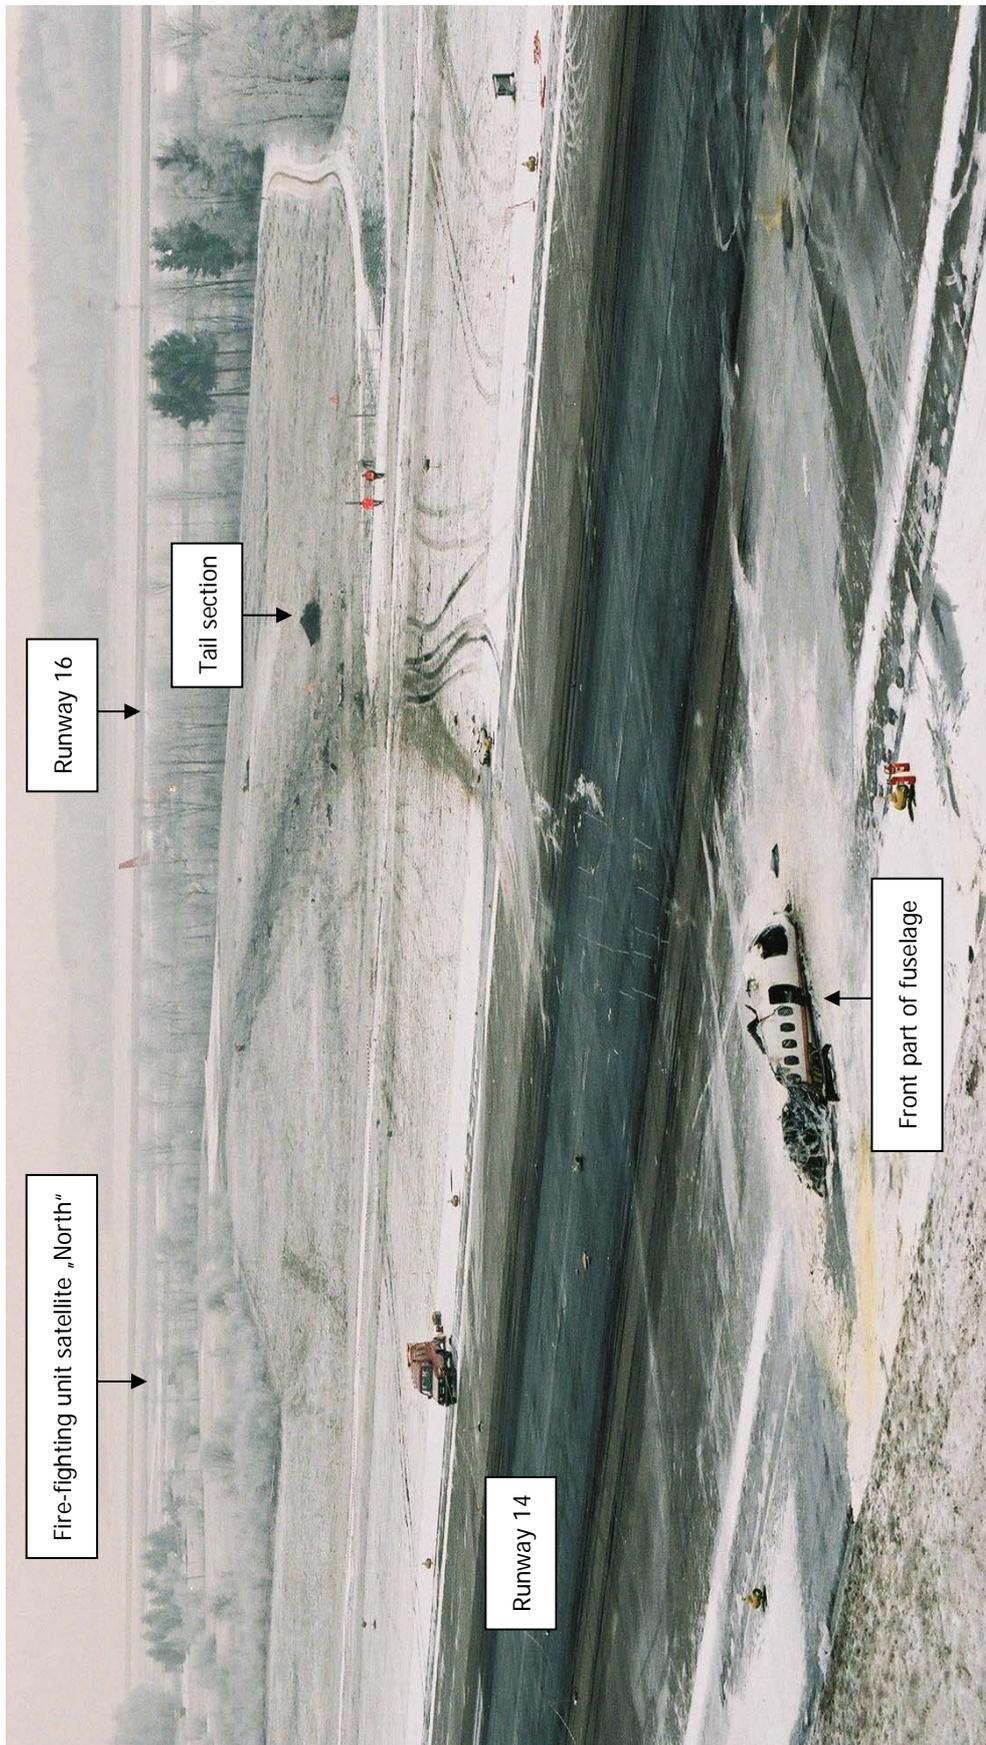
5.7 Accident location

At 21:07 UTC the aircraft impacted onto the frozen ground 400 m to the south-east of the end of runway 34 and skidded in a northerly direction, leaving a trail of debris. The main body of the wreck finally came to rest 500 m beyond the site of initial impact on runway 14/32. The rescue services reached the burning wreck after a few minutes.
