Final Report No. 1874 by the Aircraft Accident Investigation Bureau

of the aircraft Beech Super King Air 300LW, D-ICBC

on 14 February 2002

on the Piz Sarsura (20 km NE of Samedan aerodrome),
Zernez municipality

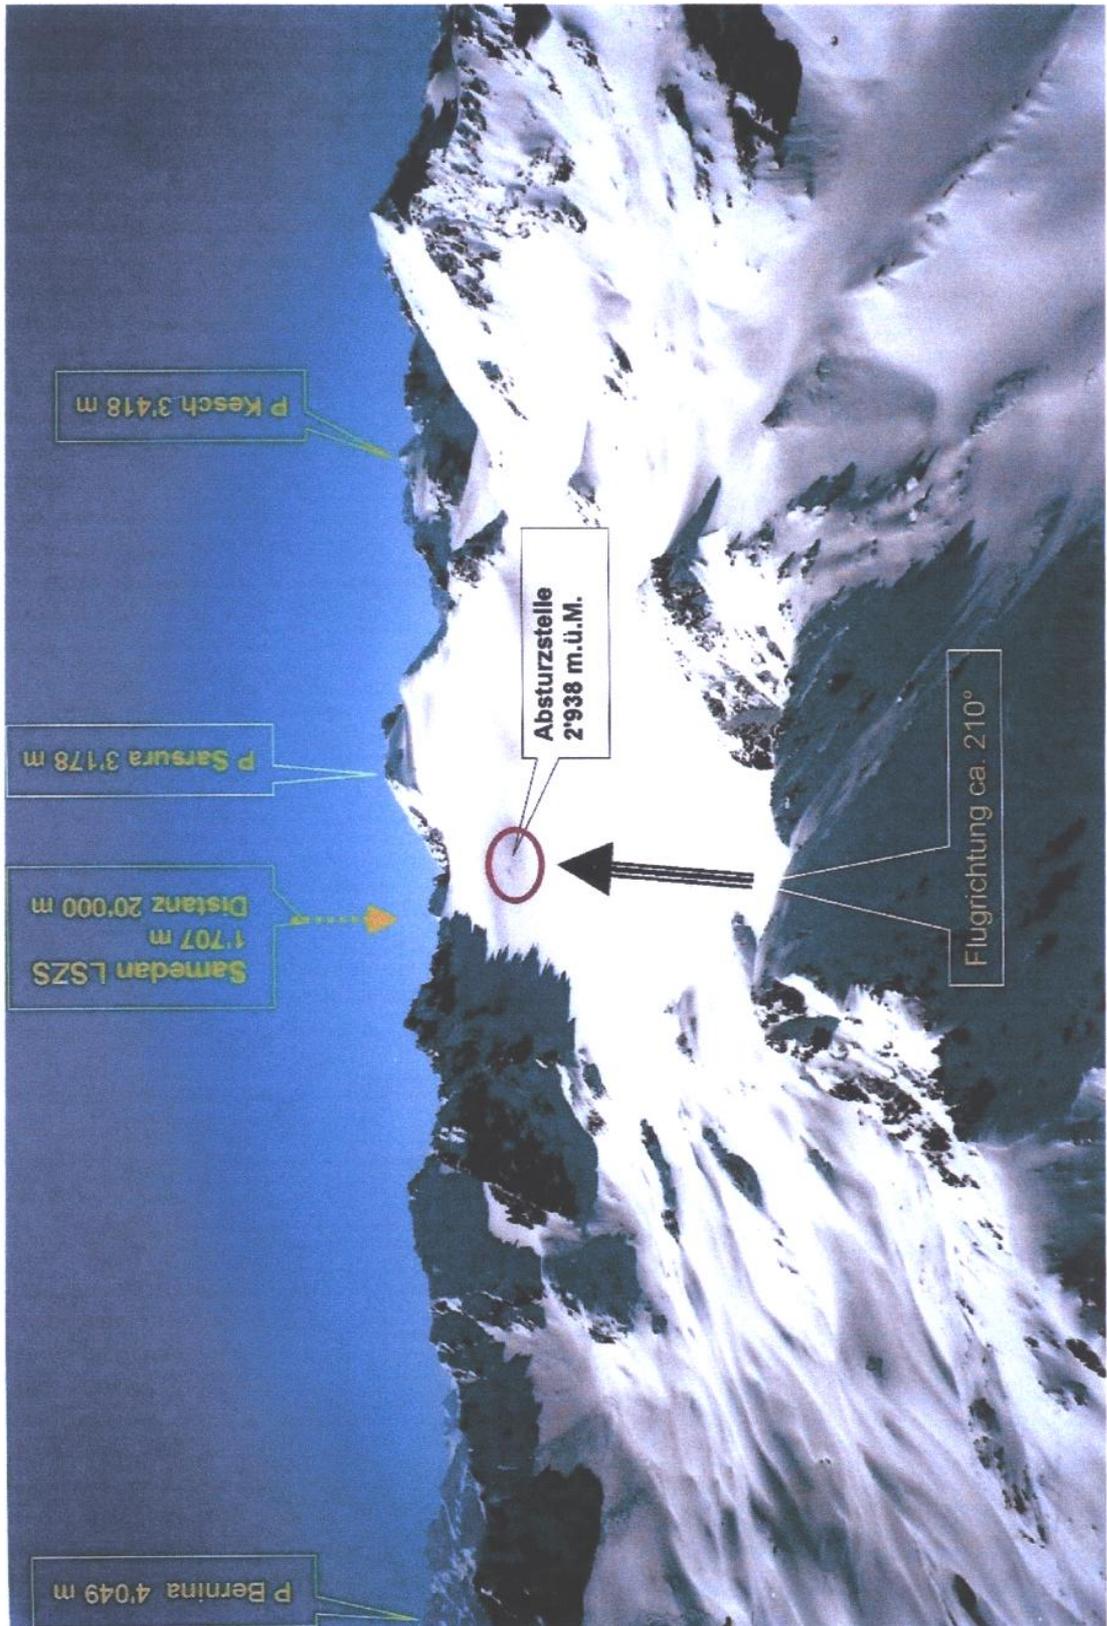
Ansicht Unfallstelle

The aircraft impacted the gently inclined Sarsura glacier without any substantial bank angle and at a small angle. At the site of the accident, the depth of the slightly compressed snow was approximately 2 m (approximately 60 cm of fresh snow).

The initial impact took place at an elevation of 2938 m/M, 240 metres below the eastern peak of the Piz Sarsura (3178 m/M) at coordinates 796 000 / 174 800 (sheet Zernez No. 1218 of the 1:25,000 national map of Switzerland). This point was located along the extended centreline of runway 21 of Samedan aerodrome. The distance to the threshold of runway 21 was 19 km.

The approximate direction of impact was 210°, which corresponds fairly accurately with the orientation of runway 21.

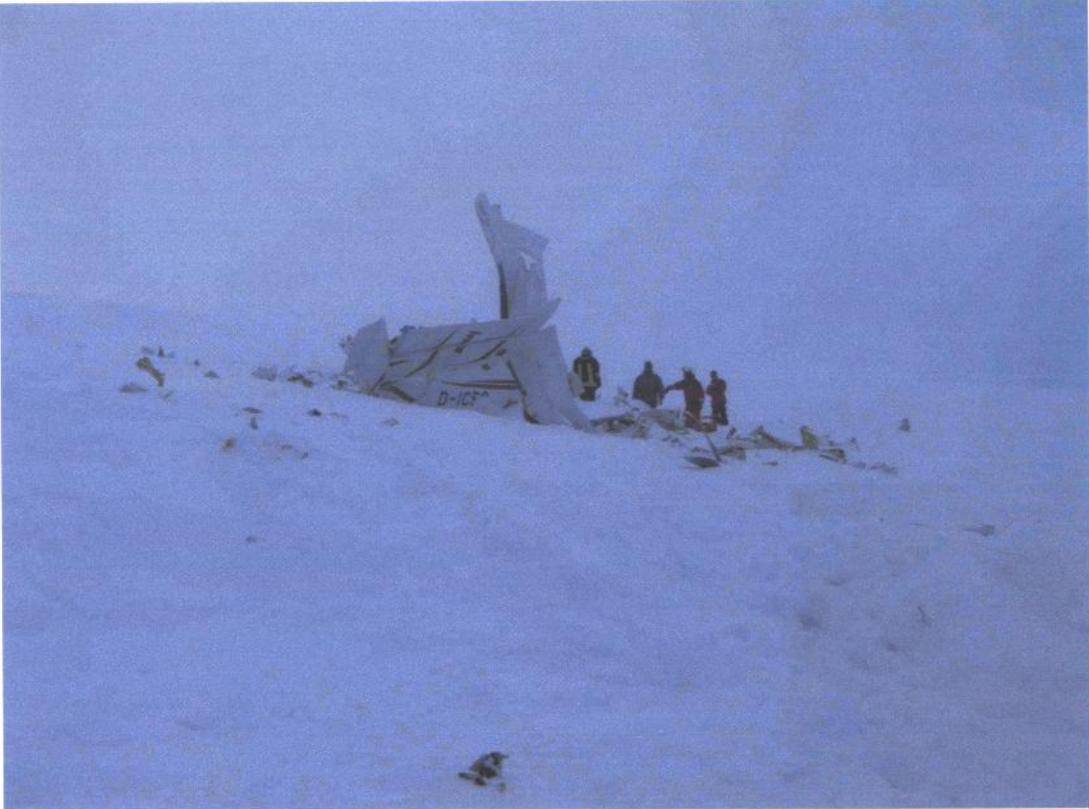
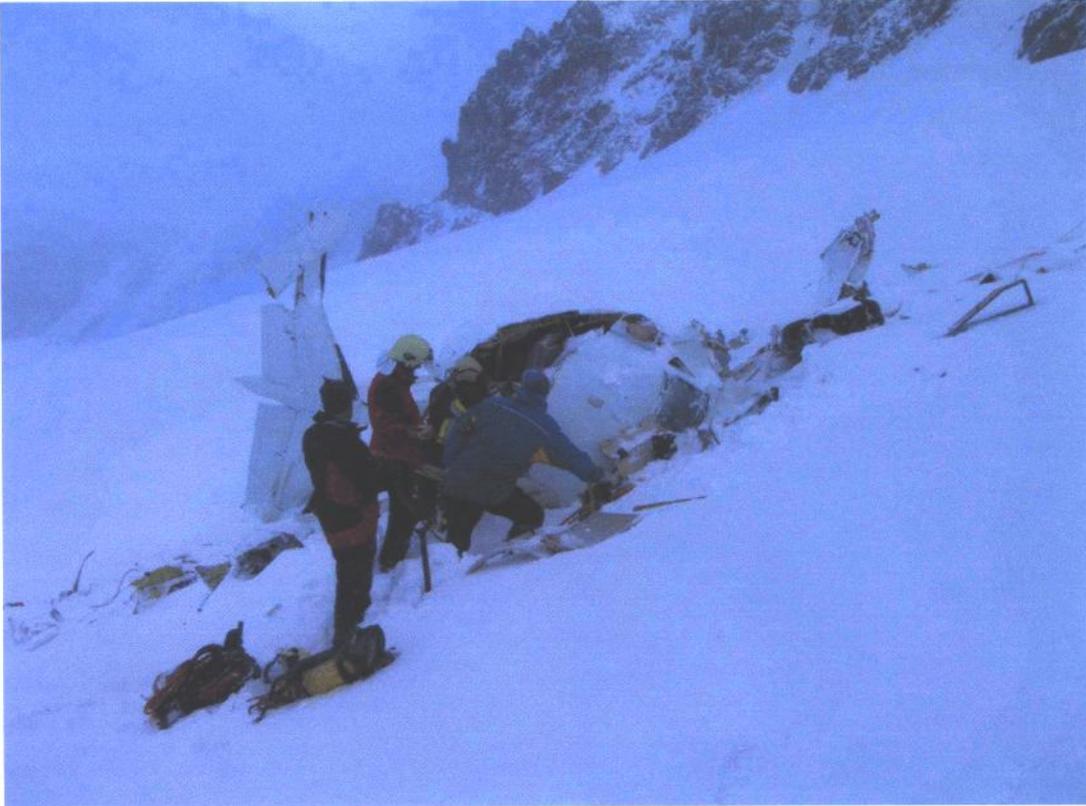
Ansicht Wrack

The right wing was partially torn off from the fuselage, but lay as a compact component together with the aileron and the flap near the fuselage. The aileron position was neutral. The flaps were partially extended. The engine was torn from its mount. The engine cowl was destroyed. The wing tank was destroyed.

The left wing was torn from the fuselage and turned rearward to the left from the engine cowl. The wing was considerably rotated upward inside. The aileron and the flap were still partly hanging from the wing. The position before impact could not be determined.

The cockpit area was badly damaged and the nosecone was shattered.

The fuselage tube was torn in the rear section near the pressure bulkhead.

The top of the fuselage was practically intact over the front section and damaged by the elevator assembly over the rear section.

The front section of the underside of the fuselage was badly damaged as far back as to the wings. Behind the trailing edge of the wings, the fuselage was virtually undamaged.

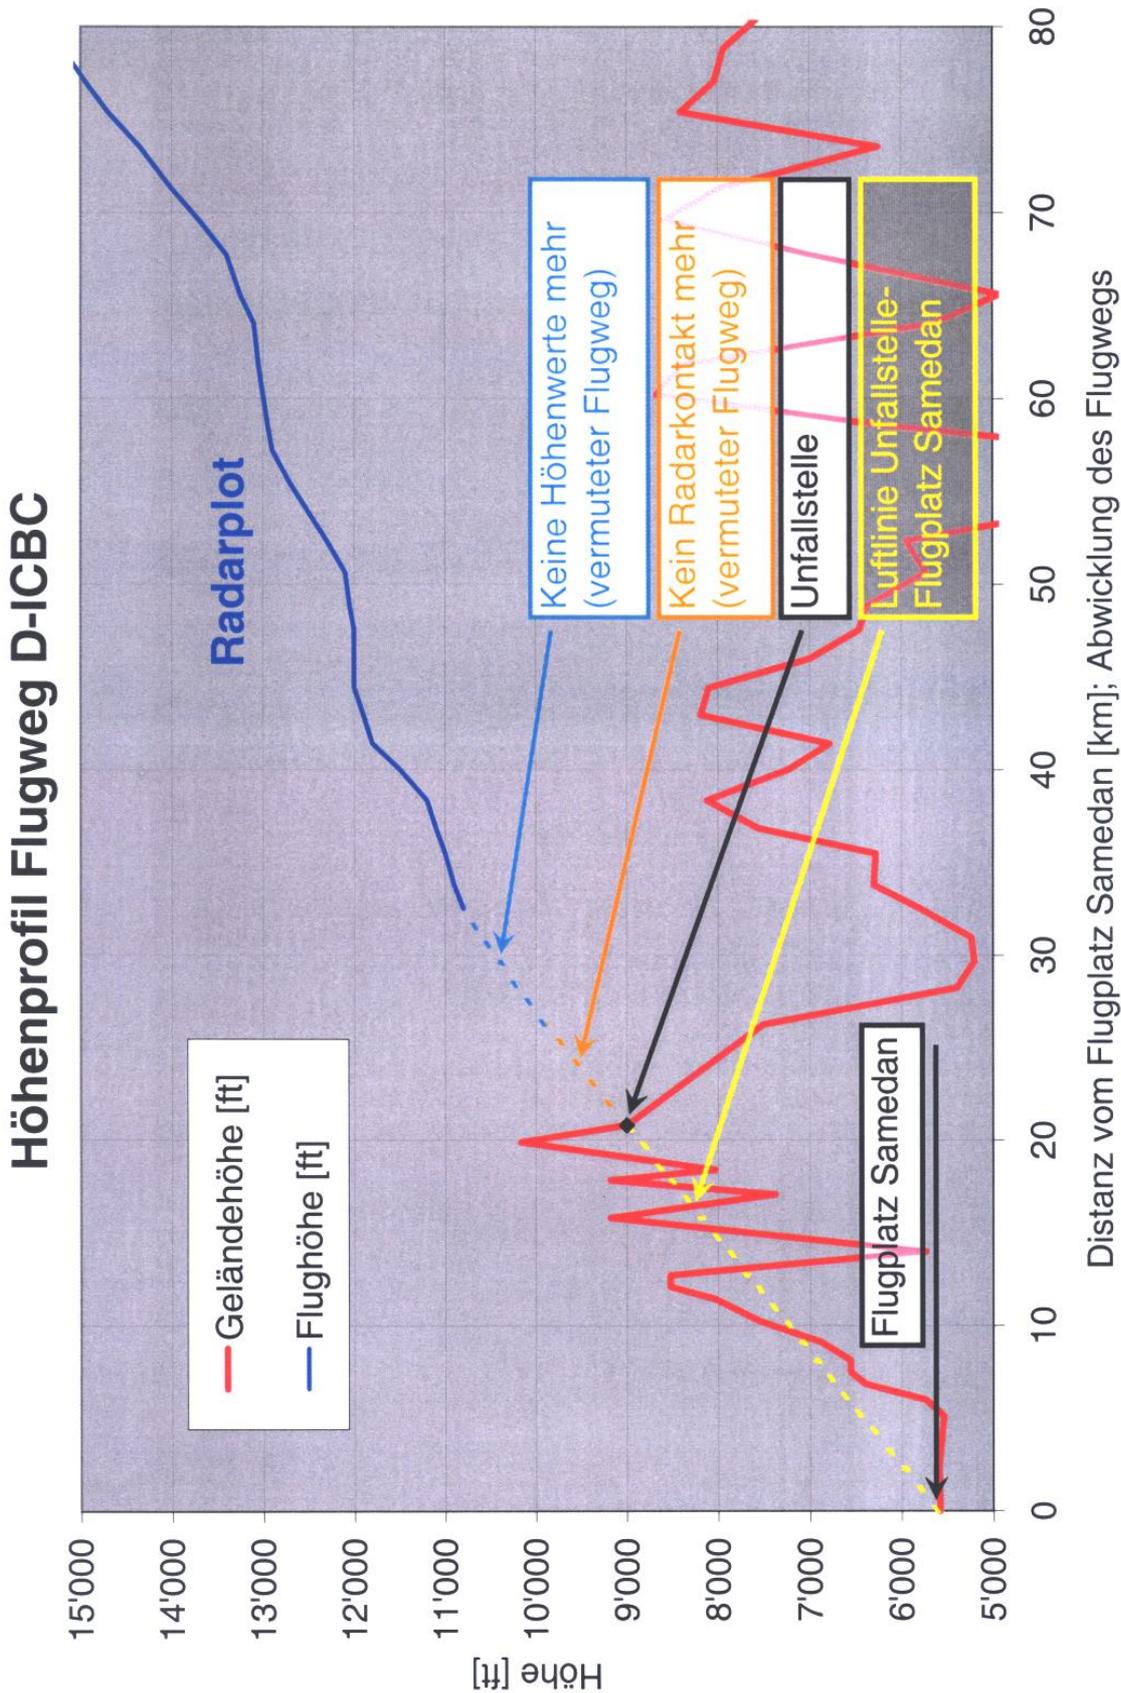
Geländeprofil entlang des Flugweges und der Projektion bis zur Piste 21

A calculation showed that the site of the accident was on an approach angle of 4° in relation to the threshold of runway 21 (see Annex 6).
