AIRCRAFT ACCIDENT REPORT

**CONTROLLED FLIGHT INTO TERRAIN
AIR CHINA INTERNATIONAL FLIGHT 129
B767-200ER, B2552
MOUNTAIN DOTDAE, GIMHAE
APRIL 15, 2002**

**KOREA MINISTRY OF CONSTRUCTION AND TRANSPORTATION
KOREA AVIATION-ACCIDENT INVESTIGATION BOARD**

KAIB/AAR F0201
Adopted March 4, 2005

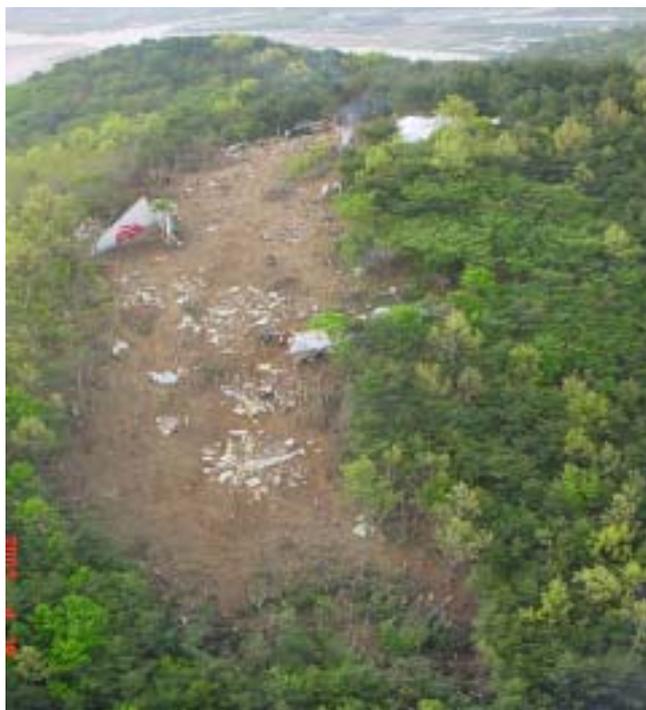
Figure 1-3 Site of Forest Damage

Damage to the forest on Mt. Dotdae of some 8,000 m², including 12 grave sites, was caused by the aircraft’s impact with trees and the ground, along with the spread of the wreckage.¹⁴

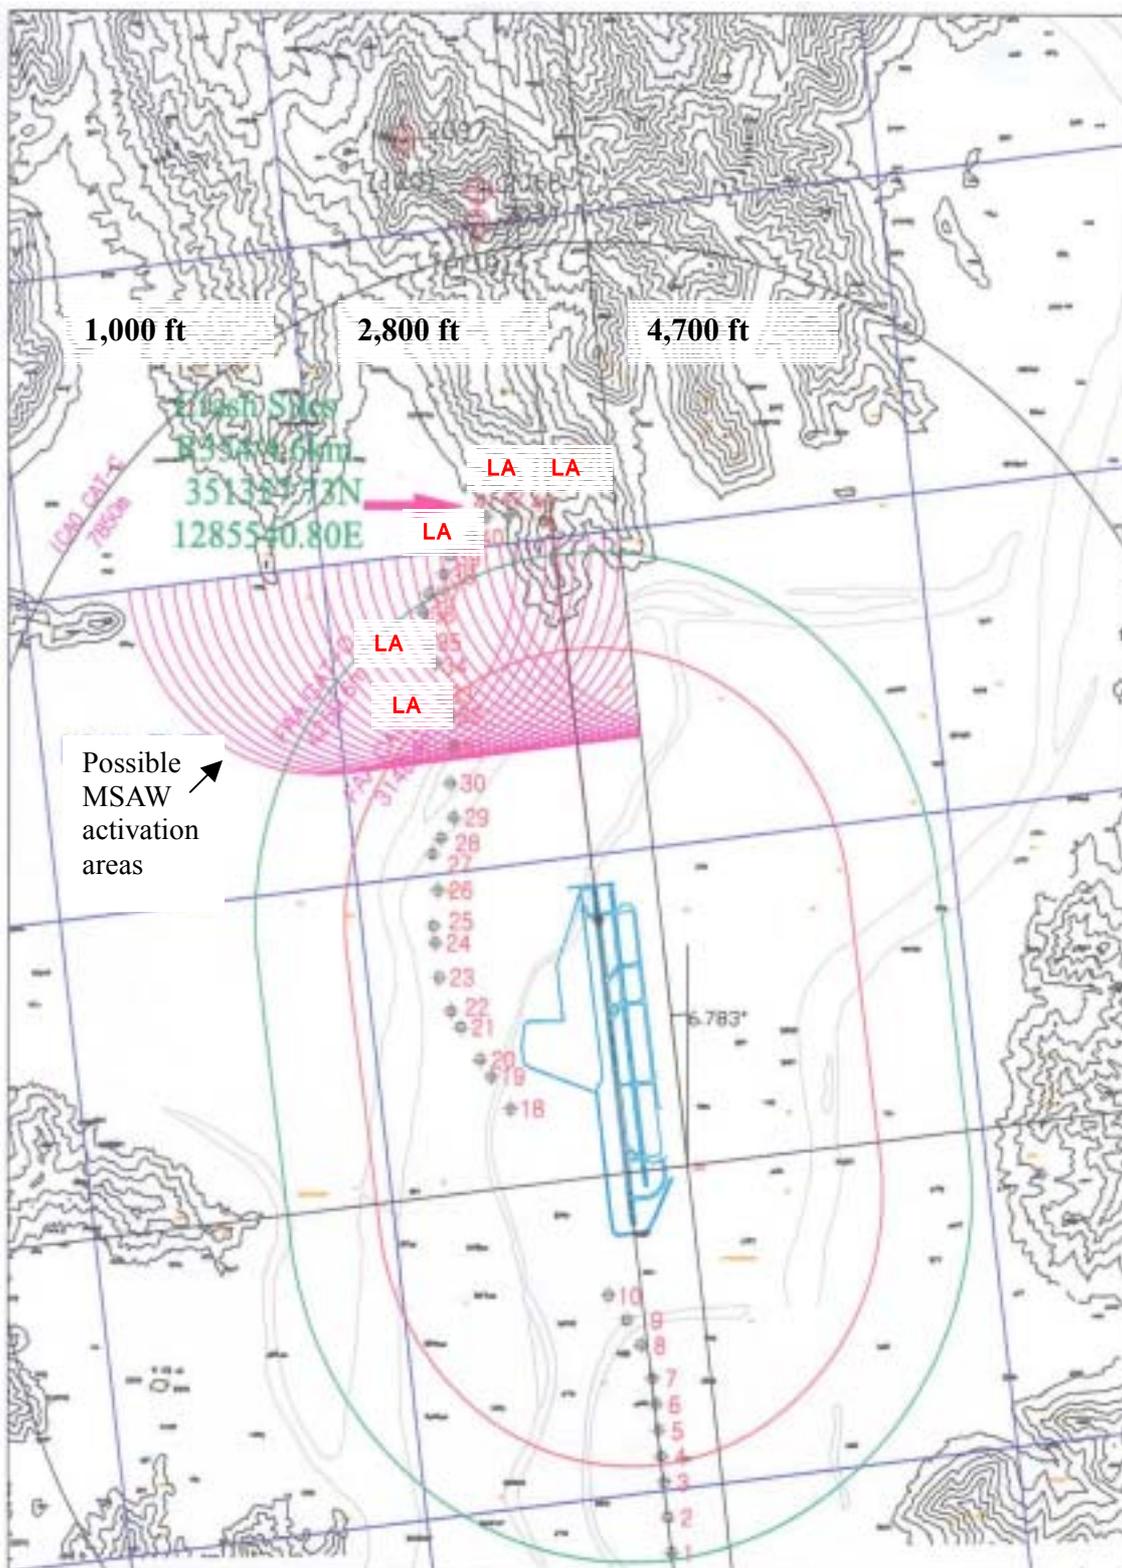
Figure 1-9 Possible MSAW Activation Areas and Circling Approach Area

⁶¹ The areas where the predictive warning can be activated in accordance with flight distance by the aircraft heading and speed by means of MSAW predictive warning function (in the case of flight 129, the predictive warning was possible in front of about 1.4 NM, applying 170 kt of ground speed).

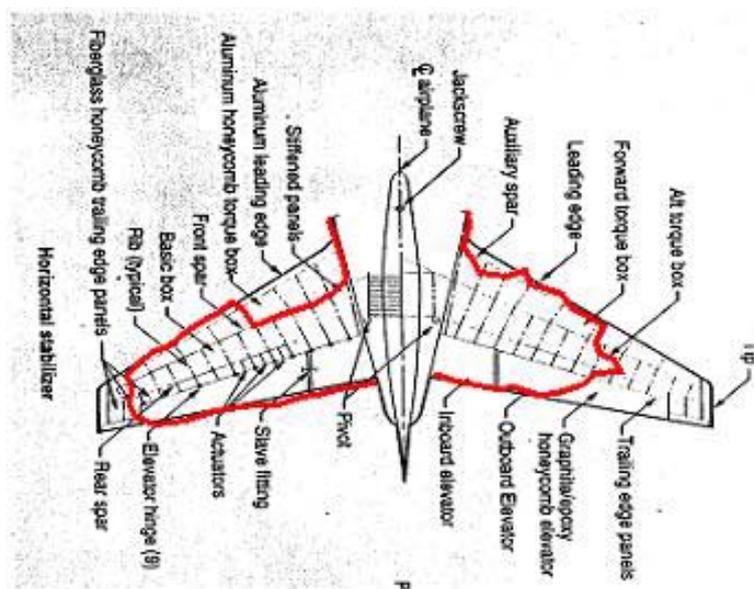
Figure 1-16 The Remaining Portion of the Wreckage (inner area of red line)

The front surface of the left horizontal stabilizer (as shown on Figure 1-16) was damaged and the tip was sheared off by an impact with the trees. While there were signs of the impact with trees on the front inner part of the left stabilizer, there was no sign of the preimpact skin corrosion or damage.

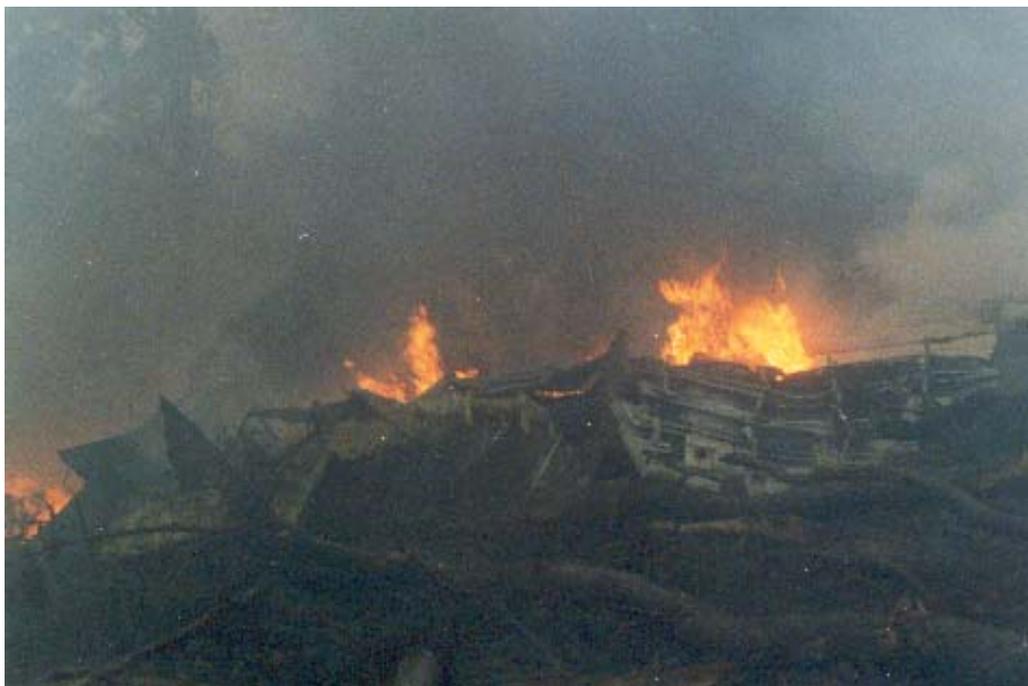
Figure 1-17 Photograph of the Aircraft on Fire after Crash

At the accident site, it was raining with heavy fog. Fire fighters, soldiers and police struggled to apply dry chemical and halon fire extinguishing agents, and dirt to put out the fire, but the interiors of the cabin and flight deck were burnt completely, as shown on Figure 1-17. The fuselage fire, accompanied with exploding sounds and heavy smoke, was extinguished about 15:00 on the day of the accident.

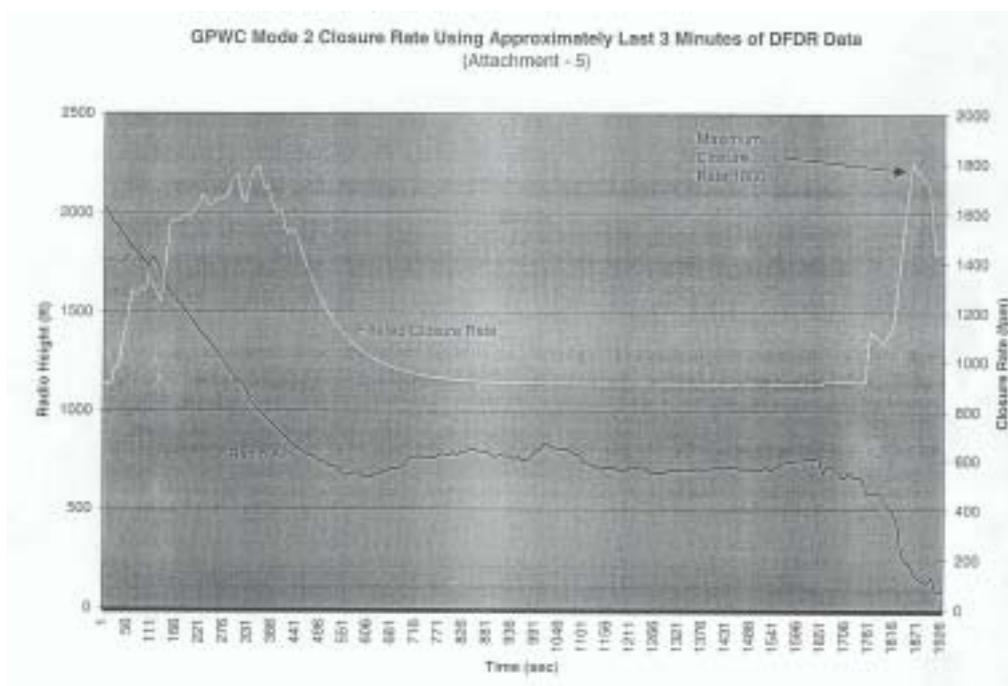
Figure 2-1: During the Last 3 Minutes of DFDR Data, GPWC Mode 2 Closure Rate

According to a close examination¹⁷⁷ by Boeing of the radio altitude data of the FDR, the descent rate for the last 3 minutes from an altitude of 2000 ft until the ground impact increased from about 900 fpm to 1800 fpm, and at 700ft on the circling approach, it decreased to 900 fpm. It again increased to 1800 fpm just before the impact, as shown in the figure 2-1.

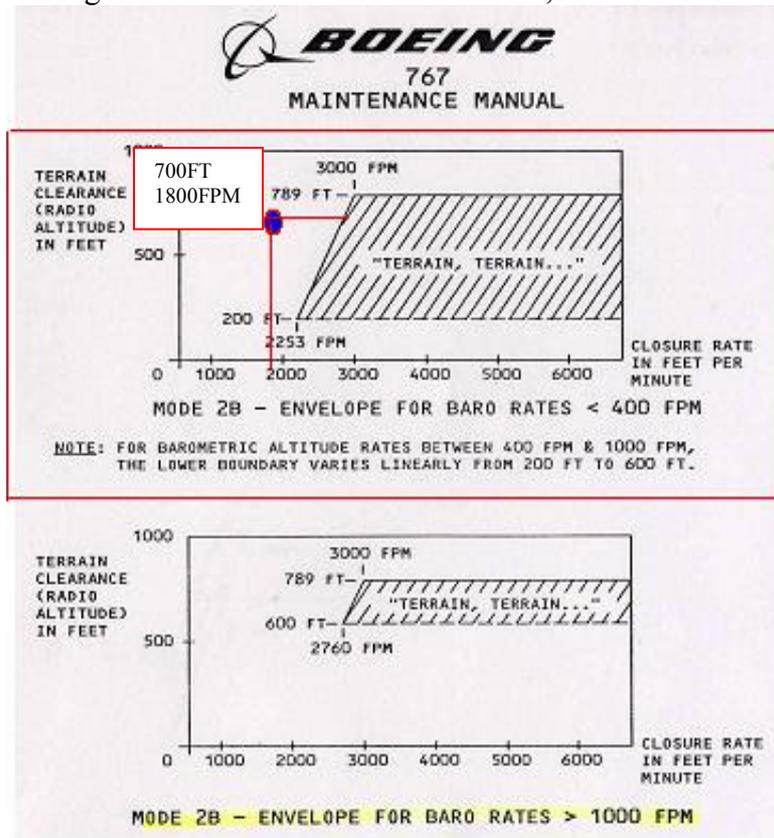
Figure 2-2 : Mode 2B Envelope for Barometric Rates < 400 FPM (Indication part)

The aircraft was in level flight and the baro rate was zero at the impact with Mt. Dotdae, which, as marked on the upper part of Figure 2-2, is applicable to Mode 2B-envelope for baro rate < 400 fpm. According to the Figure, when the closure rate is 2,253 fpm~3,000 fpm, Mode 2 warning will be generated per design. In the case of flight 129, the maximum closure rate was 1,800 fpm, which was outside the Mode 2B-envelope to generate the warning. Therefore, it was confirmed to be normal that the MK- III GPWC installed in the aircraft did not generate any warning.

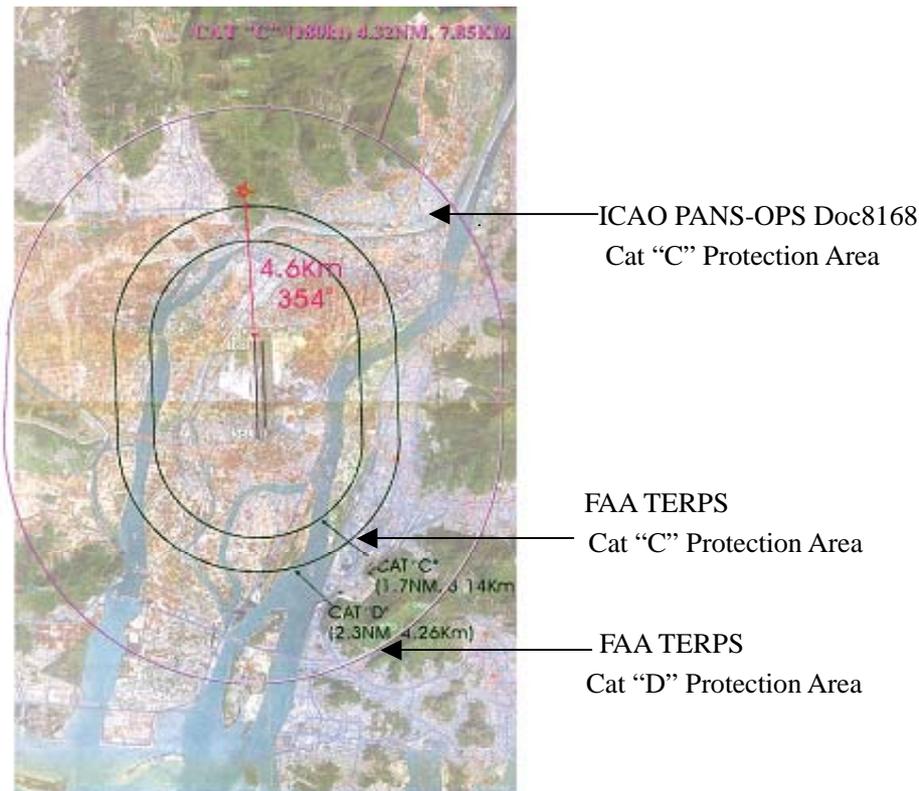
Figure 1 Relationship between aircraft crashed site and circling protection area

The aircraft crashed at a point 4.6 km form the runway threshold with true azimuth of 354°, which was outside TERPS Category "D" protection area but inside ICAO PANS-OPS Category "C" protection area.

It is difficult for pilots and controllers to understand and distinguish the difference between these two criteria, particularly when the two criteria are applied simultaneously in one country without a clear and definite explanation.
