Aviation Occurrence Report Volume I

ASC-AOR-05-02-001

IN-FLIGHT BREAKUP OVER THE TAIWAN STRAIT
NORTHEAST OF MAKUNG, PENGHU ISLAND
CHINA AIRLINES FLIGHT CI611
BOEING 747-200, B-18255
MAY 25, 2002

AVIATION SAFETY COUNCIL

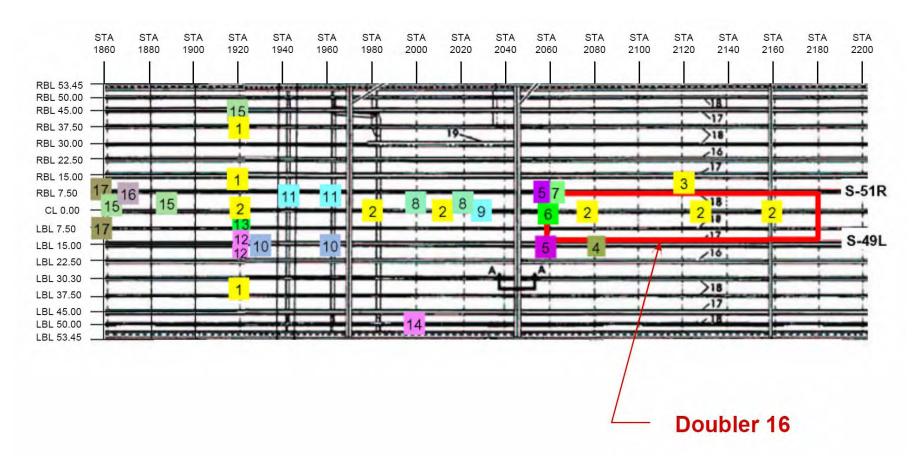
Figure 1.6-5 Locations of discrepancies adjacent to the STA 2060 doubler

The above defects were corrected by the approved methods.

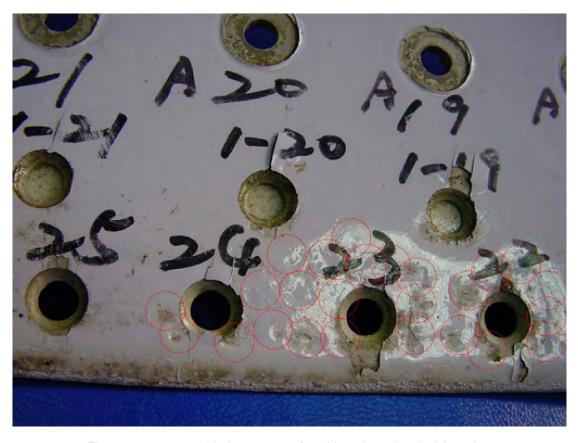
The exterior skin of number-16 doubler with various types of cavities around the rivets and along the edge of doubler can be observed as shown in Figure 1.6-10. Paint (topcoat) was present up to the edge of the doubler without sealant. In the same doubler paint (topcoat) was removed from the edge of the doubler during the doubler disassembly process, the sealant was still present, as shown in Figure 1.16-11.

Figure 1.6-10 Various types of cavities along the doubler edge

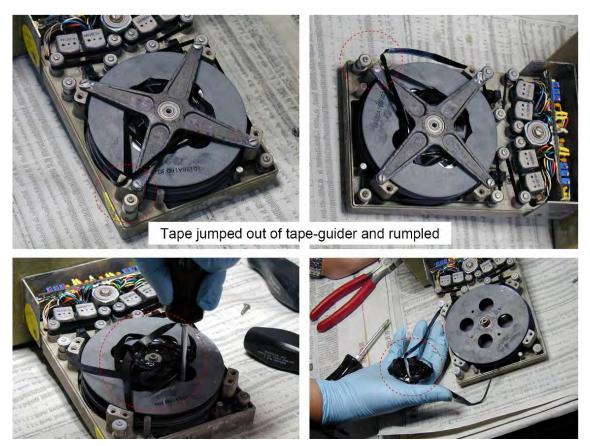
Figure 1.11-3 Photographs of damaged magnetic tape

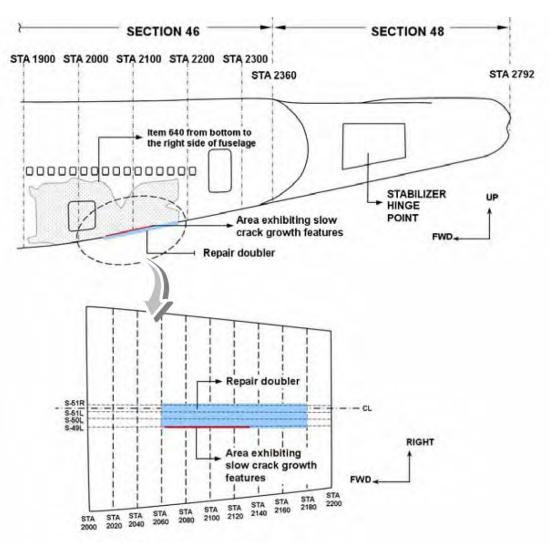
Figure 1.12-7 Item 640 and the repair doubler

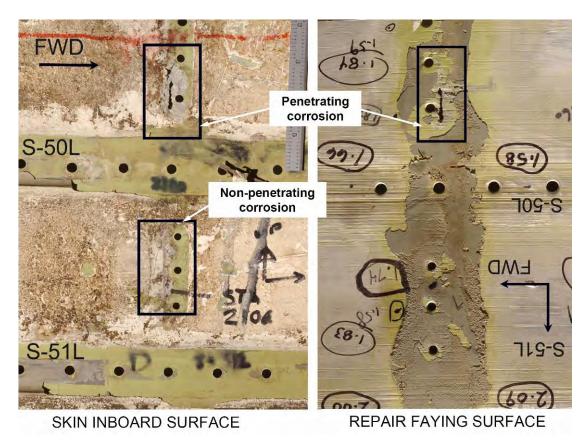
Corrosion was noted at several shear tie locations on the skin inboard surface sometimes penetrating completely through the skin thickness. Figure 1.16-5 shows the corrosion features near STA 2100. General features of this damage and condition of the skin indicate that the corrosion was not the result of salt-water immersion after the event. Table 1.16-2 displays all the corrosion features found on item 640C1.

Figure 1.16-5 Skin corrosion features at STA 2100

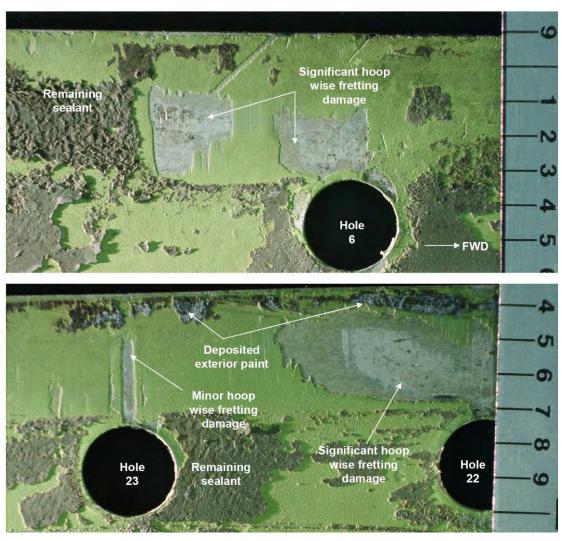
- The fretting marks observed from STA 2061 (hole +16) to STA 2132 (hole 49) are associated with most of the rivet locations. The most significant fretting damage was present between holes 8 and 43.
- The fretting marks near hole 32 and an optically magnified photograph of the area of contact is shown in Figure 1.16-9. It shows that the area of contact exhibits many colors and some hoop-wise scratches (marked by arrows).
- Two cross-section locations were chosen to characterize the area of contact.
 Figures 1.16-10 and Figure 1.16-11 show the metallographic photographs
 through the area marked by data sampling cut #1 and data sampling cut #2
 respectively. It is observed that there was some material superimposed
 over the grooves of the scratches.

Figure 1.16-8 Fretting damage observed on faying surface of the repair doubler

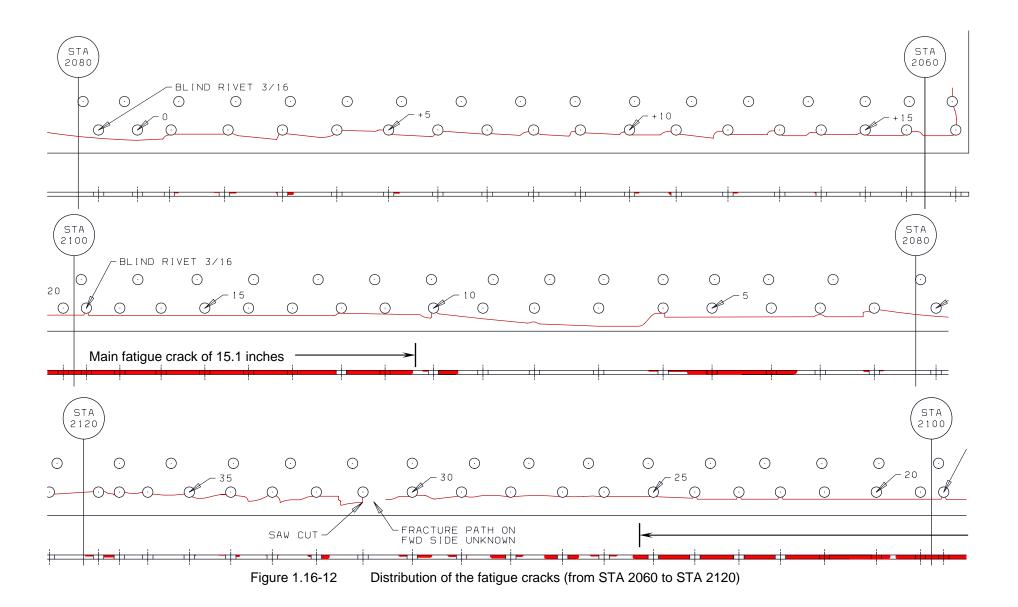
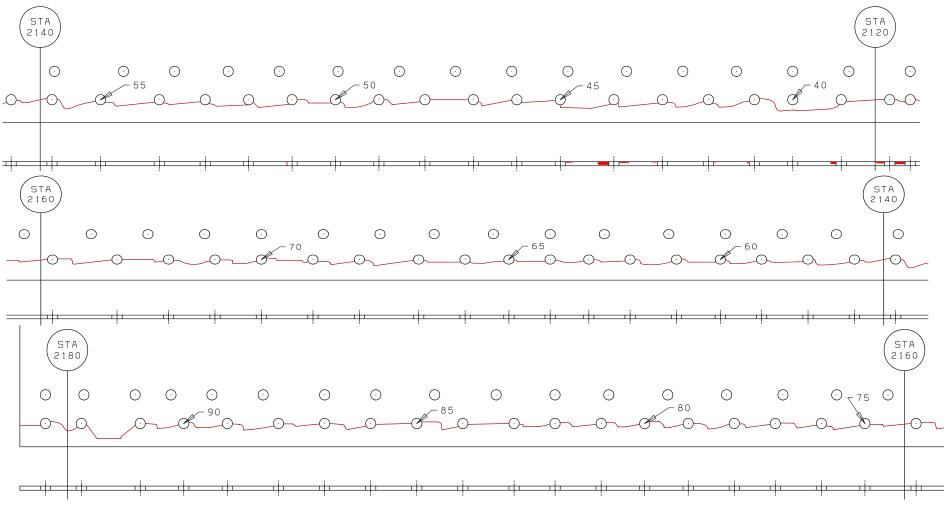
Figure 1.16-13 Distribution of the fatigue cracks (from STA 2120 to STA 2180)

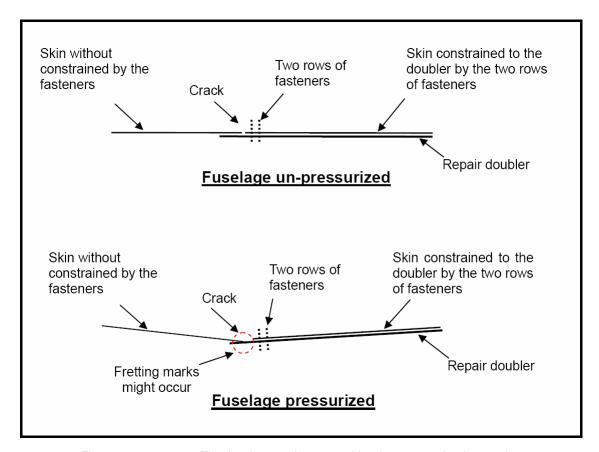
portion of the repair doubler was consistent with this phenomenon (Figure 1.16-8).

Figure 2.2-8 The fretting marks caused by the pressurization cycles

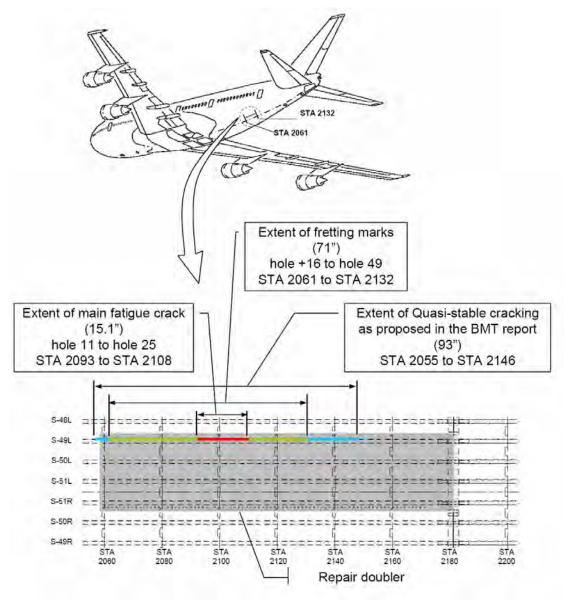
According to these observations, the BMT report suggested a pre-existing crack in the skin continuously from STA 2055 to 2146, or approximately 93 inches in length prior to the in-flight breakup. The diagram of different length of crack was shown in Figure 2.2-12.

Figure 2.2-12 Different signs of cracks

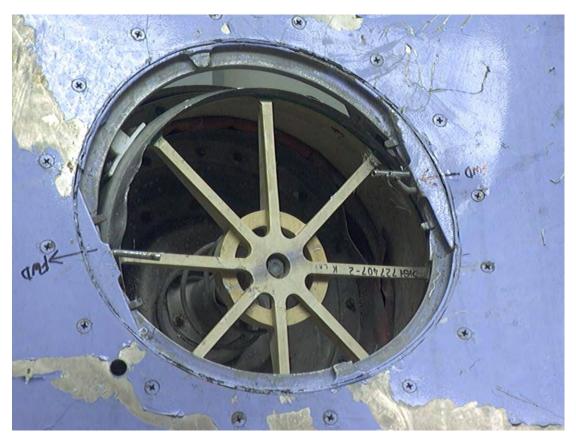
The visual inspection result shows the Upper Pressure Relief valve (Figure 2.7-5) has been deformed inward, the blowout doors are missing, the gate web fractured, FWD upper hinge pin is bent, lower hinge pin missing, AFT lower hinge pin is bent and all hinge pins are moveable.

Figure 2.7-5 Upper pressure relief valve

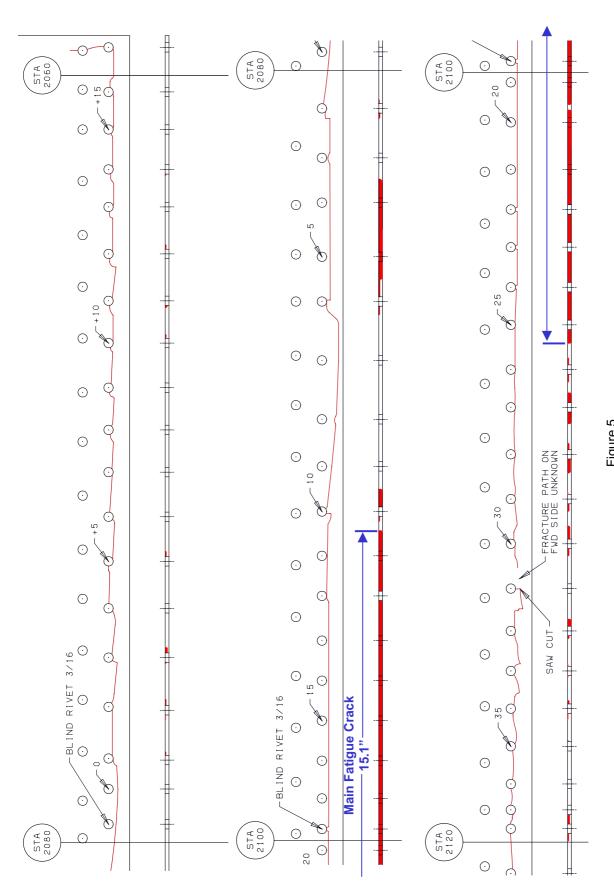
Figure 5. Map of fatigue cracking (red areas) observed on fracture above S-49L from STA 2060 to STA 2120. The length of the main fatigue crack centered about STA 2100 is shown. Refer to Table JVI for a complete list of fatigue crack lengths and depths.

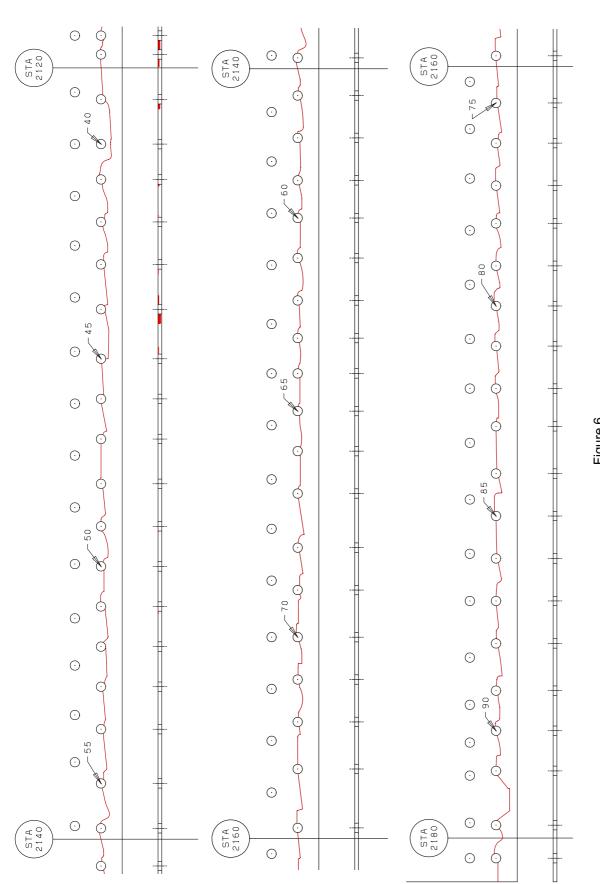
Figure 6. Map of fatigue cracking (red areas) observed on fracture above S-49L from STA 2120 to STA 2180. Refer to Table JVI for lengths and depths of the fatigue cracks provided in this figure.

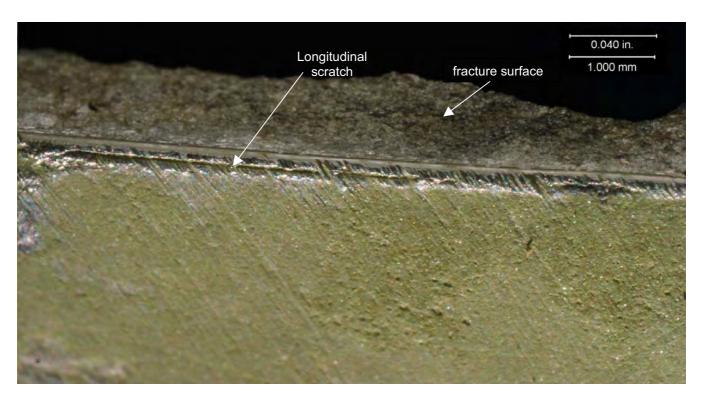
Figure 7.
Surface of skin faying with repair doubler near hole 20 showing the longitudinal scratch where fatigue crack initiation occurred from multiple origins. Also note the sanding marks induced during rework of the skin.

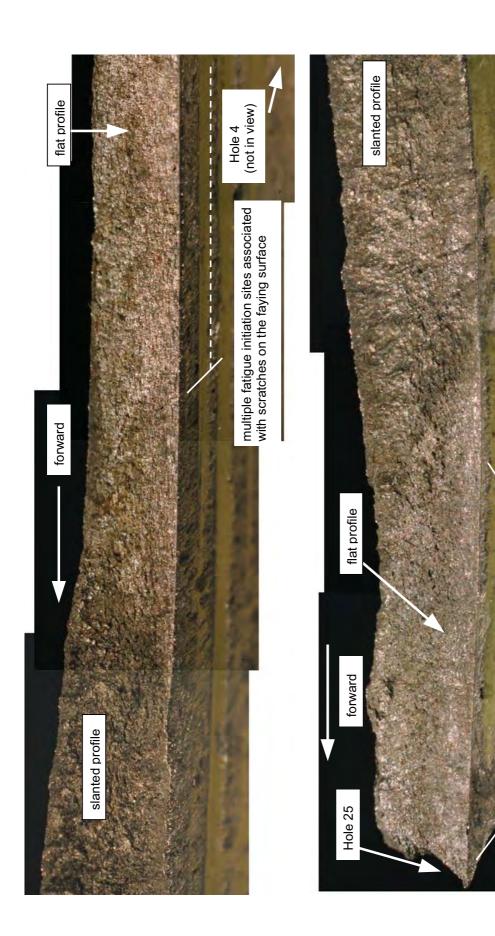
Figure 9, Photographs showing the transition regions from flat fracture profiles to slanted profiles just forward of fastener Hole 4 (top) and Hole 25 (bottom).

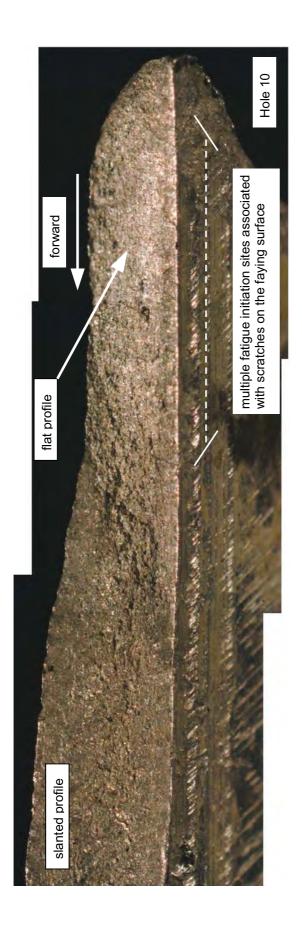
Figure 11, Photograph showing the transition region from a flat fracture profile to a slanted profile at fastener Hole 10 in the forward direction.

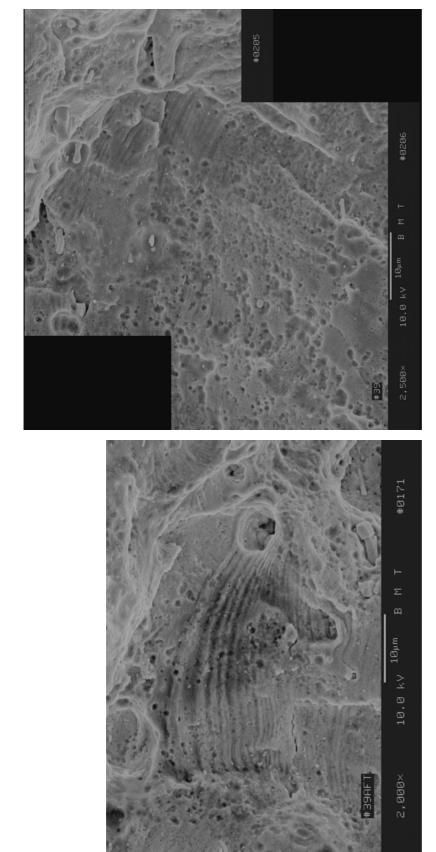
Figure 14, scanning electron microscope photographs showing fatigue striations near the end of the flat profile fracture surface aft of Hole 39. Just beyond these regions, the fracture surface was dominated by a dimpled morphology, indicative of the fracture mechanism of micro-void coalescence, or ductile separation. Severe pitting due to corrosion can also be seen.

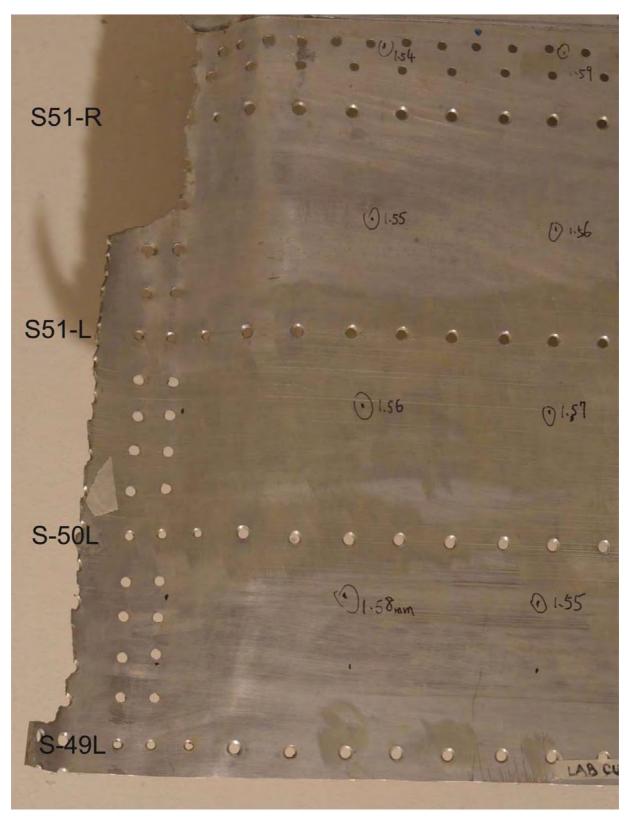
FIGURE 28 – EXTENT OF DAMAGE CONSISTENT WITH A TAIL STRIKE – Scratches may be noted at S-50L and S-51L. Numerical information on skin are results of thickness measurements at the CSIST. Scratch severity increases as you move forward on the panel as shown in the following photographs.

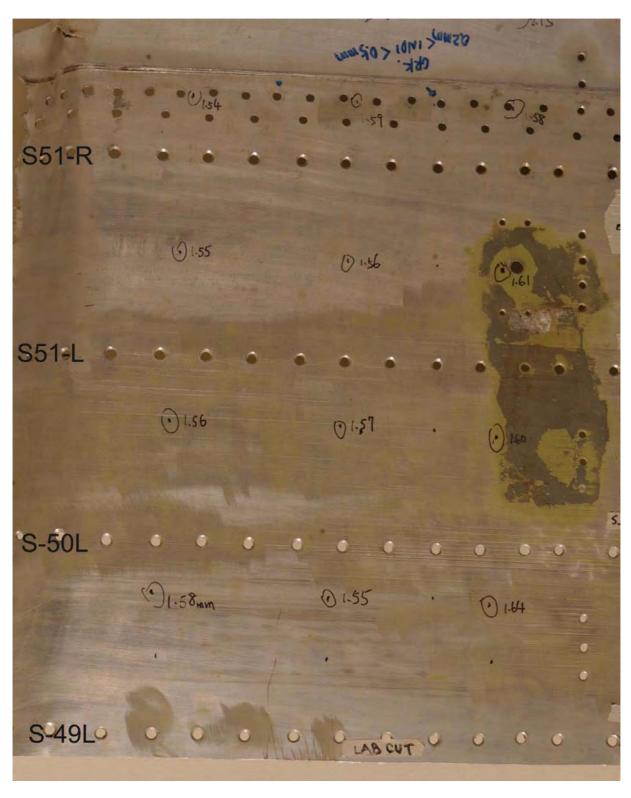
FIGURE 29. EXTENT OF DAMAGE CONSISTENT WITH A TAIL STRIKE – Scratches may be noted at S-50L and S-51L Scratches may also be noted at the shear tie between S-49L and S-50L.

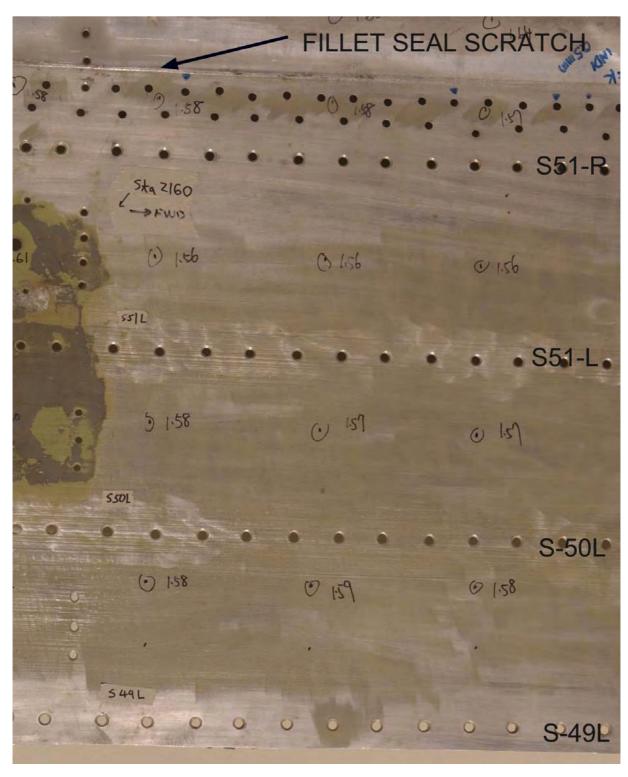
FIGURE 30. EXTENT OF DAMAGE CONSISTENT WITH A TAIL STRIKE - Note that minimal damage occurs on the right hand side of the repair area. Scratching in the doubler fillet seal area may also be seen in this photo.

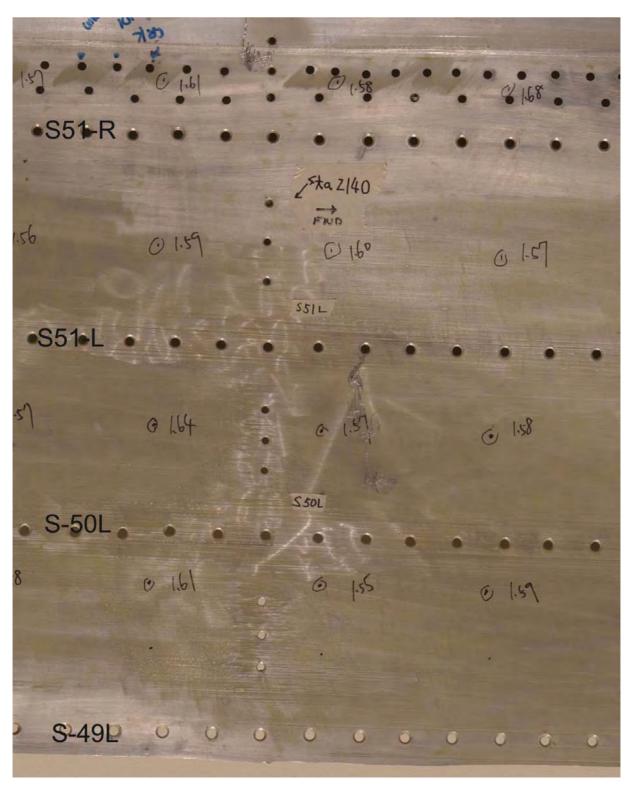
FIGURE 31. EXTENT OF DAMAGE CONSISTENT WITH A TAIL STRIKE

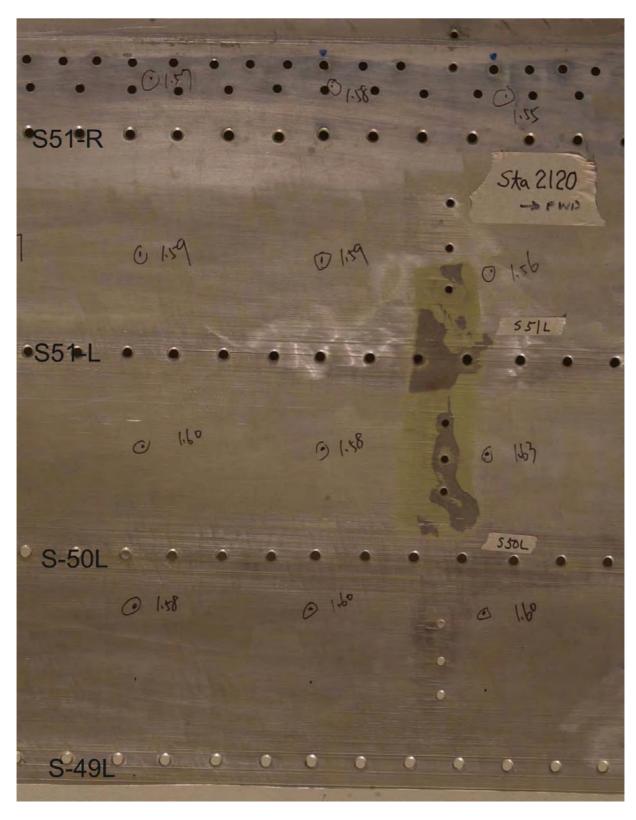
FIGURE 32. EXTENT OF DAMAGE CONSISTENT WITH A TAIL STRIKE – Deep scratches can be noted at S-49L, S-50L, AND S-51L.

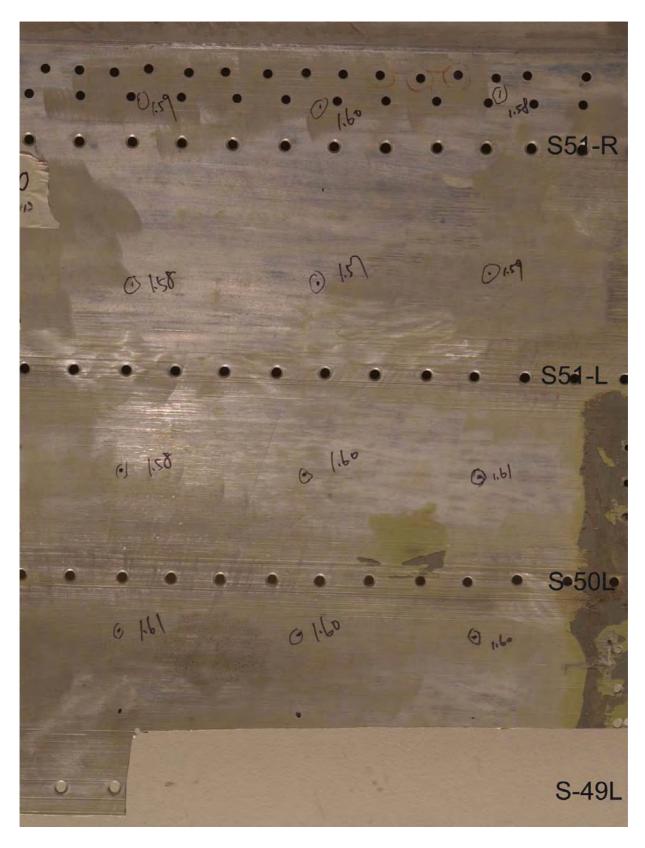
FIGURE 33. EXTENT OF DAMAGE CONSISTENT WITH A TAIL STRIKE

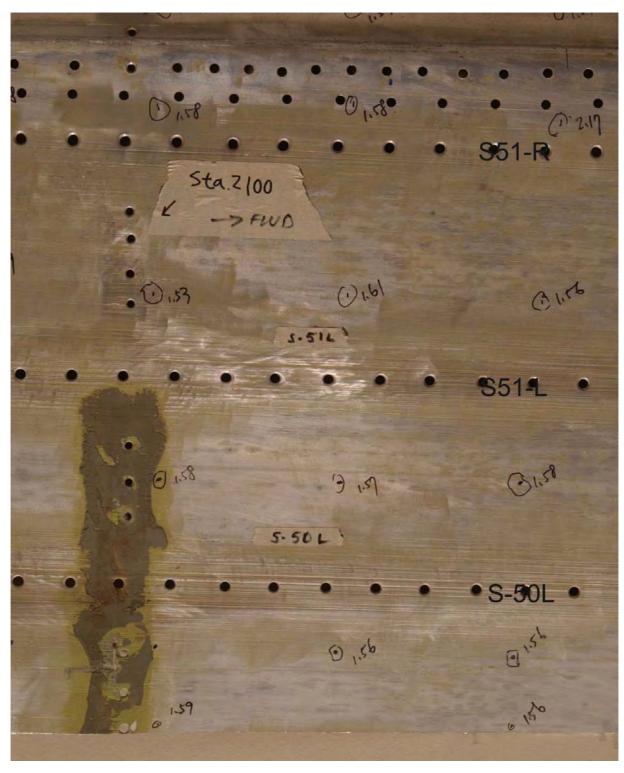
FIGURE 34. EXTENT OF DAMAGE CONSISTENT WITH A TAIL STRIKE

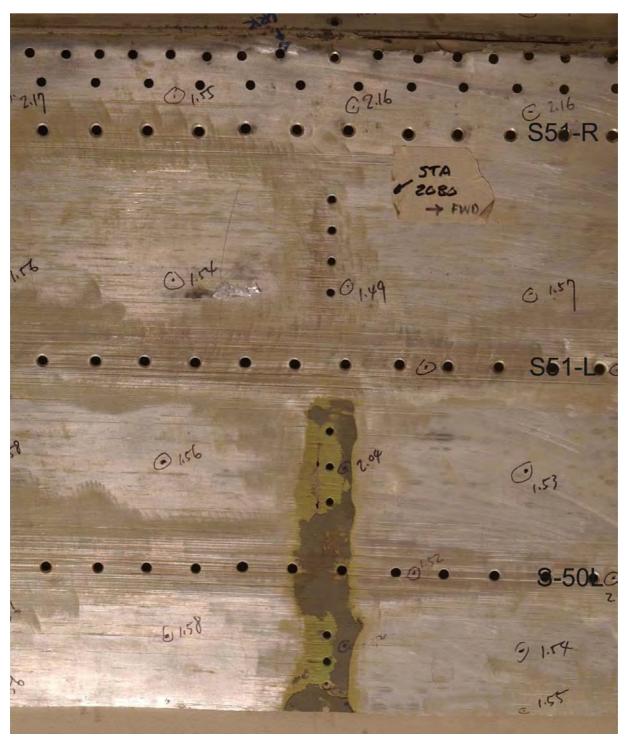
FIGURE 35. EXTENT OF DAMAGE CONSISTENT WITH A TAIL STRIKE – Note the severity of damage in this photo.

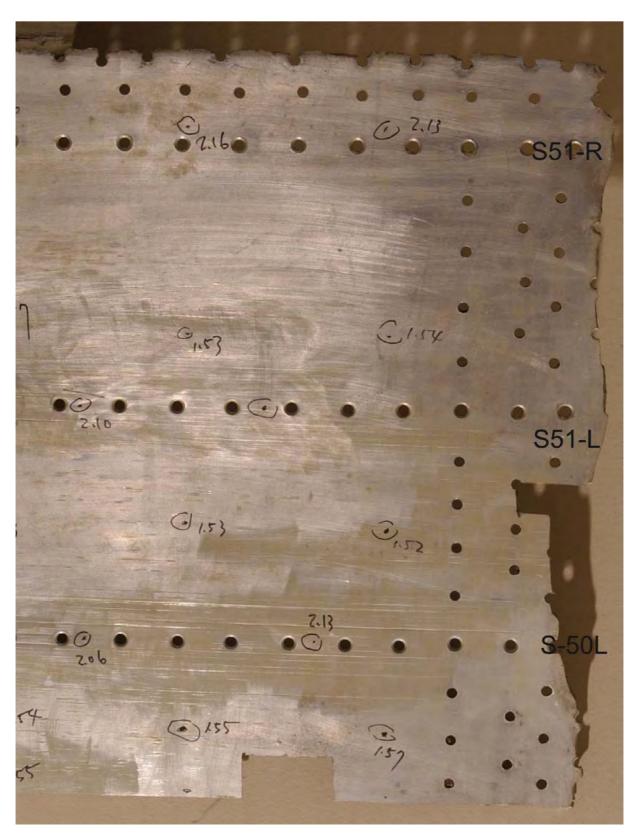
FIGURE 36. EXTENT OF DAMAGE CONSISTENT WITH A TAIL STRIKE

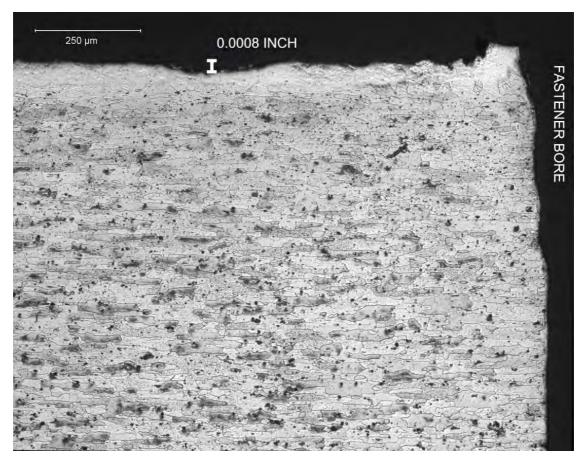
Figure 59. OUTER FASTENER ROW SCRATCH FEATURES AT PLANE A-A – Skin damage at this location was much less severe than on the left hand side of repair doubler. Skin cladding was not compromised by surface damage in this view.

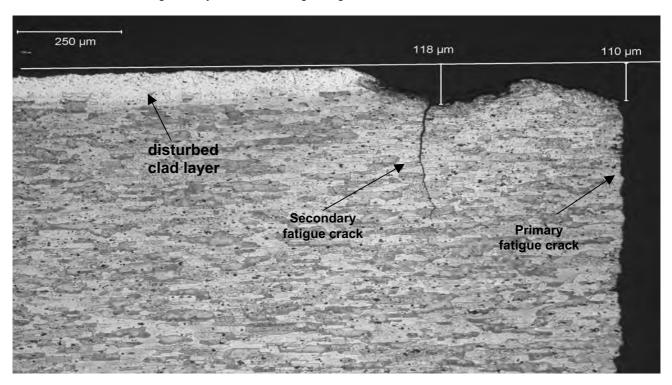
Figure 62. Metallographic specimen through the area indicated in Figure 61 above. The line shown was projected back to an area of undisturbed clad material to determine the depth of the scratches at the primary and secondary fatigue cracks present in this area.

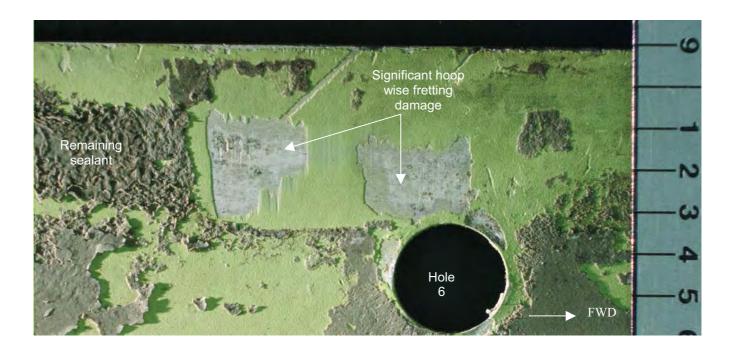
Figure 68.
Faying surface of doubler in the vicinity of hole 6 showing an example of significant fretting damage at the 10:00 to 11:00 and 1:00 to 2:00 clock positions.

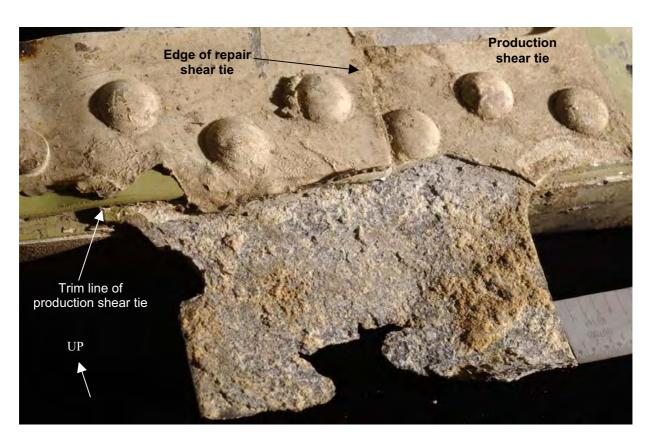
$\label{eq:Figure 73} \textit{Exfoliation corrosion present at shear tie between S-50L and S-49L of STA 2160 frame segment.}$

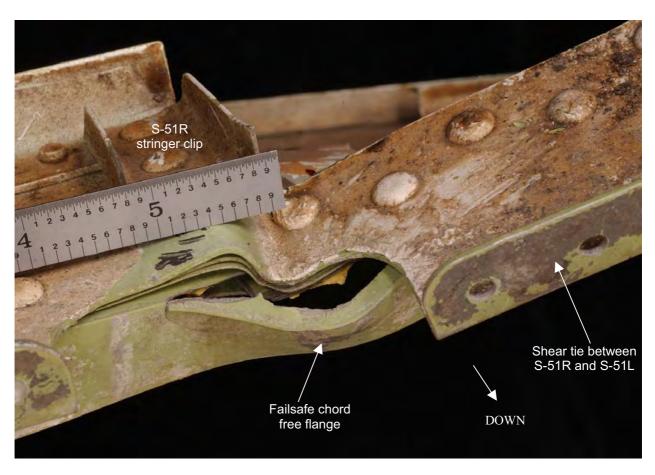
Figure 86. Fracture in failsafe chord free flange radius at S-51R of the STA 2040 frame segment.

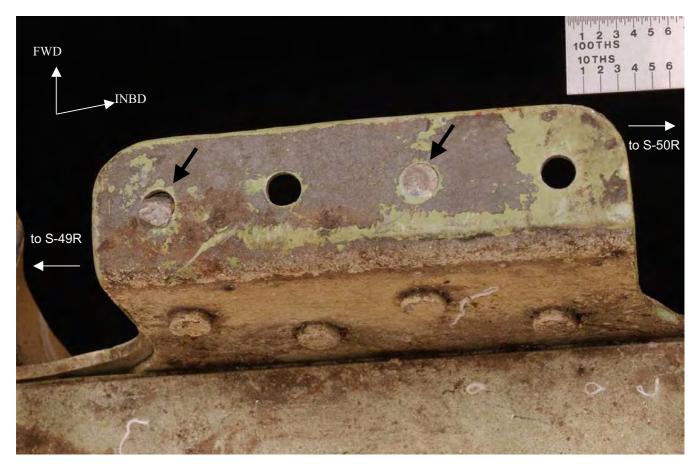
Figure 88. Skin flange rivet fractures at shear tie between S-49R and S-50R of the STA 2040 frame segment. Black arrows indicate the direction of loading.

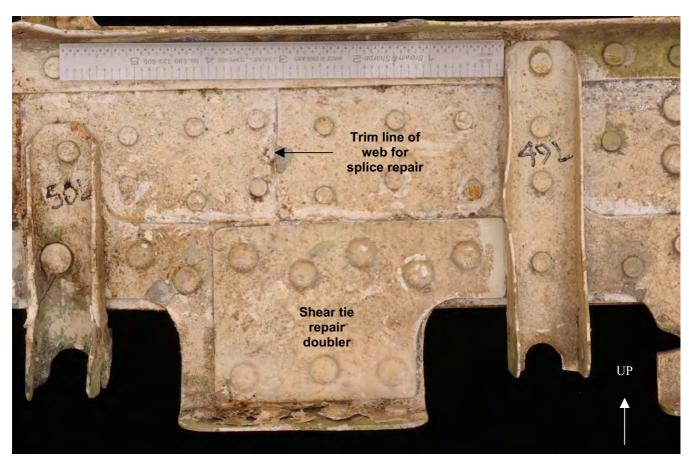
Figure 91.
STA 1940 frame segment showing the shear tie repair doubler and web splice repair at the location between S-50L and S-49L.

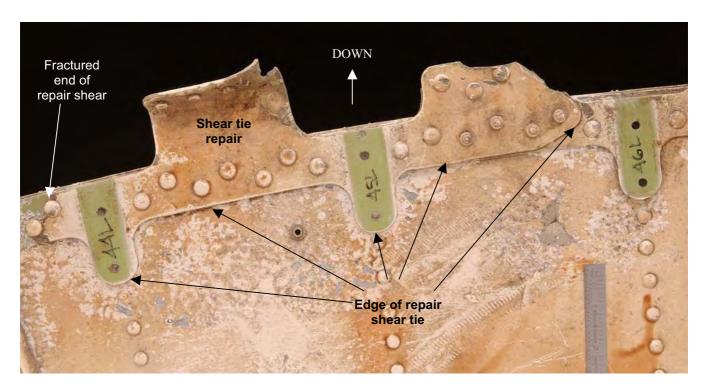
Figure 92. STA 1940 frame segment showing the shear tie repair between S-46L and S-44L.

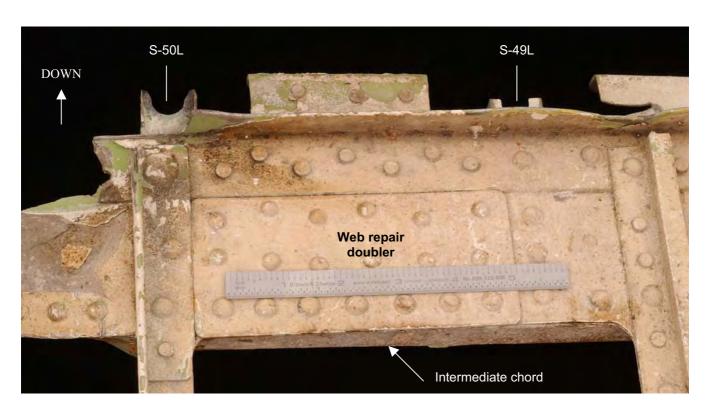
Figure 93. STA 1940 frame segment showing the web repair doubler on the aft side between S-50L and S-49L.

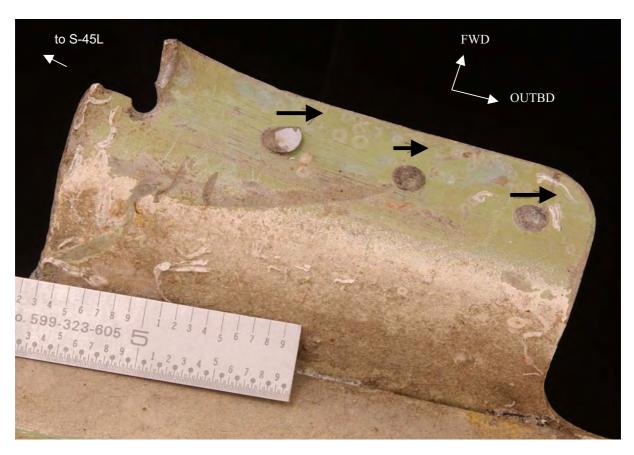
Figure 94. Shear tie between S-45L and S-44L of STA 1940 frame segment. Black arrows indicate the direction of loading.
