SL Report: 48/2005

**REPORT ON THE SERIOUS INCIDENT  
AT BERGEN AIRPORT FLESLAND (ENBR)  
ON 24 MARCH 2003,  
INVOLVING SAS329, MD-81, LN-RMO,  
OPERATED BY SCANDINAVIAN AIRLINES**

SUBMITTED  
December 2005

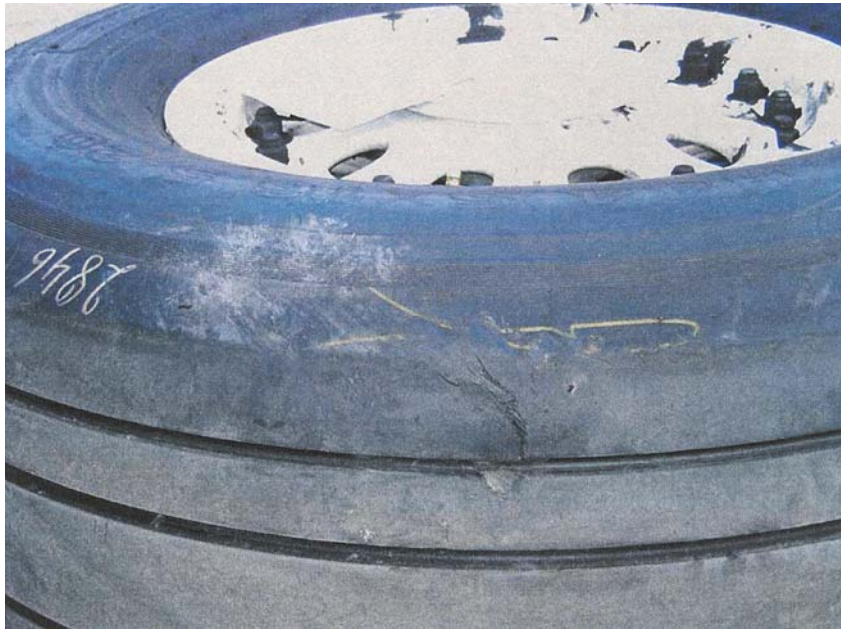
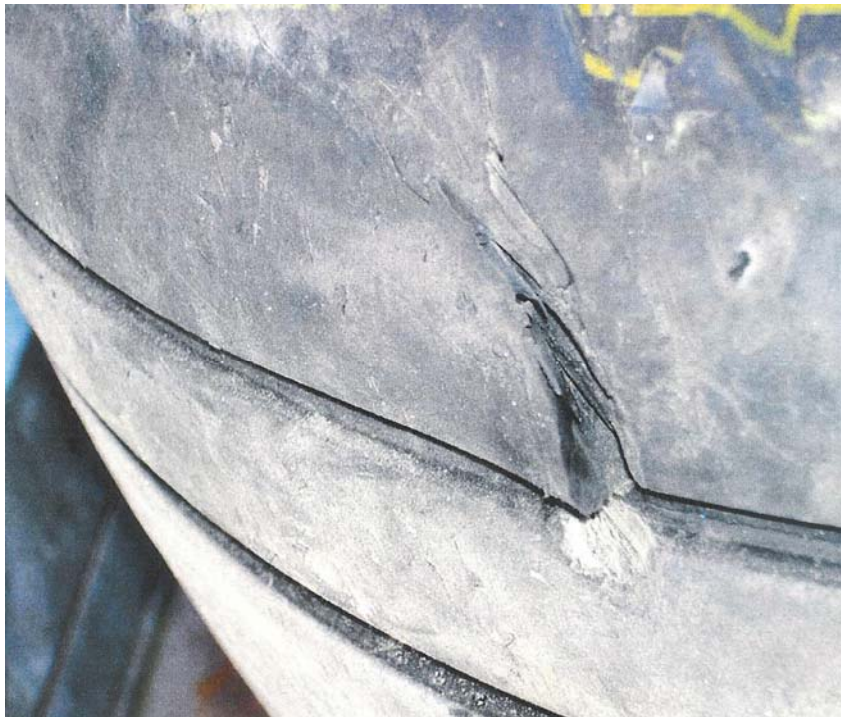
APPENDIX 1 LN-RMO

The damage to the aircraft was limited to a deep slash in the left outboard main wheel tyre (wheel no. 1). No further damage was found on the aircraft or its systems. The wheel was replaced at ENBR. Cf. Appendix 1.

*Damaged aircraft tires*

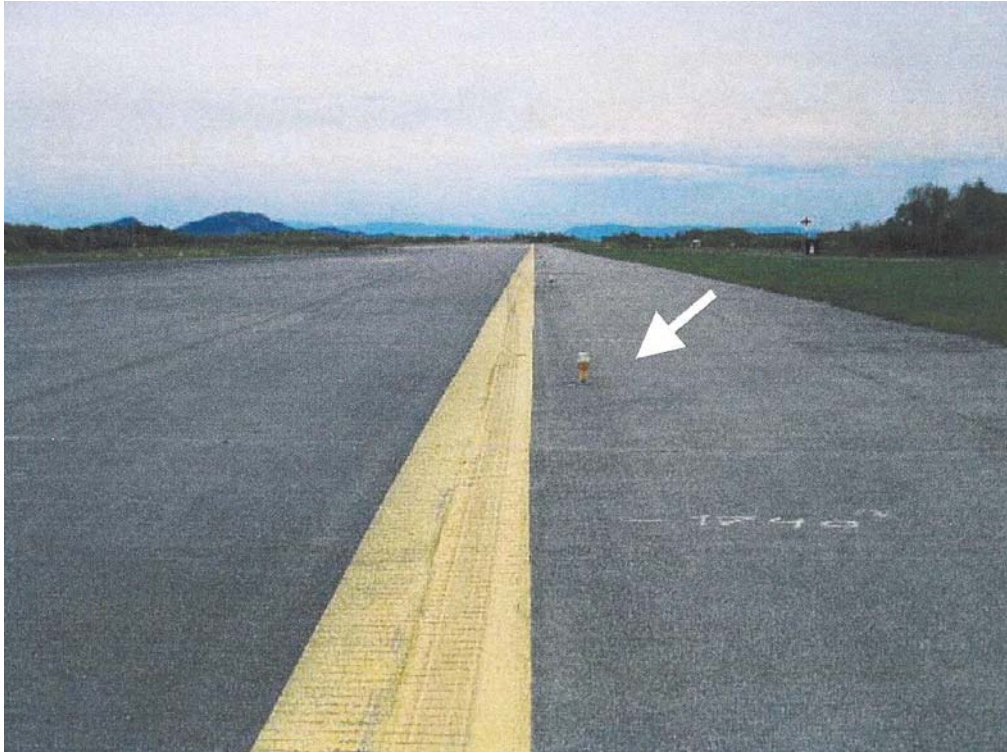
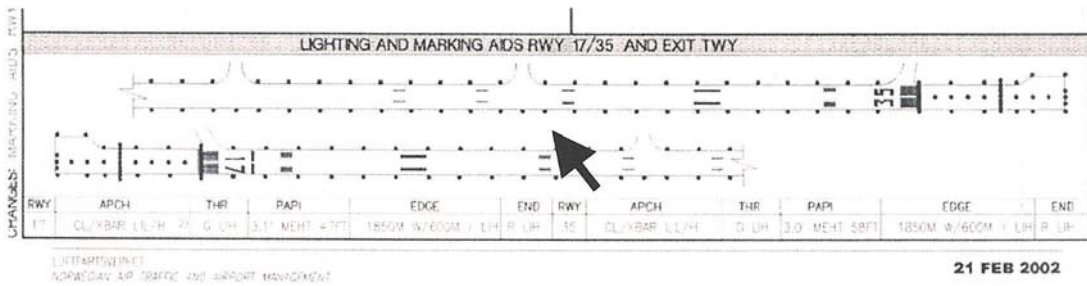
APPENDIX 2 LN-RMO

- 1.1.17 Shortly after that, damage to a left wheel tyre was reported to the TWR by the SAS maintenance crew. The Commander called the TWR and again requested a RWY inspection. This time the airport personnel did find a broken RWY edge light on the left side of RWY 35, just opposite the taxiway "D".

One (1) runway edge light, located 700 m from the threshold on the left hand side of runway 35, was broken. Cf. Appendix 2.

*Damaged runway edge light*

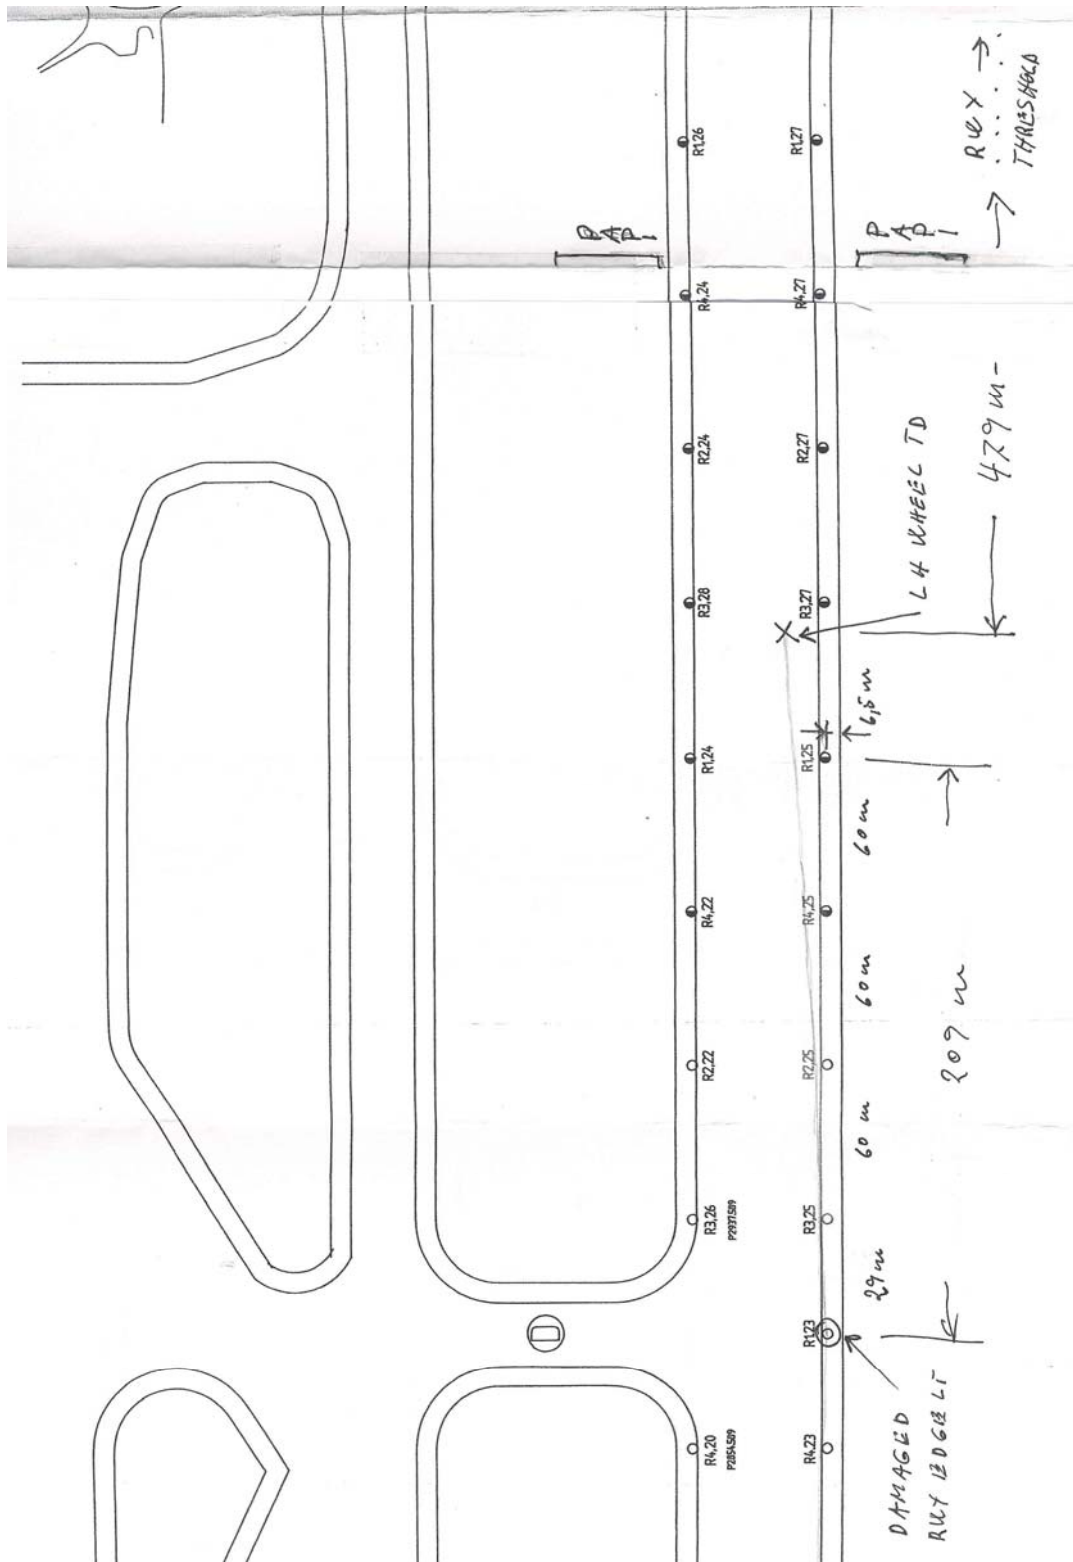
### APPENDIX 3 LN-RMO

- 1.1.14 During this turn, the outer left main (no. 1) wheel tyre collided with a RWY edge light, which was broken.
- 1.1.15 The rest of the rollout and taxiing to parking was uneventful.

*Touch down and aircraft ground track*

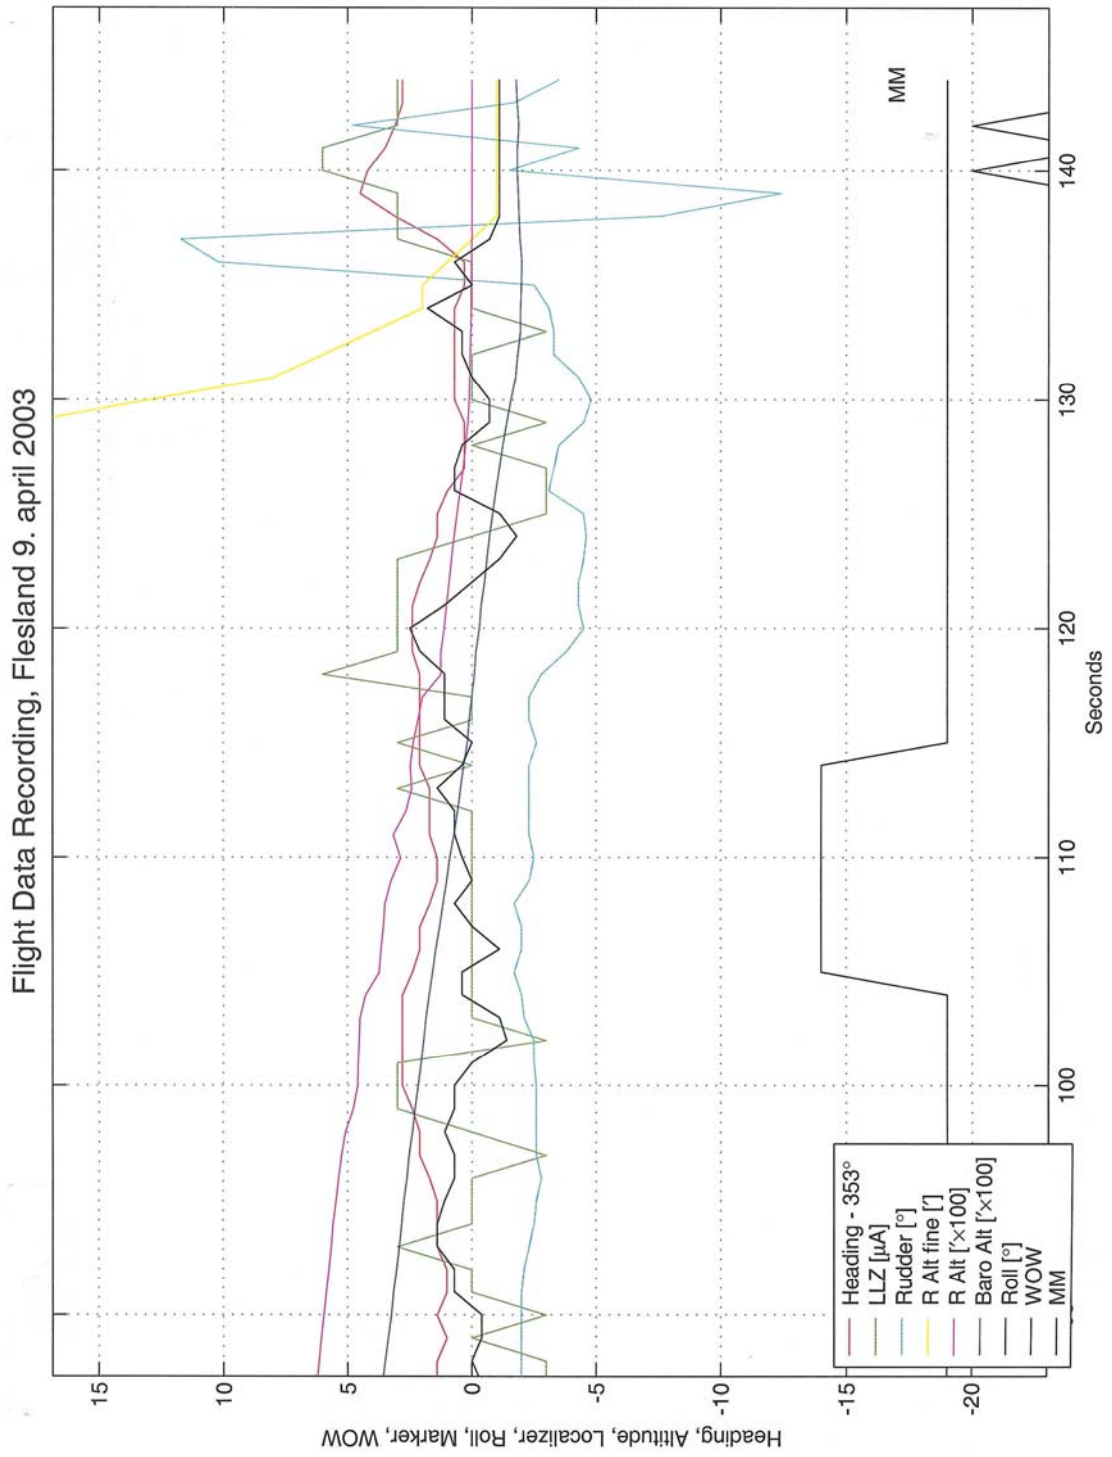
APPENDIX 4 LN-RMO

- 1.18.2.2 A closer look at the LLZ recordings show that there is a small deviation of the LLZ shortly before TD. There is a slight right deviation followed by a slight left deviation. This compares well with the incidents and may be the cause for the AP drift to the right at about 100 ft radio altitude. During autolandings the AP will correct back as the LLZ beam straightens out. Cf. Appendix 4.

2.7.4 After the incident on 24 March 2003, SAS made some evaluation flights on 9 April 2003, using AP and performed autolandings. The results indicated that the AP tracked the LLZ beam and steered the aircraft to a touch down slightly left of centre line, but within acceptable tolerances. Based on the evaluation, SAS revised the approach charts to include a note that autolandings are not recommended due to a dip in the GP. The evaluation recordings also indicate that there is a slight bend on the LLZ shortly before TD. This

SAS evaluation flight recordings
