Accident
on 25 December 2003
at Cotonou Cadjèhoun
aerodrome (Benin)
to the Boeing 727-223
registered 3X-GDO
operated by UTA
(Union des Transports Africains)

REPORT TRANSLATION
3x-o031225a

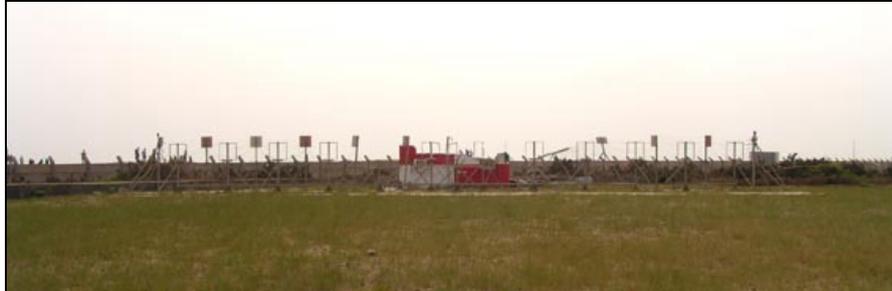
Zone 1

The airplane damaged the localizer antennas, which were about a hundred and fifteen meters from the end of the runway, then destroyed the reinforced concrete building housing the electronic equipment bays.

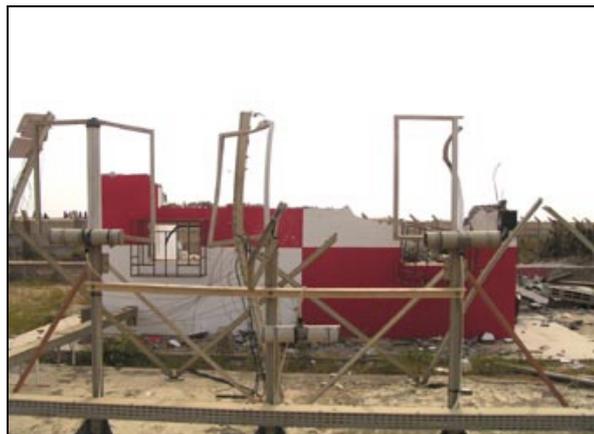
The photo below shows the north wall of the building with a black mark on the right side caused by the right inner tire. This mark was one meter twenty from the ground.

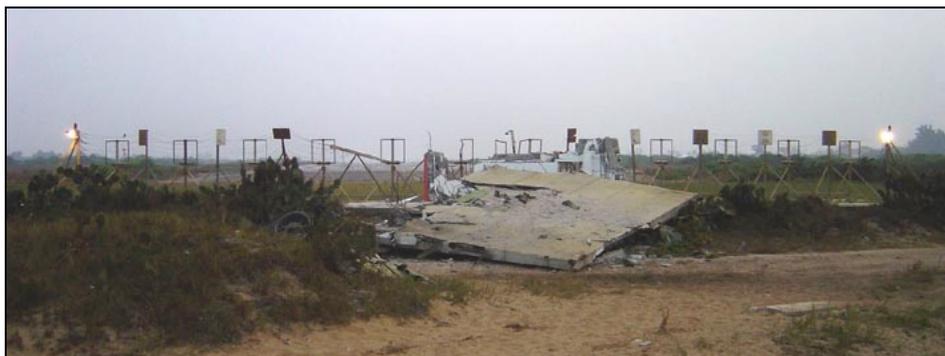
The roof of the building was torn off. It rotated 45° to the left and was thrown nine meters to the south.

Damage on the right was noted that was caused by the right main landing gear, on the central part marks were left by the lower part of the fuselage and on the left side there was damage caused by the left main landing gear.

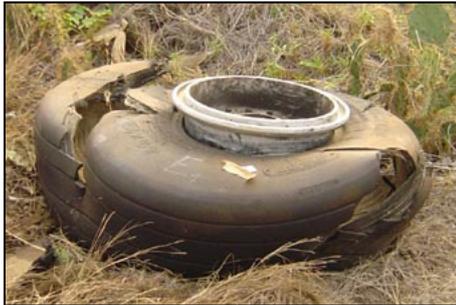
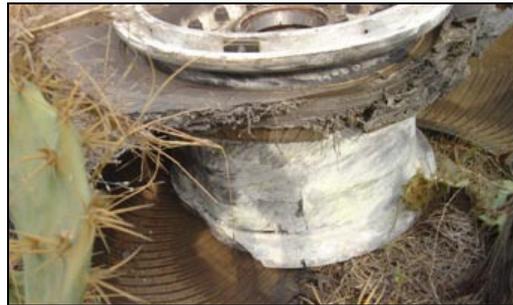
A part of the airplane's tail and some steps from the retractable ventral stairs were also found among the debris inside the building. The right main landing gear and its outer right wheel were found fifteen and eighteen meters southwest of the building respectively. The rims showed marks of the wheels' collision with the building.

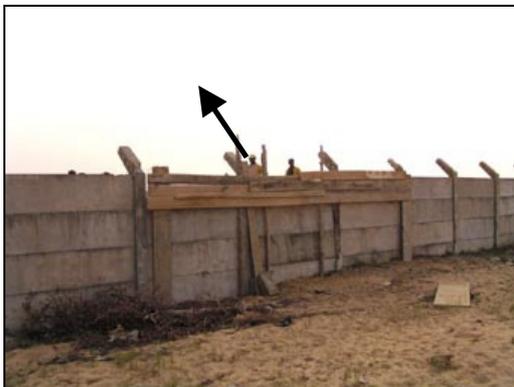
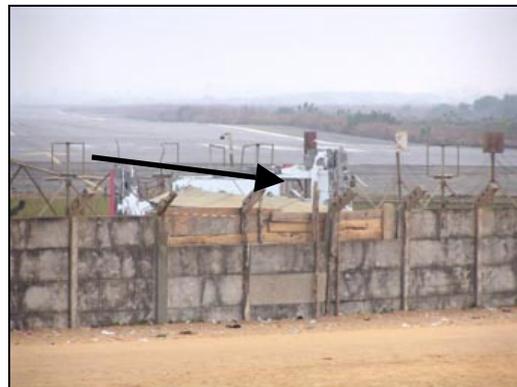
Zone 2

A part of the aerodrome boundary wall located on the runway extended centerline, at a distance of thirty-five meters from the localizer building, was damaged.

Some small debris from the lower part of the fuselage, a part of a flap and a landing gear door were also found near the damaged part of the wall.

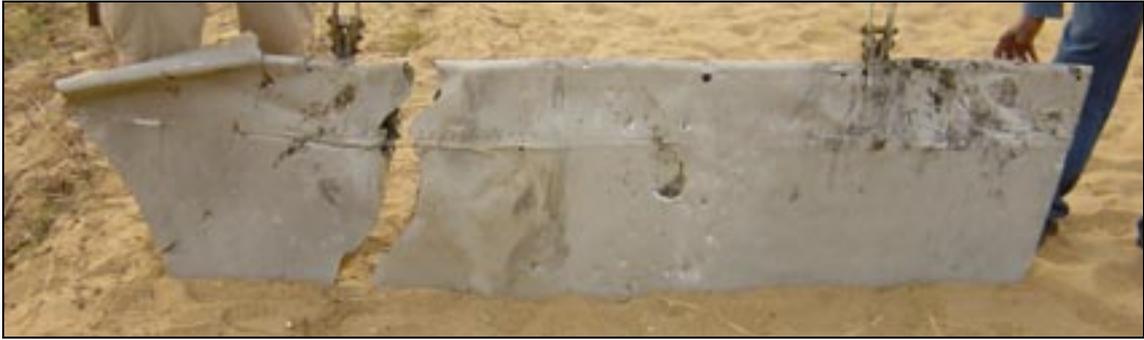
Zone 3

Six meters to the west of the previously-mentioned parts, two parts of the right flap were found. Tire marks were found on the underside along with a circular-shaped puncture about two centimeters deep.

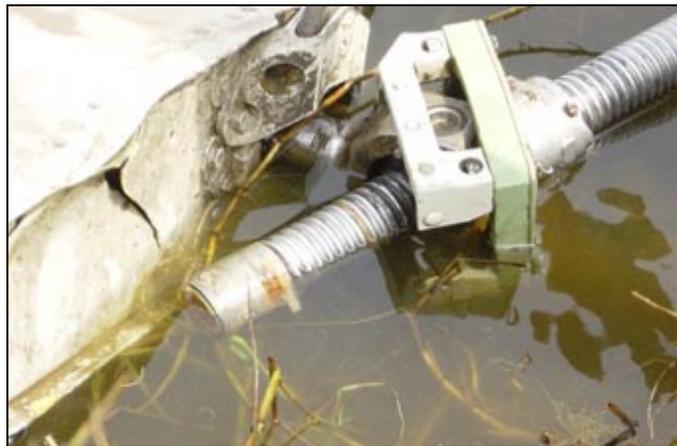
The cylinder, the drag strut, the pivot link, parts of the side strut, the lock crank and the right ① main landing gear support beam ① were found in the canal, a hundred and fifty meters from the boundary.

Beyond, near the opposite bank but in the water, a part of the right inner flap ②, with its screwjack and, a few meters away, a piece of the right wing with a part of the outer right aileron ③ were found.

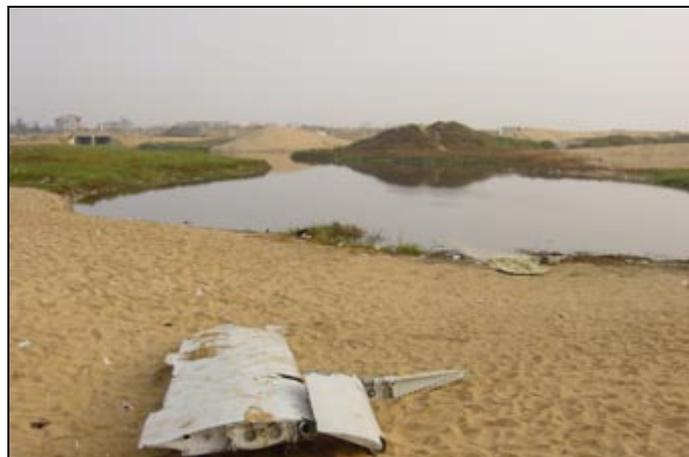
On the left bank of the canal, a part of the skin of the right wing ④ was found, then, five meters away, another part of the right wing with a leading edge slat ⑤.

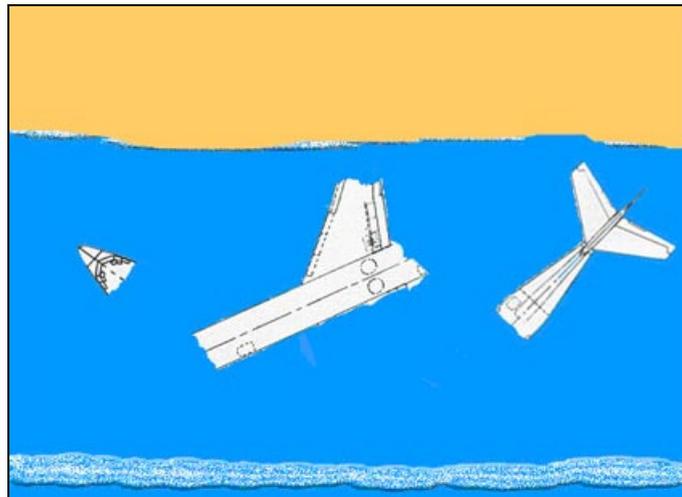
The main parts of the airplane were found in the ocean, in an area where the depth of water varied between three and ten meters. The waves that were breaking about fifty meters out kept the wreckage close to the shoreline.

The main part of the airplane had turned over and only the lower part of the fuselage and the underside of the left wing were visible. Both of the outer engines had separated from the tail.

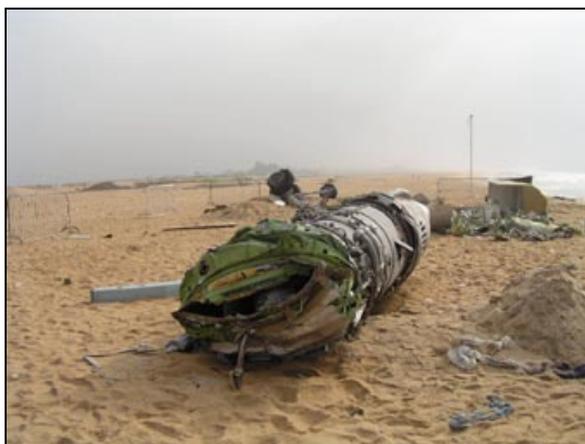
Right engine

The majority of engine 3 was intact. The thrust reverser was still attached to the engine, in the retracted position. No damage due to a fire or an uncontained burst was noted.

The visible part of the low pressure turbine did not show any signs of malfunction.

The nose cowl was crushed and twisted. The visible fan blades were intact, with the exception of a blade that had marks from an impact with a hard object on its leading edge. The visible main stage blades were severely damaged. One of them had broken off just above its base and the others were generally broken off about halfway up and bore impact marks on their leading edges.

Inside the engine, a part of the main stage was covered in sand in which blade fragments, a piece of honeycomb structure and a flattened oil tank were found.

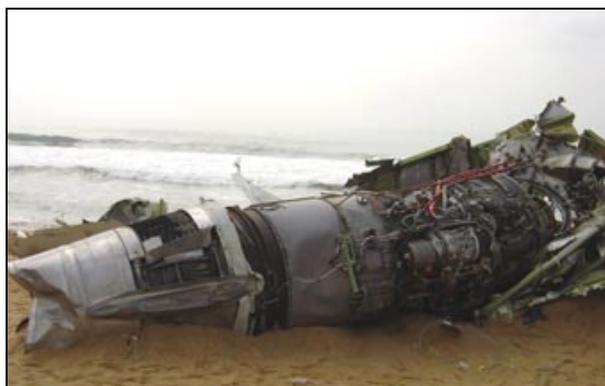
Central engine

The visible parts of engine 2 showed no signs of damage due to a fire or an uncontained burst. The nose cowl was missing. The thrust reverser, in the retracted position, and the exhaust section were intact. The last stage low pressure turbine blades were intact, which indicated that the turbine assembly was intact. The nose dome was slightly dented and pushed in. The compressor blades were not all visible due to the damage to the air intake channel, and the visible main stage blades were relatively lightly damaged.

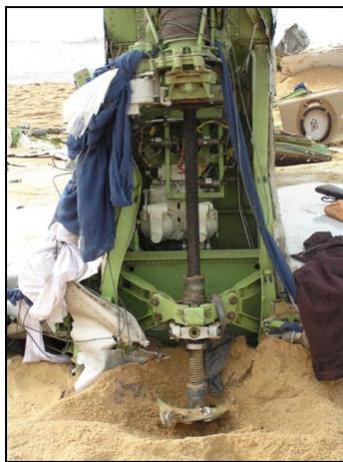
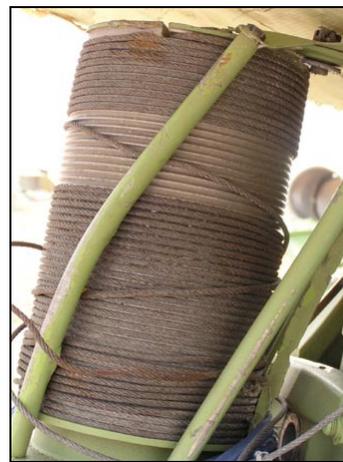
Tail

During recovery operations, the tail broke in two, the rudder and the central engine in one part and the stabilizer and the elevator in the other. The stabilizer jackscrew was intact; its drive cables were broken.

The position of the jackscrew did not make it possible to validate the position of the stabilizer, the cause and the sequence of the cable ruptures being undetermined.

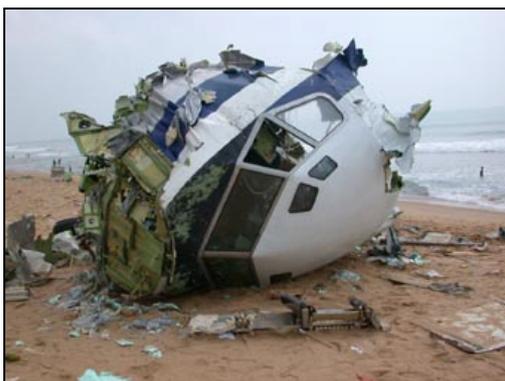
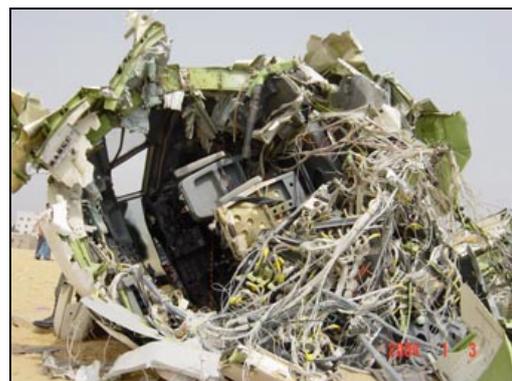
Cockpit

The cockpit was not very damaged, except for the Flight engineer's panel and a large part of the equipment. There was a strong compression mark on the floor and the skin of the partition and the outer right side of the fuselage. The nose gear had been ripped off.
