# **AIRCRAFT ACCIDENT**

**Beechcraft 1900C**

**N79YV**

**Report A0514022**

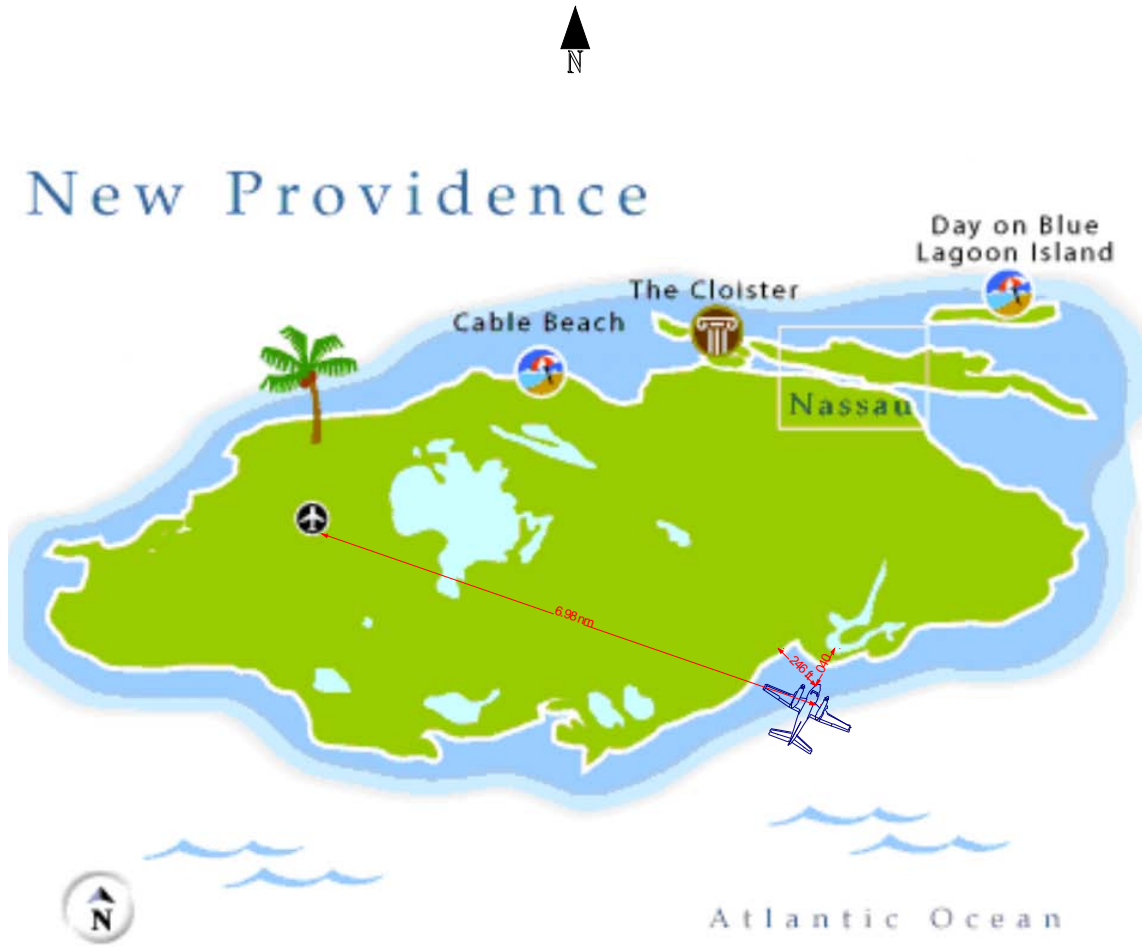
N79 YV  
 Beech 1900 C Model  
 Crashed in approx 4 ft of water  
 off the Southeastern shoreline of New Providence Island  
 October 22nd, 2004 13:45 (1845Z)
