# National Transportation Safety Board

## Aircraft Accident Brief

**Accident Number:** IAD05MA006  
**Aircraft and Registration:** Beech King Air 200, N501RH  
**Location:** Stuart, Virginia  
**Date:** October 24, 2004  
**Adopted on:** February 7, 2006

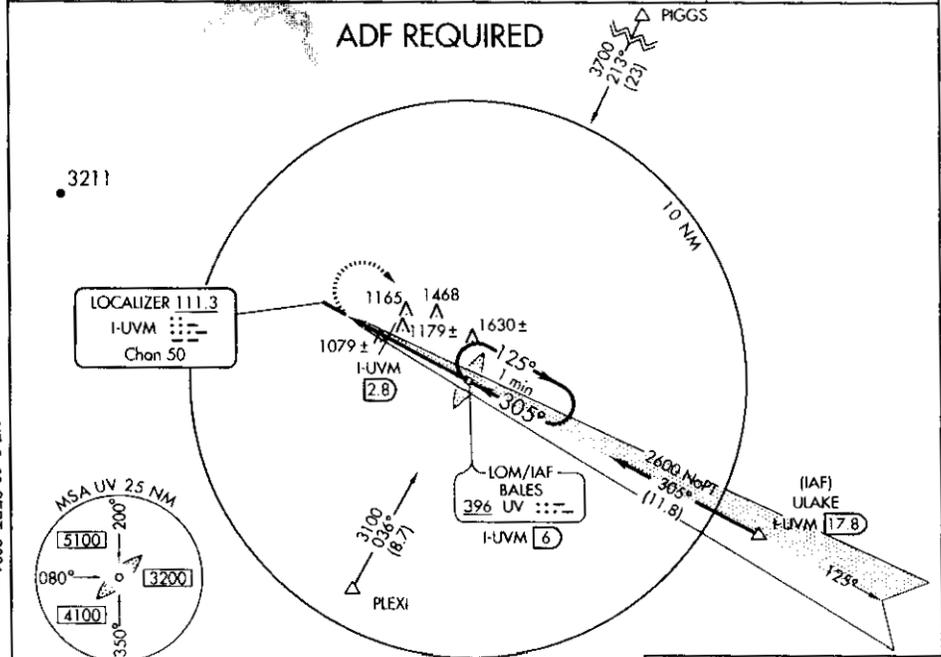
Figure 1. Localizer runway 30 approach.

The localizer runway 30 approach procedure (see figure 1) included an inbound course with a magnetic heading of 305°. The minimum descent altitude for the intermediate section of the approach and the holding pattern southeast of the BALES locator outer marker (LOM) was 2,600 feet. The BALES LOM is located at 6 distance

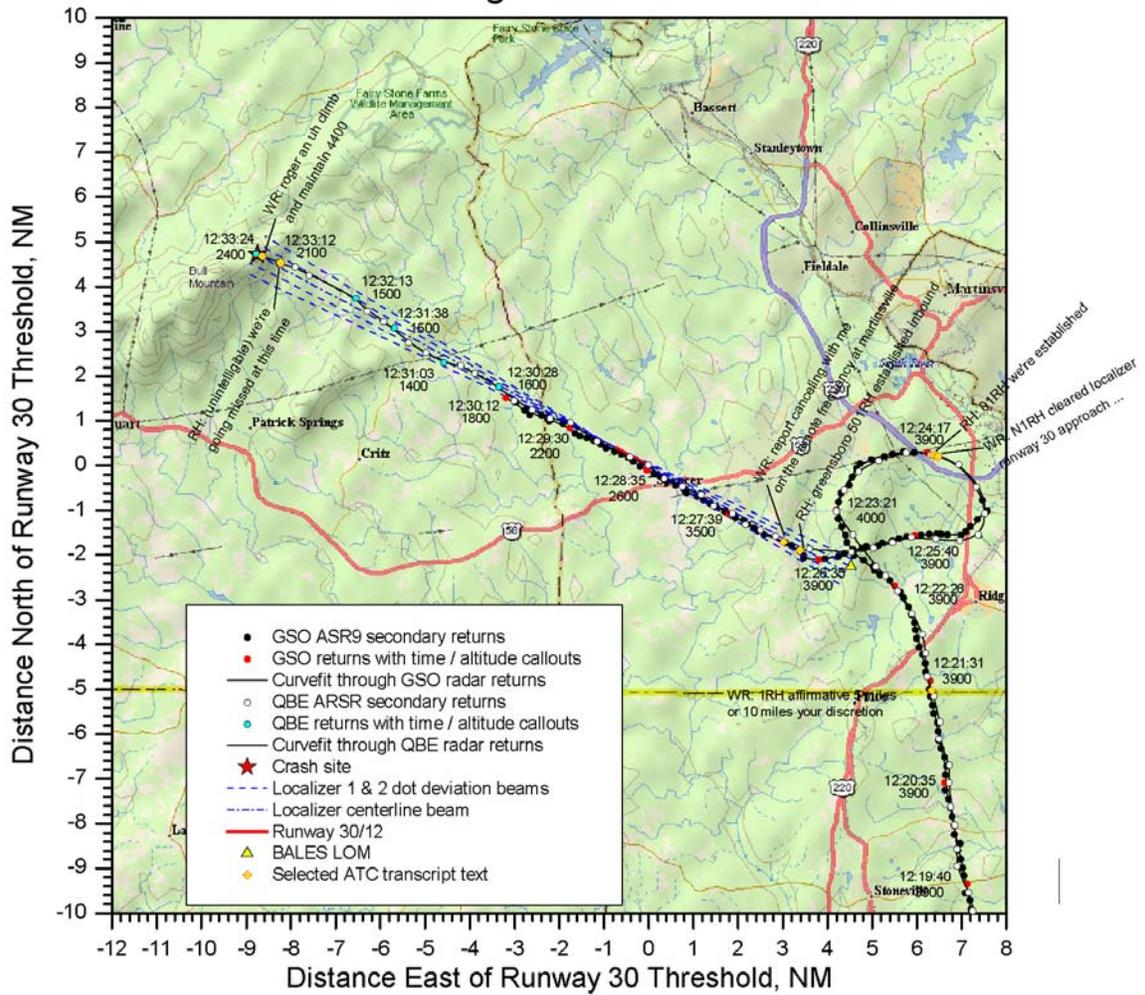
Figure 2. Accident airplane's flightpath.

The accident airplane approached the BALES LOM from the south (see figure 2), crossed BALES at 4,000 feet, and turned right toward the outbound leg of the holding pattern. About that time, the flight crewmembers of the airplane that preceded the accident airplane on the approach announced that they were canceling their IFR clearance after breaking out of the clouds during the approach and then proceeded to land at MTV.

The airplane leveled at 1,400 feet, about 4 nm beyond MTV and 5 nm beyond the MAP. The airplane maintained level flight between 1,400 and 1,500 feet for the next 1 minute 13 seconds. At 1232:13, about 8 nm beyond MTV, the airplane initiated a straight-ahead climb.

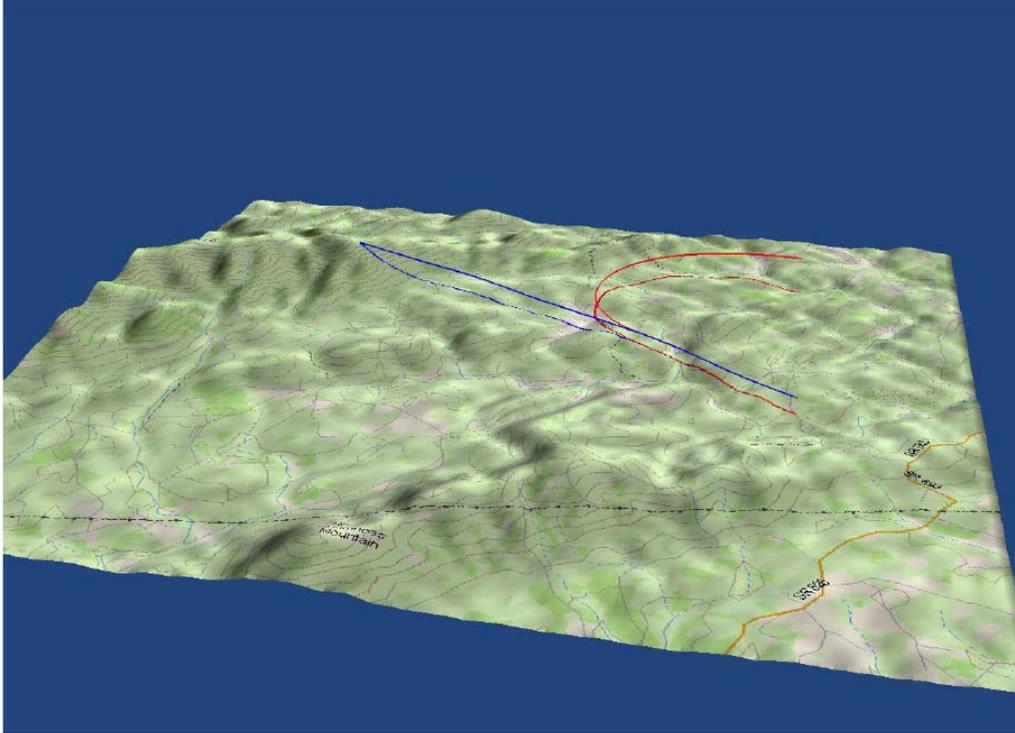
The published missed approach procedure called for a climbing right turn at the MAP, which is over the runway threshold. Radar data indicated that the flight crew initiated the missed approach 7.5 nm beyond the MAP. The airplane then entered a straight-ahead climb on the runway heading.

The aircraft performance study also presented the flightpath that the airplane would have flown if it had entered a climbing right turn at the point where the climb was initiated. Interpolation of nominal climb rates and a standard turn rate depicted a flightpath that would have kept the airplane clear of terrain. Figure 4 compares the airplane's flightpath (in blue) with the flightpath that would have resulted if the airplane had entered a standard-rate right turn during the climb (in red).

**Figure 4.** Depiction of the accident flightpath (blue) and the flightpath incorporating a climbing right turn (red) along with terrain elevations.
