Investigation report

B 2/2005 L

Aircraft accident at Helsinki–Vantaa airport on 31 January, 2005

SE-KYH

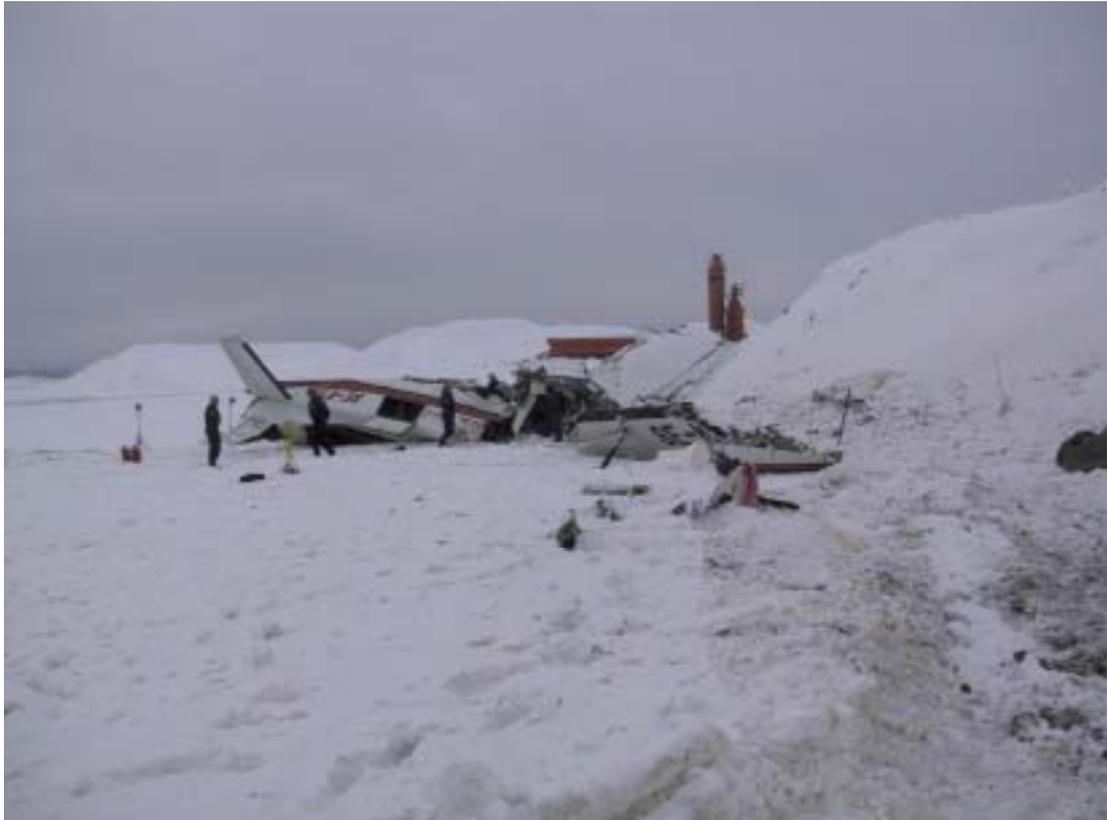
Figure 1. Aircraft Wreckage.

The aircraft was destroyed.

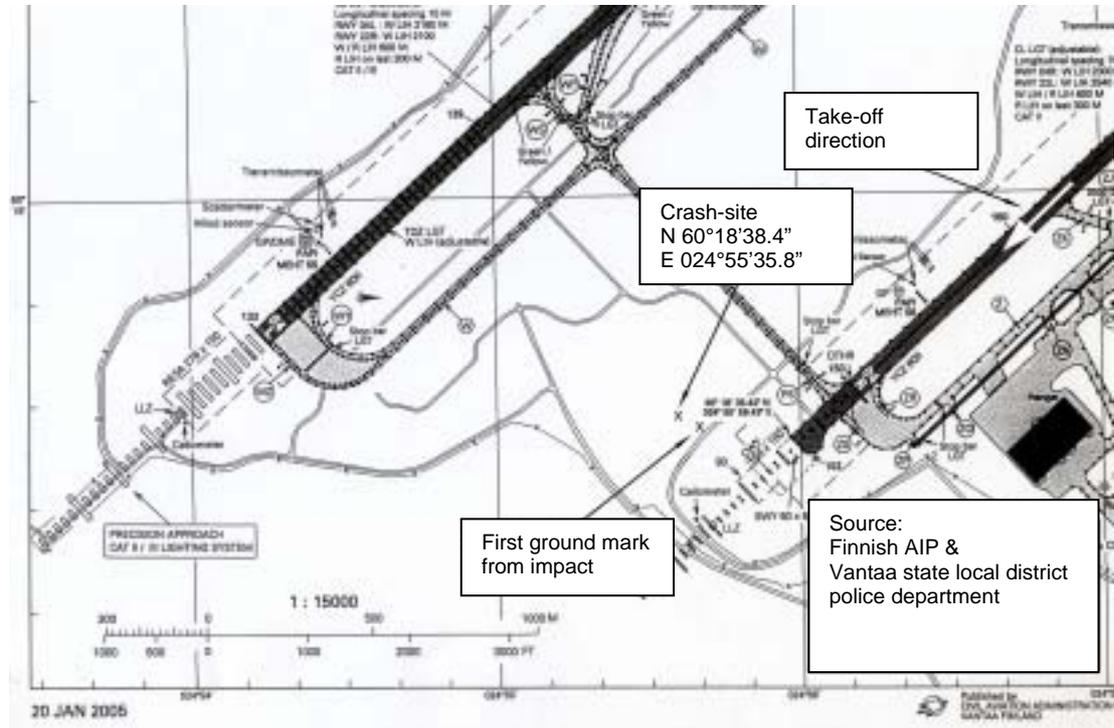
Figure 2. Accident site location

The accident site is located within the fenced area of Helsinki–Vantaa airport, in the terrain between runways 22L and 22R approximately 380 m from the end of RWY 22L at the magnetic bearing of 280 degrees. The first impact marks were found ca. 300 m from the end of RWY 22L. At the first impact point there is a rocky knoll. The marks in the

terrain were left by the undercarriage, the propeller and the bottom of the fuselage. The aircraft probably crashed into the ground fuselage bottom and landing gear first.

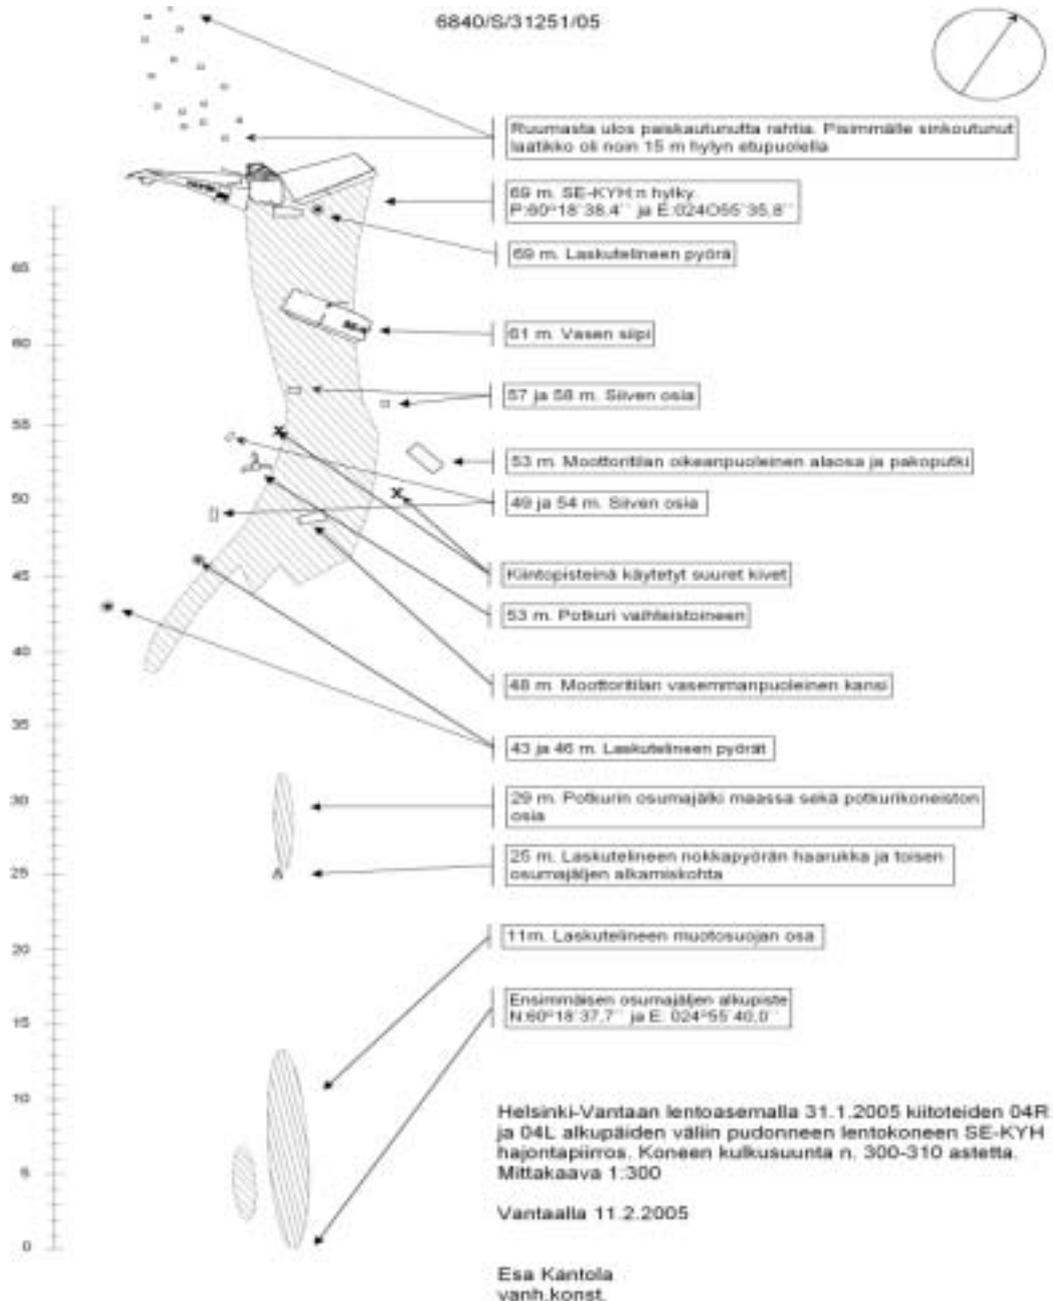
Figure 3. Accident site diagram
(Source: Vantaa state local district police department)

The landing gear wheels were torn off in the first impact with the ground. The nose gear shock strut broke above the nose wheel fork. The first impact mark was 13 m long. Thereafter, the aircraft bounced back into the air and hit the ground again approximately 25 m farther on.

The aircraft came down left wing first when it hit the ground the second time. The impact point was level ground and lower than the first point. The second impact resulted in a torn left wing. The wing strut remained attached to the wing at the upper end but the lower end detached. The propeller came loose after having been broken at the planetary reduction drive mounting flange seam.

After the second impact the aircraft still vaulted for ca. 20 m and pivoted around the nose before finally coming to rest. At the same time the right wing tip grazed a pile of macadam that was on the right side in the travel direction. The rear fuselage was almost completely separated from the cockpit and lay inverted in a 90 degree angle to the left in relation to the cockpit. The cockpit remained upright. The right wing had detached from its mounts and lay on the right side of the cockpit. The engine lay in front of the cockpit. The engine mounting frame had detached from its firewall mounting points.

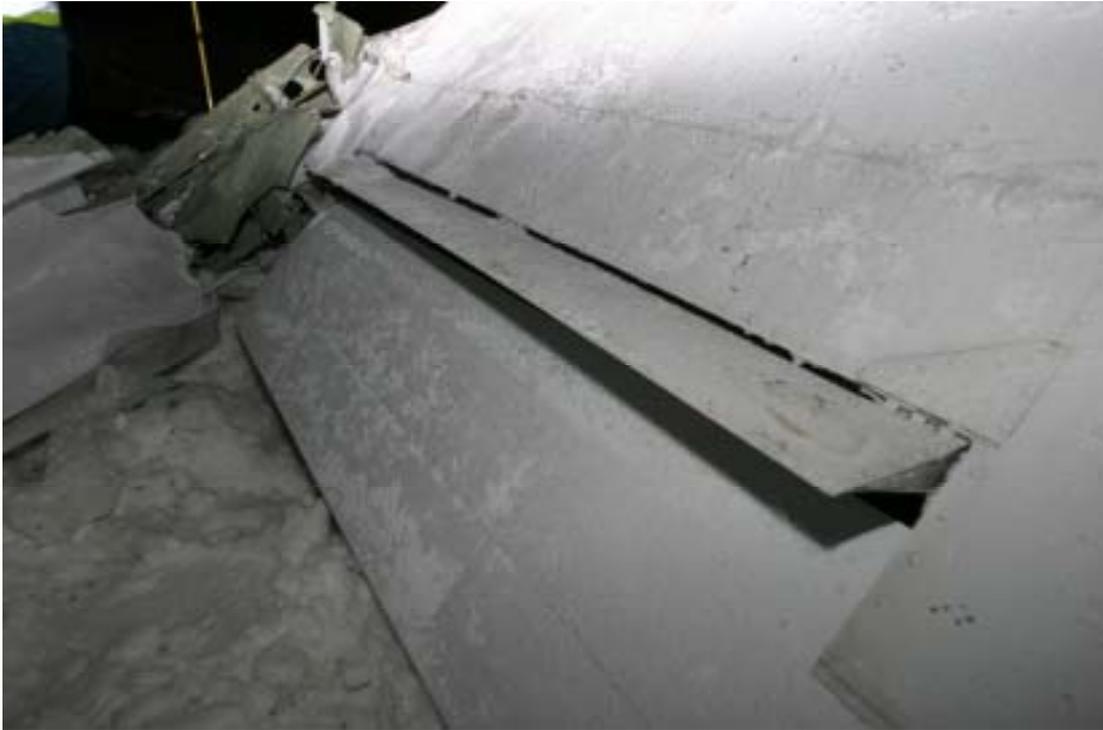
Figure 4. Impurities on the upper wing surface

After having checked in for duty at the Helsinki–Vantaa airport the pilot, unsuccessfully, tried to remove the snow and ice that had accumulated on the upper surfaces of the wing, fuselage and empennage. In conjunction with the examination of the wreckage it was estimated that the coat of snow, frozen slush and ice was 0.5-1.5 cm thick. These impurities had, in places, come loose in the crash. However, even after the crash to the ground, impurities abounded.

The upper wing surface was entirely covered with frozen snow, slush and ice. During the examination of the wreckage the thickness of the coating was found to vary between 0.5–1.5 cm. These kinds of impurities are detrimental to aerofoil aerodynamics and may reduce the coefficient of lift of the wing even as much as 20–30%.

The pilot noticed the impurities when he performed a walkaround check. However, he did not order a de-icing. Instead, he tried to remove the ice with a brush. It is only possible to remove dry and loose snow by brushing. In this case the frozen water that had trickled down remained stuck to surfaces.
