AVIATION OCCURRENCE REPORT

05-006

Fairchild-Swearingen SA227-AC Metro III ZK-POA, Loss of control and in-flight break-up, near Stratford, Taranaki province

3 May 2005

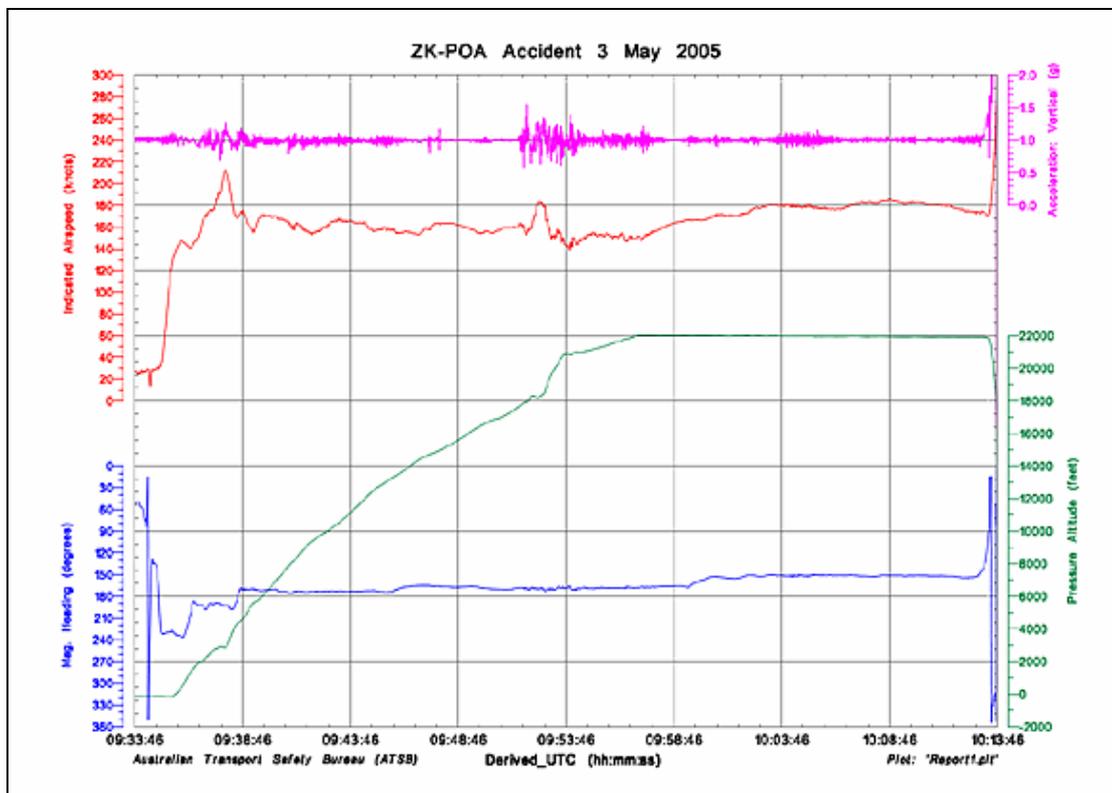
Figure 1
ZK-POA plot of FDR data – whole flight

- 1.11.6 The FDR altitude data was compared with ACNZ radar mode C data to correlate the FDR elapsed time with UTC. The correlation was accurate to ± 2 seconds. The last 3 mode C values did not match the FDR altitude trace, and were radar system “coasted”⁵ returns rather than actual returns.
- 1.11.7 The data listing covered the entire accident flight. The final data recorded was consistent with power being removed from the FDR once only. The accident flight was examined in detail and plots (refer to Figures 1 and 2) and a data listing were produced.

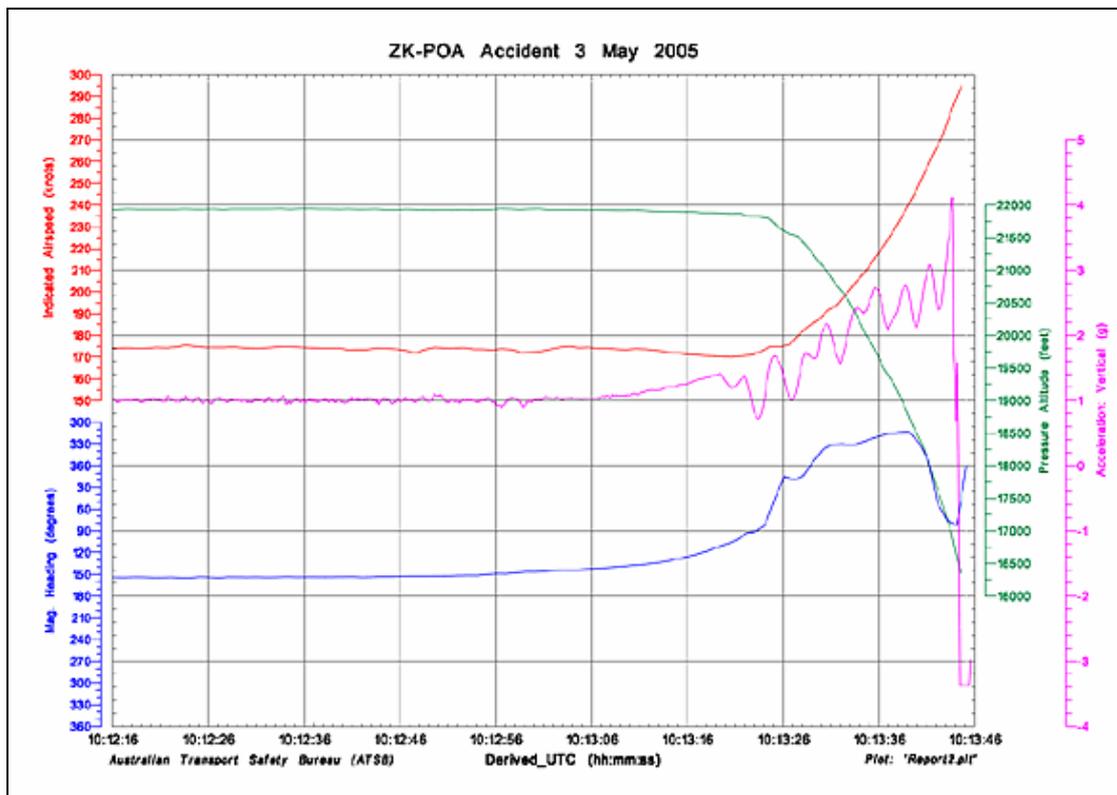
Figure 2
ZK-POA plot of FDR data – last 90 seconds

- 1.11.14 The recorded flight data showed ZK-POA experienced moderate turbulence between FL180 and FL210 during the climb and generally smooth conditions thereafter. After levelling at FL220, the IAS increased slowly from 150 kt to a maximum of 185 kt while climb power remained set. The aircraft heading was generally steady except for changes to comply with ATC instructions.
- 1.11.15 After the power reduction at about 2211, the aircraft slowly decelerated and the airspeed was 172 kt at 2213, during the fuel balancing.

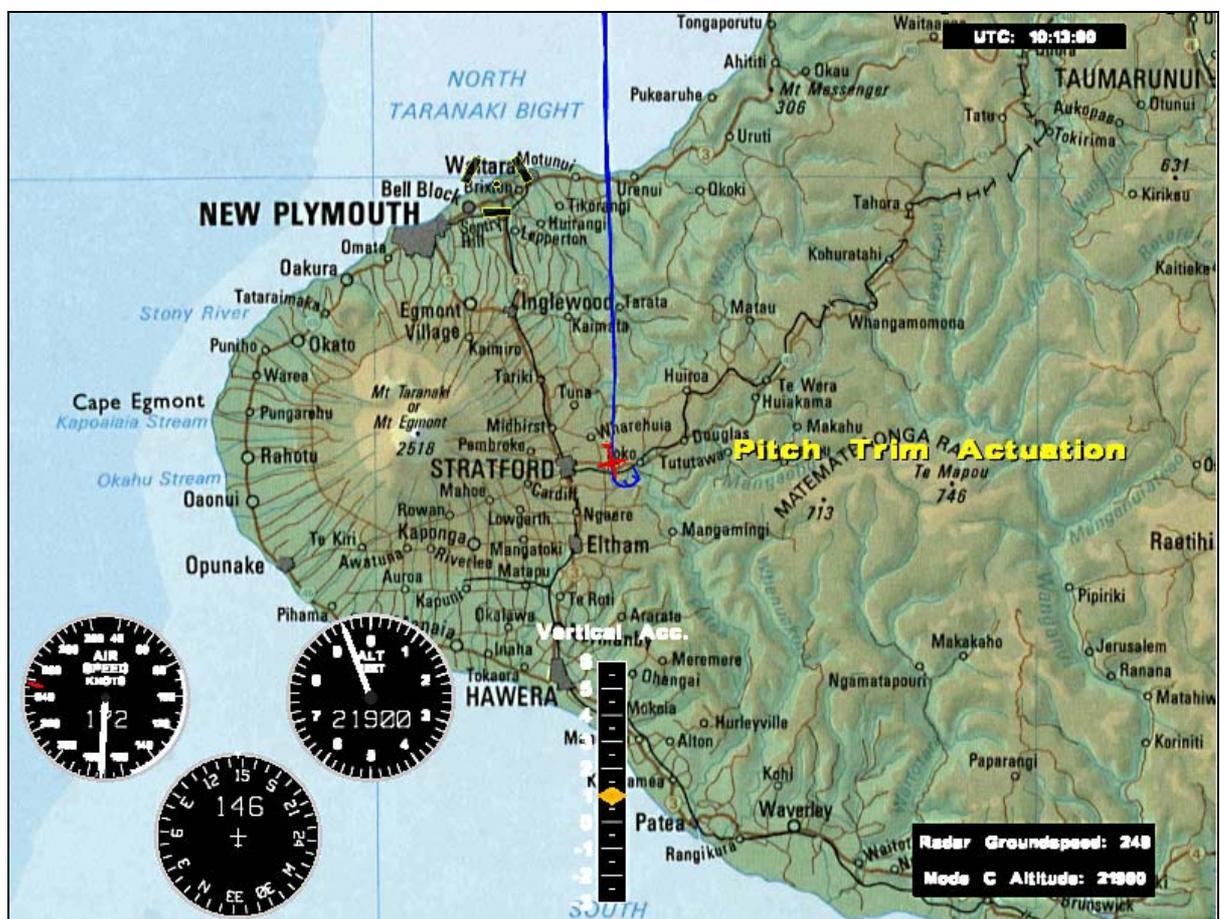
Figure 3
Computer presentation of ZK-POA radar track and FDR data at 2213:00

- 1.11.13 The ATSB produced a computer animation of the flight, using the FDR, CVR and ACNZ radar data, synchronised with CVR audio, and overlaid on a topographic map (see Figure 3).

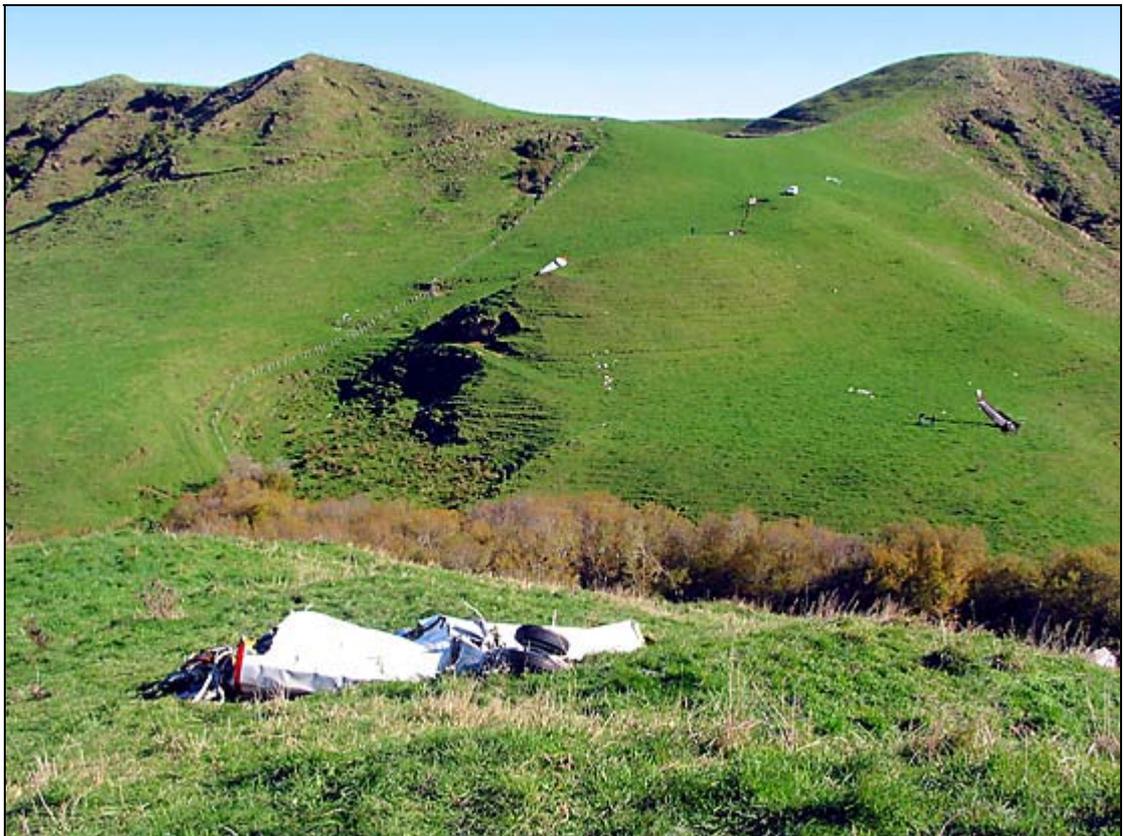
Figure 4
ZK-POA flight deck, and wings in distance

- 1.12.1 The major separated sections of the aircraft were found on rolling farmland within 250 m of the right wing (site datum). The highest elevation in the immediate area was about 950 ft, with the area gully floor at about 700 ft (see Figure 4).

1.12.14 The flight deck was lying on its left side approximately 225 m northeast of the site datum with the NLG extended. Both pilots were strapped into their normal seats; the captain in the left and the FO in the right seat. Neither pilot was wearing an oxygen or smoke mask.

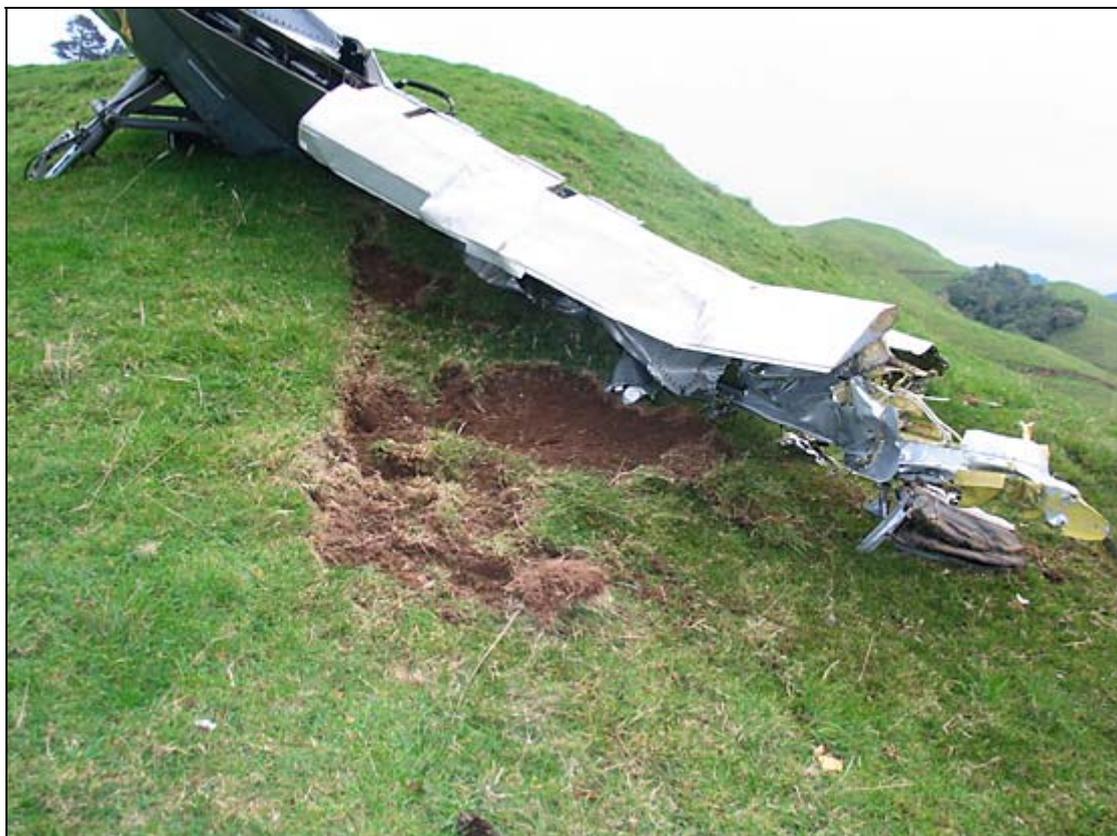
Figure 5
ZK-POA right wing

1.12.17 The right wing main spar caps had failed in tensile overload, with the upper cap end bent down, consistent with failure in upward bending; the rear spar caps and web showed tensile overload and rearward bending.

1.12.18 The right wing upper surface outboard of the nacelle showed diagonal compression buckling running from forward inboard to aft outboard, consistent with torsional overload from upward aileron deflection as well as from a high positive g load and high airspeed.

1.12.19 The complete engine and nacelle had separated downward and to the left from the right wing. The engine control cables, aileron trim cables and electrical wires had failed in tension at the wing root, where the aileron push-pull tube had also failed but in bending.

1.12.21 The right wing tip attachments had failed in forward bending, and the tip section showed evidence of forward compression from its trailing edge.

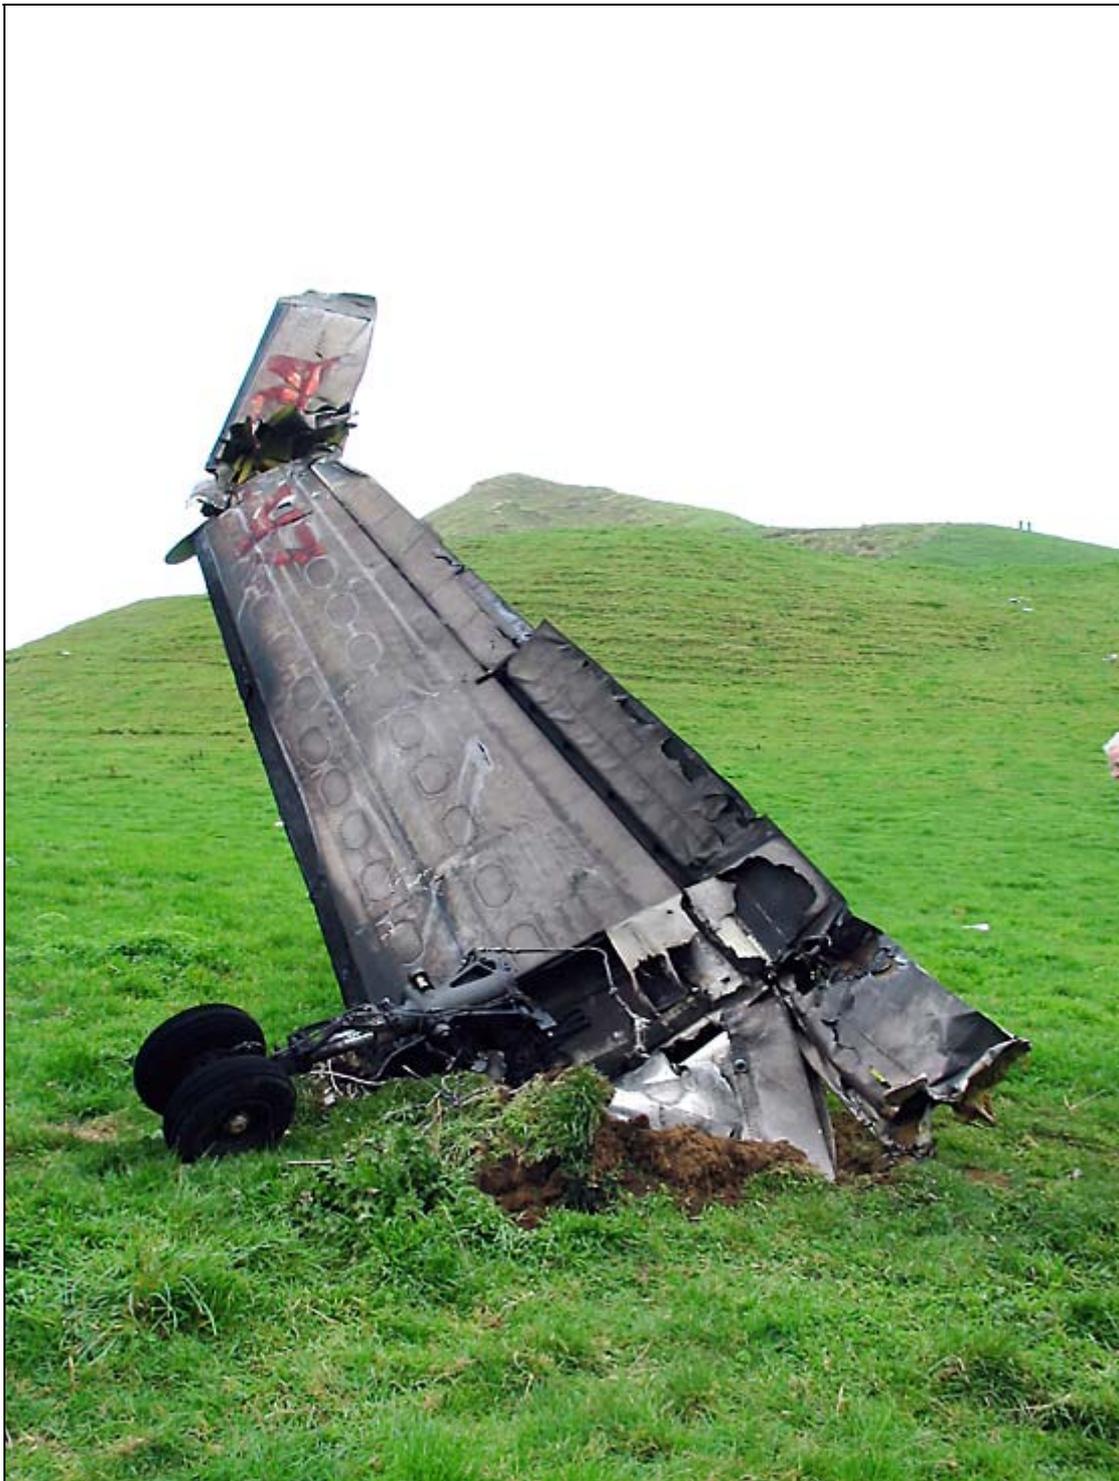
Figure 6
ZK-POA left wing

1.12.22 The left wing main spar lower cap had failed in tensile overload, and the upper cap in buckling. The rear spar lower cap had failed in tensile overload, and was also damaged by fire outboard of the fracture. The rear spar upper cap had not failed, but had pulled the attached centre section structure out of the fuselage. None of these fractures showed evidence of any structural weakening due to fire damage before the fractures occurred.

- 1.12.23 The left wing upper surface showed diagonal buckling at mid-span running from aft inboard to forward outboard, consistent with torsional overload from downward aileron deflection as well as from a high positive g load and high airspeed. The 3 leading edge slashes, at about mid-span, were consistent with contact with a rotating propeller, probably the right one.

- 1.12.24 The engine and most of the nacelle had separated downward from the left wing. Associated cables and wires had failed in tension.
- 1.12.25 The left wing tip remained attached, but folded downward, consistent with the ground impact.

- 1.12.26 The left wing was sooted overall from fire, and the upper and lower wing skins containing the fuel tank were bulged out from overpressure within the tank. The most intense fire damage was in the bay inboard of the nacelle, where some alloy structure had melted or burned away.

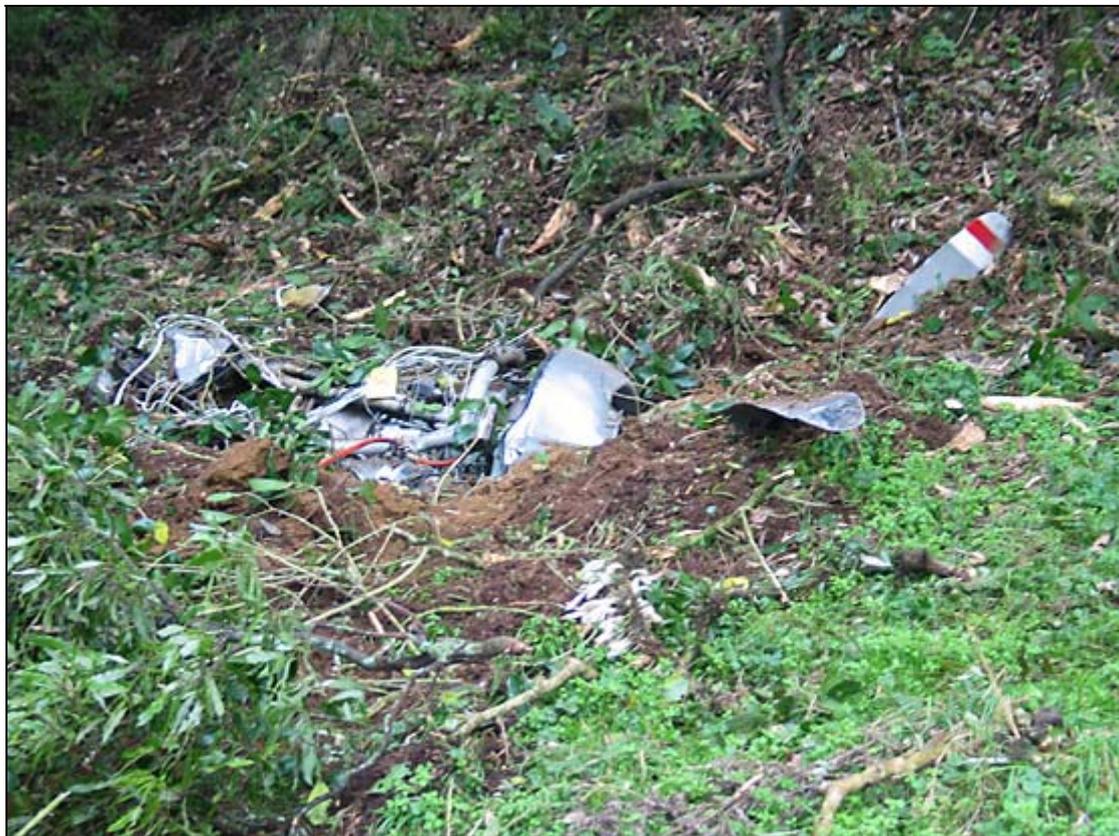
Figure 7
ZK-POA right engine

- 1.12.27 The right engine was deformed from the ground impact, preventing rotation. The first stage impeller and the aft turbine wheel showed no evidence of rotation at impact. There was no evidence of foreign object damage.

- 1.12.28 The right propeller blades all showed leading edge scrape marks and forward bending at the tip consistent with striking a metal object while rotating at speed. One blade also had a rearward bend consistent with the ground impact.

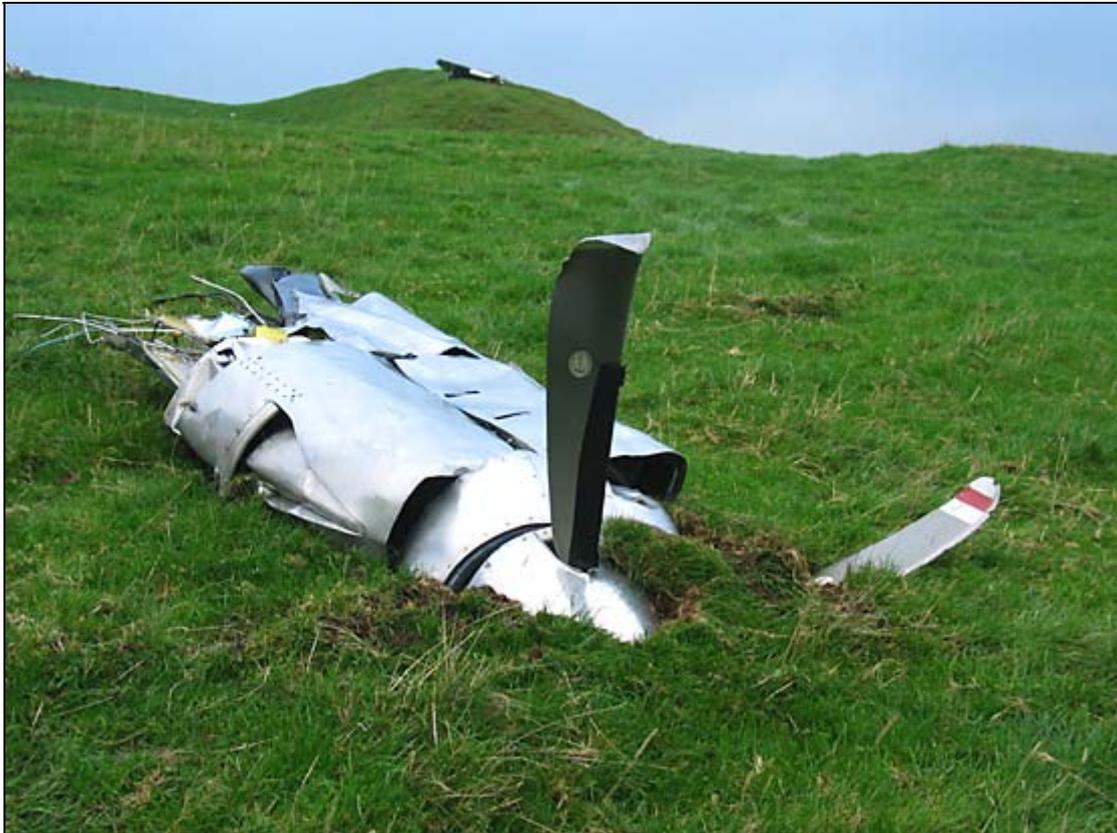
Figure 8
ZK-POA left engine

- 1.12.29 The left engine was deformed similarly to the right engine, and was also probably not rotating at ground impact. There was no evidence of foreign object damage.

- 1.12.30 The actuator motor was broken off the fuel firewall shut-off valve, showing that the valve was open. There was light sooting inside its protective cover. The nacelle showed evidence of a brief fire, aft of the firewall only. The extinguisher bottle was still charged.
- 1.12.31 The left propeller blades all showed severe leading edge damage and forward bending consistent with heavy strikes on a metal object while rotating under power. The rear faces of 2 blades showed marks characteristic of contact with teleflex cables. Two blades also had rearward bending and trailing edge scrapes consistent with the ground impact.

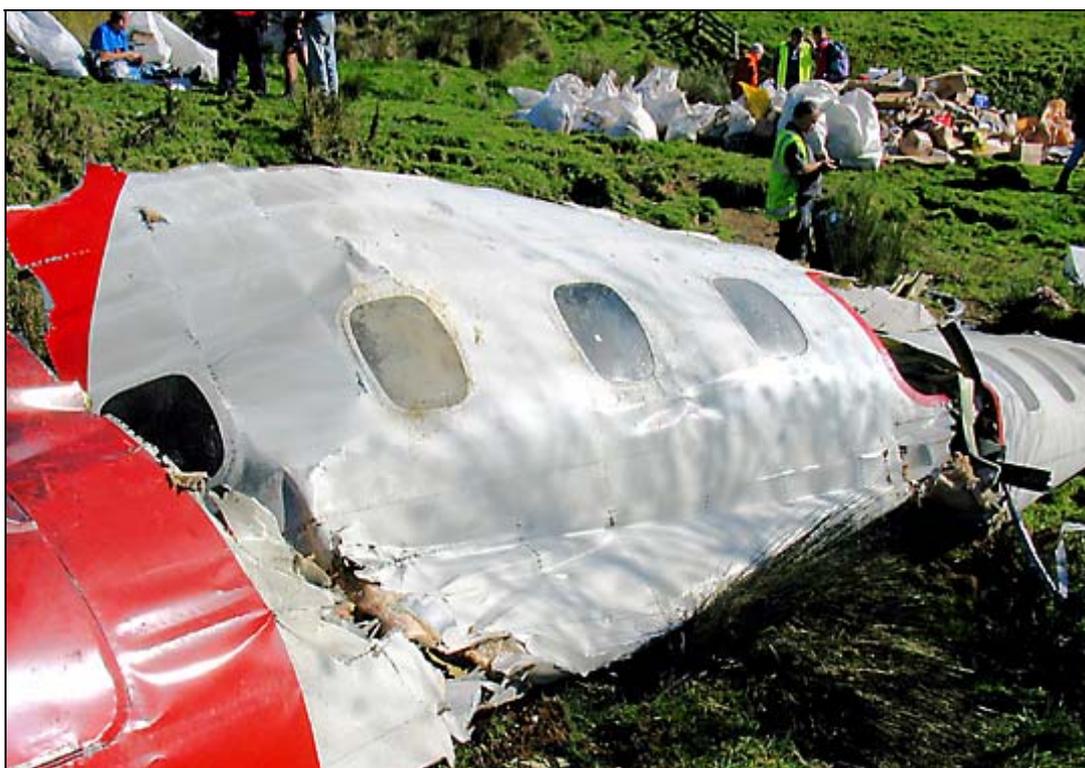
Figure 9
ZK-POA fuselage

- 1.12.36 The flight deck had completely separated from the rest of the fuselage at the aft edge of the entry door, which showed local evidence, on both parts, of strikes from the left propeller. The cabin and rear fuselage had been partially separated into 3 sections, which fell together. The left side fuselage skin had been torn open in front of the cargo door, apparently by rudder cables and by engine control cables pulling through the structure during the break-up. Most of the centre section belly and wing spar carry-through structure had separated from the fuselage and the wings, and showed tensile fractures similar to the wing spar fractures.
