# **AIRCRAFT ACCIDENT REPORT**

**Western Air Limited  
Fairchild Aircraft (SA-227)  
C6-REX  
Nassau New Providence Bahamas  
May 6, 2005**

**Report A0516317**

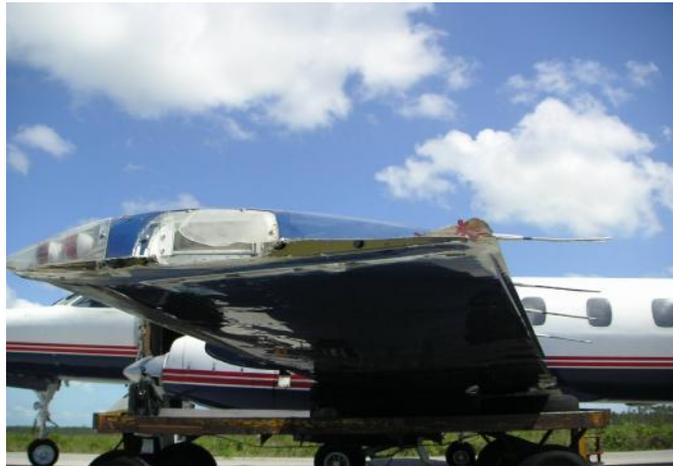
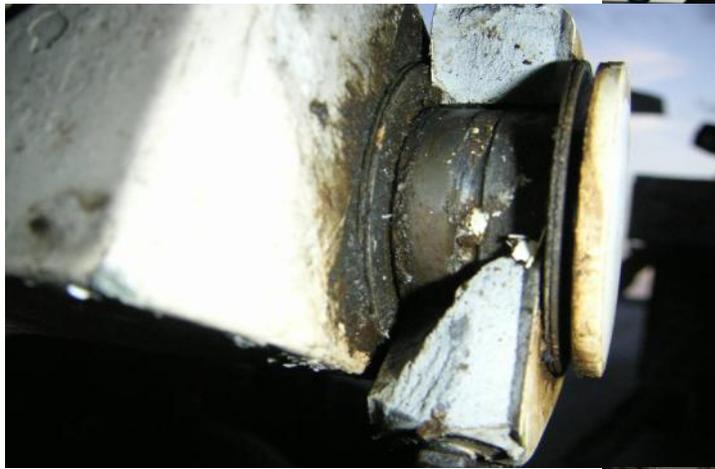
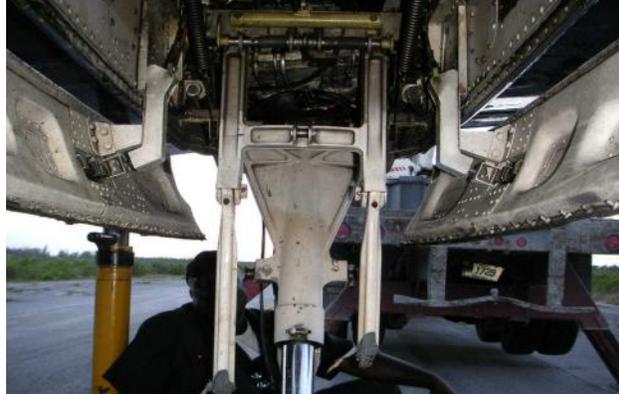
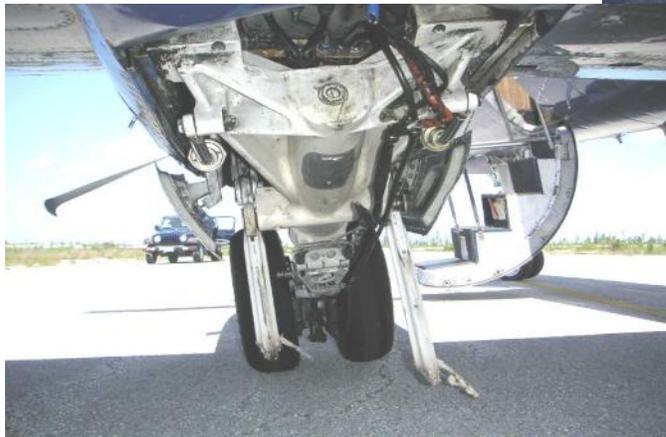
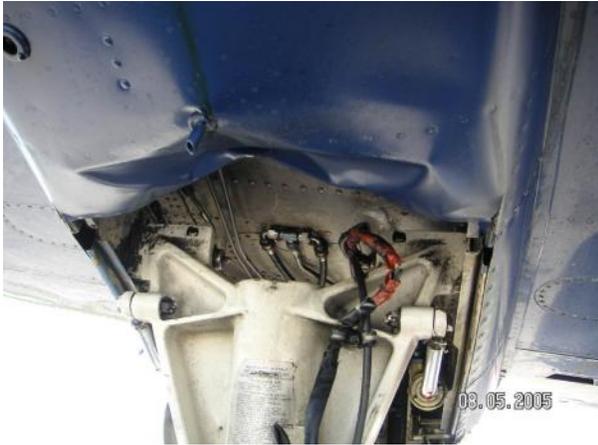
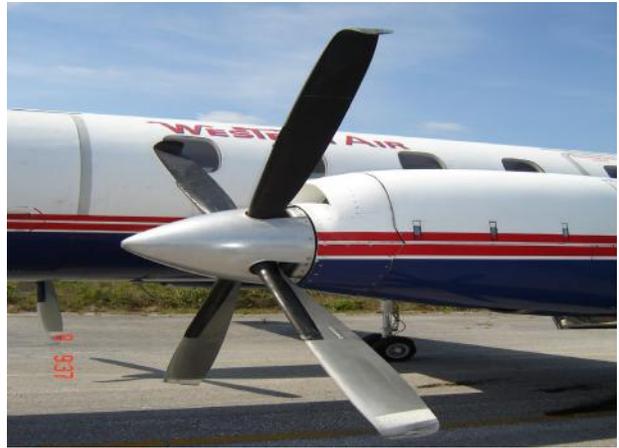
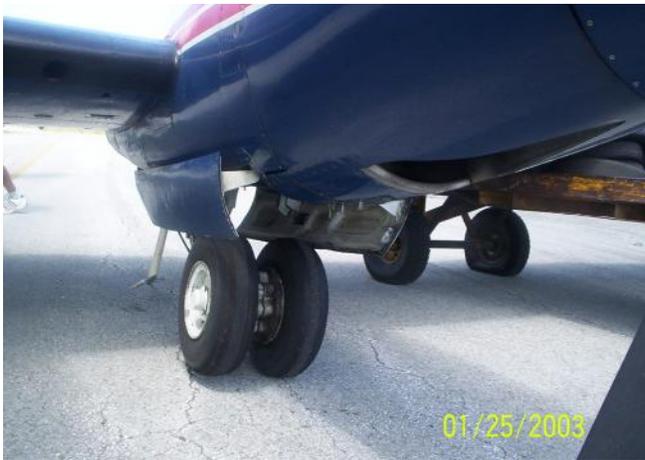
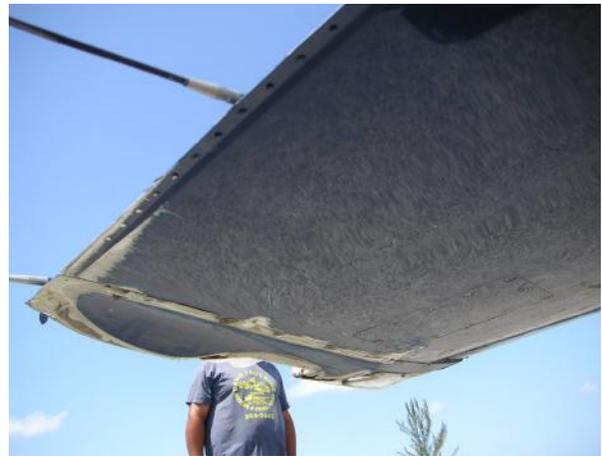
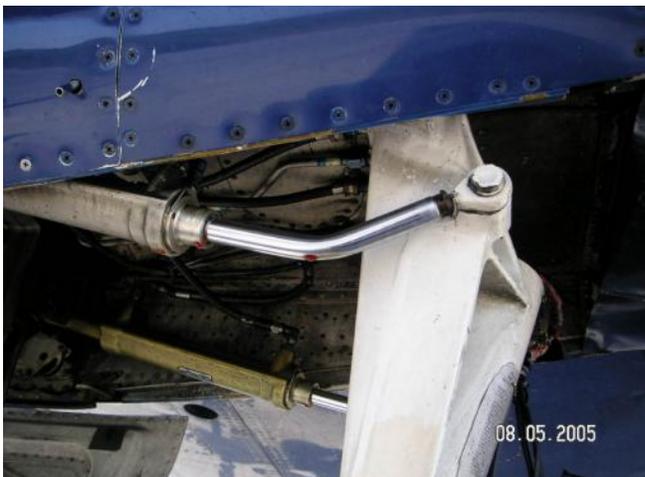
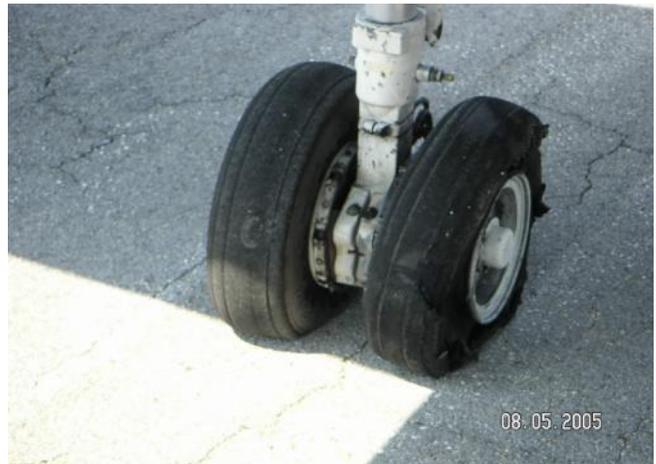
The aircraft came to rest upright. The underside of the left wingtip, the left propeller, the bottom of the left aft engine nacelle, and the left main gear, bore the main impact of the collapse. The right main gear tires also sustain damage. The fuselage remained intact. The cockpit and empennage were intact. The horizontal stabilizer and elevators had no visible impact or post impact damage. The vertical fin and rudder had no visible impact or post impact damage. There was no post impact fire.

Both engines were intact in the nacelles. Damage to the left engine could not be determined without more detailed inspection and analysis. The left propeller was extensively damaged from the impact. The right propeller did not appear to have sustained any impact damage.

8. Left gear drag brace failure occurred at San Andros International Airport. This fact evident by the recovery of portions of the left landing gear drags brace at San Andros.

9. Left Propeller strike runway at San Andros. This fact evident by the witness marks identified on the runway at San Andros.
10. All control surfaces were accounted for, and all damage to the aircraft was attributable to the impact forces.

#### **Failure of the left main drag brace.**

1. Random inspection of Western Air Limited Flight Preparation Records.
2. Fleet wide maintenance inspection of the gear link drag brace instituted immediately at Western Air Limited.  
*(Western Air Limited has been proactive and has already inspected the fleet to determine if there was any other cracked MLG link drag brace. Further, Western Air Limited has replaced any cracked components discovered as a result of their investigations.) See Exhibit – FSI2.  
The Flight Standards Inspectorate has on record the aircraft that were affected and the repairs that were carried out.*

4. Due to the high number of cycles verses the number of flight hours flown, the times interval between inspections of main landing gear drag brace shall be reduced from 1,000hours to 500hours.
