AIRCRAFT ACCIDENT REPORT

FINAL REPORT FUEL EXHAUSTION

**Flamingo Air Charter
Britten Norman (BN2-A) Islander
C6-ASA
Moss Town, Exuma Bahamas
16 May, 2005**

Report A0516517

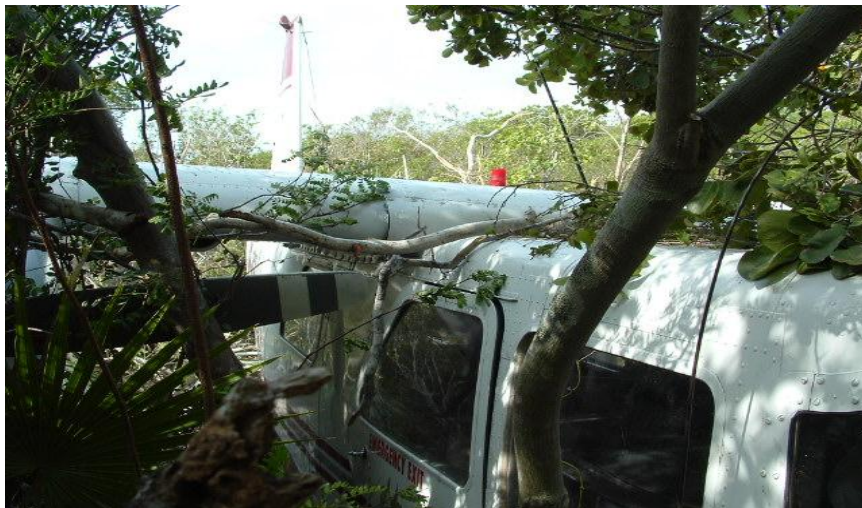
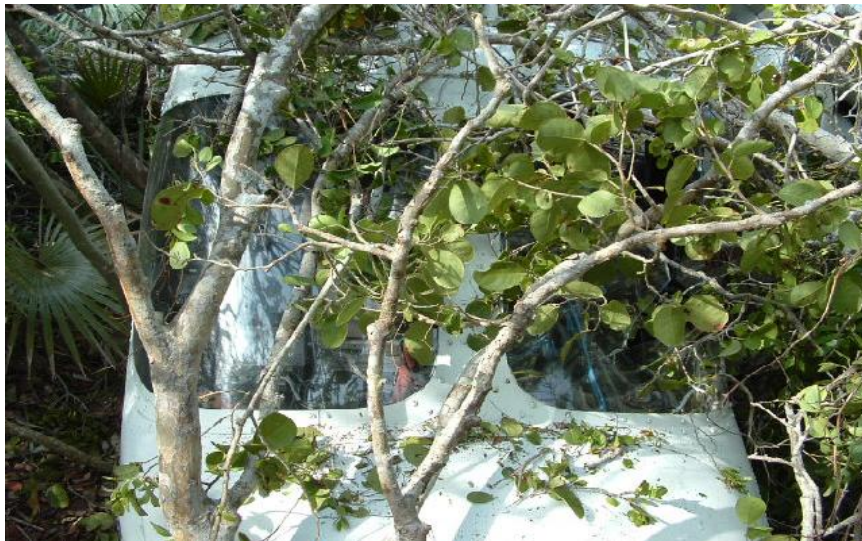
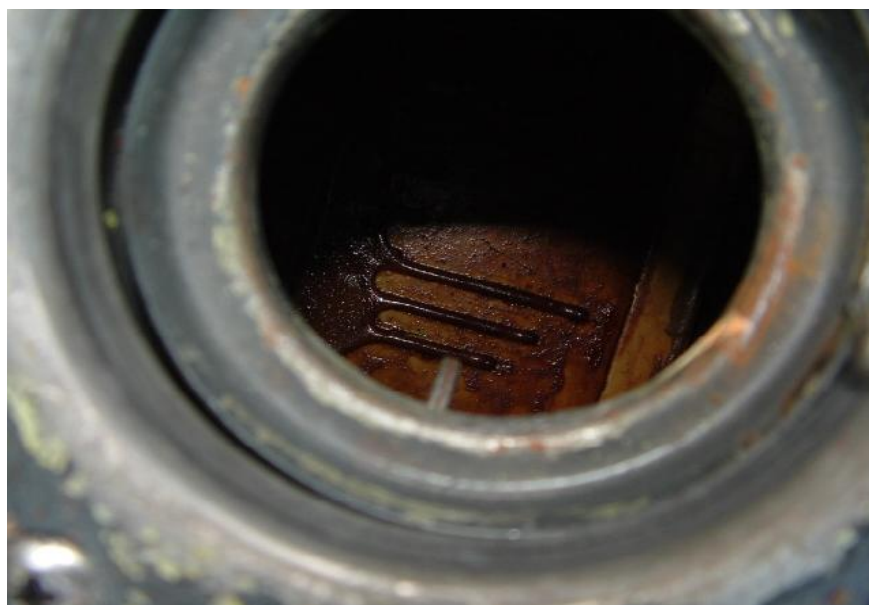
The aircraft came to rest upright. The wings, the nose and the fixed landing gears bore the impact of the crash; however the damage to the wings did not deform the wing and did not affect the integral fuel tank [wet wings]. The fuselage remained intact. The cockpit and empennage were intact. The rudder had no visible impact or post impact damage.

Both engines were intact in the nacelles. The propellers showed little or no signs of damage. Both propellers were found to be in an un-feathered position.

The instrument panels were intact. A tree branch destroyed the left windshield and lodged itself in the opening. Right windshield did not sustain any damage.
