DEPARTMENT OF AIR ACCIDENT INVESTIGATION

ACCIDENT REPORT

COLLISION 5Y-SFE & S9-BAS

CAV/ACC/BAS/SFE/05

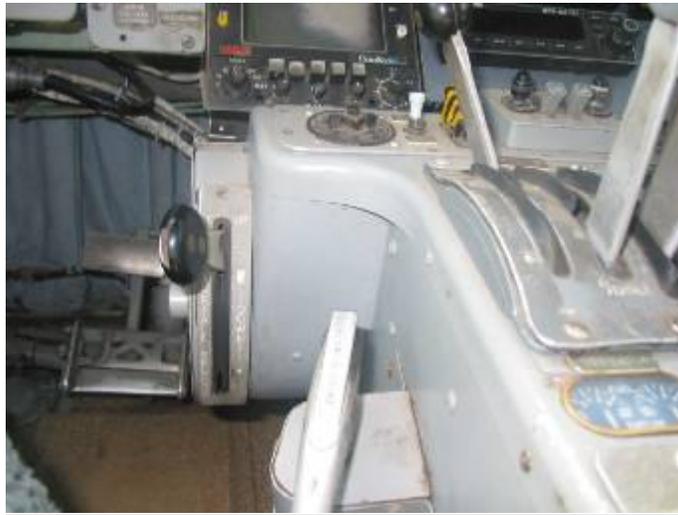
The lower fuselage was badly damaged by the impact and sliding on the bitumen. The propeller blades were bent back and slightly twisted showing that the engines were under power on landing. The bottom leading edge of the fin had a dent where it was struck by the right wing tip of the Hercules. After the accident, the landing gear selector was observed to be in the "UP" position.

The HS 748 Landing Gear Selector in the UP position
