Report A-011/2006

Accident involving
a B737-600 aircraft,
registration 7T-VJQ,
at Seville Airport,
on 18 March 2006

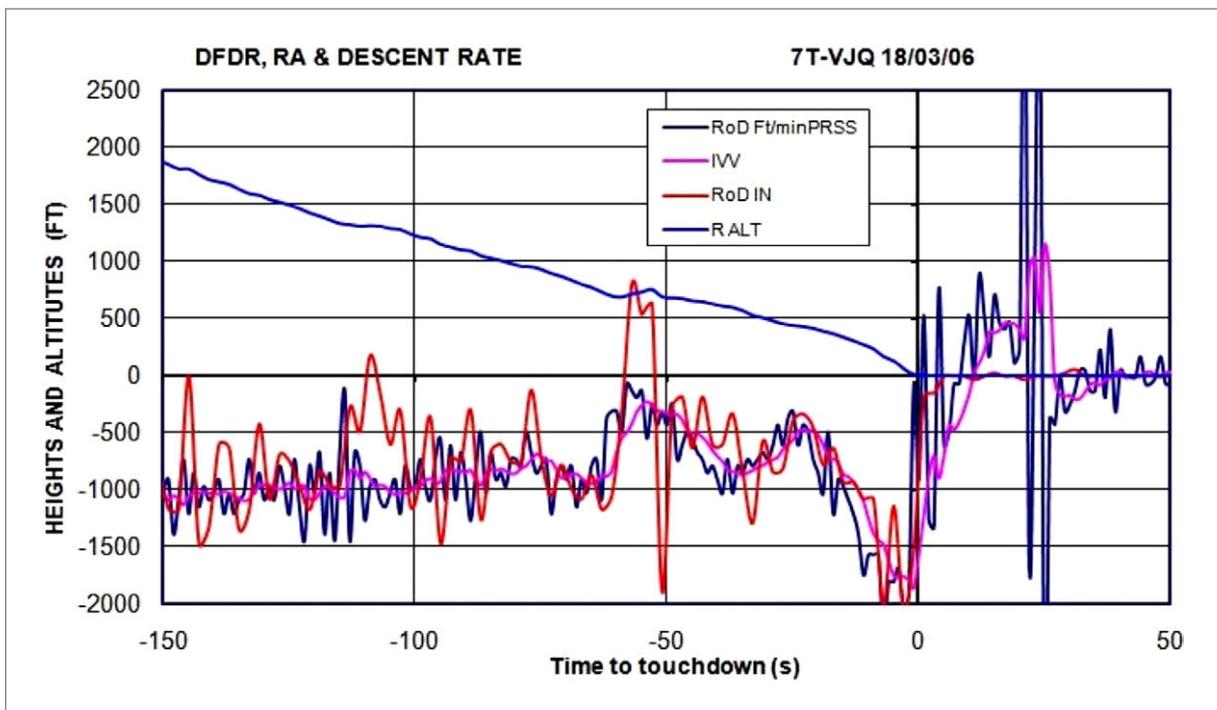
Figure 6. Rate of descent

Note how a descent rate of between 1,500 ft/min and 2,000 ft/min was reached in the ten seconds prior to touchdown.

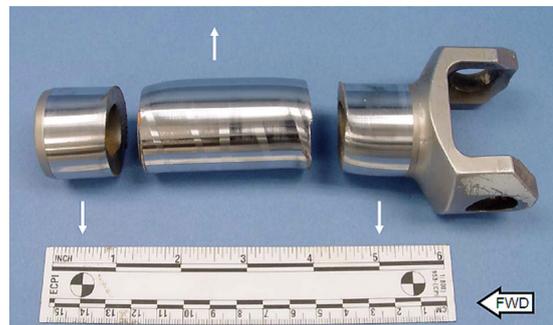
Figure 20. Joint pin

- The fusible pin that attaches the LGB to the aft spar failed due to a shear overload in the vertical direction. The hardness of the material was verified to satisfy the design specifications.
- The forward trunnion support was bent and there was a break in the outer race bearing consistent with a relative shift aft of the bearing's inner race.
- The side strut link was bent and the lower attachment lug was broken as a result of having bent backwards. The appearance of the fracture surfaces was consistent with an overload condition. The hardness of the material, checked during the analysis, was within specifications.

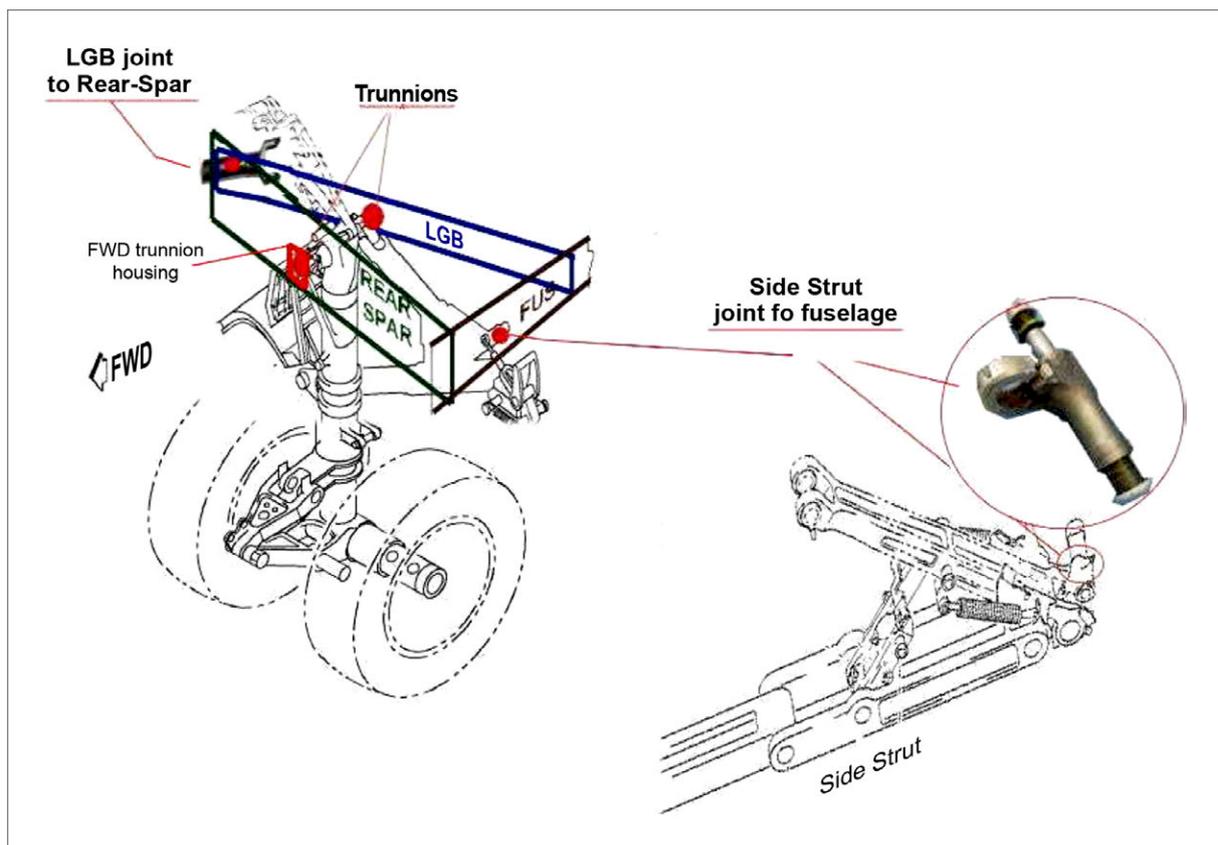
Figure 21. Main structural failures

Since the investigation did not reveal any material defects in any of the failed components, nor any deviations in their mechanical characteristics, it is assumed that the fractures occurred due to overloads at the moments of impact when landing and which resulted in high overall acceleration values in the aircraft.

Vertical ground loads transmitted through the right landing gear leg to the LGB caused the failure of the fusible link that attached the LGB to the aft spar, as intended by design. When the aft support gave way, the leg moved backwards, causing the forward trunnion to break from its housing. The aft and lateral forces exerted on the wheel loaded the side strut until it failed. At that point the entire leg was attached at a single point, the aft trunnion, and was dragged by the aircraft for the remainder of the landing run.

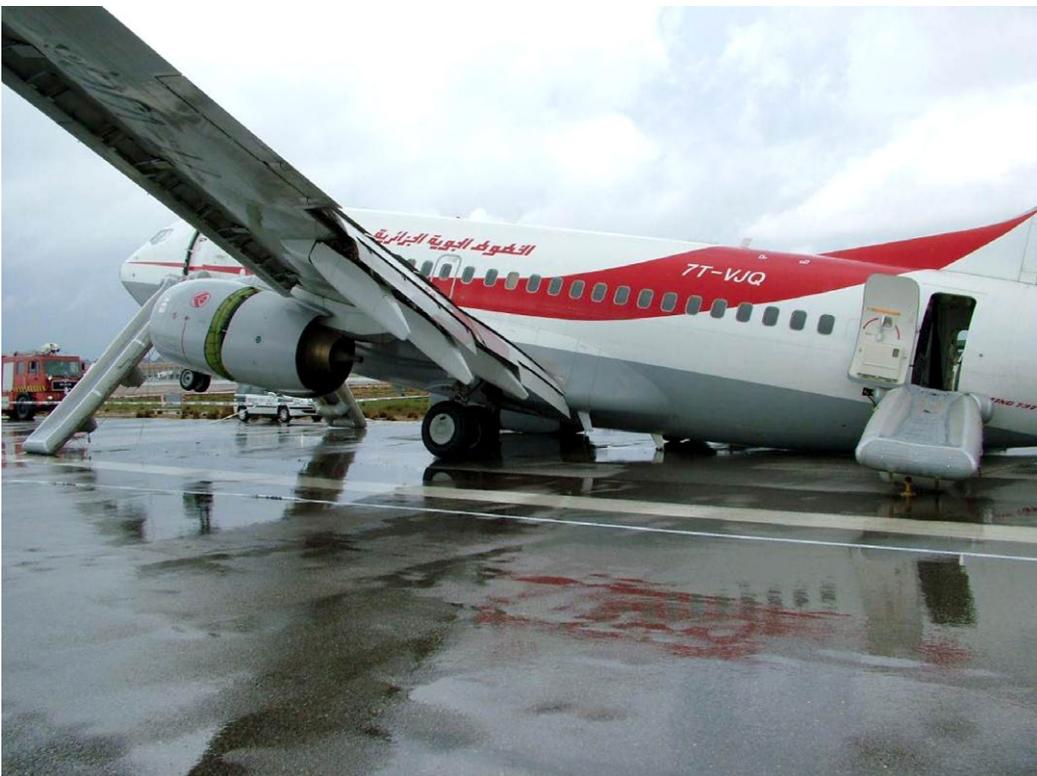
Photograph 2. Right side view

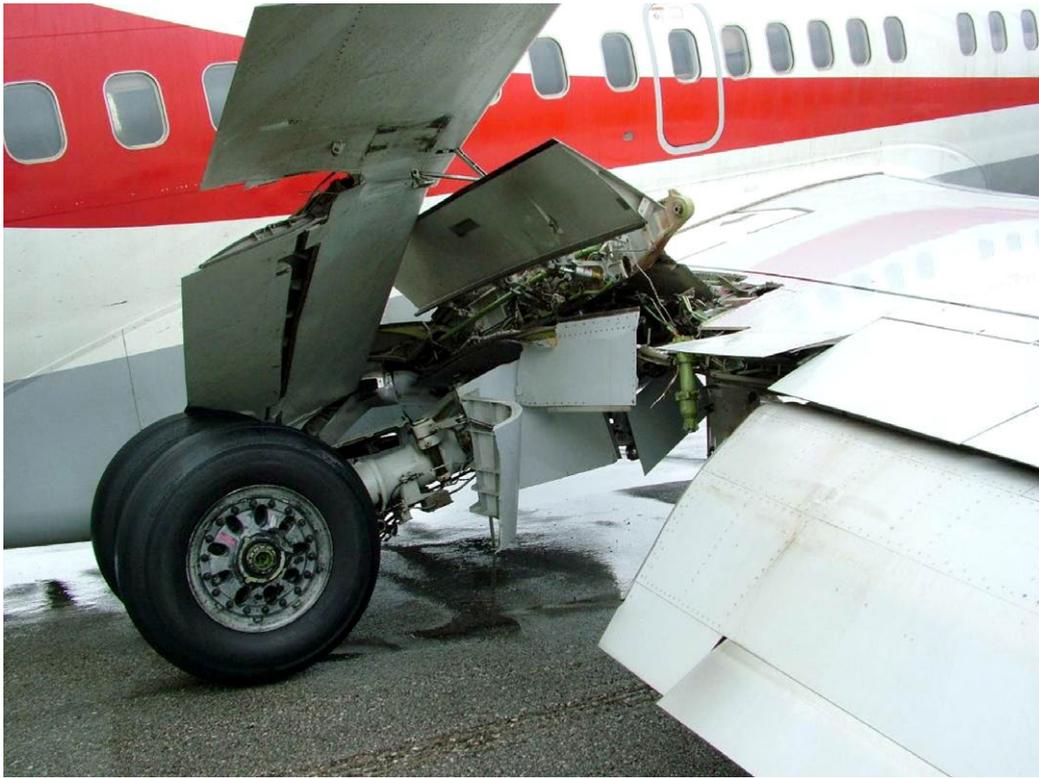
Photograph 5. Left side view. MLG right leg detail

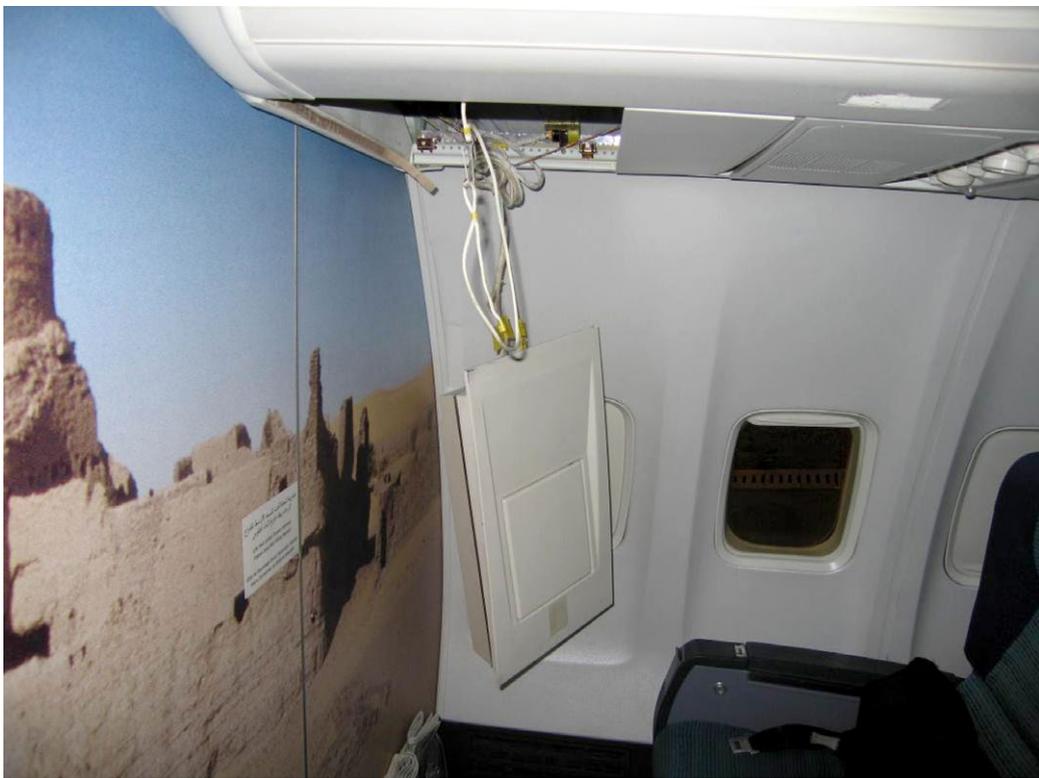
- A cowl on the left engine was bent.
- Inside the airplane three overhead panels and their associated video monitors fell to the floor and an interior wall panel was cracked.

Photograph 6. Passengers cabin. Overhead panel detached
