Aircraft Accident Report

**Hail Encounter During Approach
Asiana Airlines Flight 8942
A321-100, HL7594
20 miles South East of Anyang VOR
June 9, 2006**

**Aviation and Railway Accident Investigation Board
Korea Ministry of Construction and Transportation**

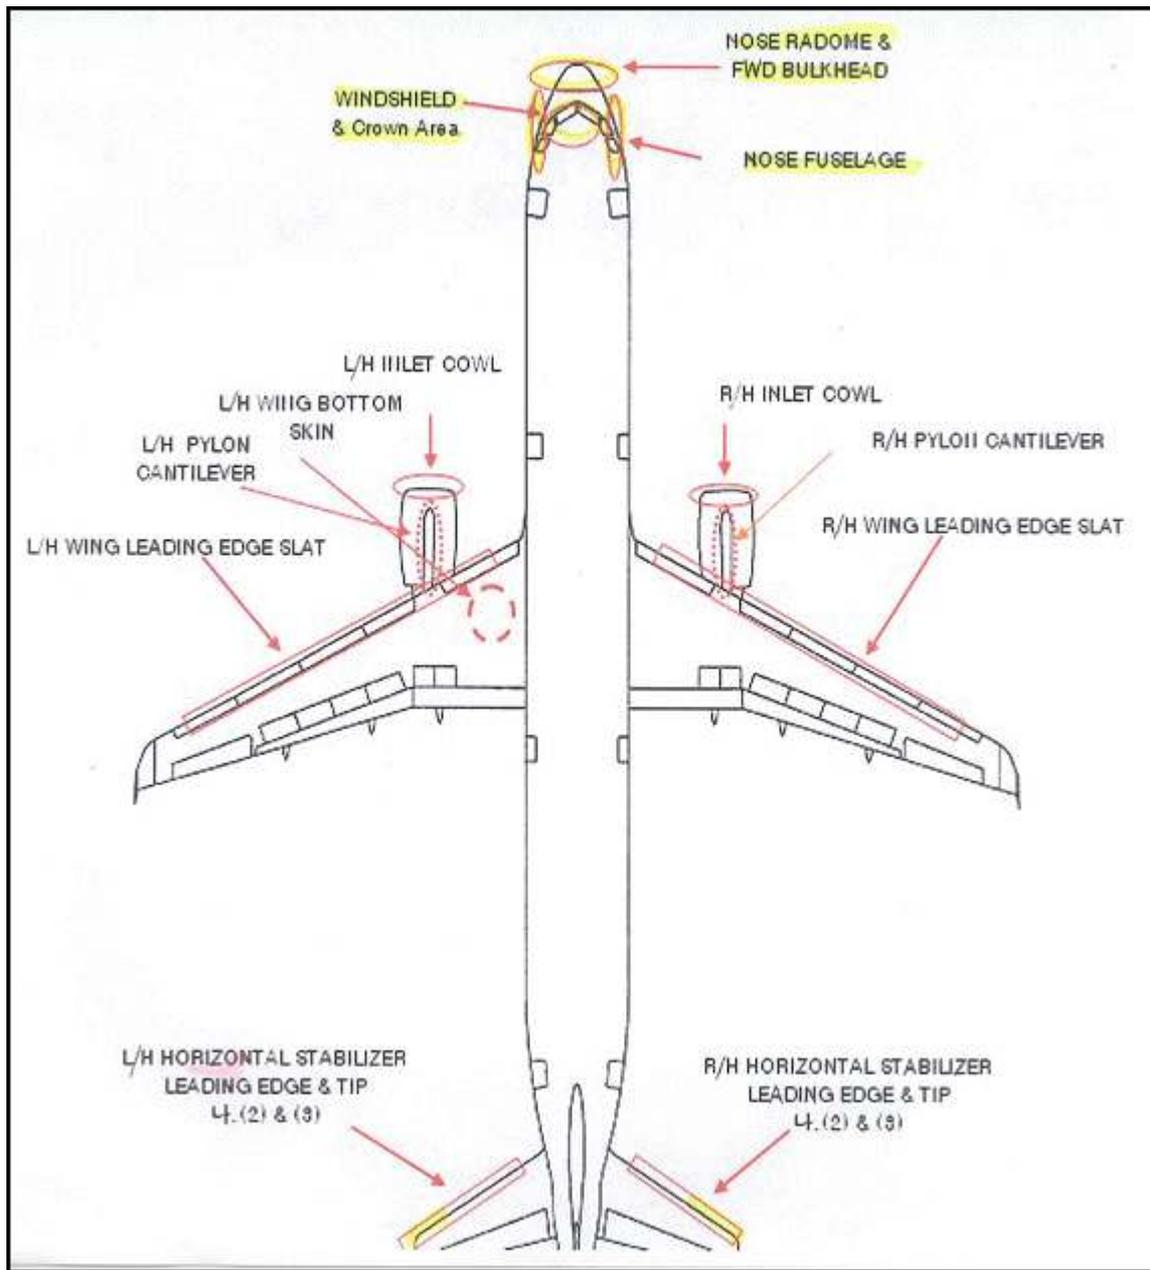
[Figure 2] Damaged Areas (Shown In Red Color)

The airframe of flight 8942 was damaged overall, and the radome in the front section of the aircraft was torn away, and there were about 40 marks found in the forward pressure bulkhead and in the rivets of the inlet cowling. Some of the rivet heads were broken off in a serious case.

Some parts of the engine mounted area were damaged by debris from the radome, and the hail marks were found in wing leading edges.

Horizontal stabilizer leading edges and both tips were also damaged by the hailstorm, and the locations of damage are shown in [Figure 2].

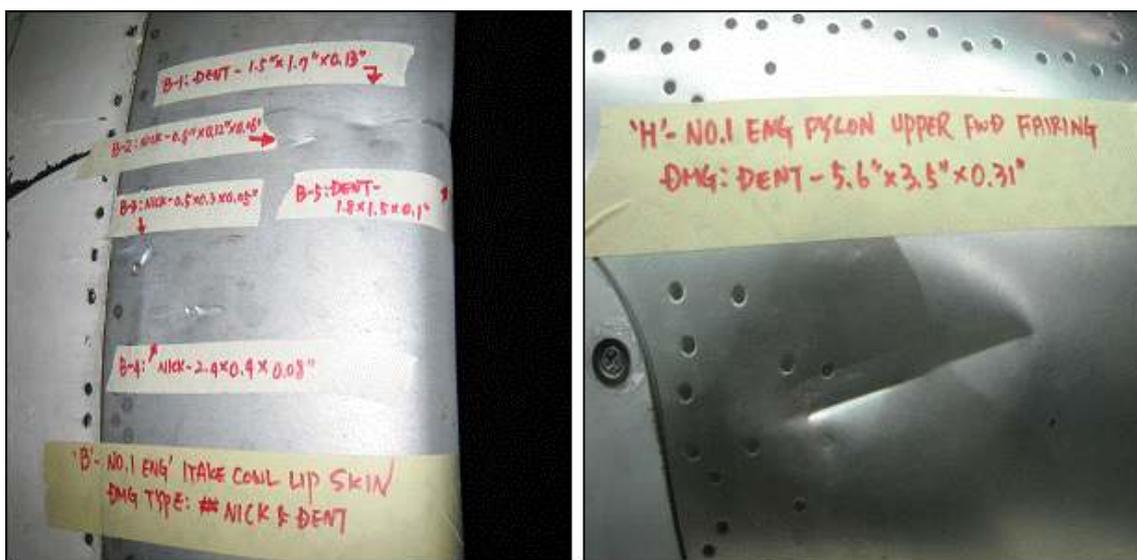
[Picture 11] Damaged Portion from Detachment of Radome

Damages on the cowl of No. 1 Engine, and top and inside of Pylon were due to radome detachment as shown in [Picture 11], and left latch to fasten the radome penetrated into the cowl of No. 1 Engine.

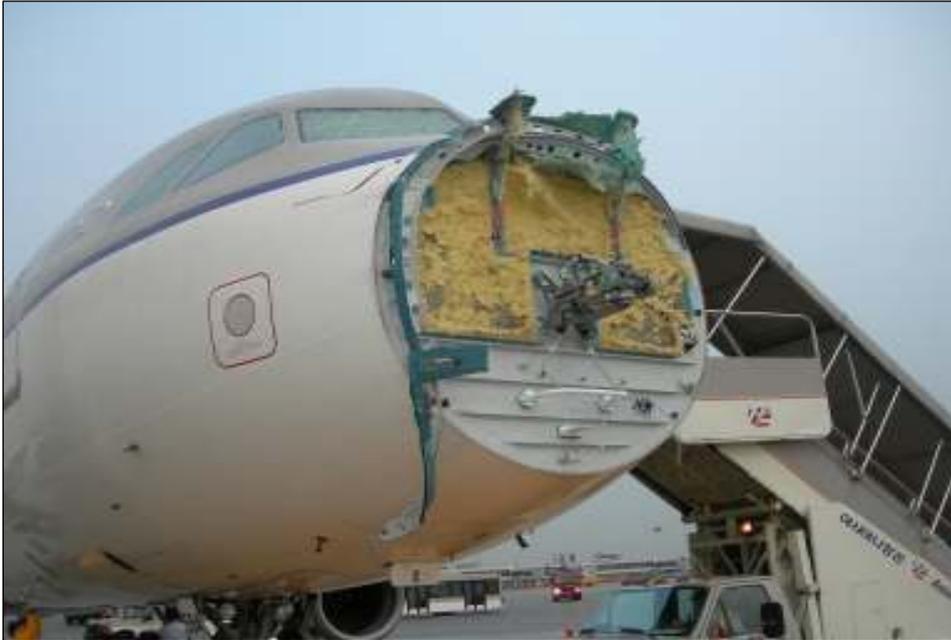
[Picture 12] Damaged Nose of Aircraft

Some debris from the detached radome caused some damages on the No.1 engine cowl and the bottom of left wing. The shape of radome detachment due to thunderstorm is shown in [Picture 12].

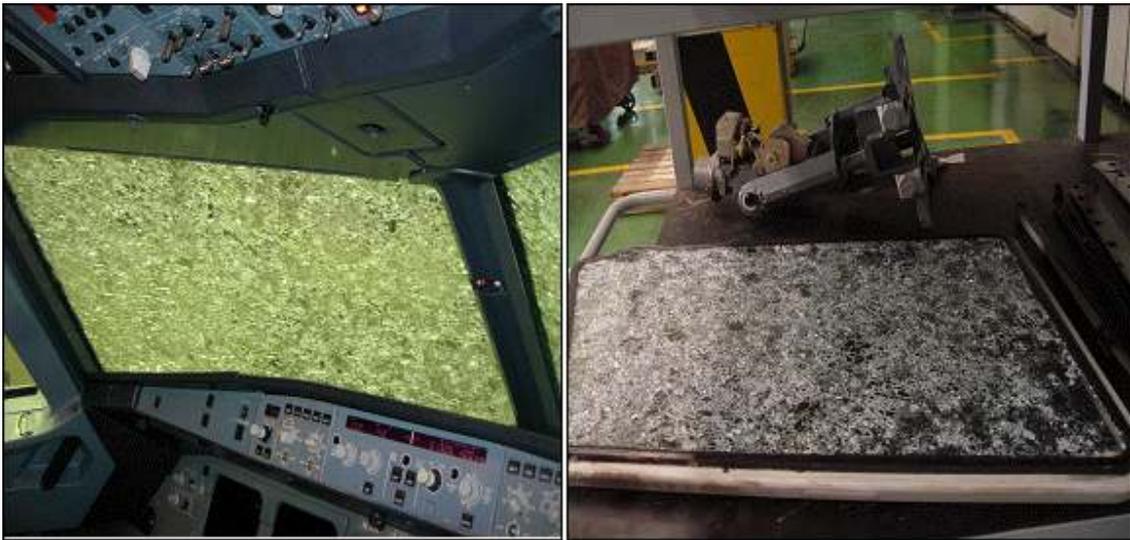
[Picture 13] Damaged Windshield Installed in Aircraft (Left) and After Separation (Right)

The [Picture 13] indicates the damaged windshield. The left Picture was taken from the inside of cockpit and the right one was taken after it was separated from the aircraft.

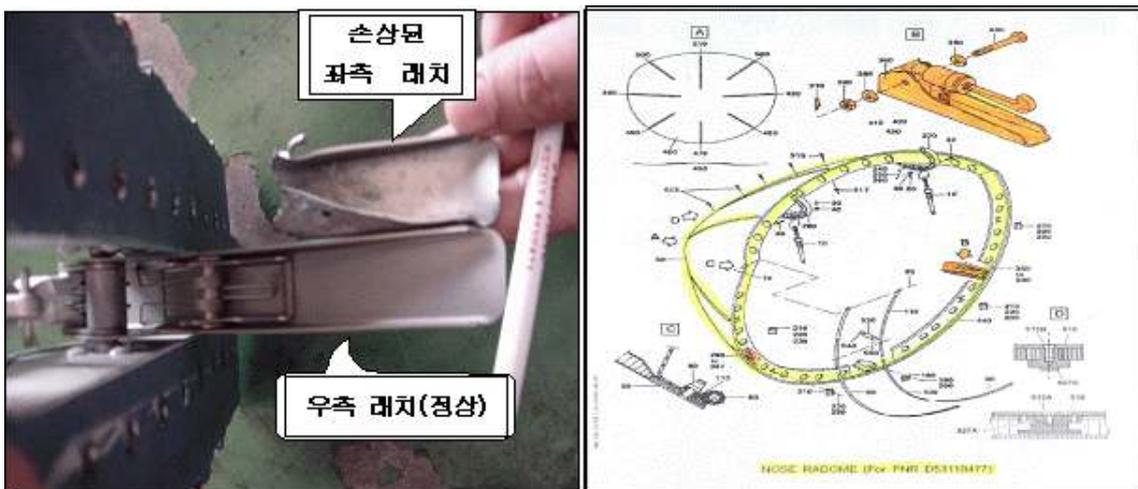
[Picture 14] Comparison of Latches (L/R)

Of the two latches⁵⁹ to fix the radome, the right one was attached to the frame; however, the left latch was separated as shown in [Picture 14] and it caused the damage to the engine cowl and was found inside of it. [Figure 15] indicates the structure of radome.

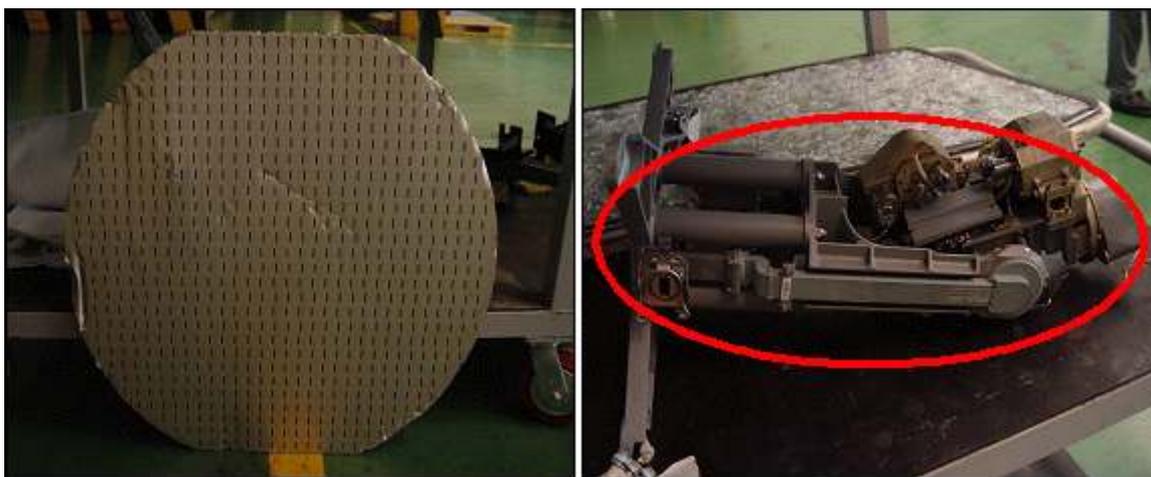
[Picture 16] Weather Radar Antenna and Antenna Drive Unit

The radar antenna was damaged by facing with the external environment installed the inside of the radome by detachment of radome. The antenna was still attached to the aircraft during flight after encountering with the thunderstorm and then fell on the runway due to impact upon landing.

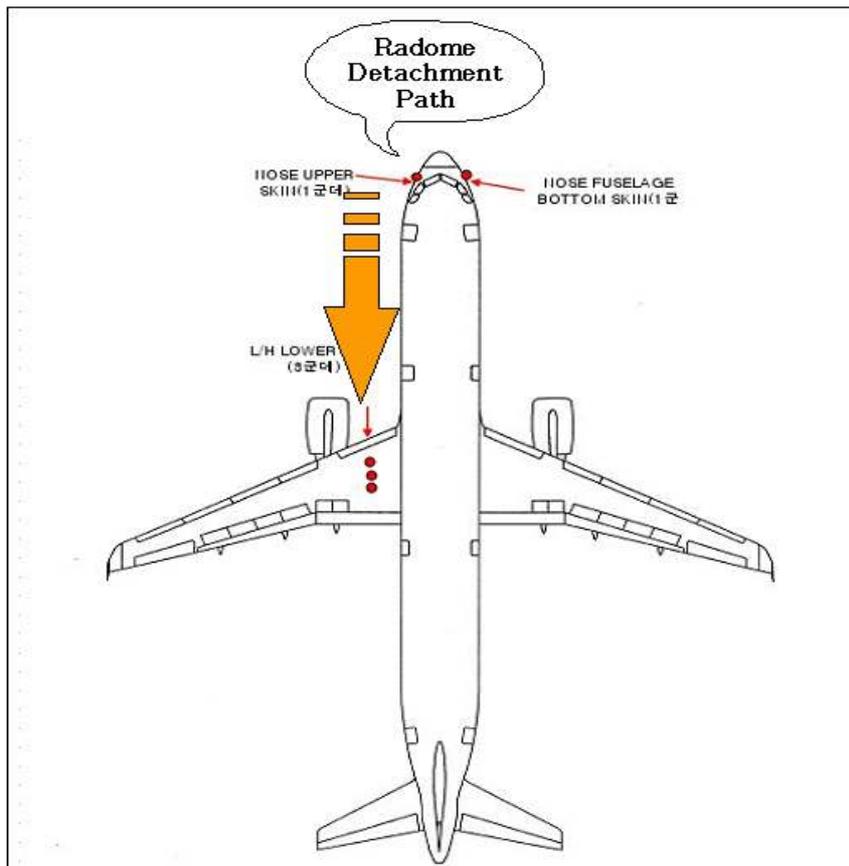
[Figure 19] Inference of Radome Detachment

As shown in [Figure 19], the hail hit the cockpit windshield and the radome and damaged to the radome made of composite material. It is presumed that (1) the radome was broken more and more and then detached due to increase of pressure as the air entered into the inside in case of puncture to the radome, or (2) it was detached from the aircraft as lifted by untied latch which support the radome due to impact by hail hit. It is analyzed that the case (1) is highly feasible and that only this case has to be considered.

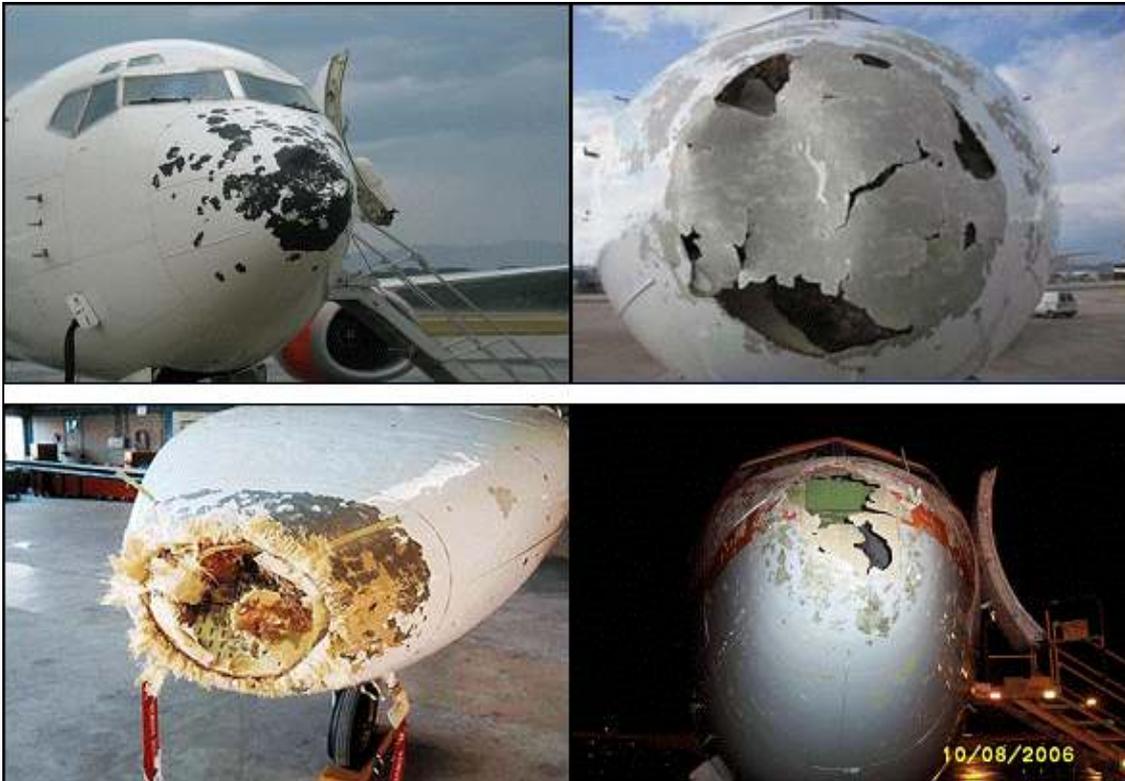
[Picture 18] Shape of Damage to the Front Radome Due to Hailstorm

There have been cases that the radome was damaged by hailstones when an aircraft encountered with a thunderstorm accompanied by hailstones. As shown in [Picture 18], it shows the damage to the radome due to the hail and it was still attached to the airframe in spite of the damage to the radome. Although it was severely damaged and partially detached, the radome itself was not detached. The shape of damage to the front radome can be seen in [Picture 18] due to the hailstorm.

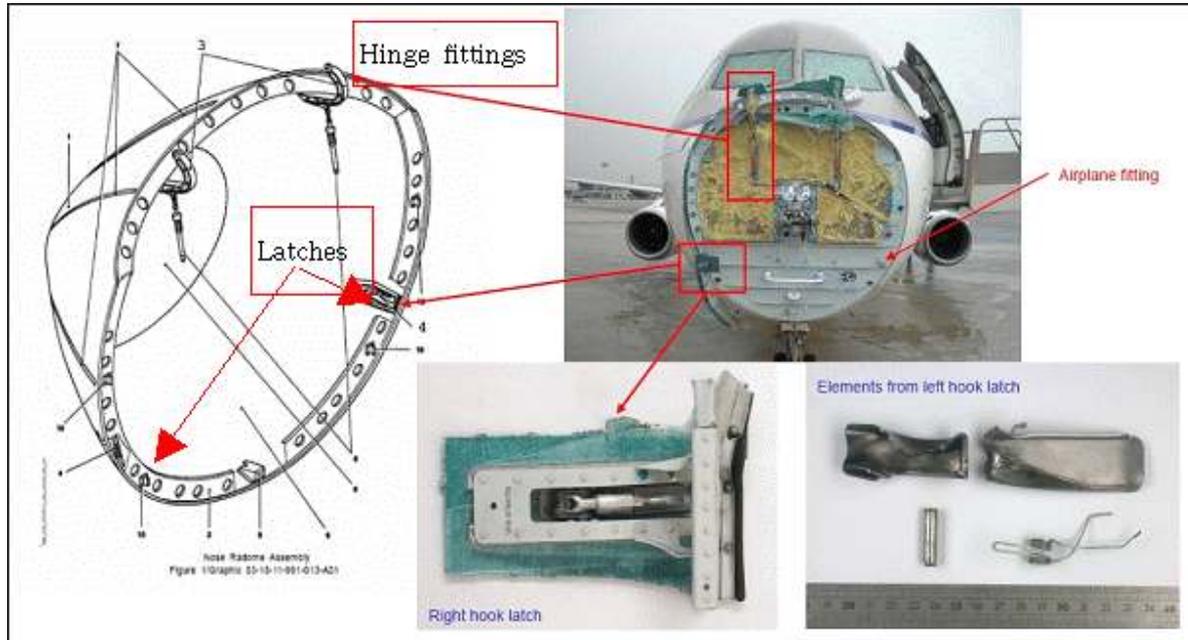
[Figure 21] Location of Latch Installed in the Aircraft and Damaged Pattern

[Figure 21] shows the location of parts installed in the aircraft and damaged pattern analyzed in the France BEA research lab.

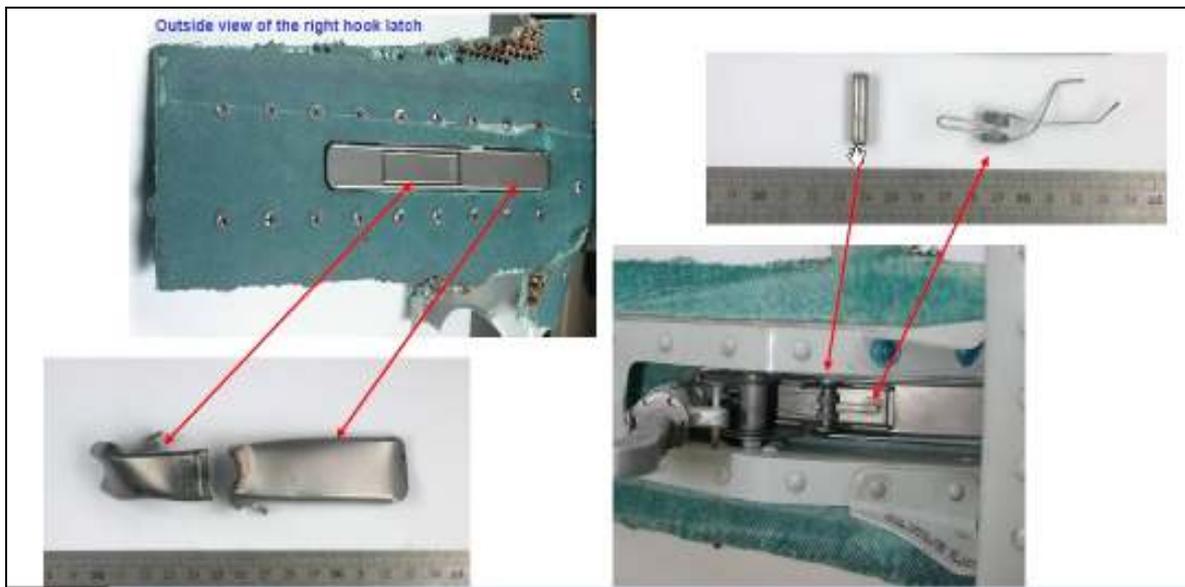
[Picture 20] Damaged Parts of the Left Hook Latch

[Picture 20] shows the damage parts from the left hook latch. The damaged part is the pushbutton marked as “PUSH,” the axle pushbutton spring and the rear part of the locking handle detached from pushbutton.

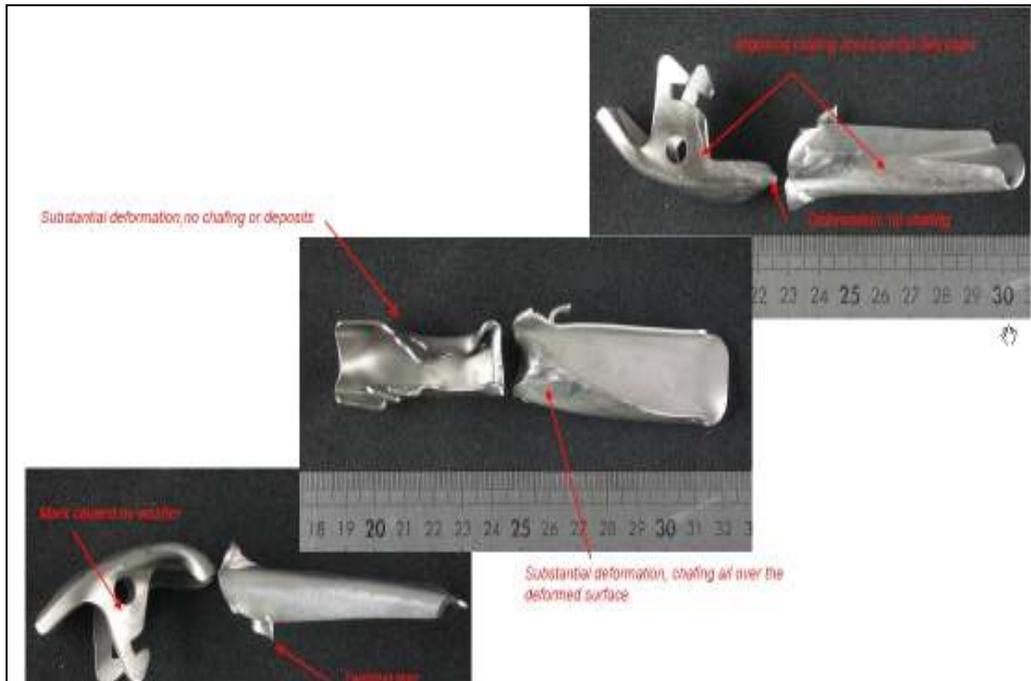
[Picture 21] Damage to the Left Handle

There were many deformation found in the left side and chafing was also found on the entire surface deformed. There were mark made by washer and twisting found as shown in the left lower picture.

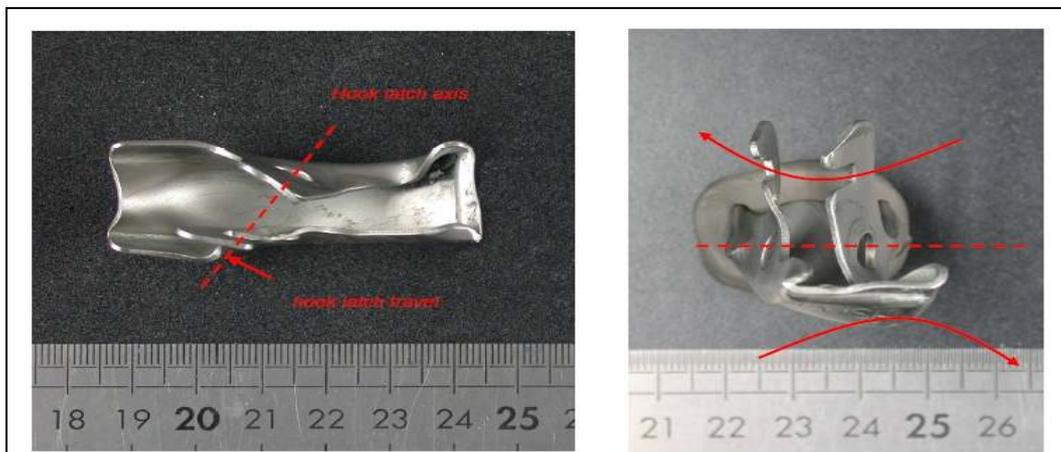
[Picture 22] Deformation of Pushbutton

The hook latch moves along its axle. The left picture on the [Figure 22] shows the deformed pushbutton. The reason of deformation was that the high energy applied to the pushbutton. The direction applied was the direction of bent arrow. As shown in [Picture 22], the indentation of hook latch was by spigots.
