Investigation Report

3X181-0/06
April 2010

Kind of occurrence: Accident
Date: 29 November 2006
Location: Mattsies
Type of aircraft: Fixed wing
Manufacturer/Model: Grob Aerospace / G 180A
Injuries to persons: Pilot fatally injured
Damage to aircraft: Aircraft destroyed
Other damage: Crop damage
Source of information: Investigation by BFU

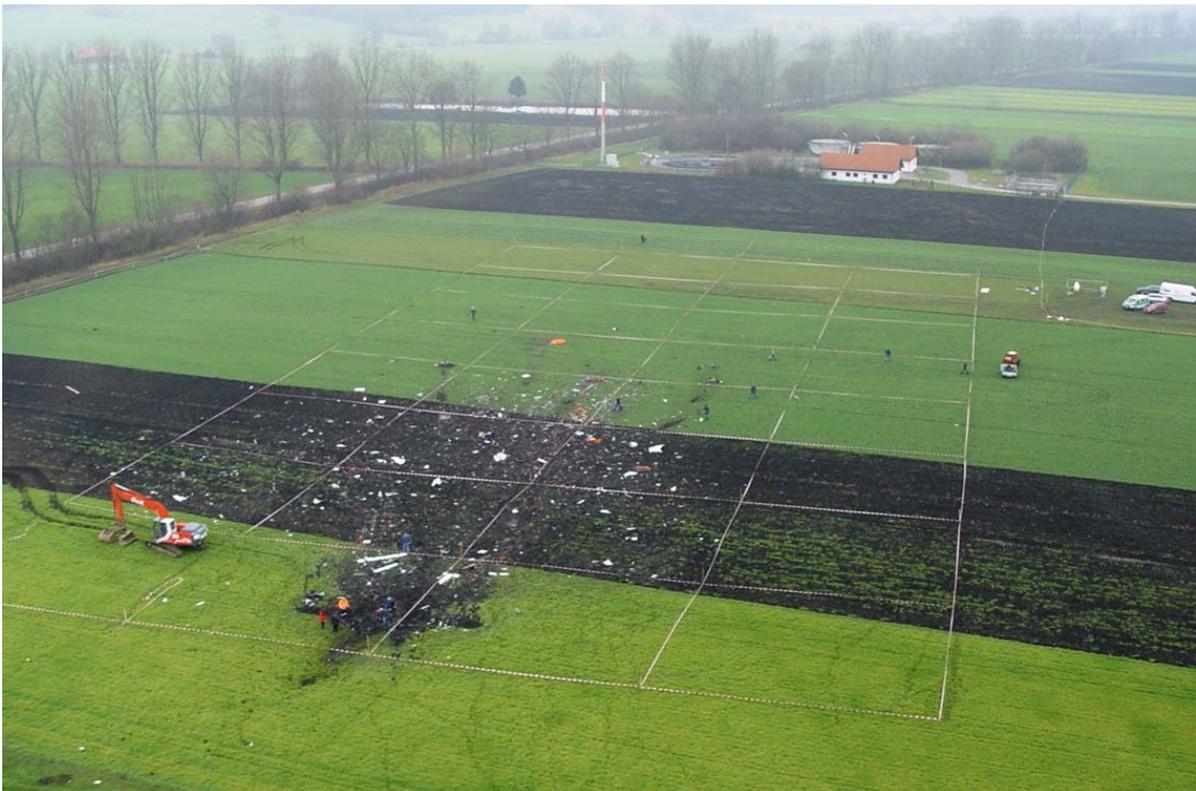
Diagram 3: Accident site

The aircraft first made contact with the ground wings level and penetrated about 1 metre into the ground. From this point, wreckage was strewn over a path about 200 metres long and 120 metres wide. Surface marks left by wreckage and their scatter pattern indicated that the aircraft heading was about 280°.

The aircraft was destroyed by the impact. Most of the fragments were less than 10 cm x 10 cm. Aggregate components such as the landing gear and avionics were fragmented.

The wings made distinctive marks in the ground at the point of initial impact, where the residue of the main spar was found. Traces of fire were found in and around the impact crater. In this area, some of the carbon fibre components were reduced to ashes.

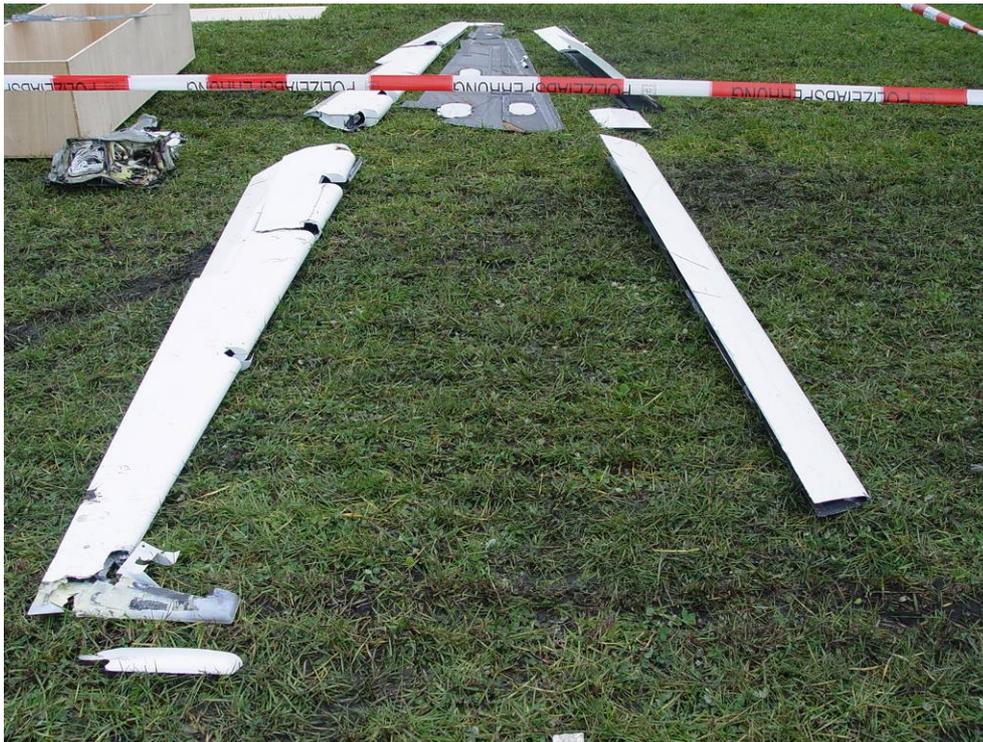
Diagram 4: Parts of the horizontal stabiliser found prior to the main point of impact

Parts of the elevator, the lower shell from the left stabilizer, and the leading edges from both stabilizers, were found about 400 metres prior to the point of initial impact. These components were found in a field scattered within an area about 100 m x 50 m. Small carbon fibre fragments were found south-east of this field several hundred metres away.

Part of the left elevator horn with mass balance was found between the two main areas of wreckage.

The largest parts of the horizontal stabiliser such as elevator and skin were located on the ground several hundred metres prior to the point of impact, either directly on or near to the track left by the wreckage and confirmed by witnesses. They had separated from the aircraft in flight. It was not possible to determine the exact time or place at which this happened. However, separation must have occurred before the aircraft had flown over the point at which these components were subsequently found.

The left elevator horn with mass balance was subsequently found on the ground between the horizontal stabiliser wreckage and the main point of impact. After the elevator horn separated from the stabiliser it continued on a longer trajectory than the other stabiliser components, because it had a better ratio of mass to coefficient of drag and therefore did not decelerate so quickly in the air. The elevator horn was found about 300 metres from the other horizontal stabiliser components, which supports the assumption that these components detached from the aircraft at the same moment.

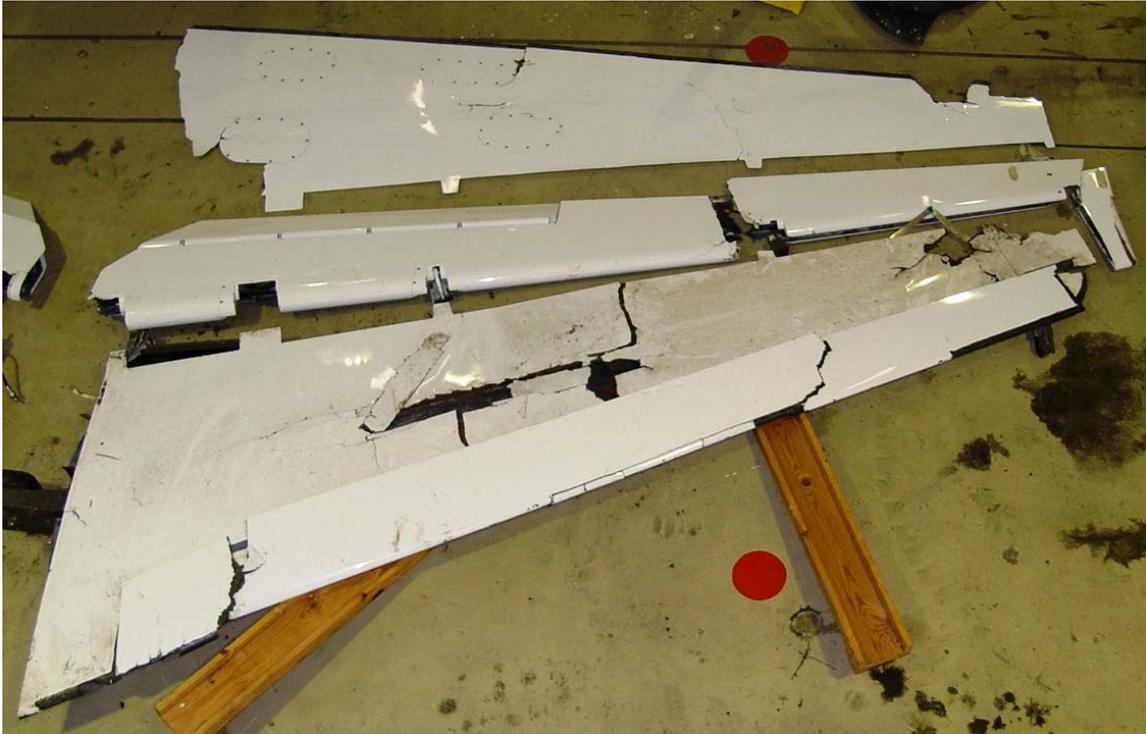
Diagram 5: Parts of the left stabiliser

All identifiable stabiliser components were separated from the remaining wreckage and rearranged in their original positions (see appendix). Examination of the stabiliser and elevators revealed the following:

1. The pattern of damage to the residual components provided no indication of Foreign Object Damage (FOD).
2. The total damage pattern pointed towards a rapid structural failure at different positions.
3. There was noticeable symmetrical similarity in the damage to the left and right stabilisers.
4. A continual fracture was found on the left stabiliser, running in the direction of flight via the leading edge, stabiliser and elevator (near the third elevator bearing).
5. Symmetrical fractures were found in the stabiliser leading edges, both left and right.
6. There were symmetrical cracks left and right above the main spars in the stabiliser upper shells.
7. Both elevator horns bore clear traces of their supplementary weights (lead shot in resin); the mass balances were absent.

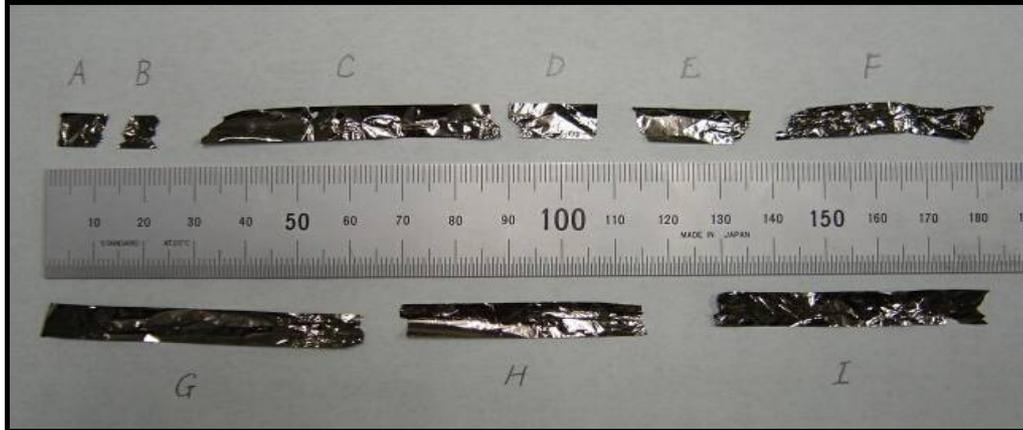
Diagram 7: Parts of the damaged magnetic tape

In addition, an attempt was made to extract data from the fragments (diagram 7). The fragments were carefully flattened and spliced with an undamaged tape, followed by an attempt to extract further data.

The damage was so severe, that it was not possible to extract data.

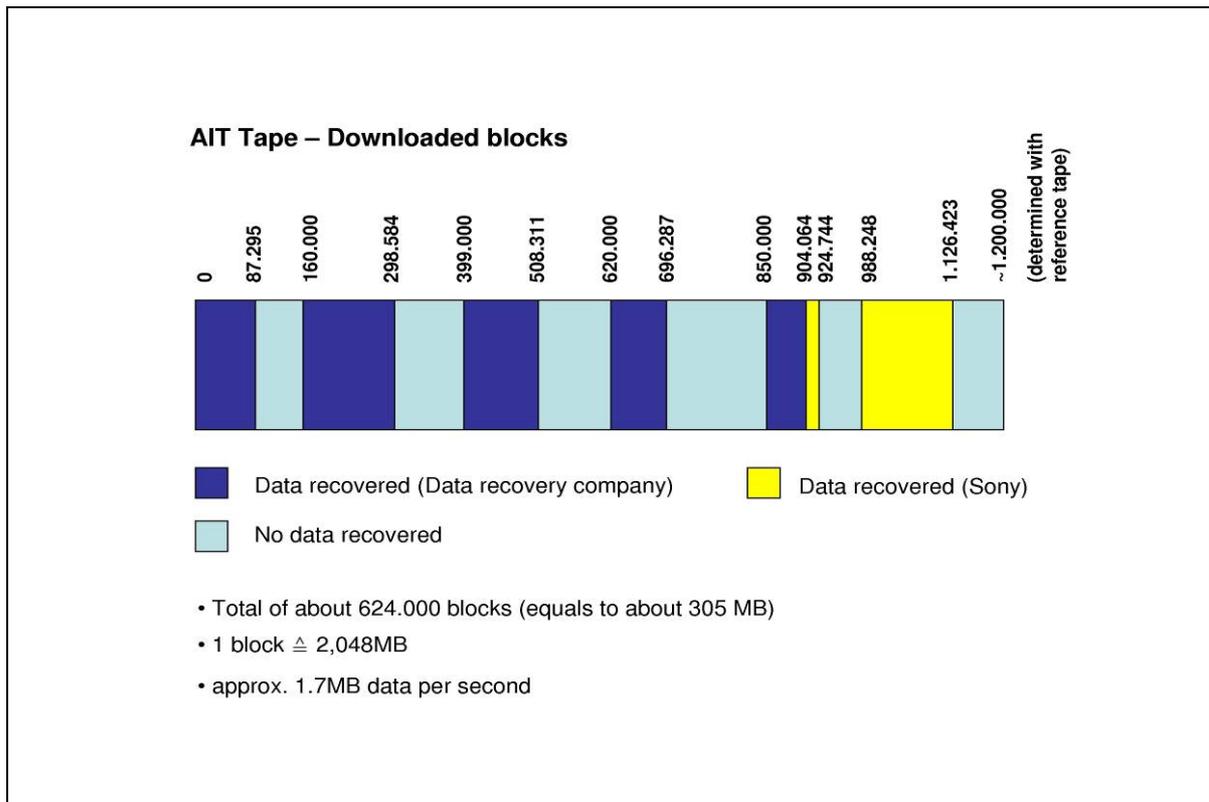
Diagram 9: Reconstructed data blocks (Magnetic tape original input feed)

By changing the playback parameters, the manufacturer was able to reconstruct more data than that which had been read from the original input feed (see diagram 9).

It was found that further data could be read out by changing the playback parameters. The reconstructed data are from the accident flight recording, but prior to take-off. The actual flight phase data was on the fragmented sections and was unreadable due to impact damage.

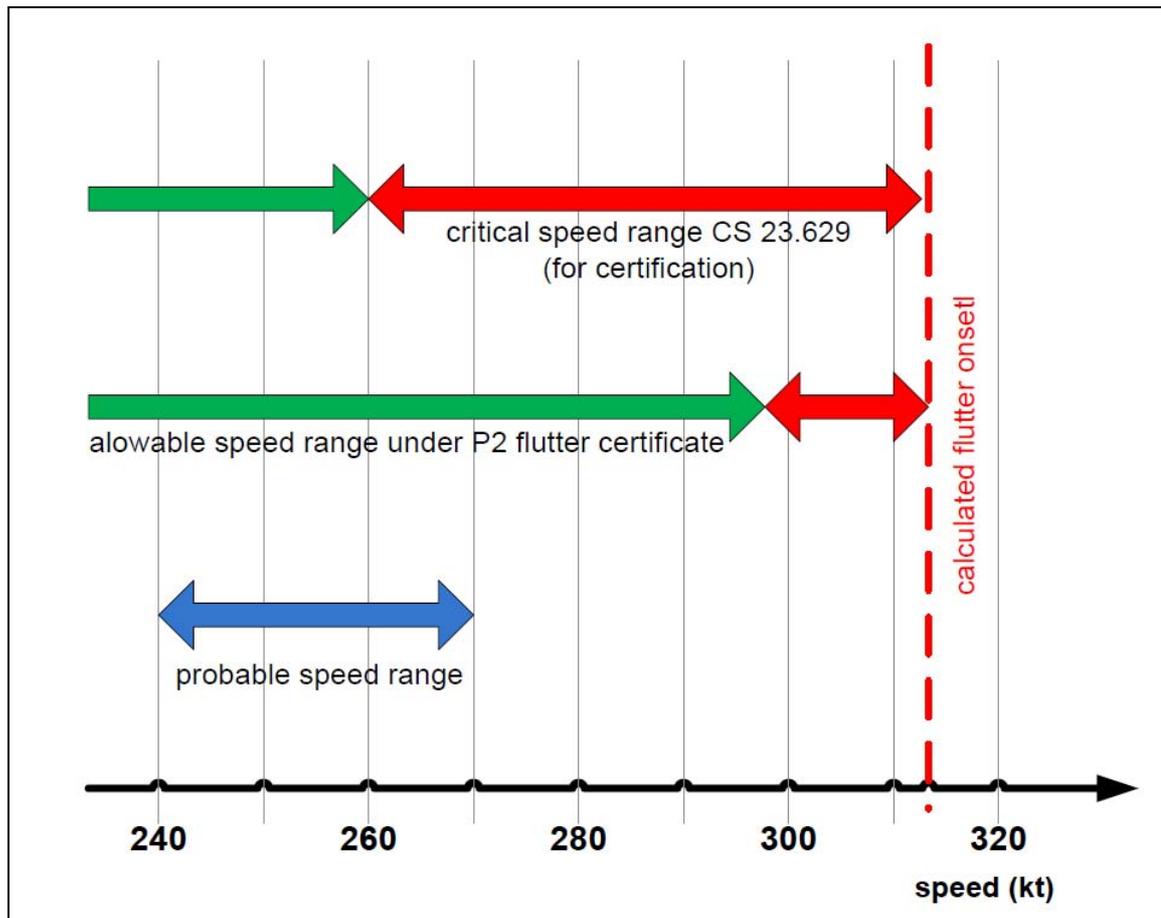
Diagram 11: Overview of flutter onset speeds

The following conditions could have resulted in a reduction in flutter strength (at the speeds in the critical range):

- Prior damage to the elevator horn in the vicinity between the horn and elevator.
- Failure of the bond between the mass balance and the adjacent structure.
