# NATIONAL TRANSPORTATION SAFETY COMMITTEE

*Aircraft Accident Investigation Report*

**PT. Adam SkyConnection Airline (Adam Air)  
Boeing 737-300 ; PK-KKV  
Juanda Airport, Surabaya, East Java  
Republic of Indonesia**

**21 February 2007**

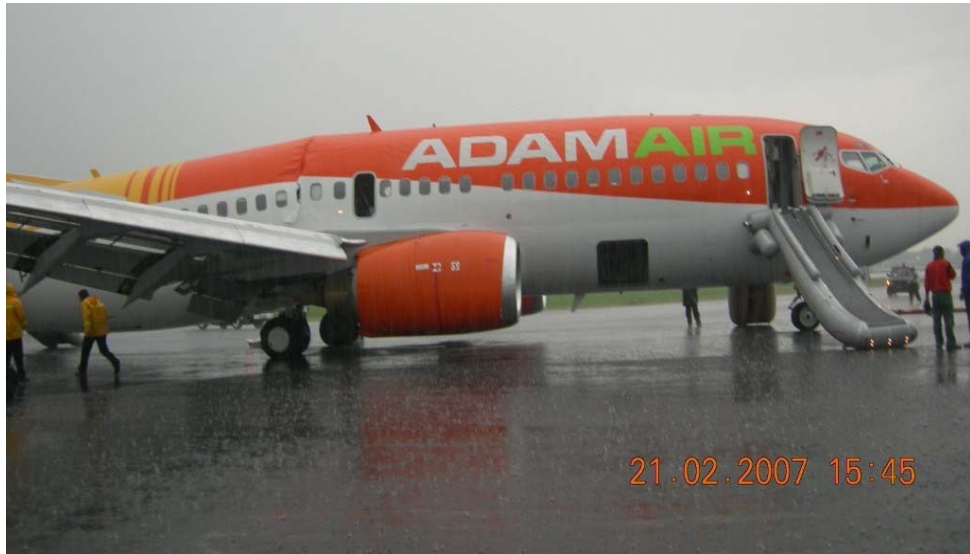
After aircraft touched down, the fuselage aft of passenger seat row 16 was bended down. The passengers were panic. Flight attendants evacuated the passengers via all exits available and door slides were inflated.

**Figure 1: The aircraft condition after accident**

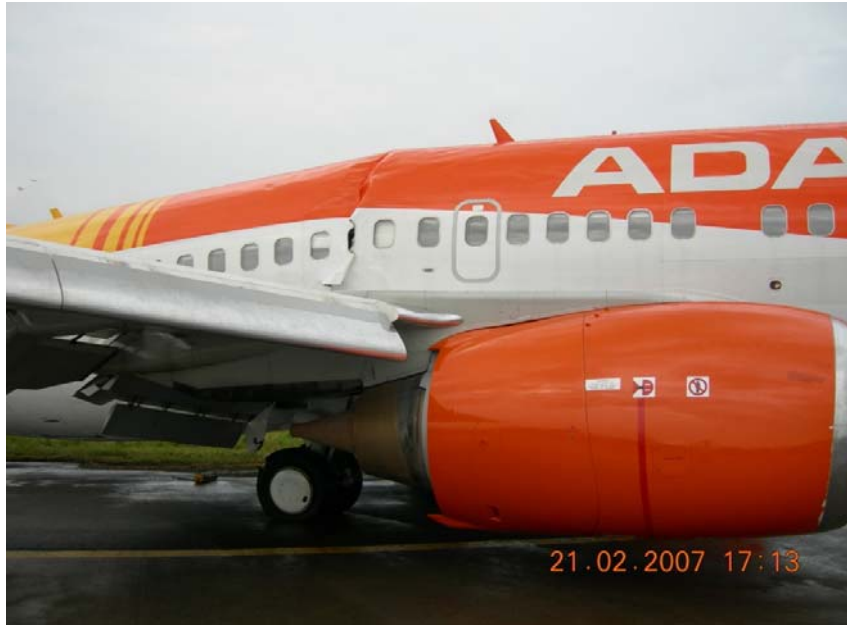
In general the fuselage was bended starting from wheel well area or seat row number 16. (Figure 2) The damages were skin buckling and twisting.

**Figure 2: The fuselage was broken**

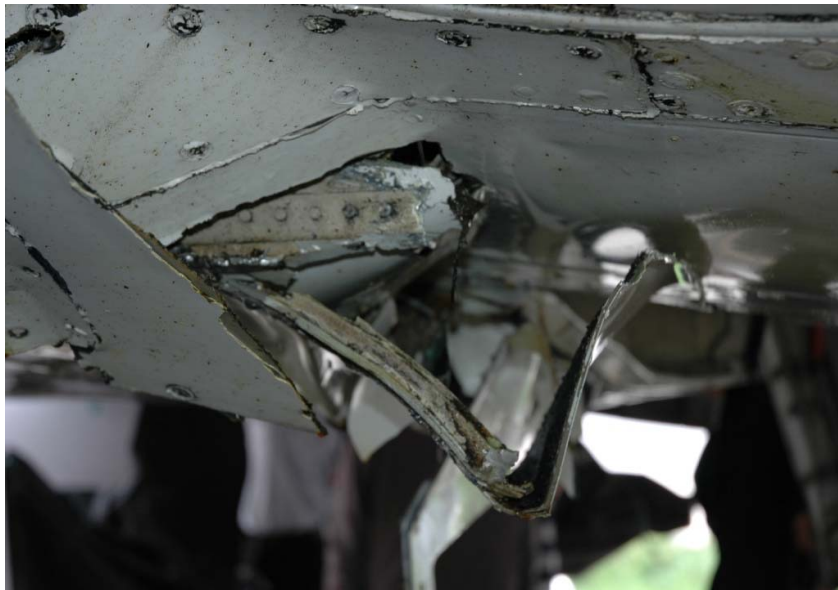
The keel beam of the lower fuselage in the wheel well area was damaged due to excessive bending moment and torsion load. The aft part of the keel beam was crushed and twisted counter clock wise, displaced about 15 cm. (Figure 3 and Figure 4)

**Figure 3: The Keel beam was broken**

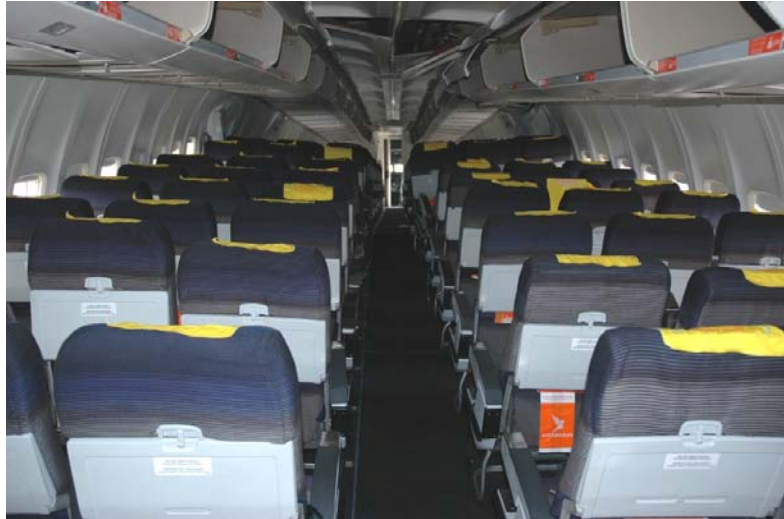
**Figure 4: The fuselage was broken viewed from passenger cabin**

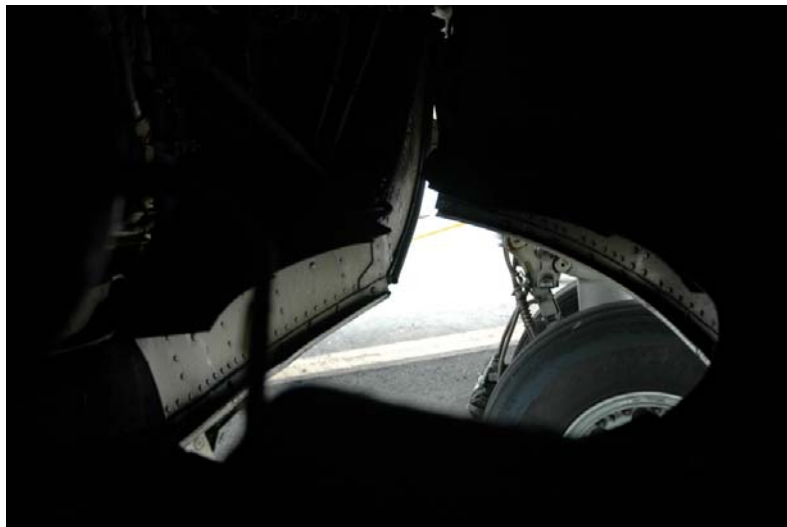
### **1.3.2 Wheel well: deformed (Figure 5)**

A large deformation was observed on the wheel-well area. The deformation was due to bending load and crushing of the keel beam. The aft section of the landing gear bay area was displaced forward about 35 cm.

**Figure 5: Wheel bay deformed**

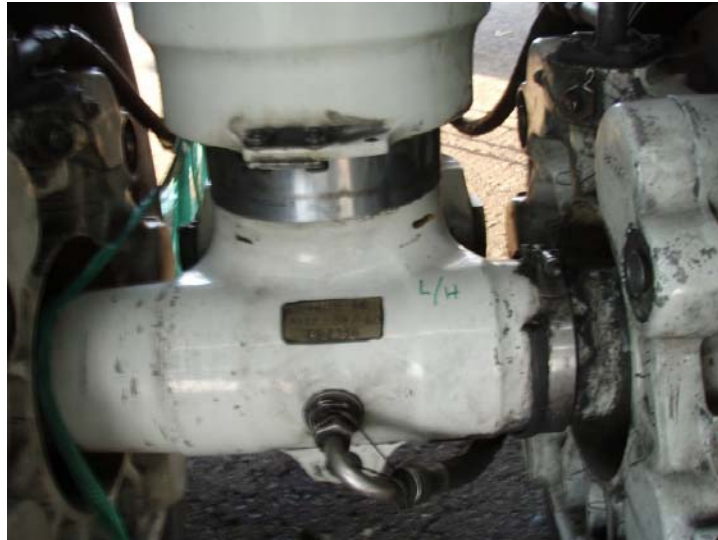
Bottoming marks were found on the bottom on the shock strut on both of the main landing gears. Bottoming marks appear indicated that there was an excessive impact load. The mark on the right main landing gear (Figure 7) was deeper than the mark on the left main landing gear (Figure 6). This indicated that the right main landing gear suffered a higher impact load.

**Figure 6: Bottoming marker on left main landing gear**

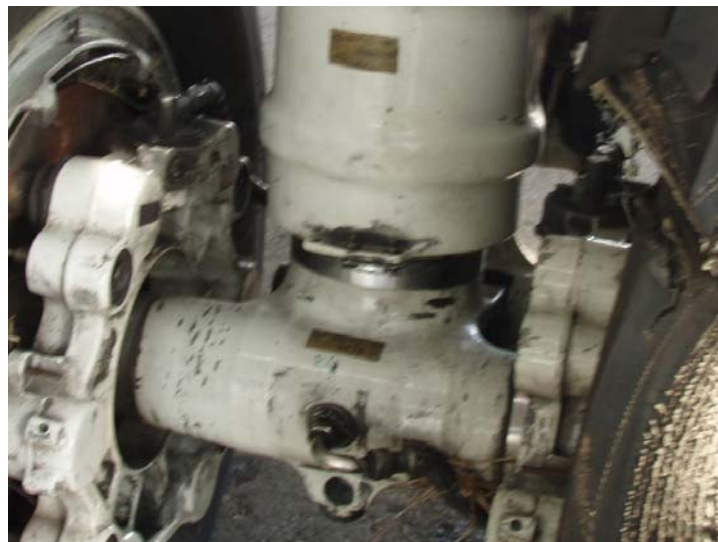
**Figure 7: Bottoming mark on right main landing gear**

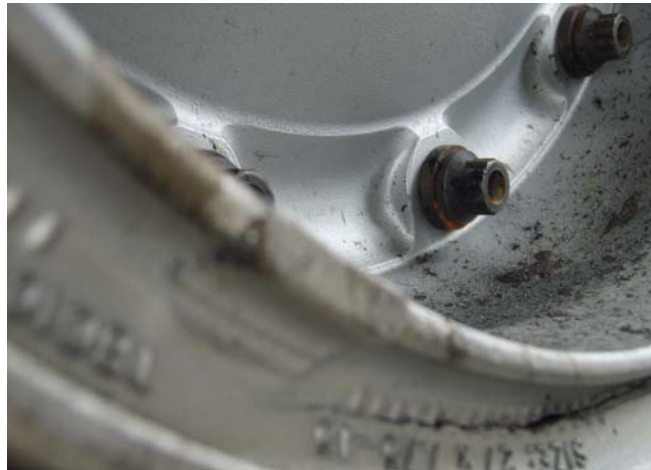
#### **1.3.4 Nose landing gear: broken wheel hub (Figure 8)**

The right hand of the nose landing gear showed crack on wheel hub and damage on its bearing.

**Figure 8: Wheel hub of the nose landing gear: crack**

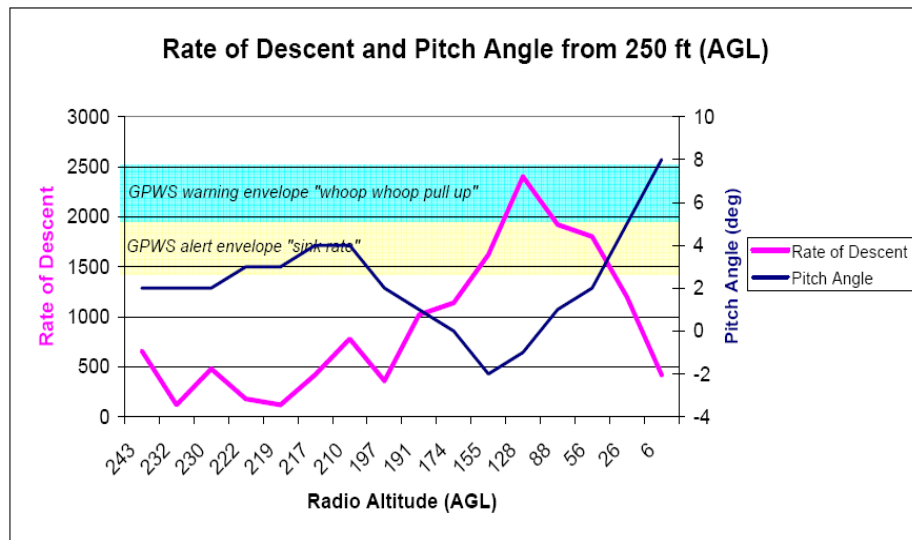
The FDR revealed that during this time, the pitch attitude was two degrees down and the rate of descend was greater than 2000 feet.

**Figure 12: FDR graph of rate of descend and pitch angle below 250 feet**

The rate of descent, the pitch attitude and late of flap selection to 40 were the indication that a stabilized approach criteria was not met. According to the Boeing FCTM, the go around should be initiated.
