FINAL REPORT OF AIRCRAFT ACCIDENT INVESTIGATION

Britten Norman BN-2B-26, D-ILFB

Ruhnu, Estonia, March 3rd, 2007

Tallinn 2011

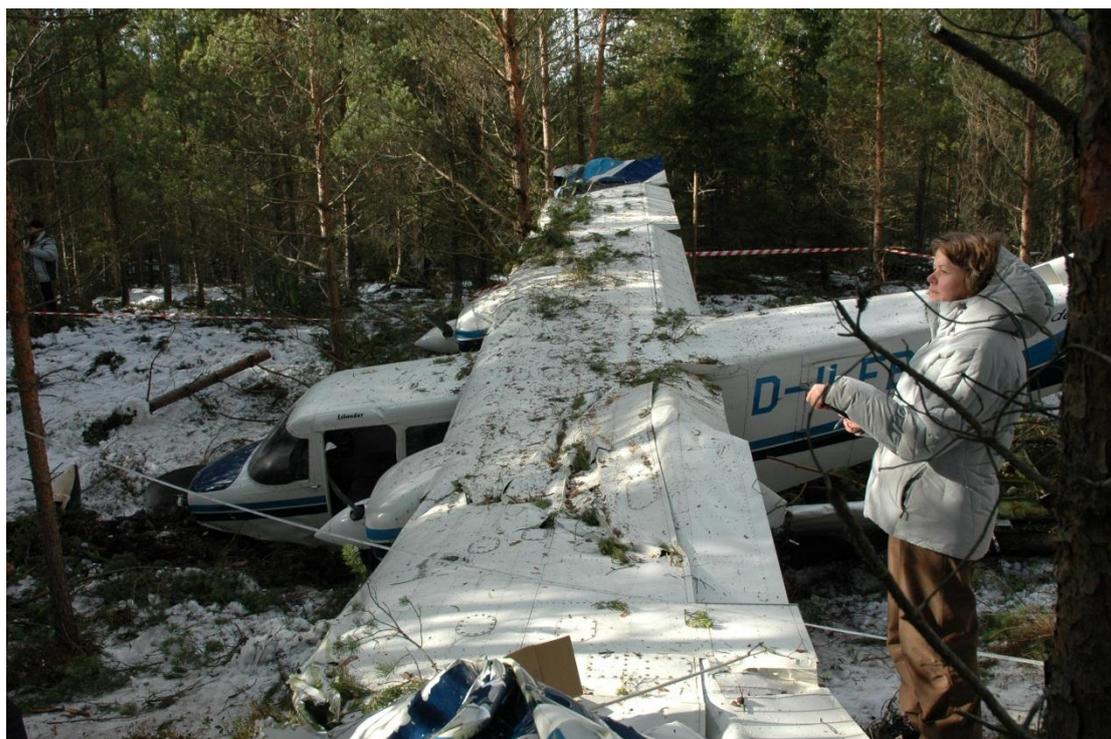
Due to impact with trees and ground, the aircraft was damaged beyond repair. A wing, especially the leading edge and the wingtips were substantially damaged. Horizontal stabilizer and left horizontal stabilizer were separated and indented.

D-IILFB wreckage on impact site

Damage to aircraft fuselage was moderate and limited mainly to damages to its lower part.

The first impact of the aircraft with trees had taken place at the altitude of 10 m 67 m from the location of the wreckage (indicated by indentations on the trees). The left wingtip collided with a tree 6 m above the ground and at 29 m distance from the wreckage. Damages to the fuselage of the aircraft indicated that when impacting the terrain the aircraft was in 5-10° nose down position with wings horizontal.

Circular marks are clearly visible on the blades of both propellers. Stress marks were visible across the propeller blades of the aircraft. Tips of right propeller blades were bent back, the blades of left propeller were undamaged, two blades were in feathered position.
