ATSB TRANSPORT SAFETY INVESTIGATION REPORT

Aviation Occurrence Investigation –200702171

Landing Gear Collapse

Beech Aircraft Corp - Super King Air 200

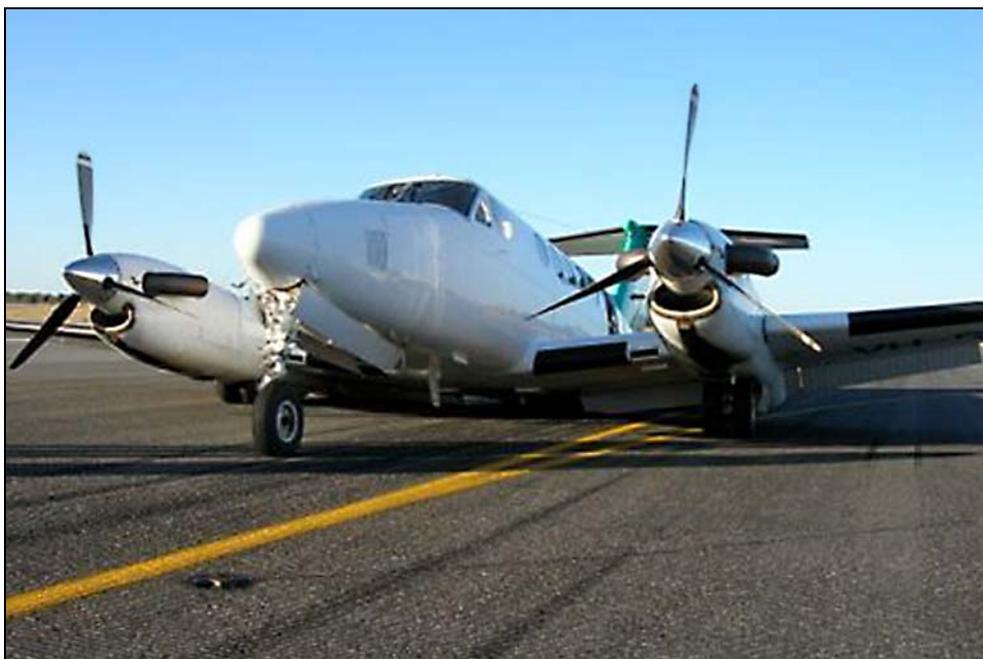
Following the flyovers and after holding over Rottnest Island at 5,000 ft for a period of approximately two hours, the pilot flew the King Air back to Perth airport. With the gear still jammed in the partially retracted position, both the left and right main landing gear assemblies collapsed after the aircraft touched down on Runway 24. The aircraft was substantially damaged as a result of the collapse (Figure 1).

Figure 1: The Super King Air 200 on the runway after landing at Perth².

The lower right wing skin surface had been extensively damaged through severe abrasive contact with the runway. Several internal members within the right wing sustained consequential buckling and permanent deformation.

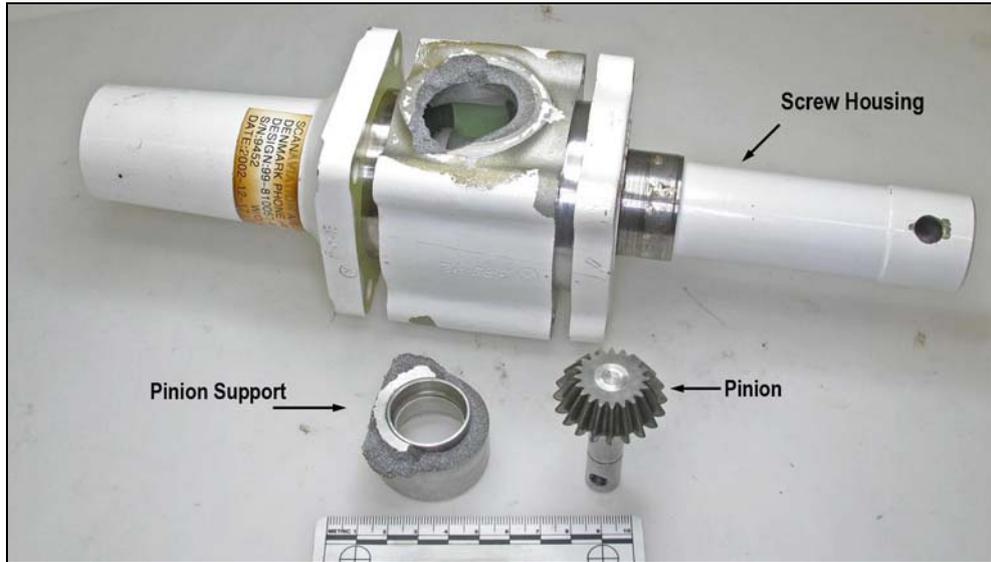
Initial examination of the disassembled right main landing gear actuator indicated two sites of primary damage; the first was located on the body of the actuator housing, and the second located within the gearing of the screw housing (Figure 4).

Figure 4: The partially reassembled right main landing gear actuator.

The side of the actuator housing that supported the pinion gear and bearings had fractured. Examination of the fracture surfaces of the cast aluminium housing was performed at low power using the binocular microscope and at higher power using the scanning electron microscope (SEM). Only features associated with gross overload of the material were observed. Those features indicated that the pinion support within the actuator housing had been exposed to abnormally high loads encountered during the landing event. No evidence was found of a pre-existing crack or defect within the actuator housing.

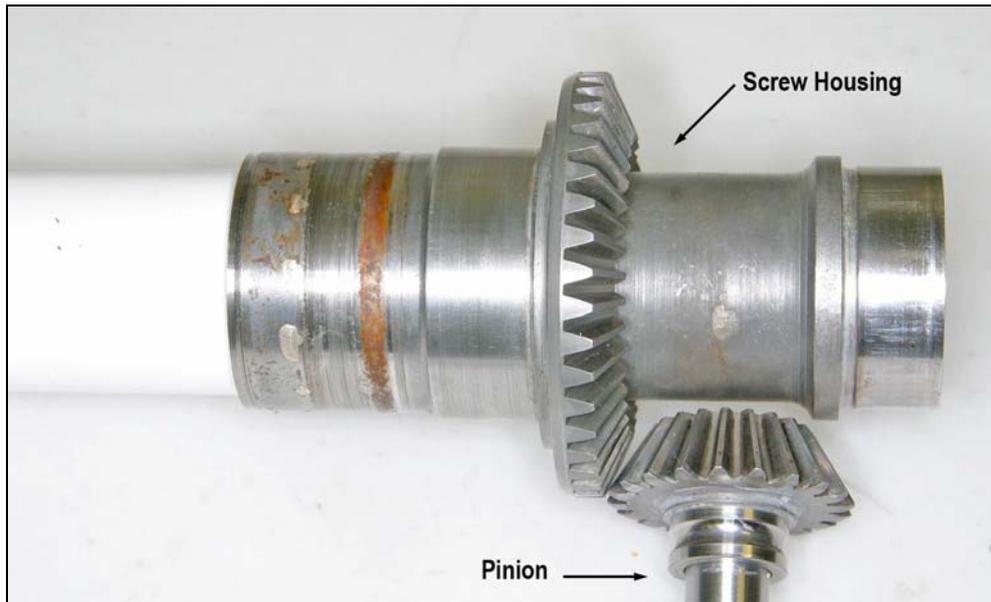
Figure 5: Close view of the mechanical relationship between the pinion and actuator screw.

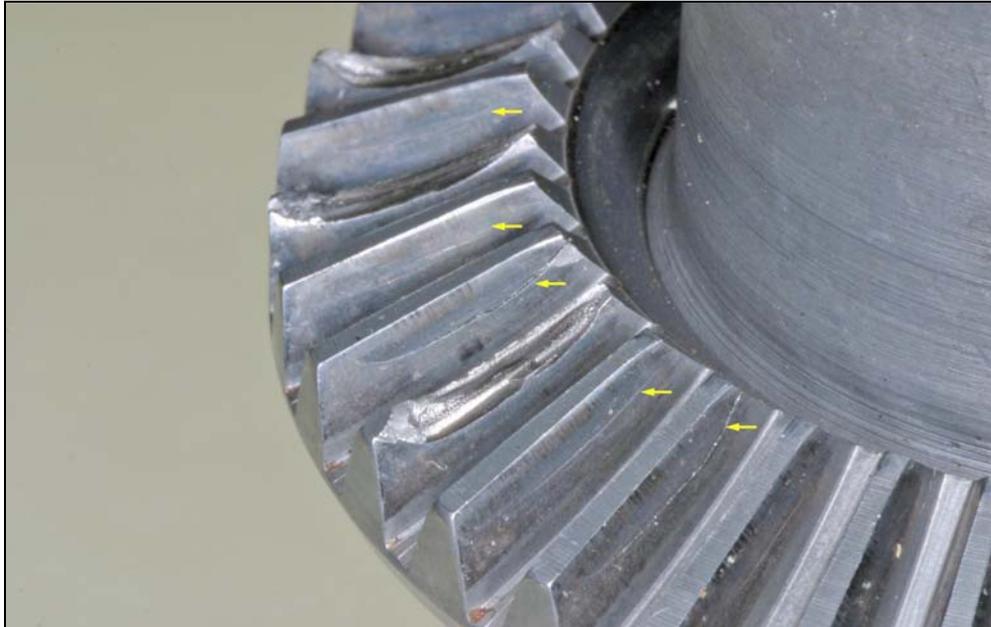
The second site of damage was located on the screw housing. Four out of the 40 teeth from the bevel gear had completely fractured from the contact face. Close inspection of the remaining gear teeth revealed that most teeth also contained

cracks. The cracks were noted to initiate about the pitch line of the bevel gear assembly. At high magnification, clear and distinct bands of crack progression were observed on the fracture surfaces of the broken teeth. This indicated that the gear tooth failure mechanism was by cyclic fatigue from reverse-bending loads (Figure 6 and 7).

Figure 6: Close-up of the bevelled gear teeth from the screw housing. Note the cracking (arrowed) and tooth loss.

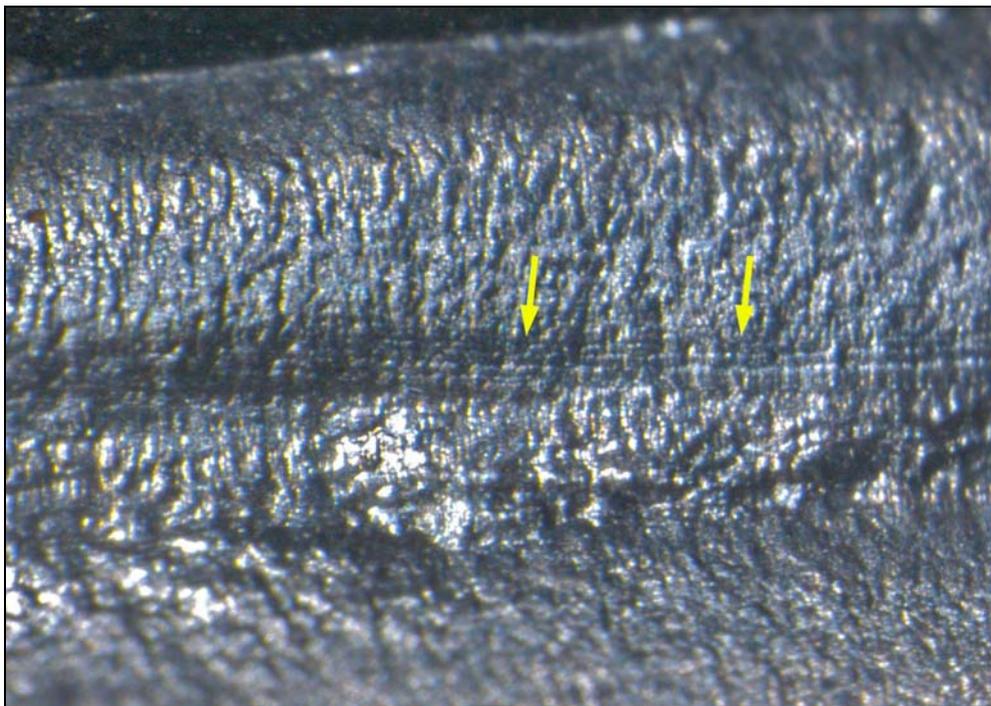
Figure 7: Close-up of the fracture surface from a broken tooth off the screw housing bevel gear.

Bands (arrowed) from progressive fatigue crack growth are clearly visible.

The presence of such cracks indicated that the screw housing gear teeth had been abnormally stressed as the right main landing actuator extended and retracted during service. The fatigue cracks had not developed as a result of this landing occurrence.

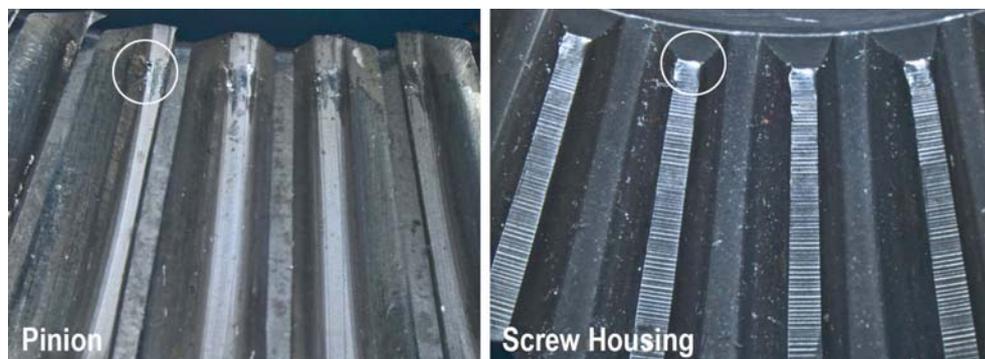
Another feature of significance was the pattern of irregular wear around the innermost corner of each gear tooth. The pattern indicated that the screw housing gear teeth may have been misaligned when they engaged with the pinion gear during service, resulting in the observed corner damage (Figure 8).

Figure 8: Image montage showing abnormal wear features (circled) on the inner radial meshing teeth off the screw housing and pinion gear.

Abnormal wear marks between the intermeshing pinion and screw housing gear teeth suggested that an incorrect clearance or misalignment may have been present during operation. Such misalignment may have elevated the tooth bending loads sustained by the bevel gear and pinion, thus contributing to the premature component failure.

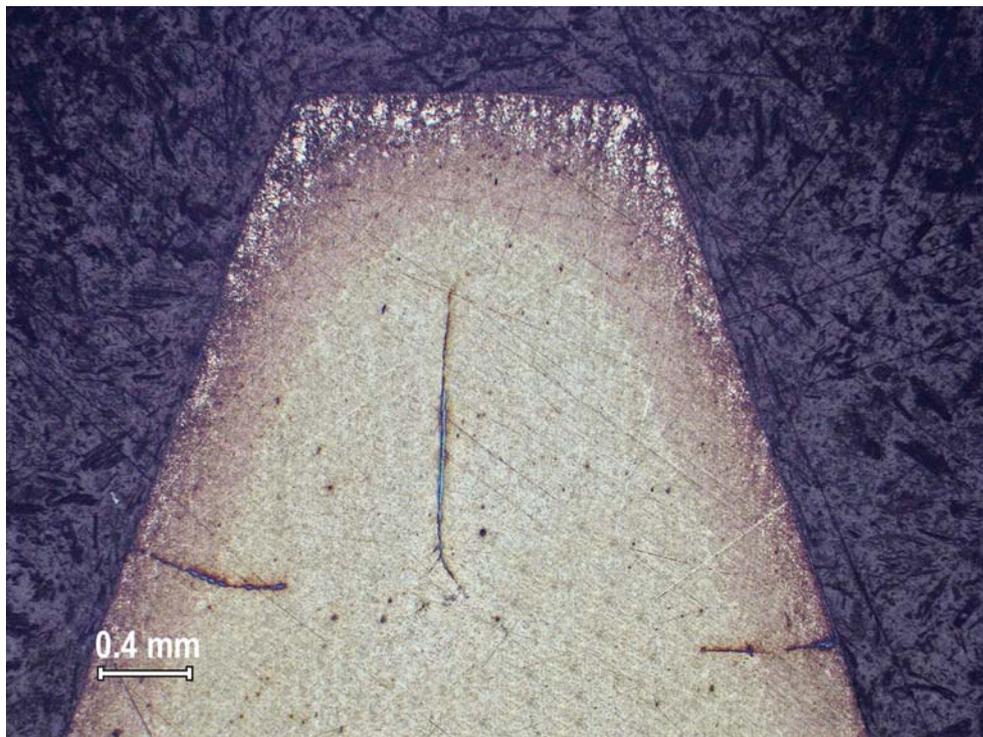
Examination of the etched metallographic specimens revealed a core steel microstructure that consisted primarily of finely tempered martensite. The actuator screw teeth had been carburized to a depth of approximately 0.4 mm (Figure 9). Carburizing is a case-hardening process commonly used to improve the surface properties of a component by producing a strong, wear resistant surface layer (as needed for gear-type mechanical applications).

Within the case-hardened layer, a lighter etched phase of retained austenite was observed close to the surface in the uppermost corner of each gear tooth. Excessive amounts are considered detrimental to the mechanical properties of a component; for example, lower hardness and bending fatigue resistance. The amount of austenite in the component was considered moderate and unlikely to have contributed to the premature failure of the gear teeth.

The metallographic cross-sections also exposed further detail on each of the previously identified cracked gear teeth. Not only were both transverse cracks at the screw housing gear tooth pitch line identified, but vertical cracks were also found through the centre of each gear tooth. The vertical cracks were internally located and unable to be identified using visual inspection or by magnetic particle crack detection techniques (refer to Figure 9 for detail).

The presence of such cracking implied that the geared components within the right actuator had been subjected to abnormal elevated loads during service.

Figure 9: Polished and etched metallographic cross-section through one of the cracked teeth from the screw housing. One internal vertical crack and two transverse cracks can be seen.

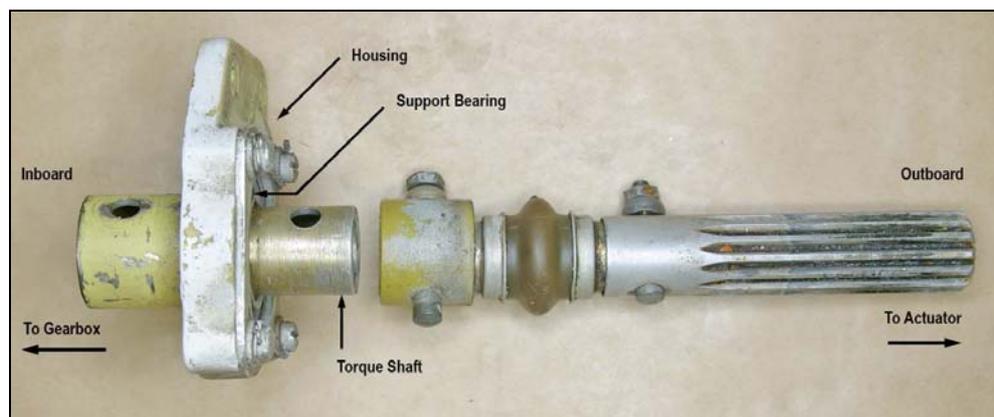
The left inboard torque tube support bearing assembly was received by the ATSB disassembled to the piece-part level (Figure 10). An attempt was made to rotate the bearing which confirmed that it had seized. Examination showed that the seized bearing (part number KP168S; a sealed spherical roller bearing) comprised primarily small steel ball rollers and with inner and outer races that had been cadmium plated. Thin flexible Teflon seals and steel rings had been used to seal the ball bearings from the external service environment. The seals were found to be intact and showed no evidence of breakdown or abnormal degradation.

Figure 10: An assembled torque tube bearing support assembly.

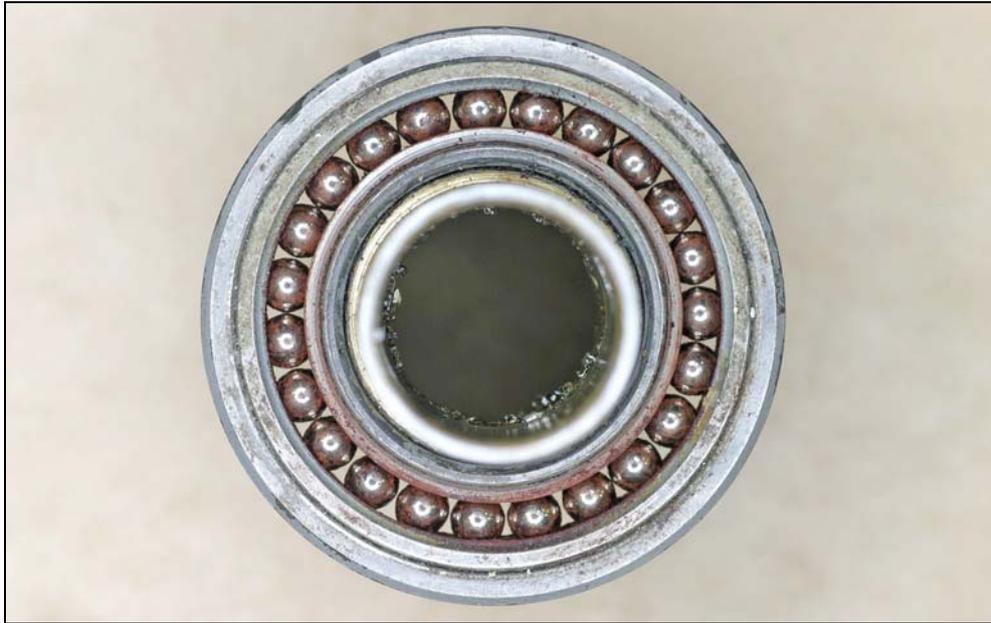
It was required that the bearing be normally filled with MIL-G-811322 grease. On inspection, no grease or any other type of lubricant was found within the bearing.

A reddish brown substance had become dispersed within the spherical rollers. Both bearing races were examined and found to be in good condition with no sign of damage or breakdown of the rolling surfaces (Figure 11 and 12).

The red/brown substance was loose and could easily be cleaned from the surfaces of the spherical rollers. This substance was chemically analysed using energy dispersive spectrometry (EDS) under the scanning electron microscope. The analysis revealed that the contaminant consisted primarily of iron (Fe), and oxygen (O). Smaller amounts of magnesium (Mg), silicon (Si) and sulphur (S) were also found. As such, the substance was probably a contaminant that had migrated from the external service environment into the rolling elements.

Figure 11: Bearing (P/N KP168S) from the left inboard torque tube support assembly.

Note the reddish discoloration on each of the balls.

The operator changed their system of maintenance by the introduction of an inspection interval and replacement schedule for all landing gear torque tube support bearings within their Super King Air 200 fleet.

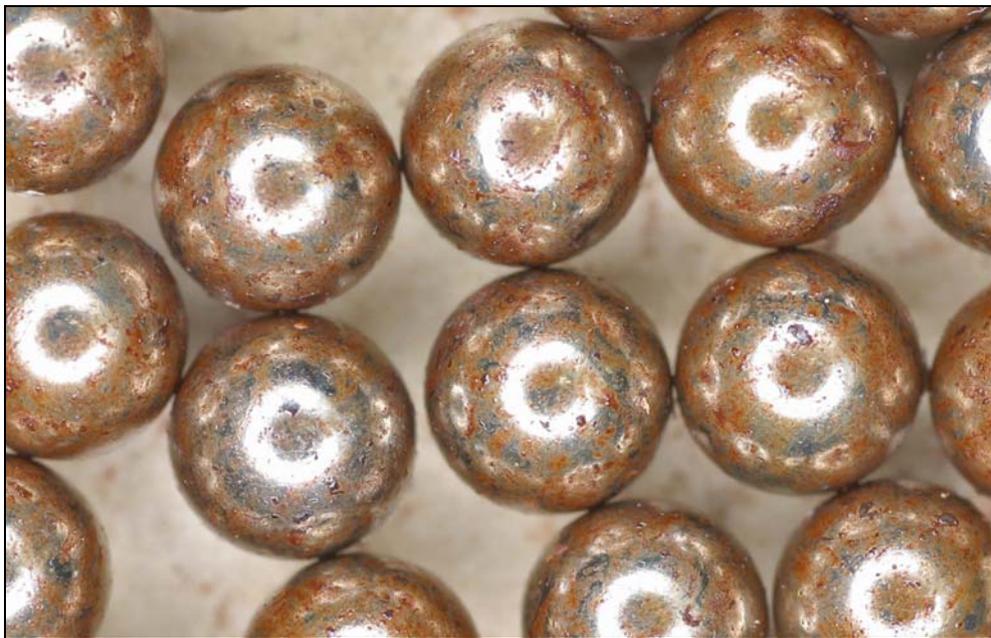
Aside from the bearing contamination, no evidence was found of other known failure mechanisms; for example, corrosion, brinelling, spalling, overheating, misalignment, or excessive loading that could have contributed to the seized state of the bearing.

Figure 12: Close-up of the balls from the left bearing showing gross amounts of red contamination over the rolling surfaces.

The investigation also revealed that one of the four torque tube support bearings from the main landing gear system had seized. Seizure of that bearing could have produced a lock-up and prevented the main gear from properly retracting after takeoff. The examination showed that the seized bearing was unlubricated and had become contaminated with dirt and dust from the external service environment. Those contaminants had migrated into the spherical bearing rollers which directly contributed to the bearing failure.

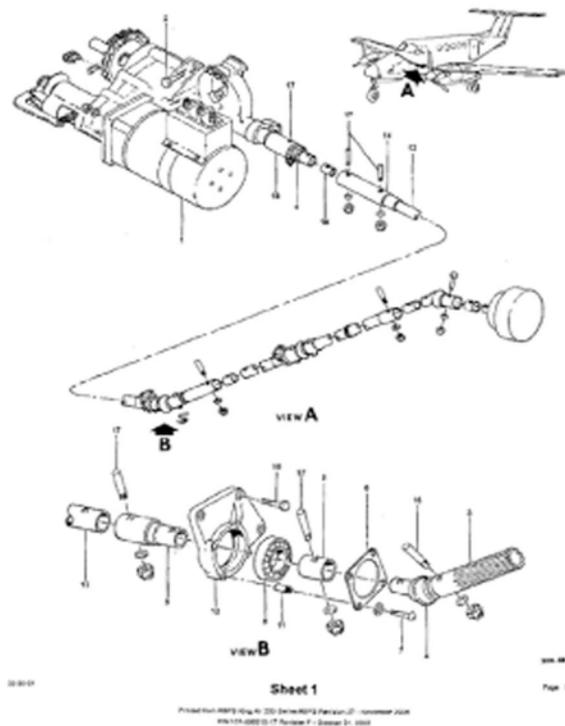
The assembly shown is the Left Hand Side; the same assembly is repeated on the Right Hand Side. The failed bearing is indicated by No 8

- A recent Service Difficulty Report after an accident has reported that the support bearings for the main landing gear retraction system had seized.
- This caused a complete failure of the system preventing the main undercarriage being extended during a landing.
- These universal joints and bearings are not included in the lubrication schedule for the aircraft.
- These universal joints and bearings are currently not included in the manufacturer's maintenance requirements.
- There is currently no inspection schedule for these universal joints and bearings recommended by the aircraft manufacturer.

- Inspecting the two Main Landing Gear Retraction System support bearings part Number KP16BS or KP16B, and the universal joint part number 101-810001-3 at the next scheduled inspection to determine their condition.

- Replacing all bearings and universal joints at either 6 year or 8000 cycle intervals which ever comes first to coincide with the undercarriage overhaul schedule regardless of condition.

- Replacing all bearings, torque tube splines and universal joints, that show any sign of corrosion, damage or binding.
