**TECHNICAL INVESTIGATION INTO THE ACCIDENT OF
THE B737-800 REGISTRATION 5Y-KYA OPERATED BY
KENYA AIRWAYS THAT OCCURRED ON THE 5th OF
MAY 2007 IN DOUALA**

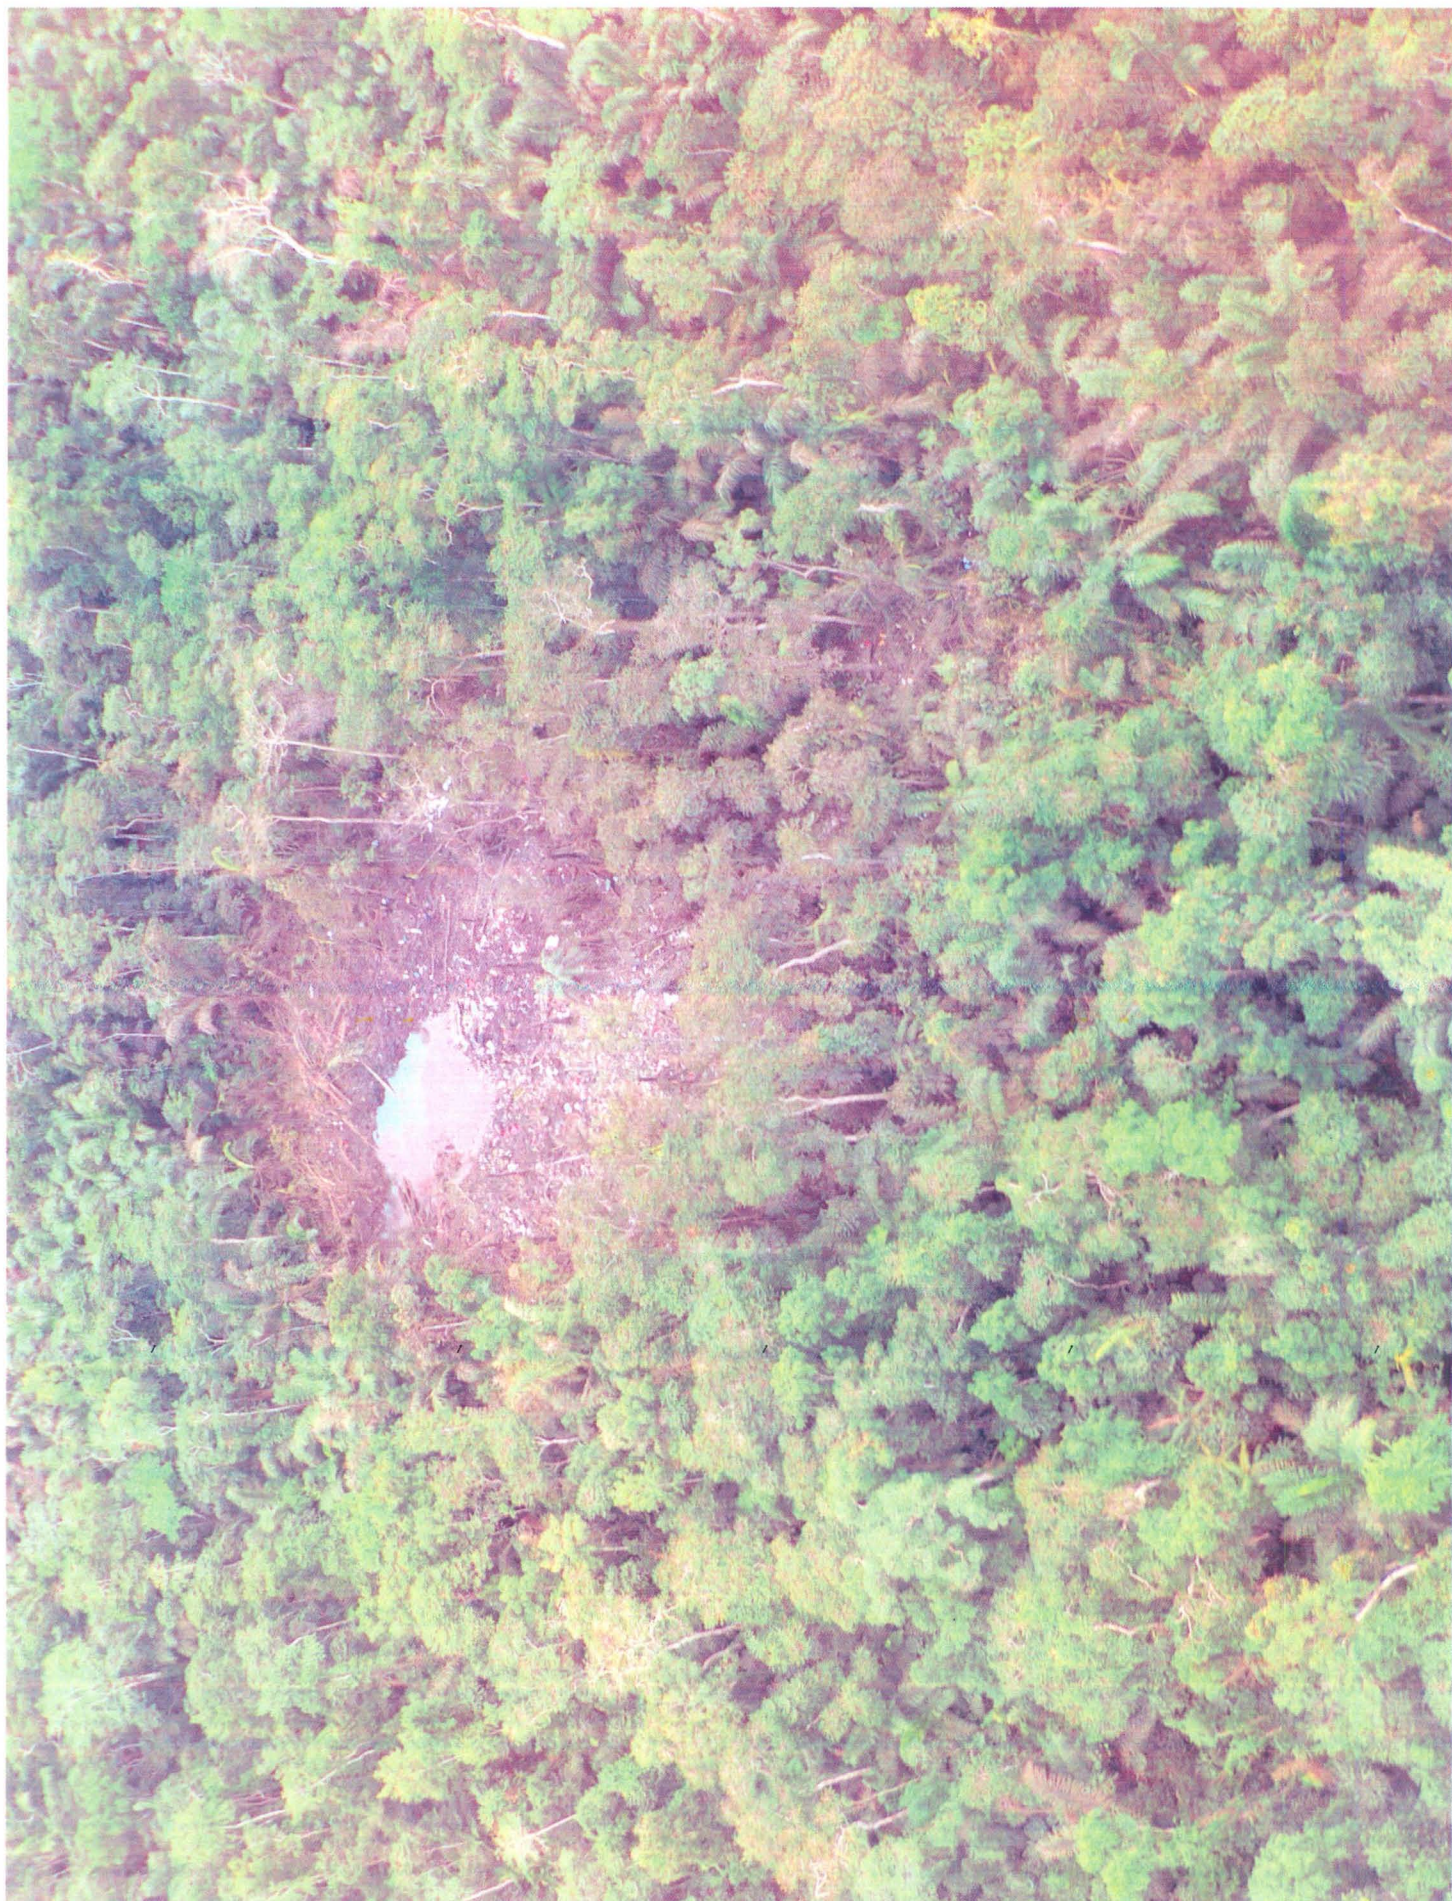
Aerial photo of crash site

A significant mass of overturned mud is found on the North West and South West borders of the crater. The vegetation all around is covered with mud up to 30 m away. The trees in the immediate vicinity of the crater are lying down because they were either uprooted or broken. The damage done to the vegetation extends over a surface area of about 2000 m². The North West side of the crater is the most affected.

The content of the airplane (flight deck, cabin and cargo compartment) is found concentrated in the 70° direction as follows: nearest to the crater-economic class (blue seats); next first class (red seats); and finally the front part of the plane.

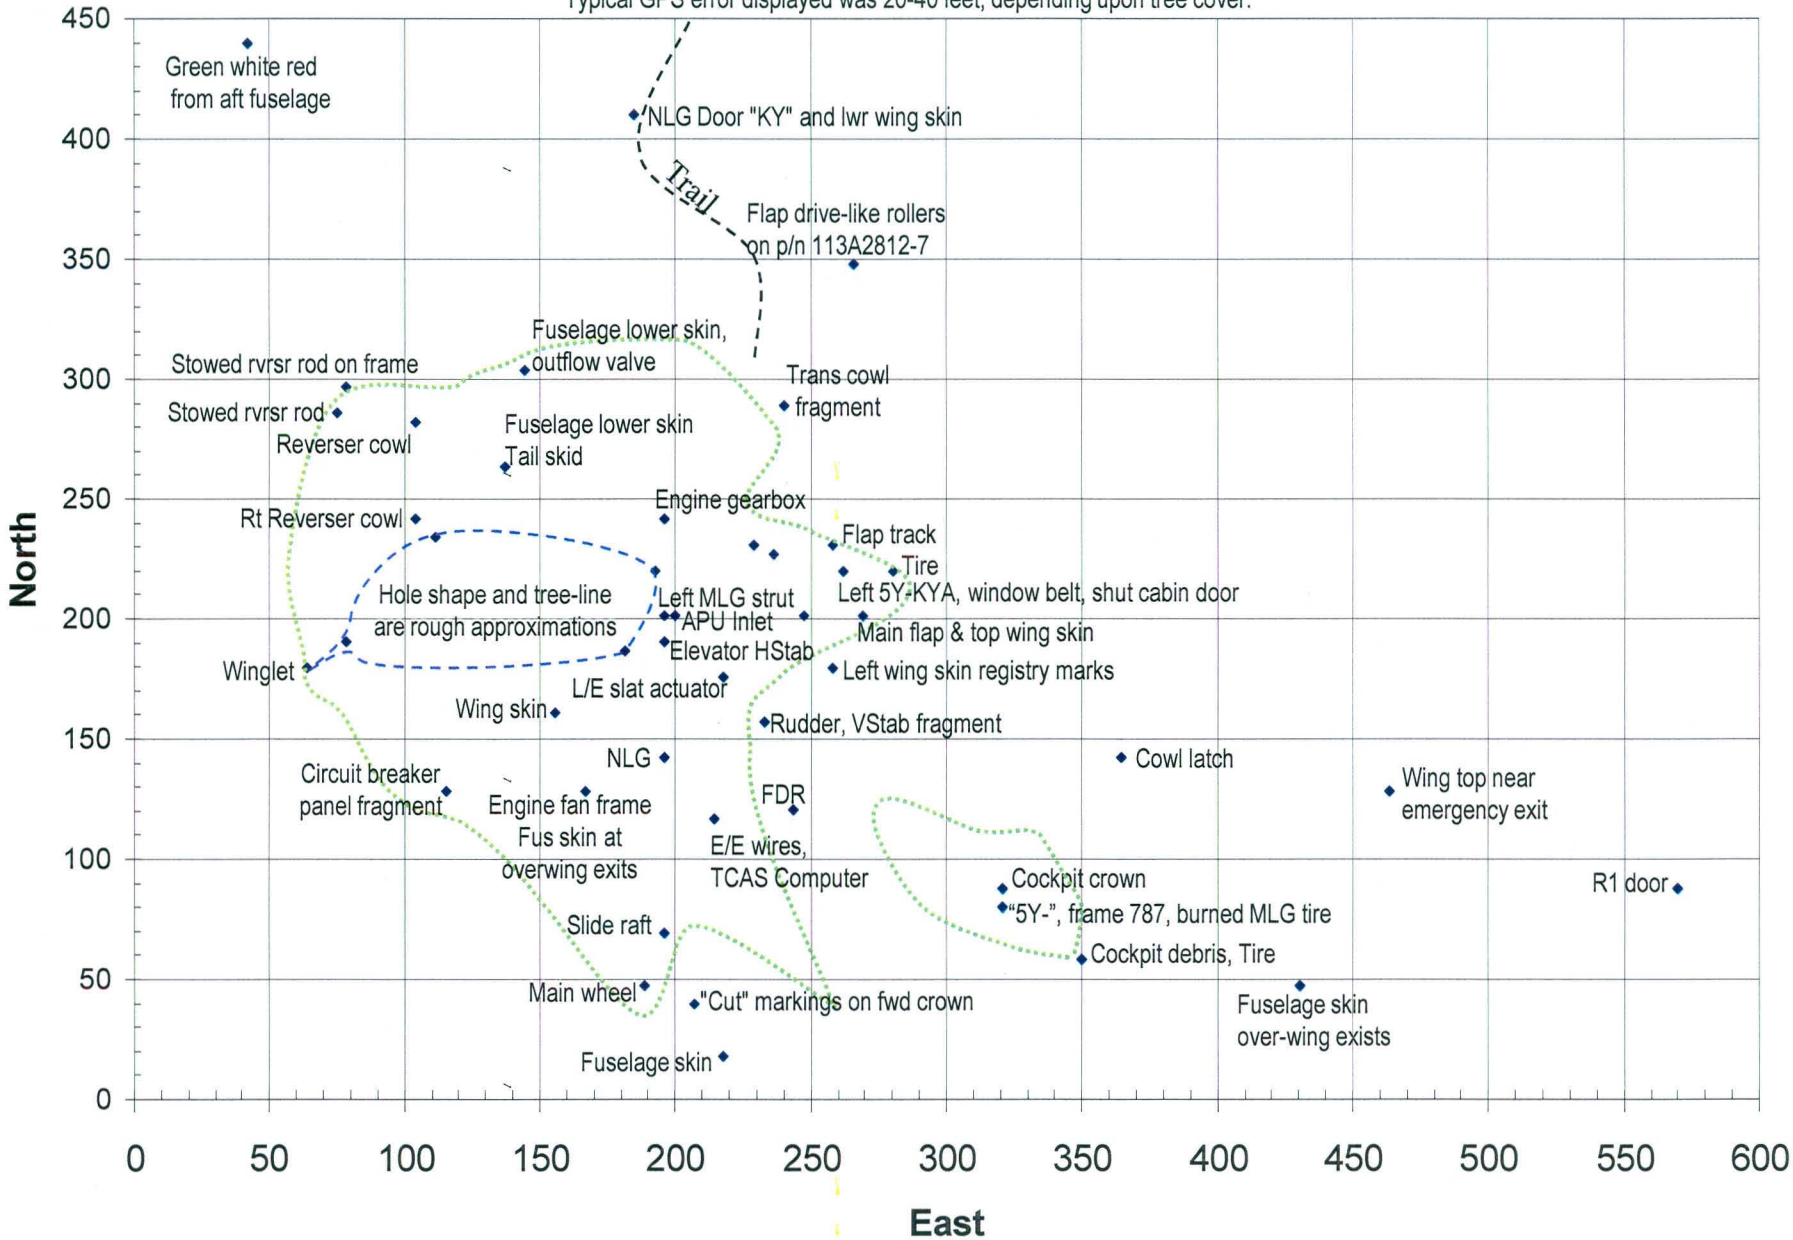
KA507 Debris Coordinates

Typical GPS error displayed was 20-40 feet, depending upon tree cover.
