FINAL
KNKT.07.14.06.04

Aircraft Accident Investigation Report

**Trigana Air Service
de Havilland DHC 6-300 Twin Otter; PK-YRU
Mulia Airstrip, Papua
Republic of Indonesia**

1 June 2007

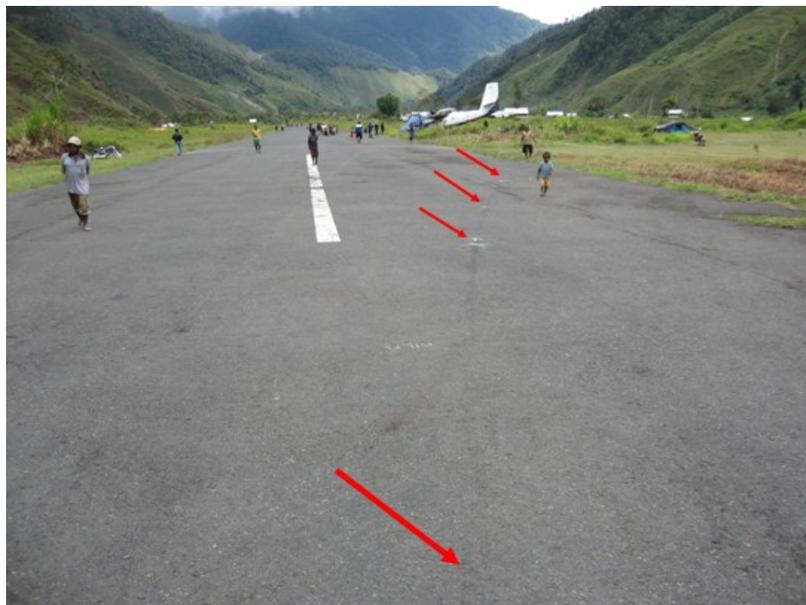
On Friday 1 June 2007, a de Havilland Twin Otter DHC 6-300, registered PK-YRU overran the right side of the runway during the take-off roll. The aircraft left the runway and impacted a ditch and rocks on the right shoulder of the runway. Main-wheel tire marks for more than 65 meters on the runway indicated that heavy braking action was being applied to the left brake.

Figure 1: Left main wheel track showing runway excursion to the right

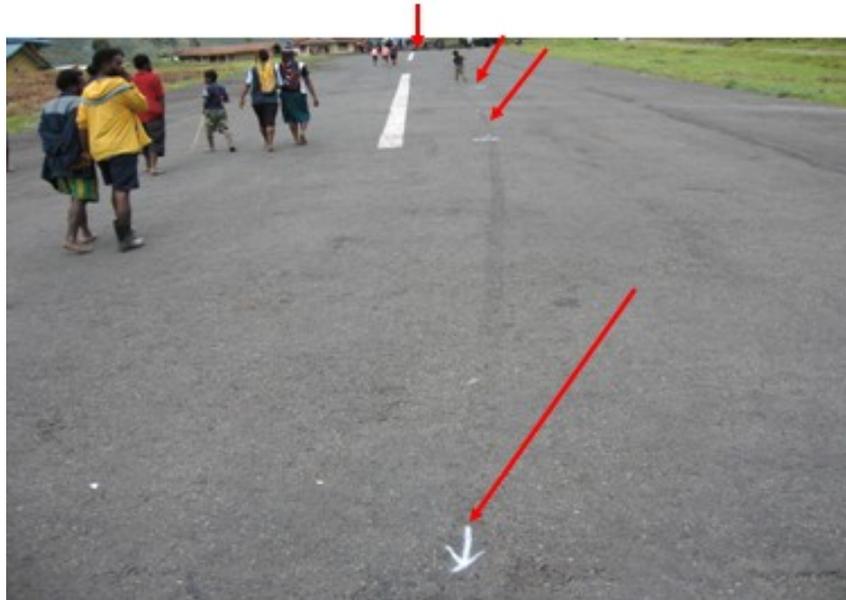
Figure 2 : View looking up slope back along the take-off track

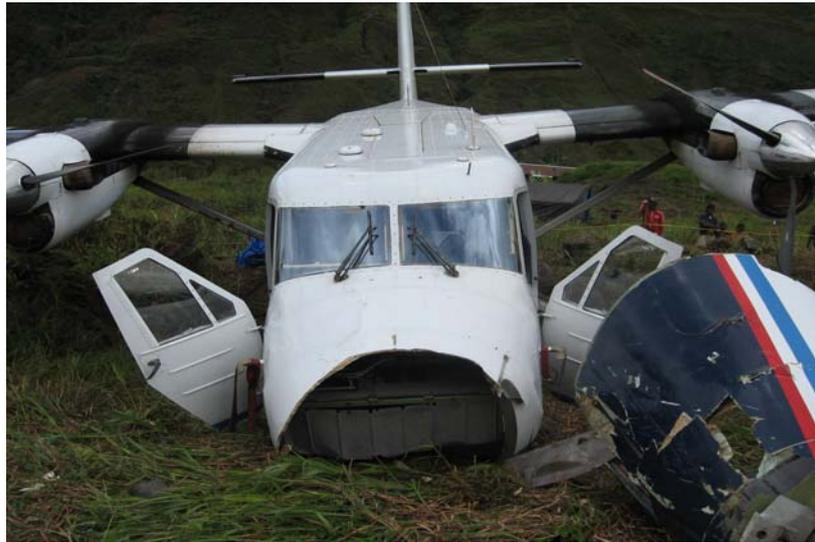
Figure 3 : Forward fuselage substantially damaged

The nose section, including the radome and the nose landing gear housing, was substantially damaged.

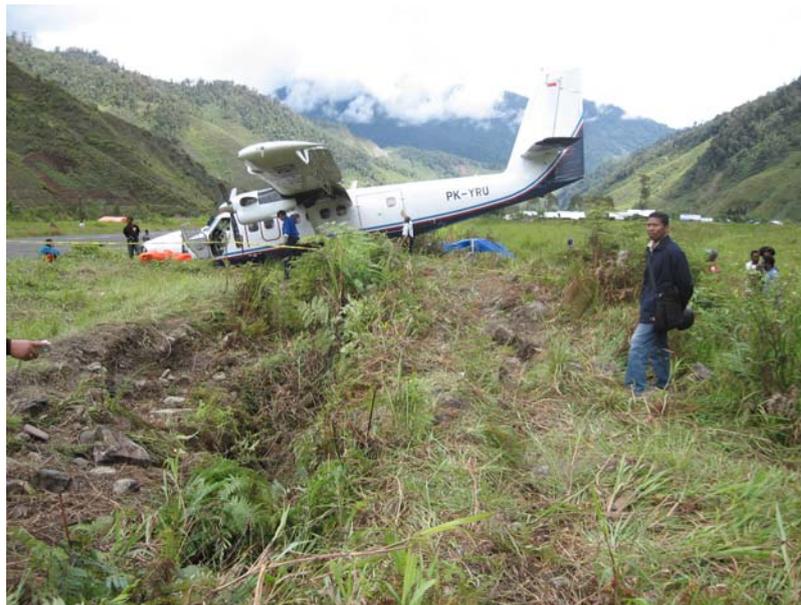
Figure 4 : The right shoulder of runway 27 showing rocks and ditch

The nose landing gear was fractured, the struts were separated from their housing, and the nose wheel was damaged. The nose landing gear strut was damaged as result of impacting rocks and a ditch.

The aircraft subsequently entered the runway shoulder, which had a ditch and was covered with slippery grass and large rocks.

The National Transportation Safety Committee recommends that the Directorate General of Civil Aviation review the safety of the Mulia runway shoulder area and require the airport operator to ensure that there are no obstacles to safety, such as ditches and rocks, to prevent an aircraft from safely negotiating the runway shoulder in the event of a runway excursion.

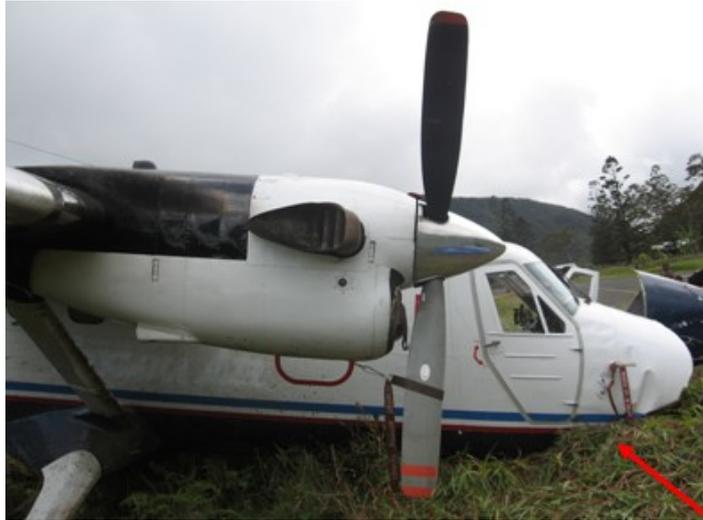
Figure 5 : Nose landing gear area indicated by arrow

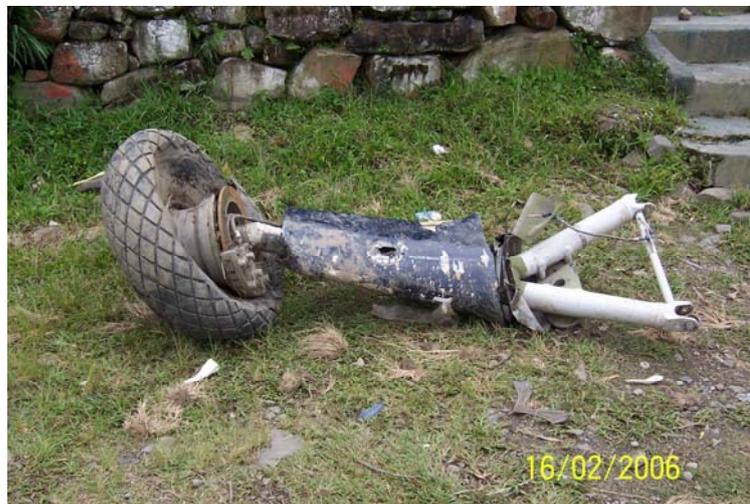
Figure 6: Left main landing gear

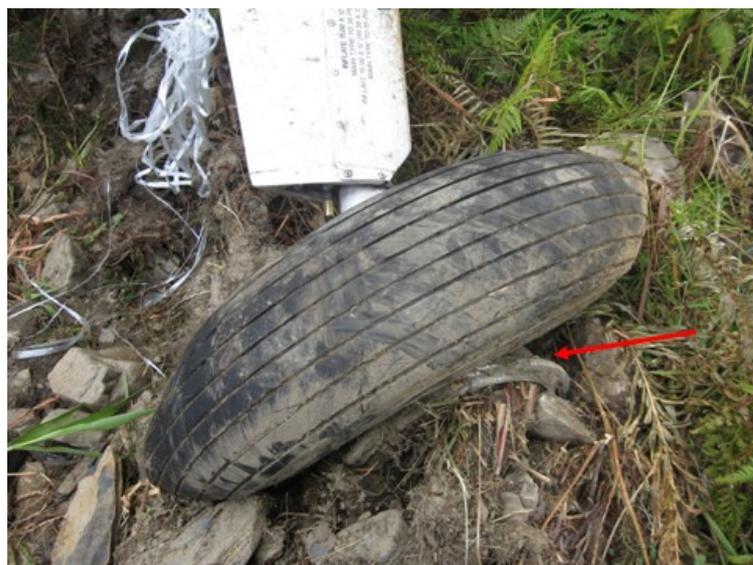
Figure 7 : The damaged right main landing gear wheel

The right main landing gear wheel was damaged as a result of its collision with rocks on the shoulder of the runway.

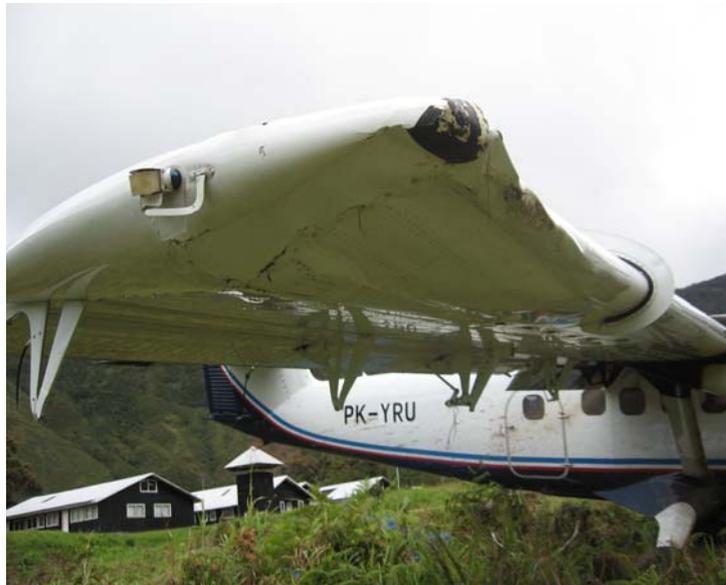
Figure 8 : Right wing substantially damaged

The outboard section of the right wing was substantially damaged as a result of ground impact. This occurred when the aircraft swung to the left as a result of the left main landing gear being stuck in a ditch. The aircraft then swung further left through 90 degrees, resulting in the right wing impacting the ground.

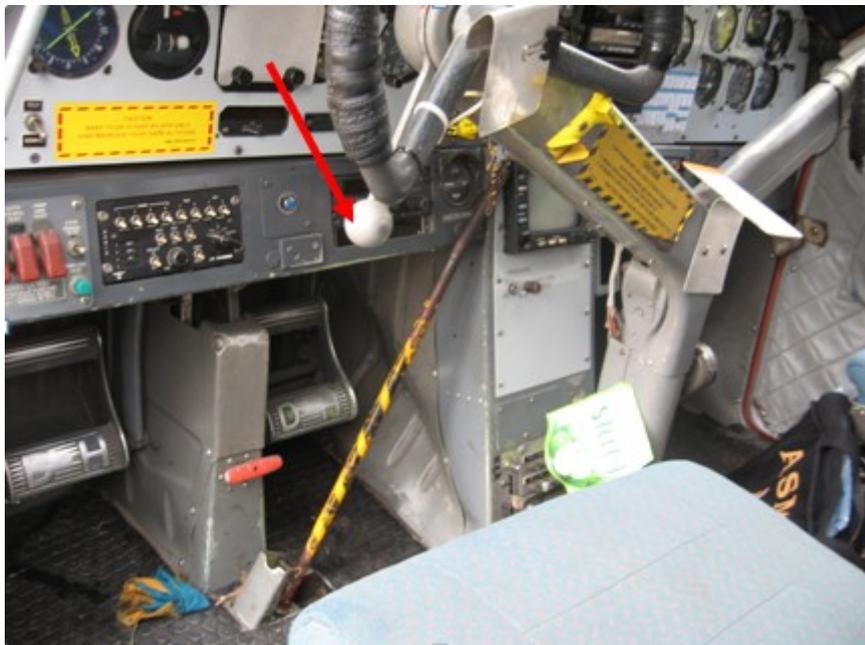
Figure 9 : Arrow pointing to the nose-wheel steering lever

The final position of the nose-wheel steering lever was down (indicating that the nose-wheel steering was selected to the left). That may indicate that the pilot under training attempted to steer the aircraft to the left using nose-wheel steering. However, the investigation could not conclusively determine if the steering lever had been moved after the accident.

The investigation considered that it was possible that the nose-wheel steering was not centred before commencing the take-off roll and that the pilot under training may have been unaware that he was holding an inappropriate nose-wheel steering position during the take-off roll.

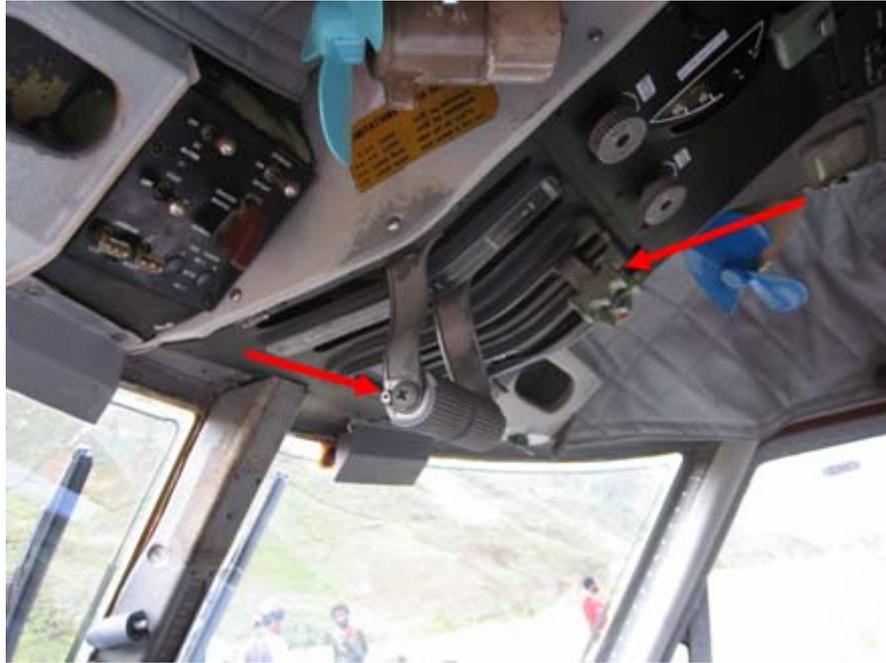
Figure 10 : Left arrow Power Levers and right arrow Propeller Levers

The investigation determined that the power-lever position also did not necessarily indicate the position of the power lever at the time of the accident, because the pilot had shut the engines down after the aircraft came to a stop.
