Report 07-006, Hawker Beechcraft Corporation 1900D, ZK-EAK, landing gear malfunction and subsequent wheels-up landing, Woodbourne Aerodrome, Blenheim, 18 June 2007

Report 07-006

Hawker Beechcraft Corporation 1900D ZK-EAK

landing gear malfunction and subsequent wheels-up landing

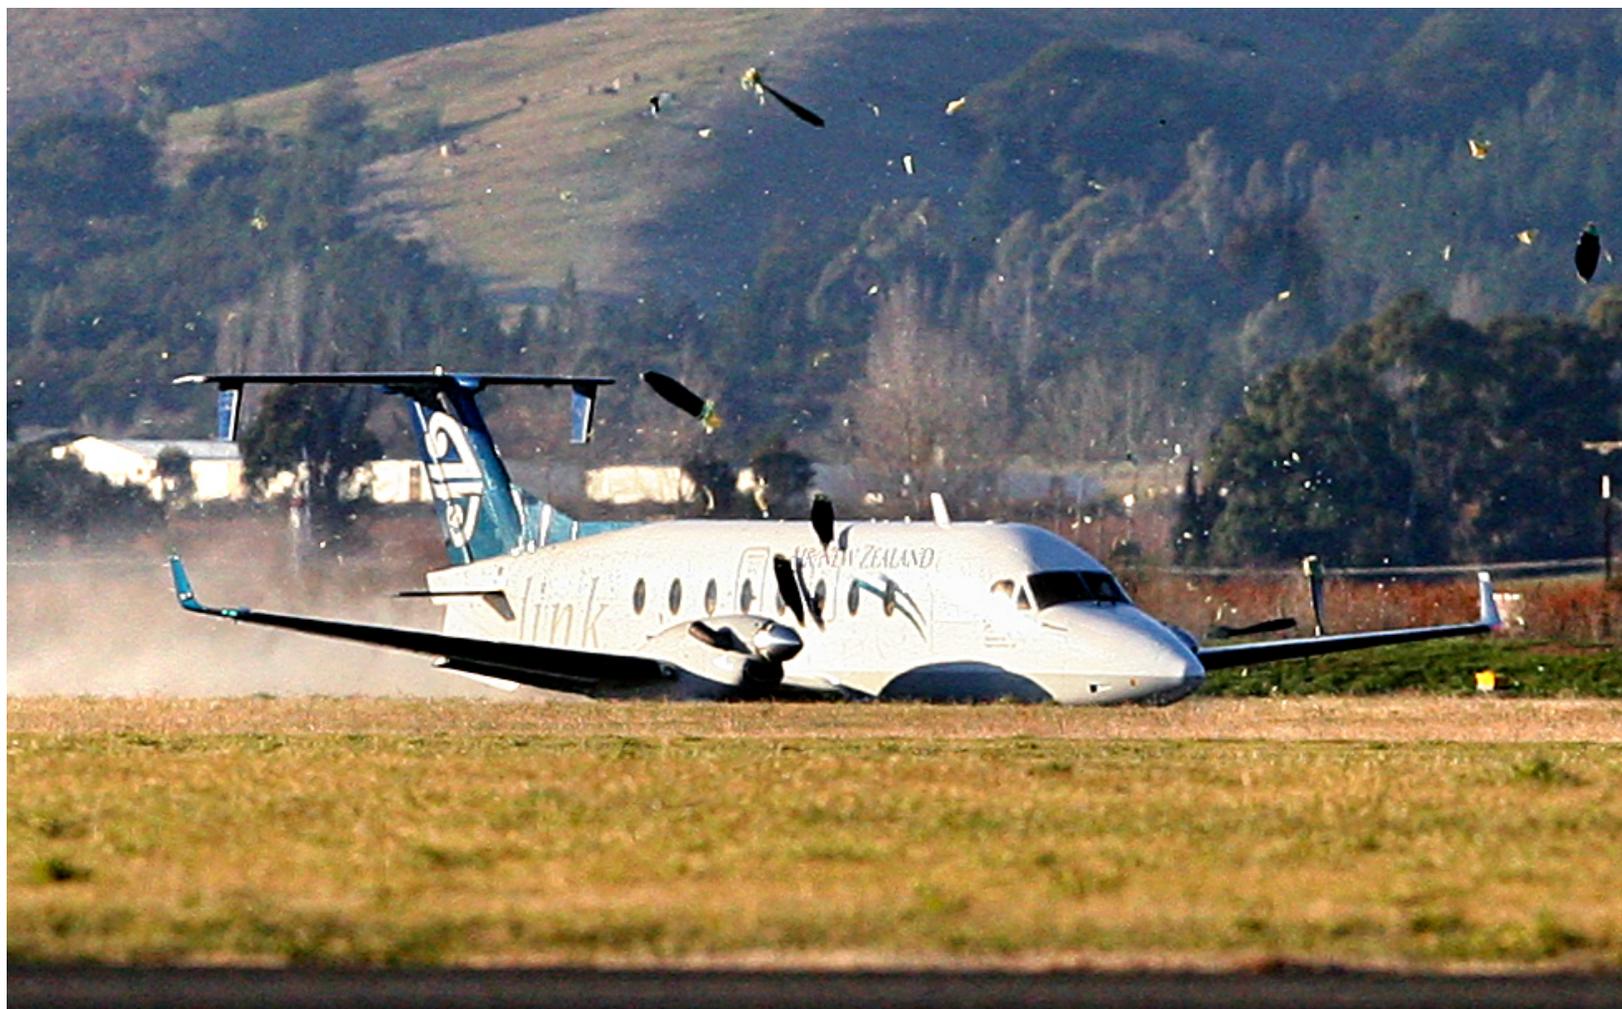
**Hawker Beechcraft 1900D ZK-EAK
landing at Woodbourne, 18 June 2007
(courtesy of The Marlborough Express)**

- 1.2.5 Both propellers were destroyed, with the engines requiring impact damage inspection and repairs. Severe scraping to the underside of the aircraft required major panel repairs and aerial replacements. Some impact damage was observed, mainly to the right side of the fuselage, as a result of the propeller blades disintegrating and sections striking the reinforced panelling. However, no items penetrated the fuselage.

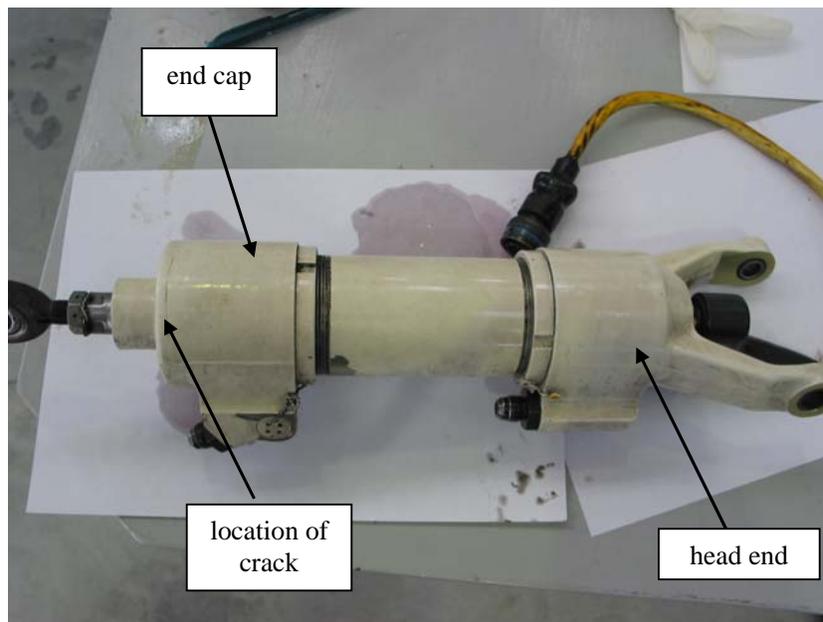
Figure 3
Actuator after removal from ZK-EAK

- 1.5.2 Hydraulic fluid was found sprayed around the inside of the right main wheel well and running rearwards from the wheel well to the trailing edge of the underside of the wing. Hydraulic fluid was also found streaked down the right side of the fuselage as far back as the strakes at the tail of the aircraft. The hydraulic reservoir was partially replenished and the hand pump used to pressurise the system. Fluid was soon observed flowing from the top side of the hydraulic gear actuator for the right main landing gear. The actuator was removed and fluid was found seeping from a crack in the end cap (see Figure 3).

- 1.5.4 The failed actuator was a Frisby Airborne Hydraulics⁸ component, part number 114-380041-15, serial number 1145A. The actuator had been fitted new to the aircraft on production and at the time of the accident had accrued the same hours and cycles as the aircraft – 10 315 hours and 17 149 cycles.

- 1.5.3 A replacement actuator was fitted to ZK-EAK, the hydraulic reservoir replenished and several gear retractions and extensions completed successfully. Manual or emergency cycling of the gear was also completed. The landing gear performed according to specifications. Checks of the main landing gear rigging before and after the actuator was replaced found it to be within documented limits. Despite functioning correctly, the operator as a precaution replaced the hydraulic power pack, including the low-level sensor.

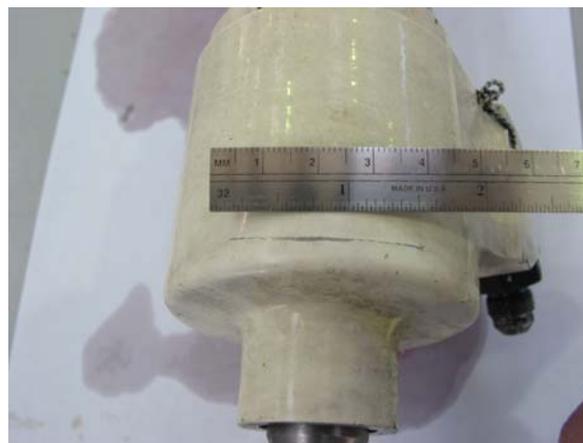
Figure 4
Close-up of crack

- 1.5.11 The cracks in the 2 actuators were both in similar positions in the end caps – in line with the inside corner radius of the end cap. The crack in the actuator from ZK-EAK was nearly 50 mm long and covered an arc of about 120° (see Figure 4). The crack in the ZK-EAF actuator was about 25 mm long.

- 2.2 The landing gear would not lower because a fatigue crack in the hydraulic actuator for the right main landing gear assembly had propagated through the thickness of the end cap wall, allowing the hydraulic system to be depleted of fluid. This prevented a build-up of pressure on the extend side of the system, which would normally have started moving the actuator and relieved up-line pressure, thereby lowering the gear.

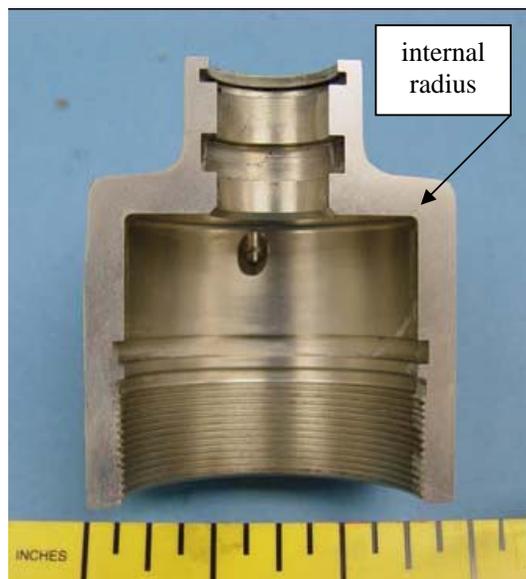
Figure 5
Sectional view of end cap from ZK-EAK
(Courtesy of NTSB)

- 1.5.12 Cuts were made at both ends of the visible cracks for both actuators, and the fracture surfaces exposed for closer examination. A closer view of the exposed surfaces, in particular the internal surfaces, identified numerous individual ratchet marks, “consistent with fatigue initiating from multiple origins before propagating into a unified crack front” (see Figures 5, 6 and 7). Closer examination of the radius identified in Figure 5 revealed a distinct crack originating in the radius (see Figure 8) and smaller cracks in its vicinity (see Figure 9). Examination showed the cracks were coincidental with circumferential machine marks resulting from manufacture.

- 1.5.13 The design drawings for the actuator specified an inside corner radius for the end cap of 0.06 inches (1.52 mm). The radii for both actuators were measured and determined to be within the design tolerance range of 1.27 mm to 1.78 mm, with the actuator from ZK-EAK in the mid-range and the actuator from ZK-EAF at the lower limit. The wall thickness was 7 mm, which also corresponded to design specifications (see Figure 7).

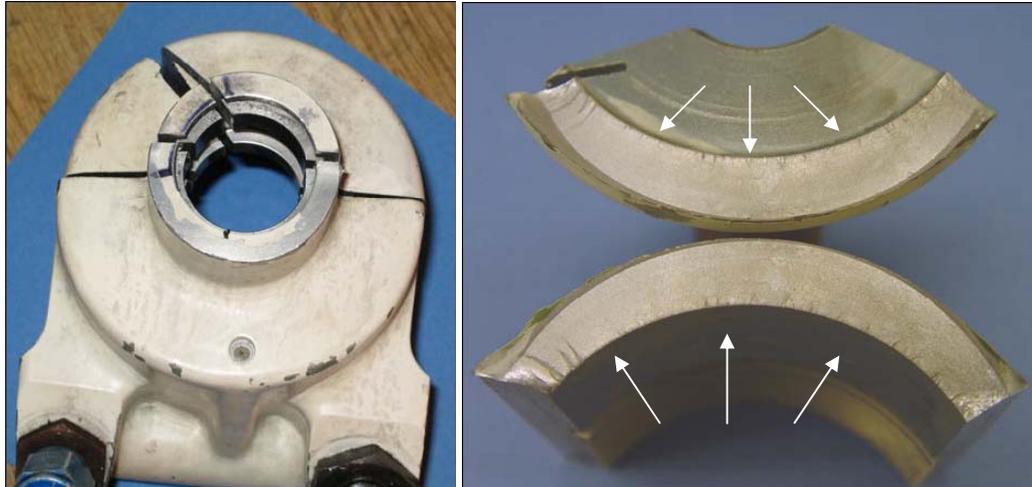
Figures 6 and 7
Sectioned end cap and fracture faces from ZK-EAK
 (Courtesy of NTSB)

- 1.5.14 High-magnification examination of the section cap from ZK-EAF identified fatigue striations. The crack striations had propagated across the end cap wall until about 0.4 mm from the edge, where it sheared apart. Examination of the striations showed that the crack propagation rate increased as it progressed across the fracture surface and grew in length. Eight sample points across the fracture surface were examined in detail to give a more accurate assessment of the total time to failure.

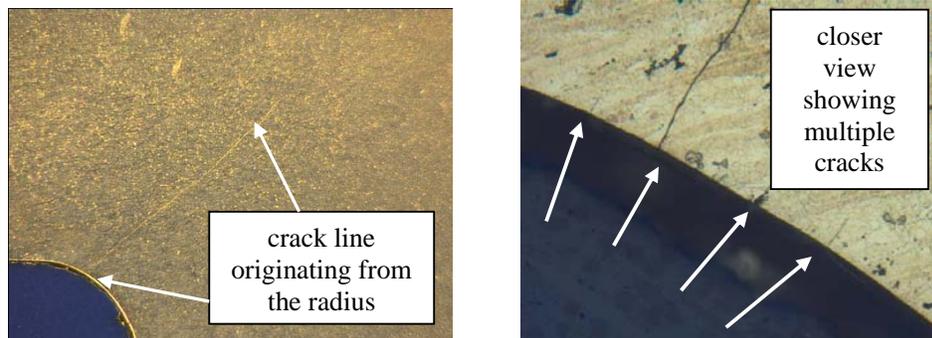
Figures 8 and 9
Close-ups of cracking in end cap from ZK-EAK
 (Courtesy of NTSB)

- 1.5.15 A summation of the striation counts at the 8 points gave a total measurement of 11 960 striations across the 6.6 mm of the wall. The striations equated to cycles and therefore it was calculated that after initiation of the crack, it reached a critical size after 11 960 cycles. The crack had sheared the last 0.4 mm of the wall and allowed hydraulic fluid to leak from the actuator.¹¹

- 1.5.16 The end cap material was subjected to hardness testing and micro-structural examination and determined to be in accordance with design specifications. The actuator, including the end cap, matched design drawings provided by the manufacturer. Examination also determined that the inside of the actuator cap was covered by an anodised aluminium oxide layer, about 7 microns thick. The anodising had been completed after machining of the actuator components during manufacture.¹²

- 2.9 The fractures in the actuators from ZK-EAK and ZK-EAF originated from the same part of the actuator end cap, namely the inside corner radius. The fractures were the culmination of numerous small fatigue cracks that had joined to produce a unified crack front. The crack front eventually propagated through the thickness of the end cap wall and reduced its capability to withstand normal operational pressure until it eventually failed. Most, if not all, of the cracks coincided with machining marks on the inside radius of the end cap. The cracking initiated in the more brittle 7-micron-thick anodised aluminium oxide layer and progressed through to the underlying aluminium material.

- 2.14 An improvement in the standard of surface finishing, a redesign of the profile around the radius, or a complete redesign of the actuator would be an acceptable solution to prevent further premature failures. A combination of all would provide a more robust product. Alternatively, imposing operating limitations, in terms of cycles or hours, could ensure the actuators were removed well before any sign of failure.
