**Accident Investigation Board
Denmark**

Report

HCLJ510-000433

Accident to Bombardier DHC-8-400,
registration LN-RDK,
at Aalborg Airport (Denmark),
on 9 September 2007

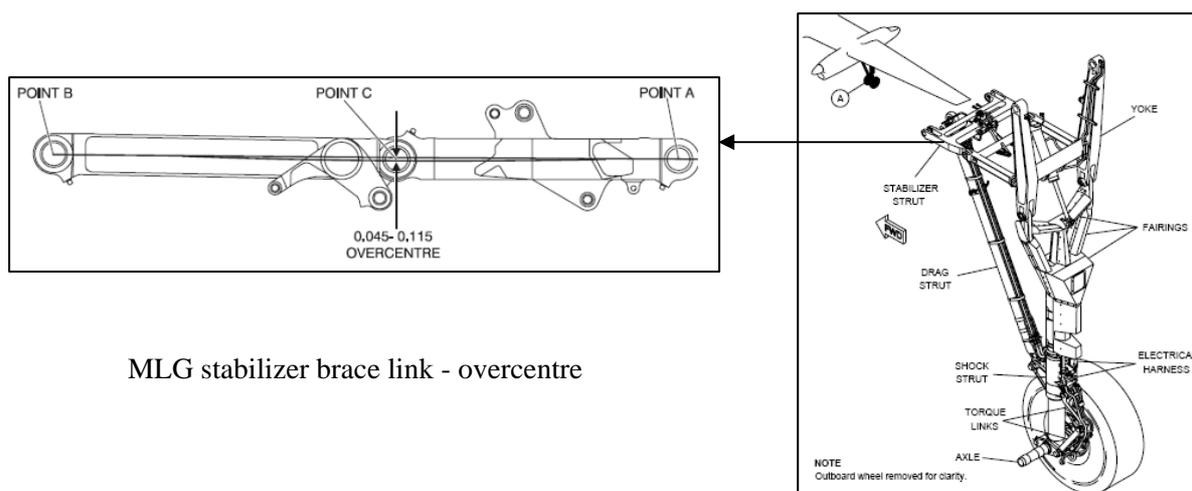
MLG stabilizer brace link - overcentre

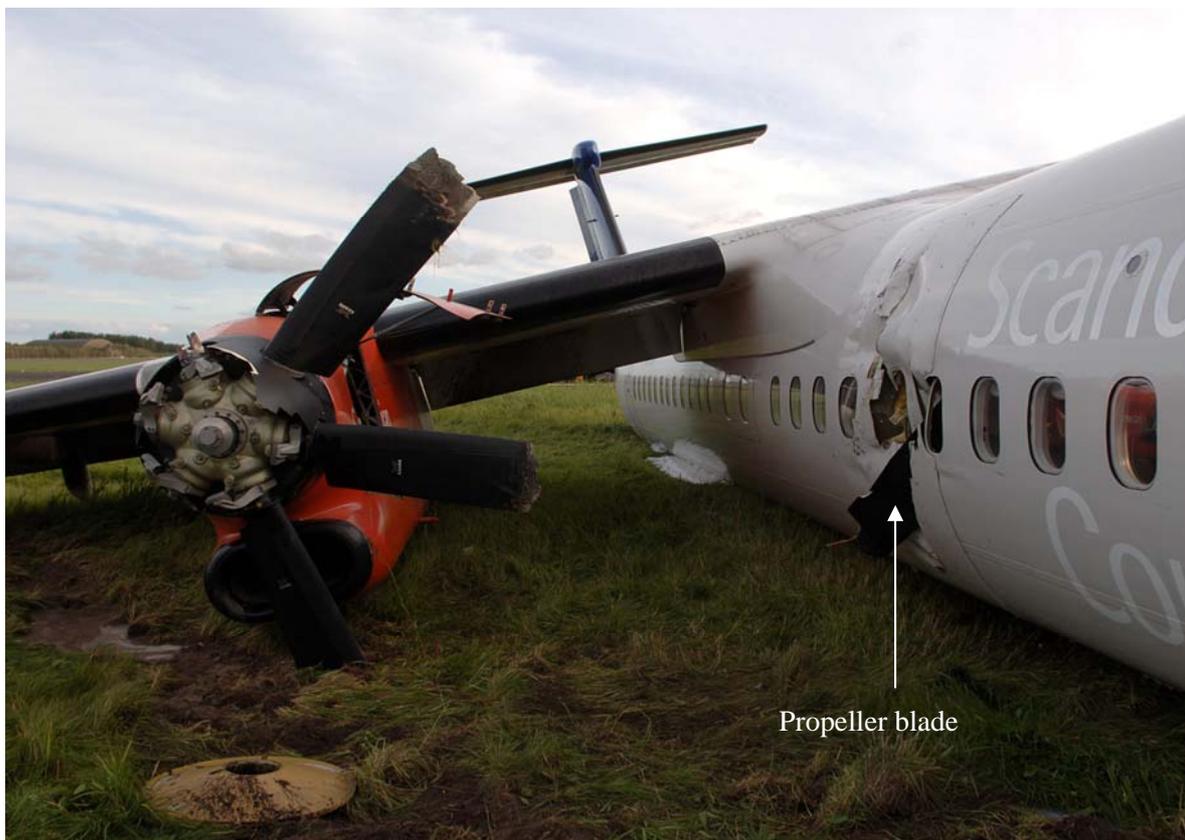
When the gear collapsed the propeller blades struck the runway. Three propeller blades separated from the propeller dome. One blade was found on the runway. A second blade was found wedged into the right side of the fuselage at row 7. The third propeller blade had entered the cabin through the right cabin window at row 8. This resulted in extensive damage to the left and right interior sidewalls, including the overhead bins and passenger service unit (PSU) components.

Propeller blade wedged into the fuselage

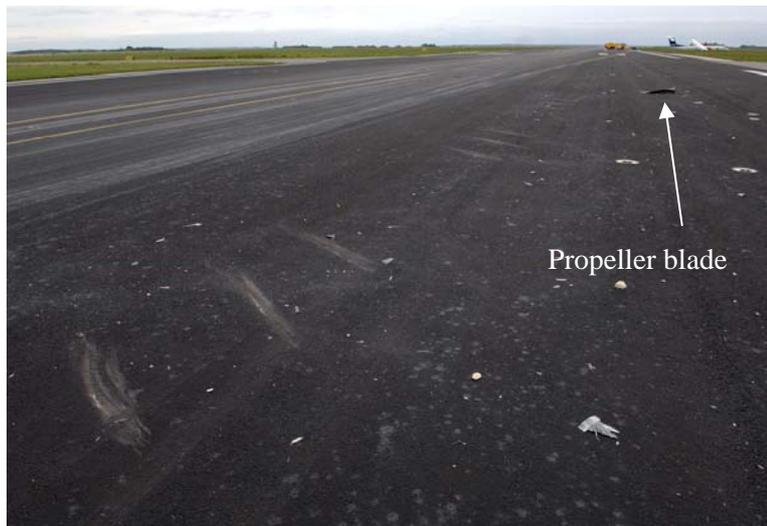
At this point it shows that three blades had left the propeller dome and the engine was still running.

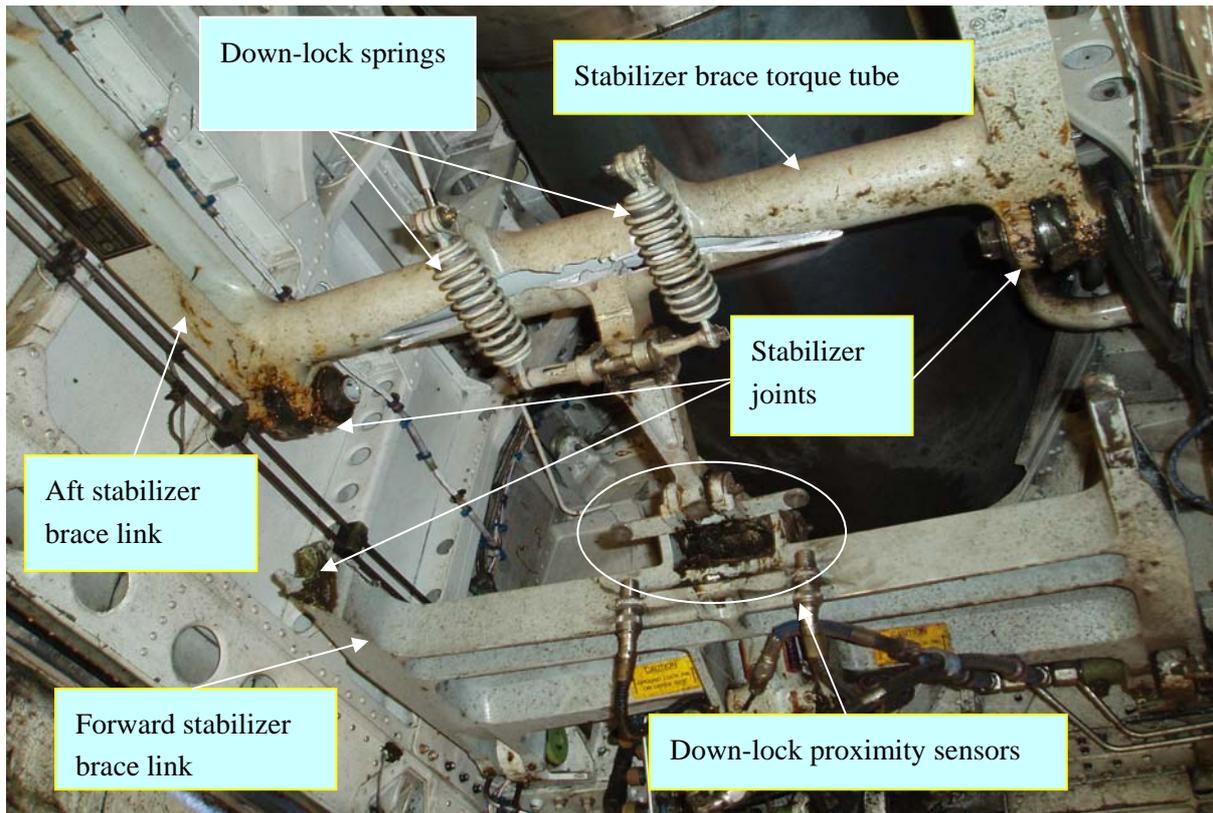
Fig. A. Right MLG stabilizer brace.

The investigation focused on the right MLG assembly which had significant fracture damage. The stabilizer brace link was fractured and separated at both joint lugs. The aft stabilizer brace torque tube was bent, and a large section had broken and separated. The aft stabilizer brace link was connected to the forward stabilizer brace link by the down-lock springs only. The down-lock proximity sensors were displaced from their respective targets (figure A).

The examination of the forward brace showed that the joint lugs had failed. The fracture surfaces were magnified and showed grainy texture with shear lips which are characteristic for an overload condition. No sign of striations was observed, see figure A.

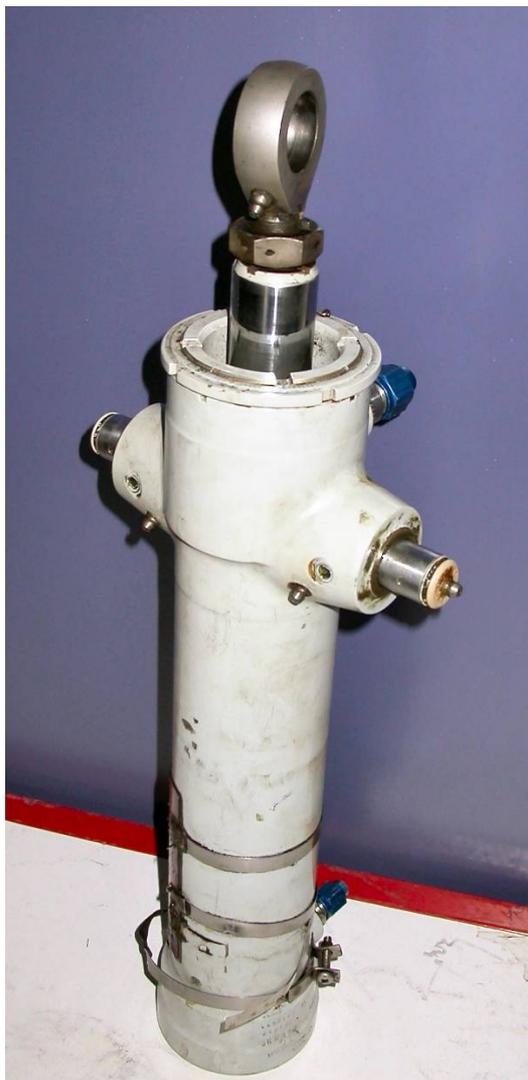
Figure 1: View of right MLG retract actuator with piston rod and rod end.

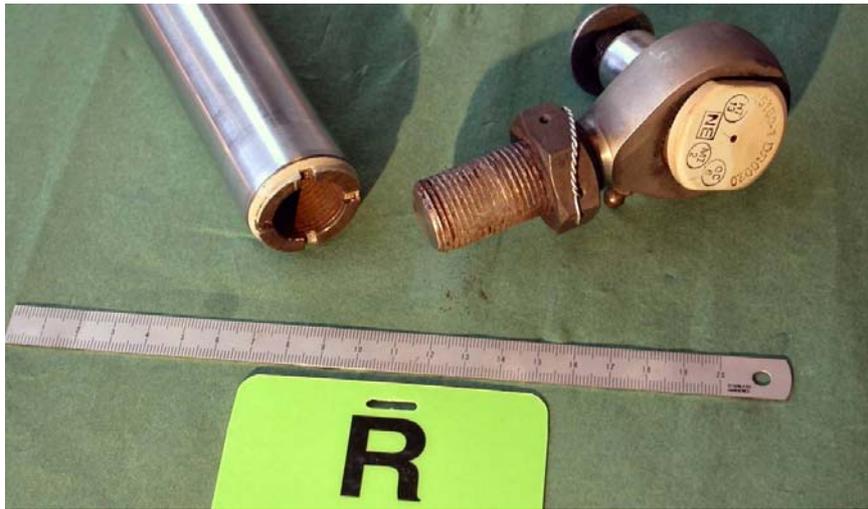
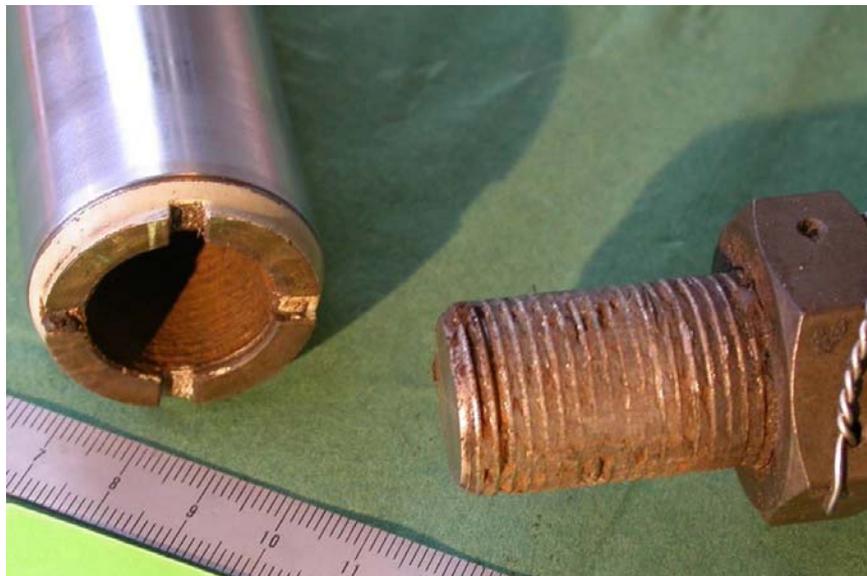
- Rod end was separated.
- Piston rod internal threads were noticeably stripped out to the depth of the rod end engagement.
- The retraction/extension actuator piston rod revealed the presence of internal corrosion.

- The bearing surfaces were adequately lubricated.
- The jam nut was present and lock-wire was intact, but without the manufacturer's originally installed lead seal.
- The threads were clogged with what appeared to be corrosion.

Figure 2: Threaded parts of piston rod and rod end in “as found” condition.

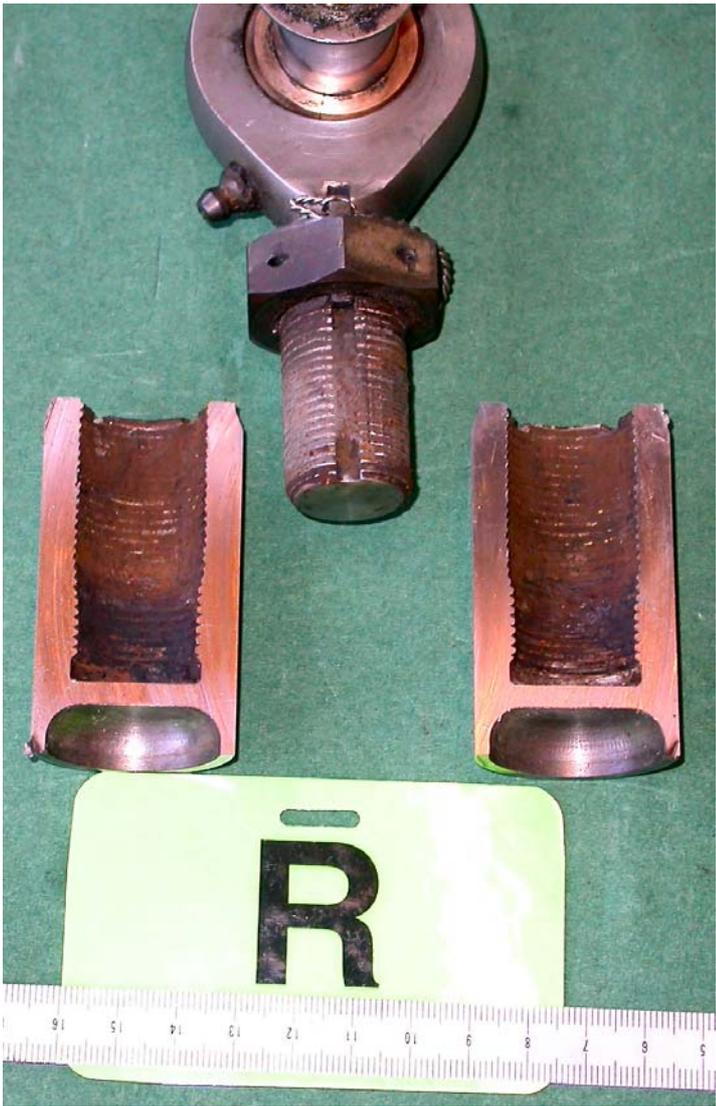
Figure 3: Longitudinal sectioning of piston rod end.

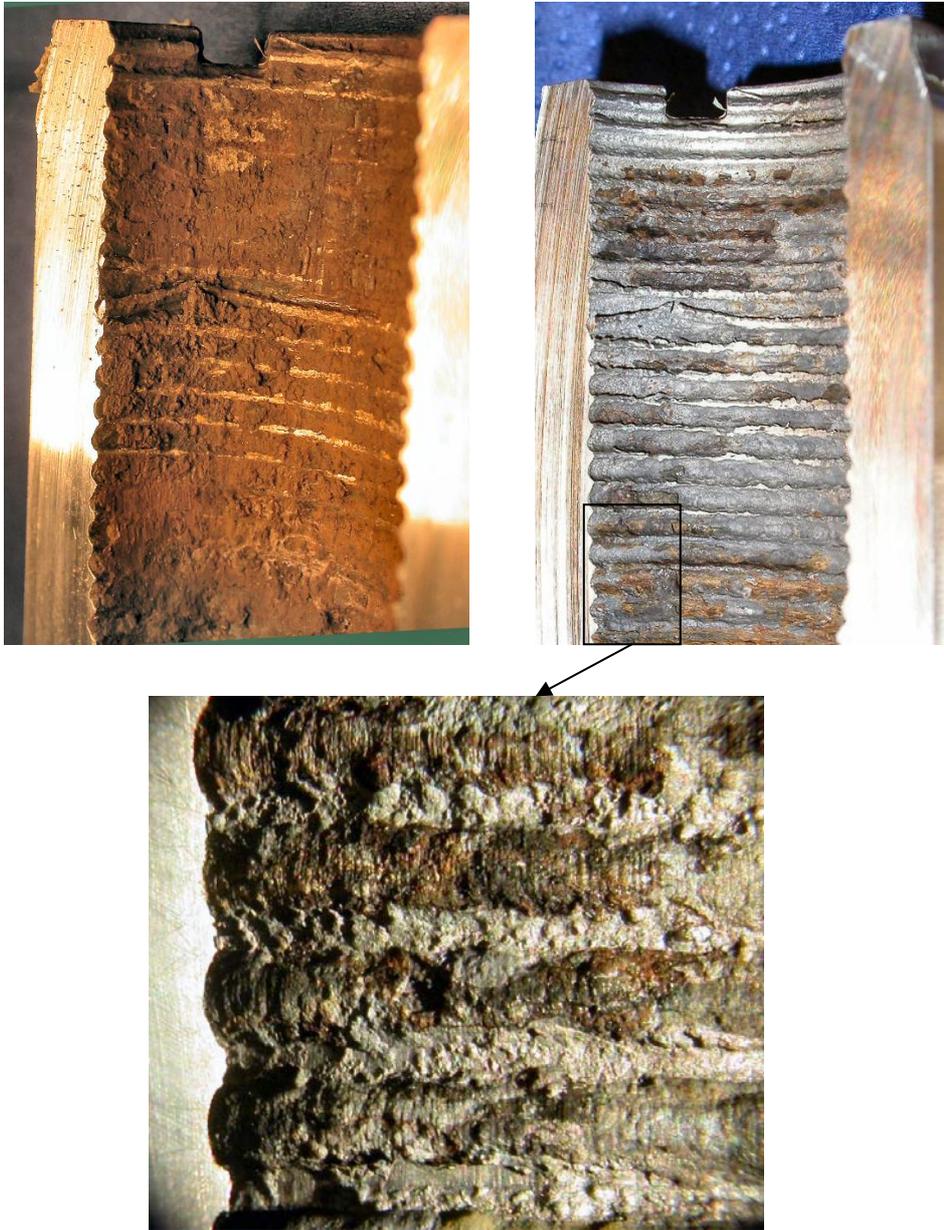
Figure 6: Part of piston rod in cleaned condition. Note the severe corrosion of thread tops and bottoms.

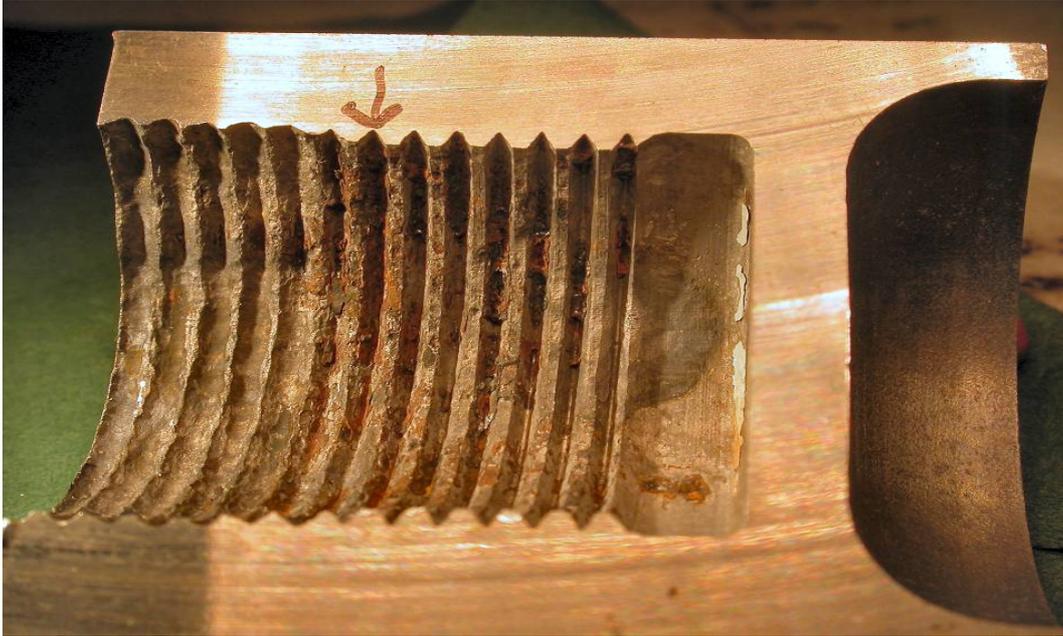
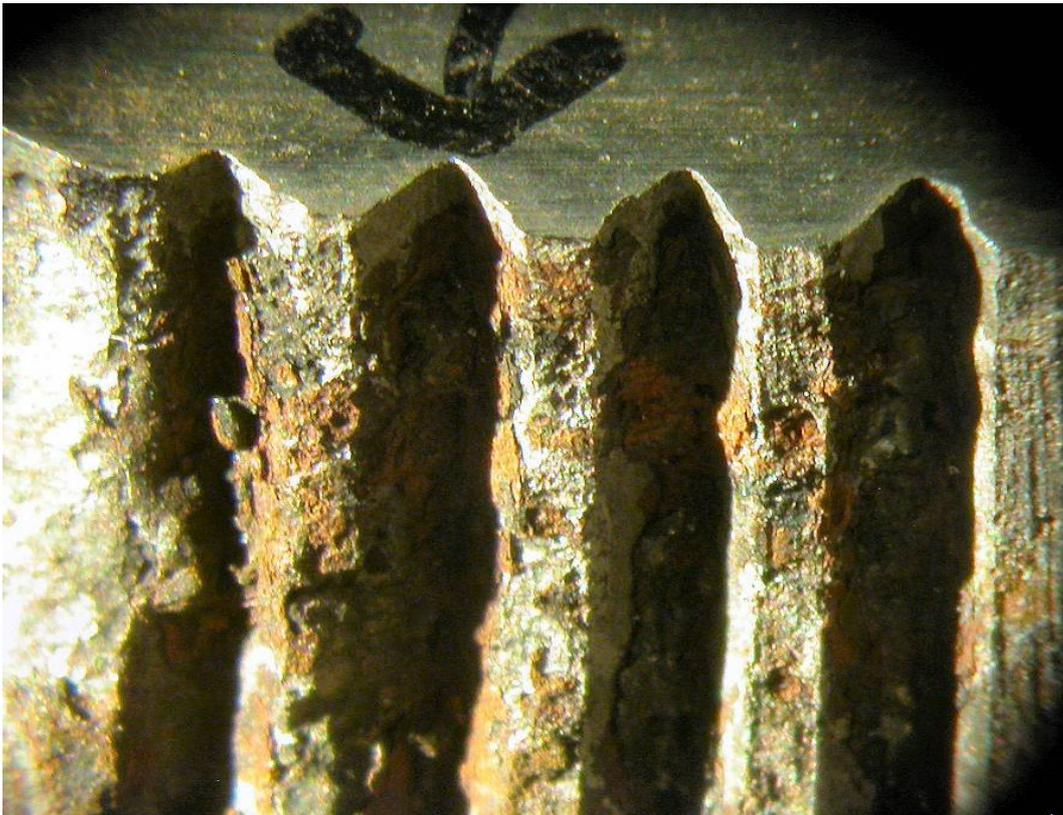
Figure 10: View of threads near bottom of piston rod. The arrow points to the last engaged thread.

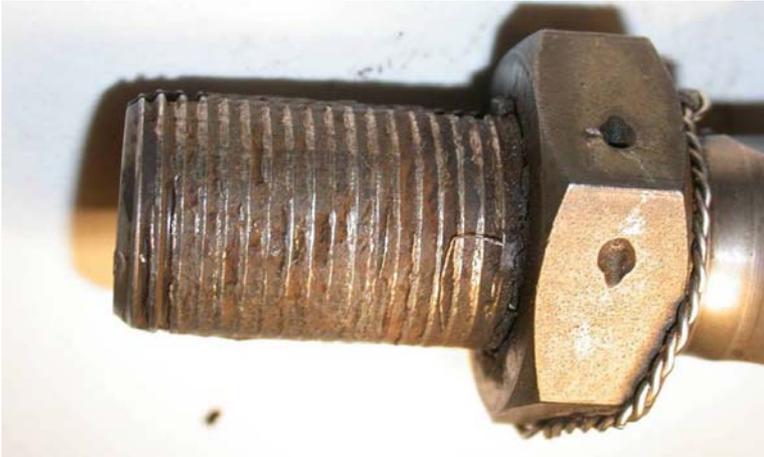
Figures 17 and 18 show the appearance of the rod end male thread. The thread valleys were filled with a dry powder-like product and metallic ligaments. A longitudinal cut in the male thread is shown in Figure 19.

Figure 17: Right MLG actuator rod end in “as found” condition.

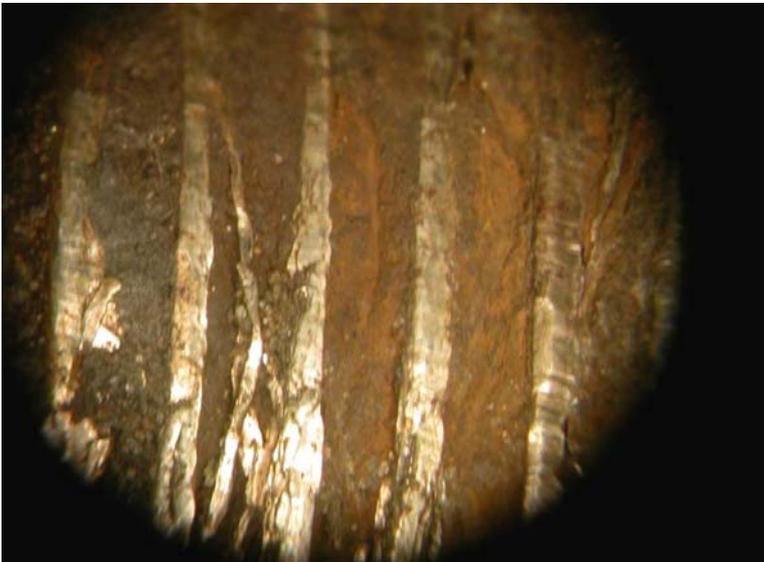
Figure 18: Close up view of the male threads in Figure 17

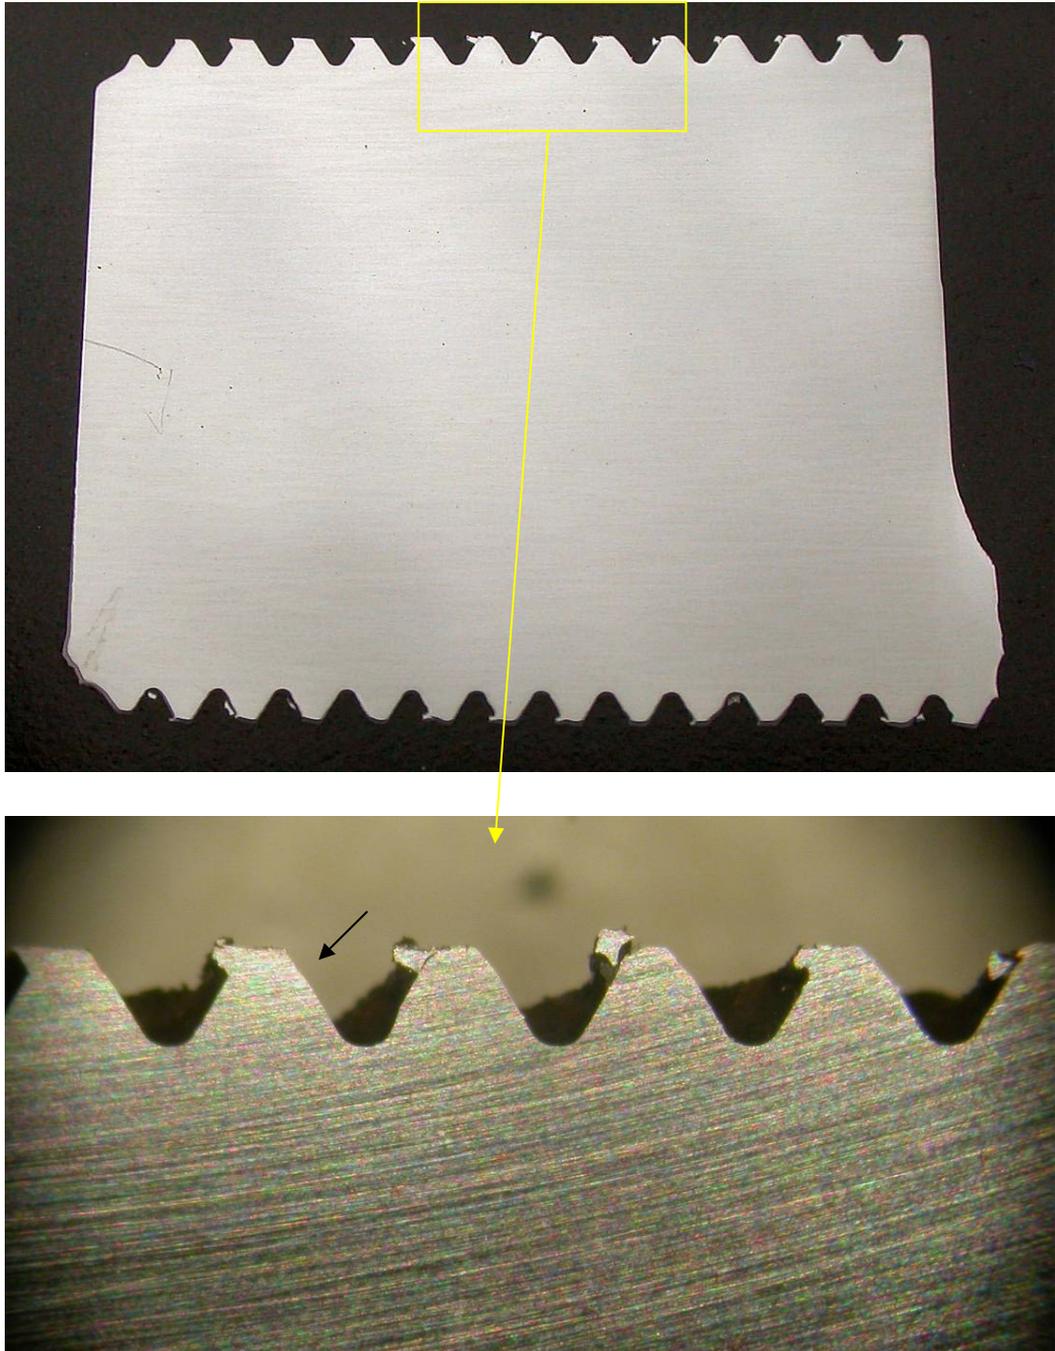
Figure 19: Longitudinal section of male thread showing some deformation/wear near top (example at arrow) and sheared off metal at the thread tip corners.

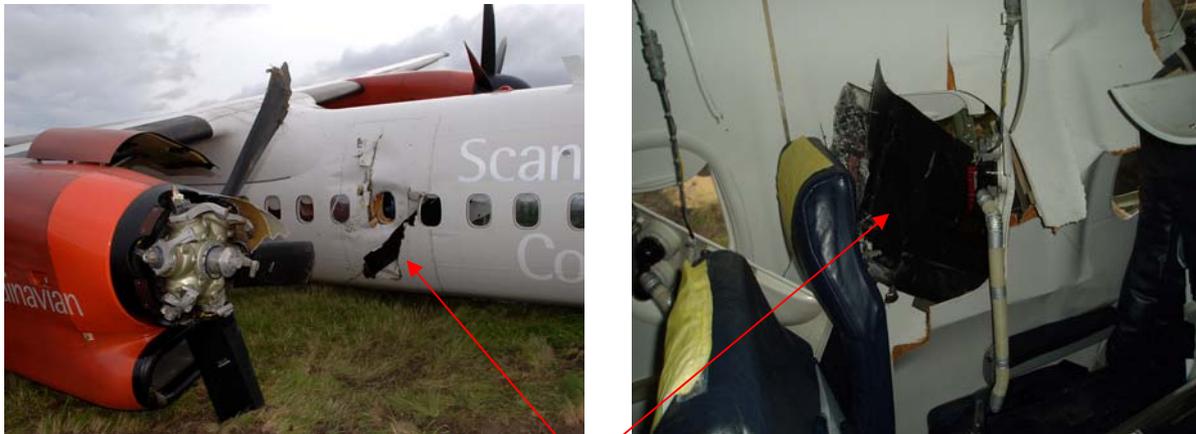
Three propeller blades separated from the propeller dome when the propeller struck the runway. One blade was found on the runway. Two blades penetrated the passenger cabin. One of the propeller blades was wedged into the fuselage at row 7 seat F and one entered the cabin through the cabin window at row 8 seat F (between fuselage station 258.5 and 281.0) (figure C). This blade crossed the passenger cabin and left a witness mark in the opposite sidewall above row 8, seat A.

Figure C: One propeller blade was wedged into the cabin

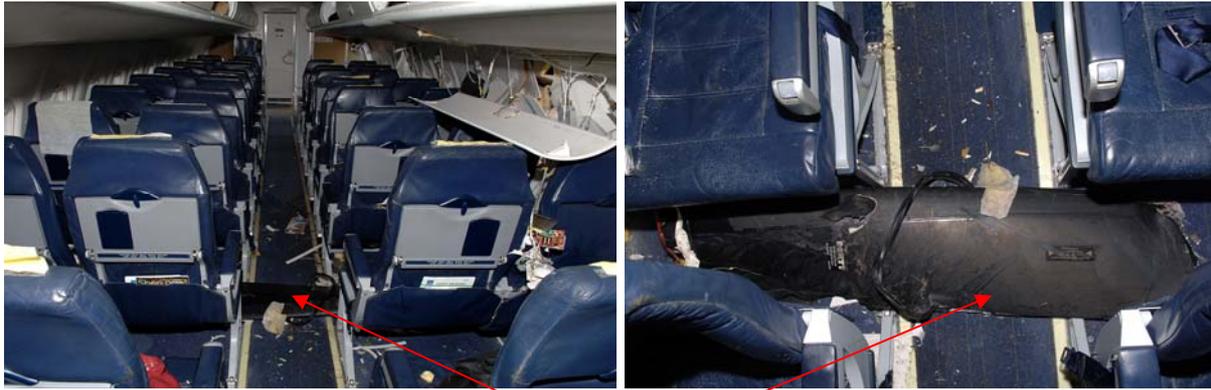
Some debris was found lying on the cabin floor including a large propeller fragment (figure D). Some storage bins were found deployed.

Figure D: One Propeller blade was found inside the cabin.

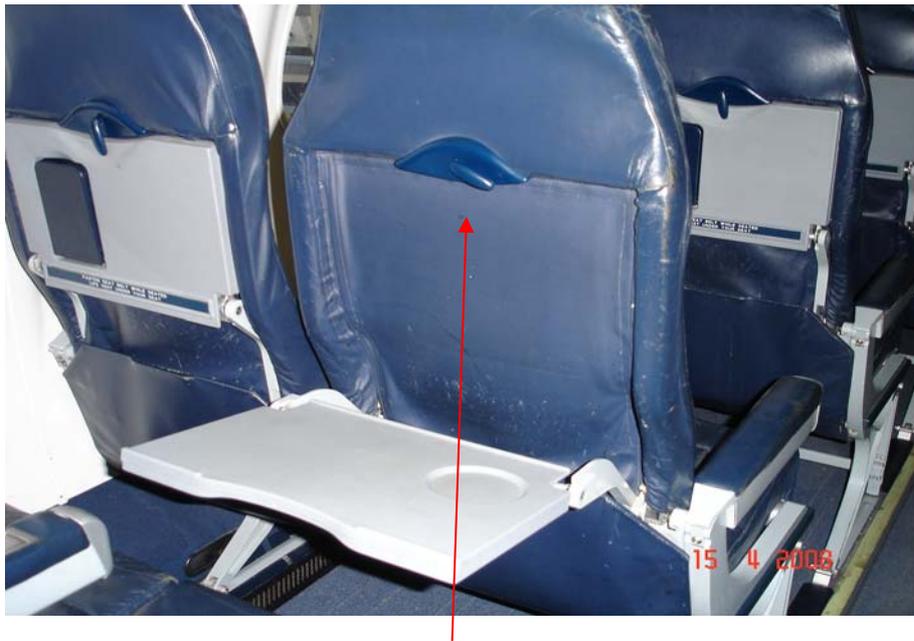
The latch of the meal tables was found slack and easy to move. The latch could rotate both to the left and to the right. All latch pins was found moved towards the aisle and therefore the tables could have been released during the emergency evacuation.

Figure E: Latch moved toward the aisle

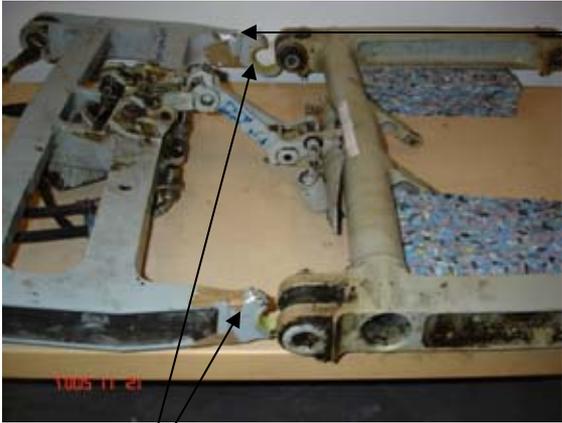
Sequence 4: Failed stabilizer joint lugs due to free fall.

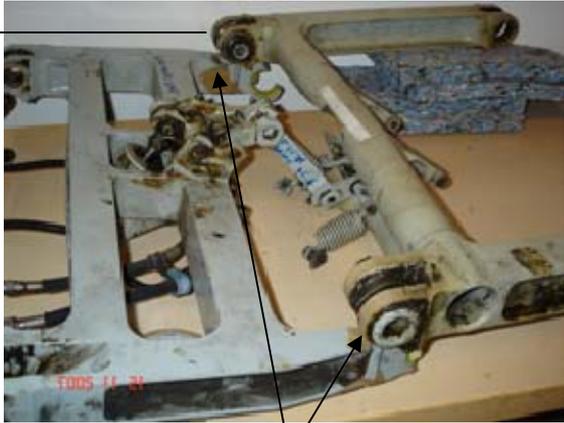
Sequence 5: The aft stabilizer was forced over the forward stabilizer.

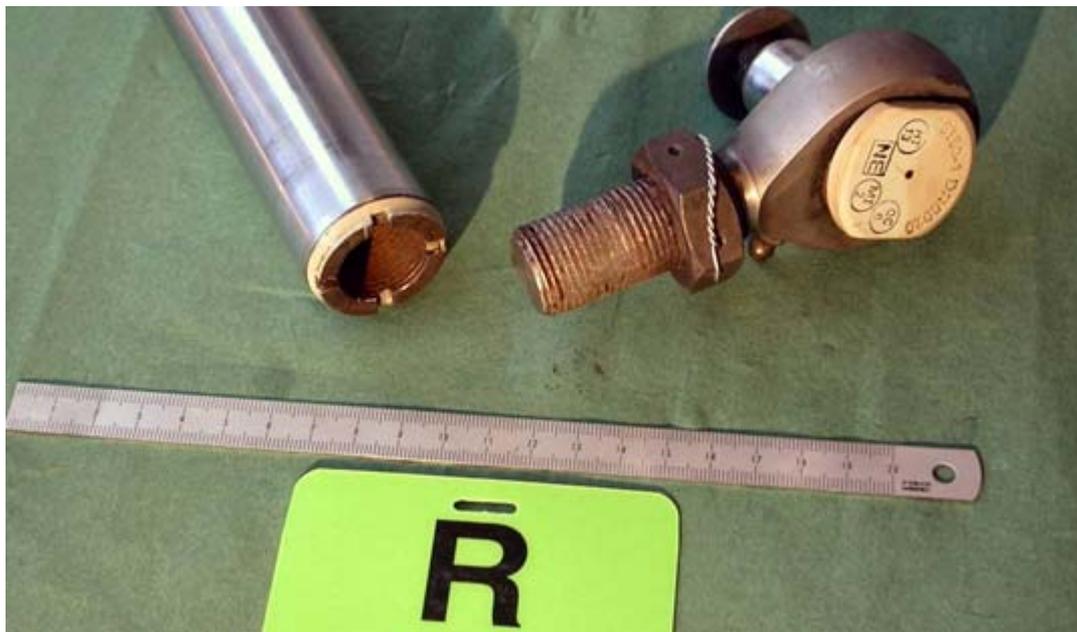
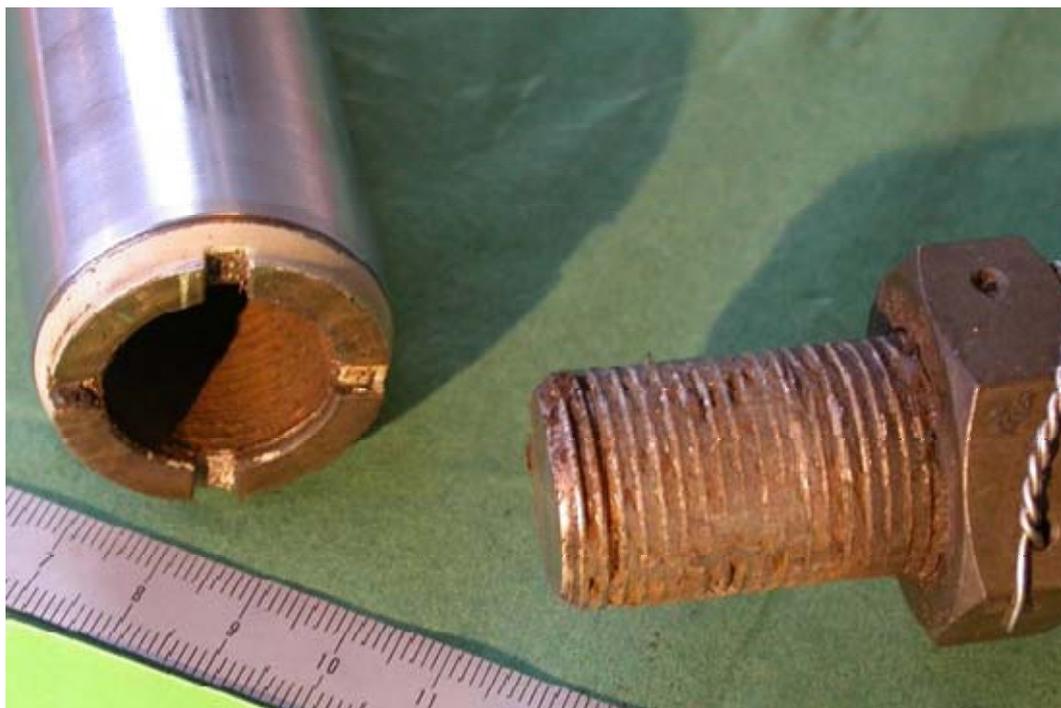
Figure 2: Threaded parts of piston rod and rod end in “as received” condition.

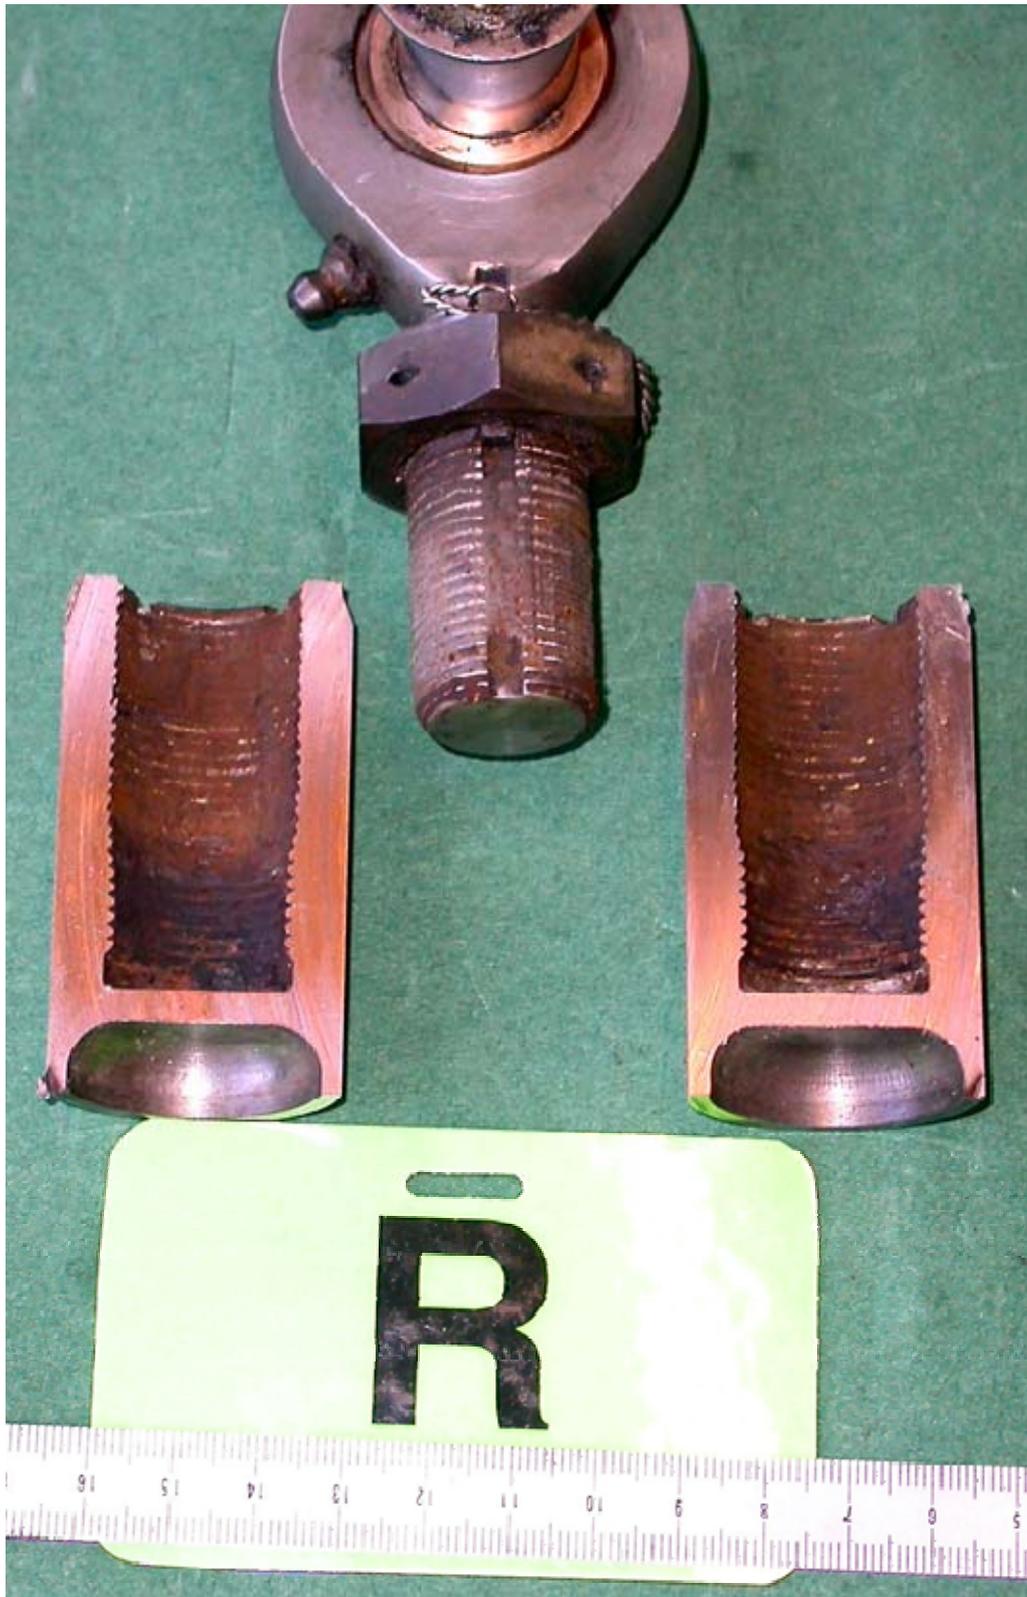
Figure 3: Longitudinal sectioning of piston rod end.

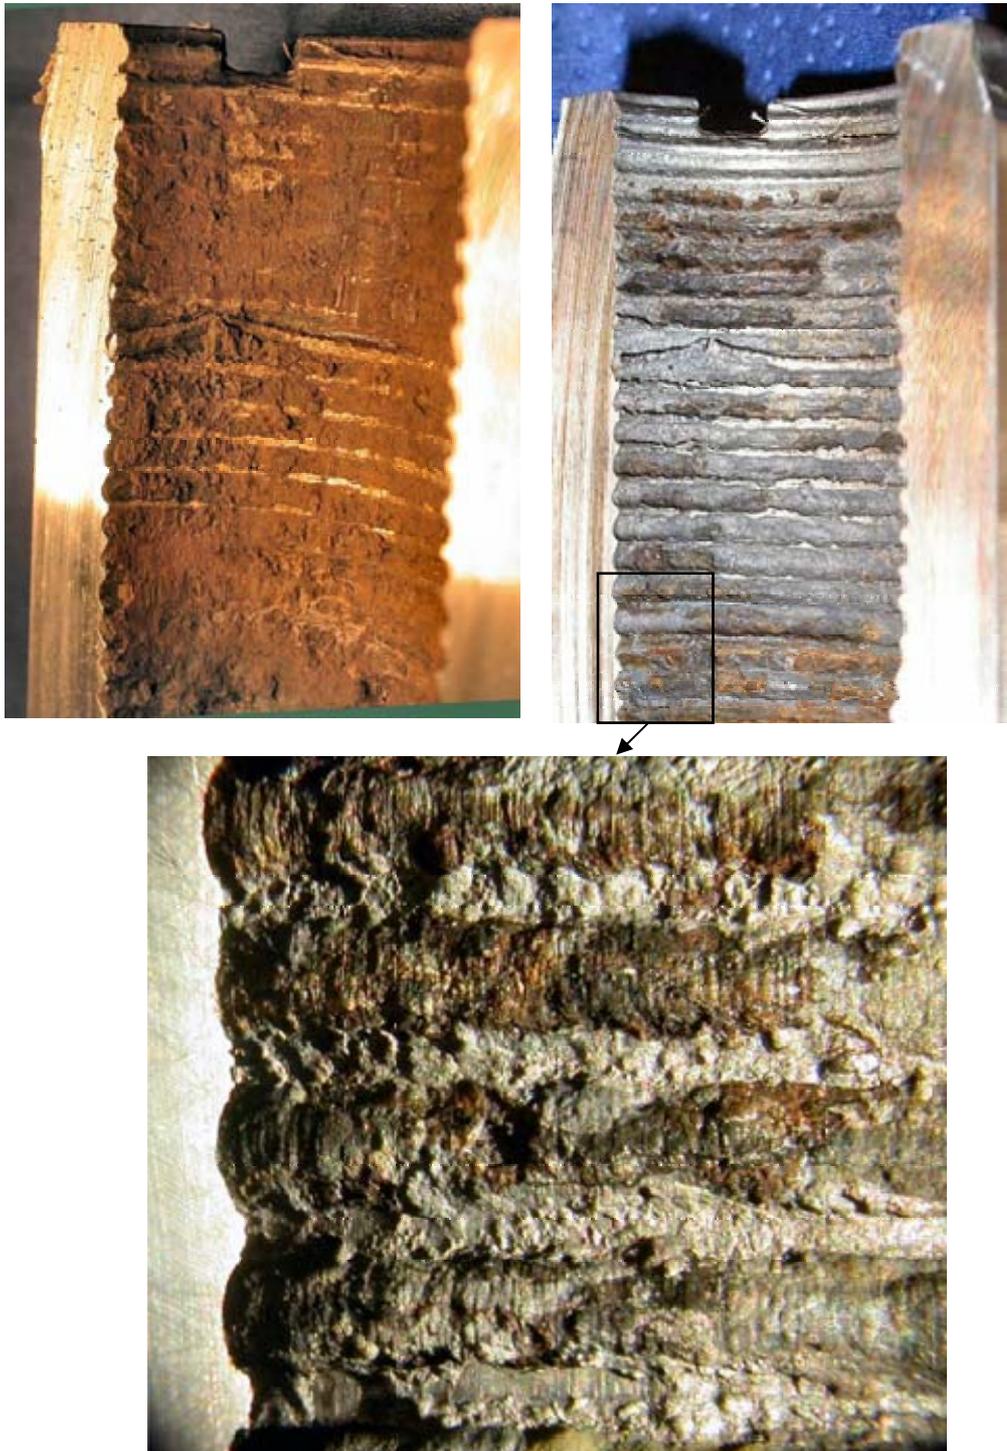
Figure 6: Part of piston rod in “as received” and cleaned condition. Note the severe corrosion of thread tops and bottoms.

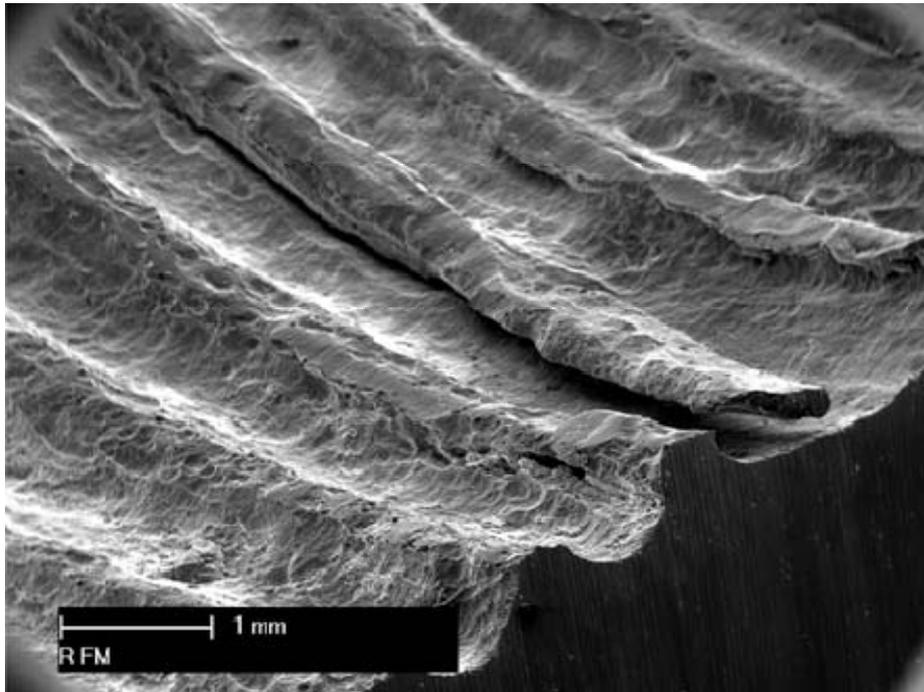
Figure 7: Scanning electron microscope image and metallographic section of severely corroded threads.

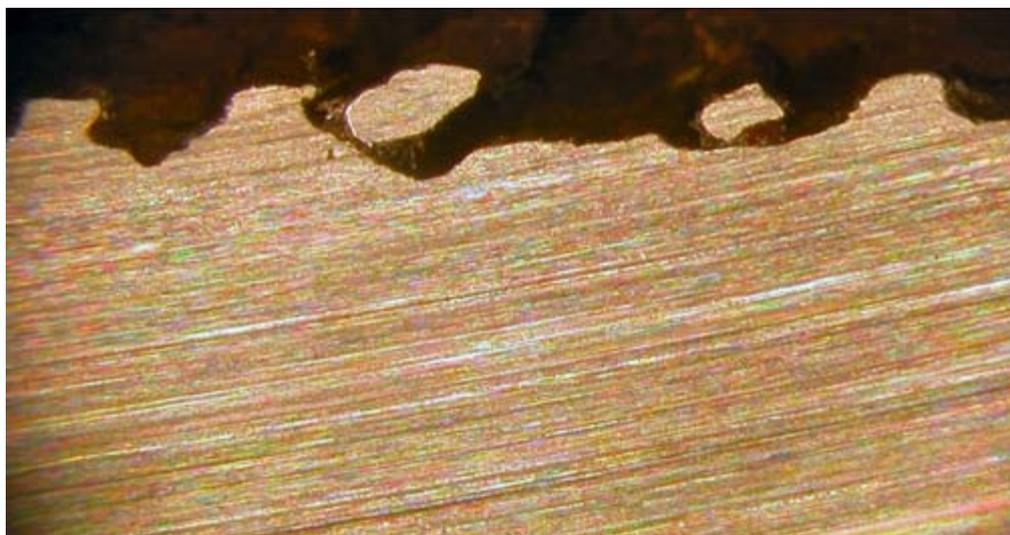
Figure 8: Metallographic section of severely corroded threads in Figure 7. Note that 2 of the threads are completely undermined by corrosion.

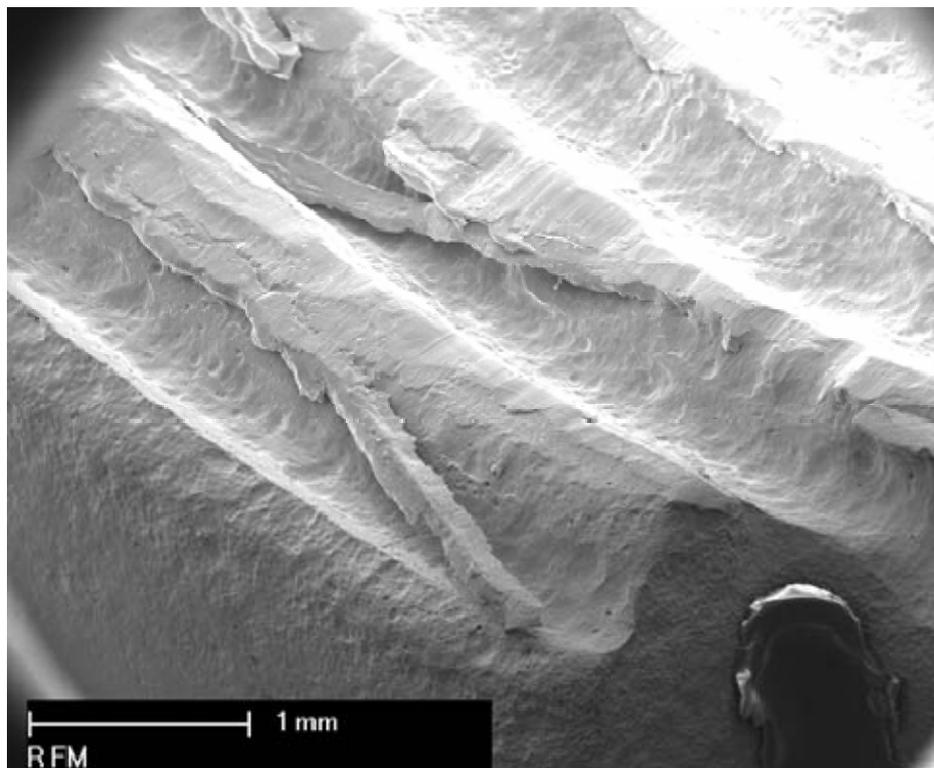
Figure 9: Scanning electron microscope image of threads at mouth of piston rod, showing shearing off of thread tops during final disengagement.

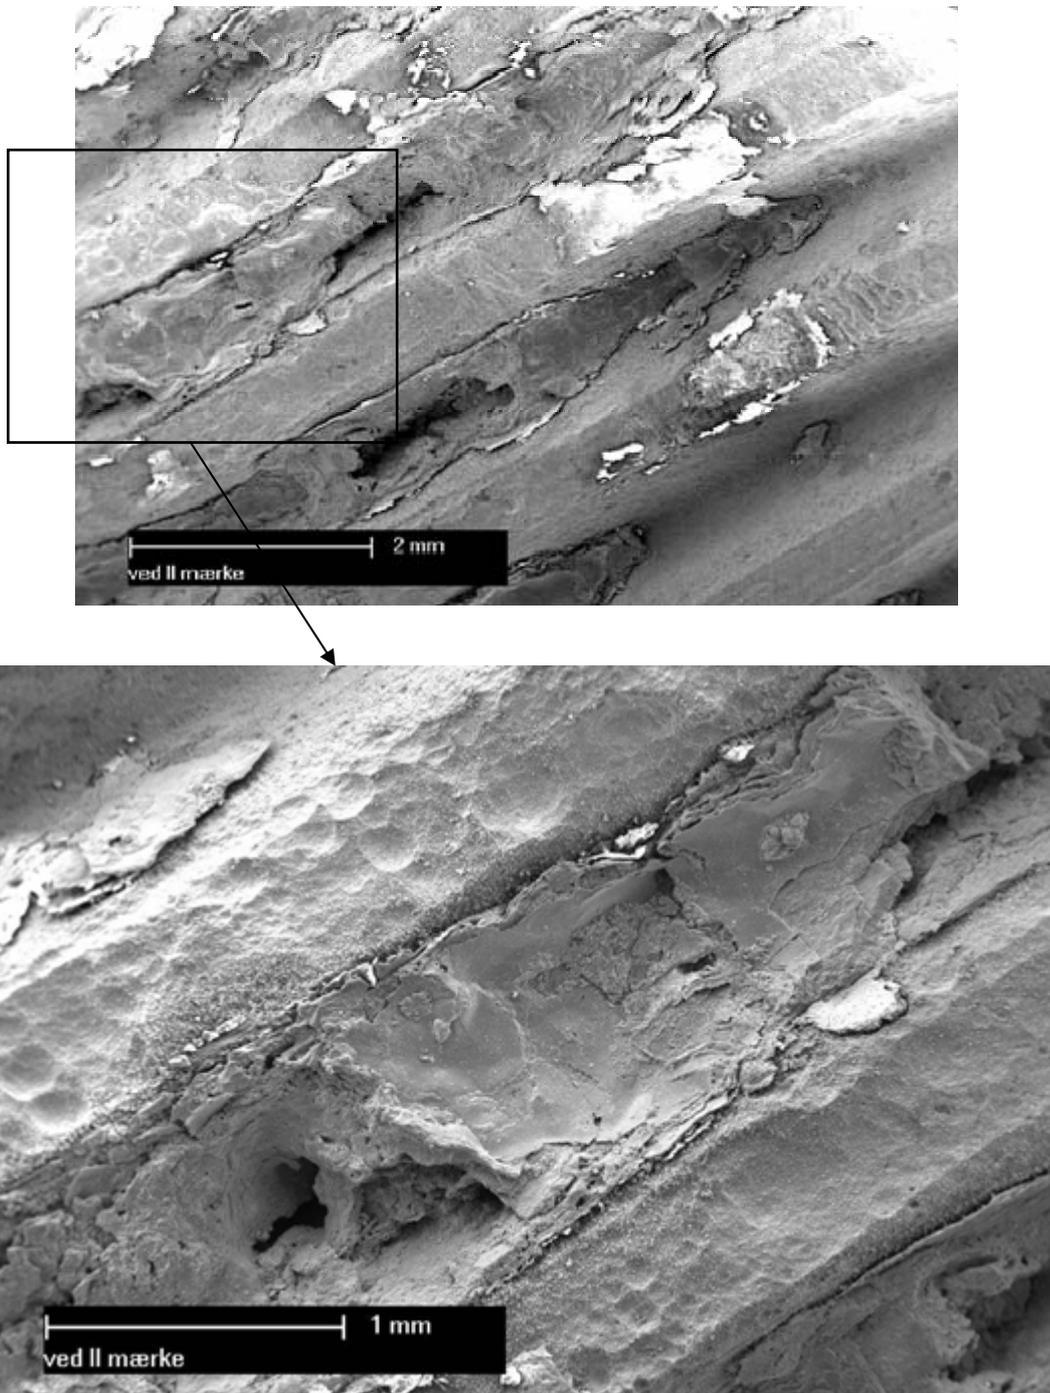
Figure 11: Scanning electron microscope images of non-engaged threads. Note the corrosion attacks in the thread tops.

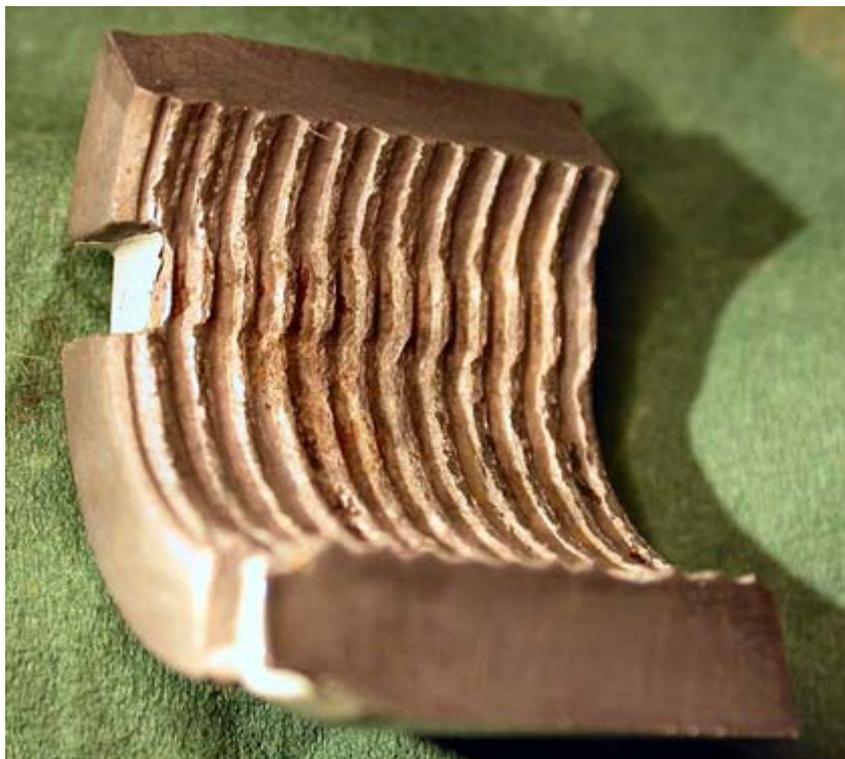
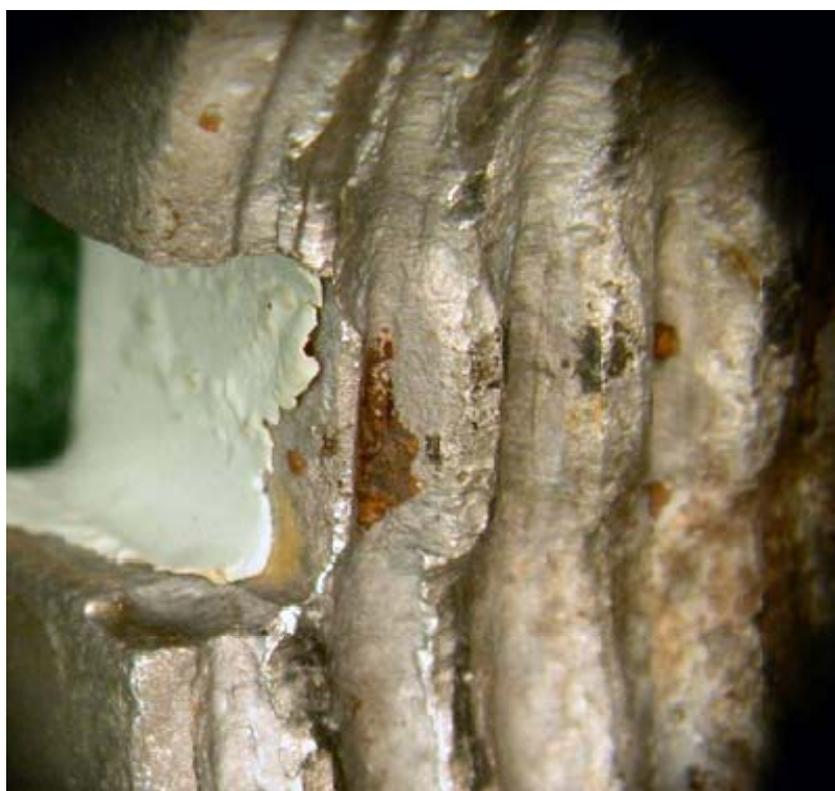
Figure 12: View of threads near piston rod mouth showing significantly less metal loss in the key way area.
