**Accident Investigation Board
Denmark**

Report

HCLJ510-000433

Accident to Bombardier DHC-8-400,
registration LN-RDK,
at Aalborg Airport (Denmark),
on 9 September 2007

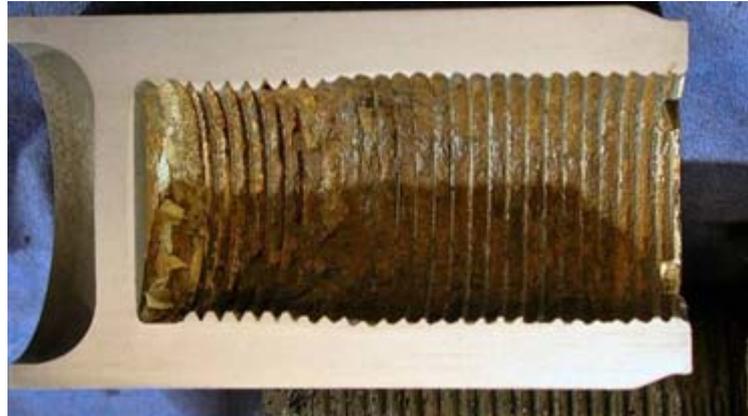
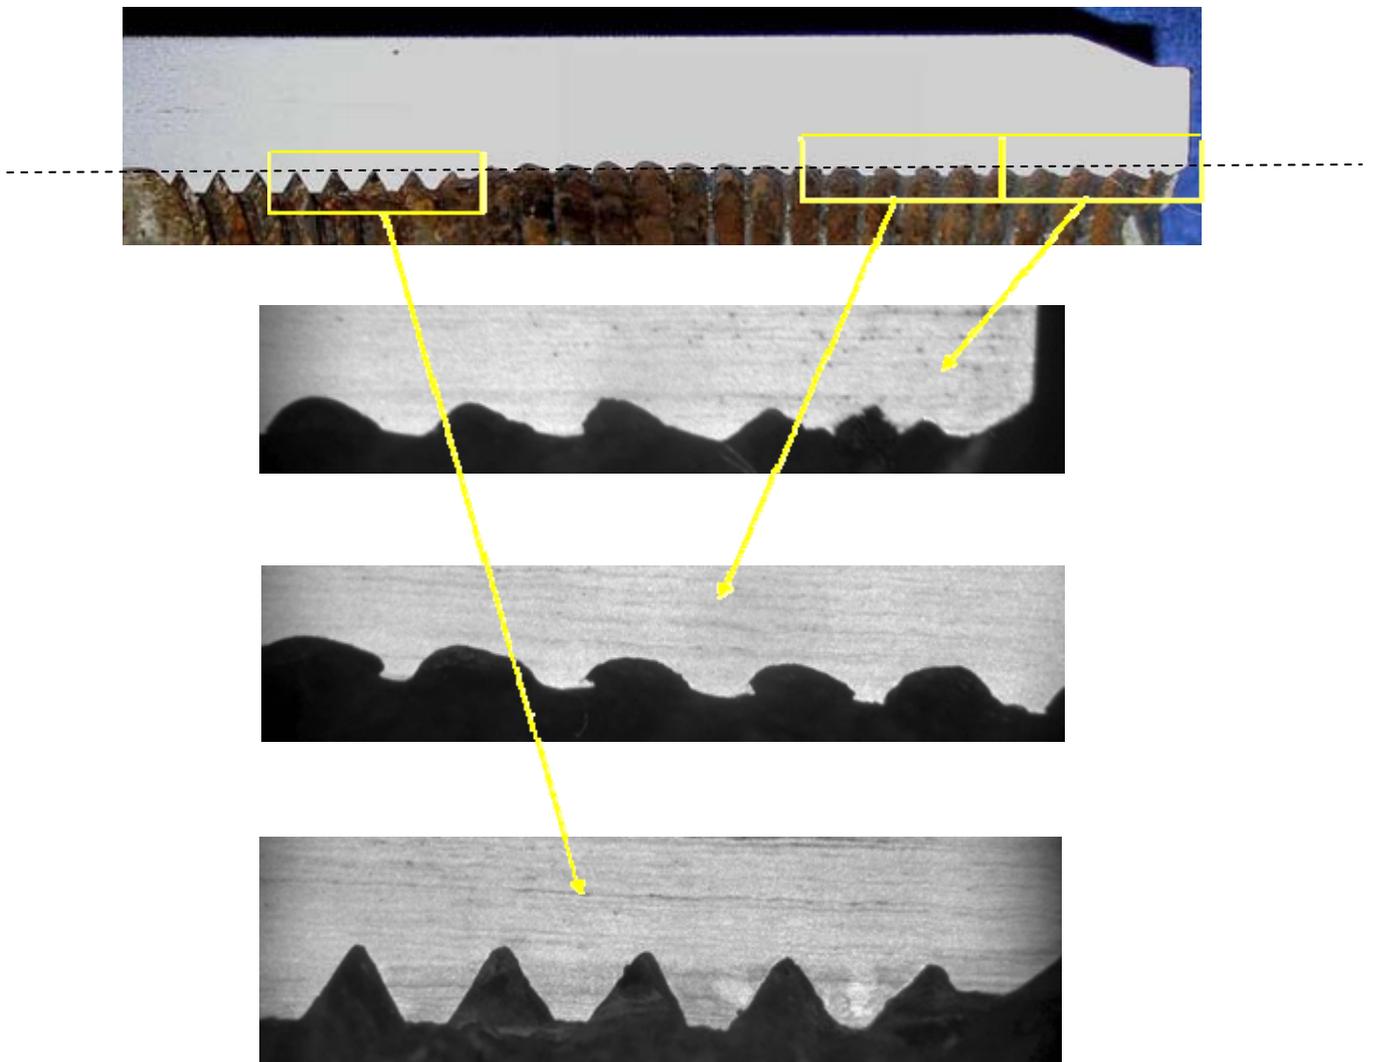
Figure 14: Illustration of the thread condition along the bore of the piston rod end. The super imposed dashed line shows the nominal thread depth.

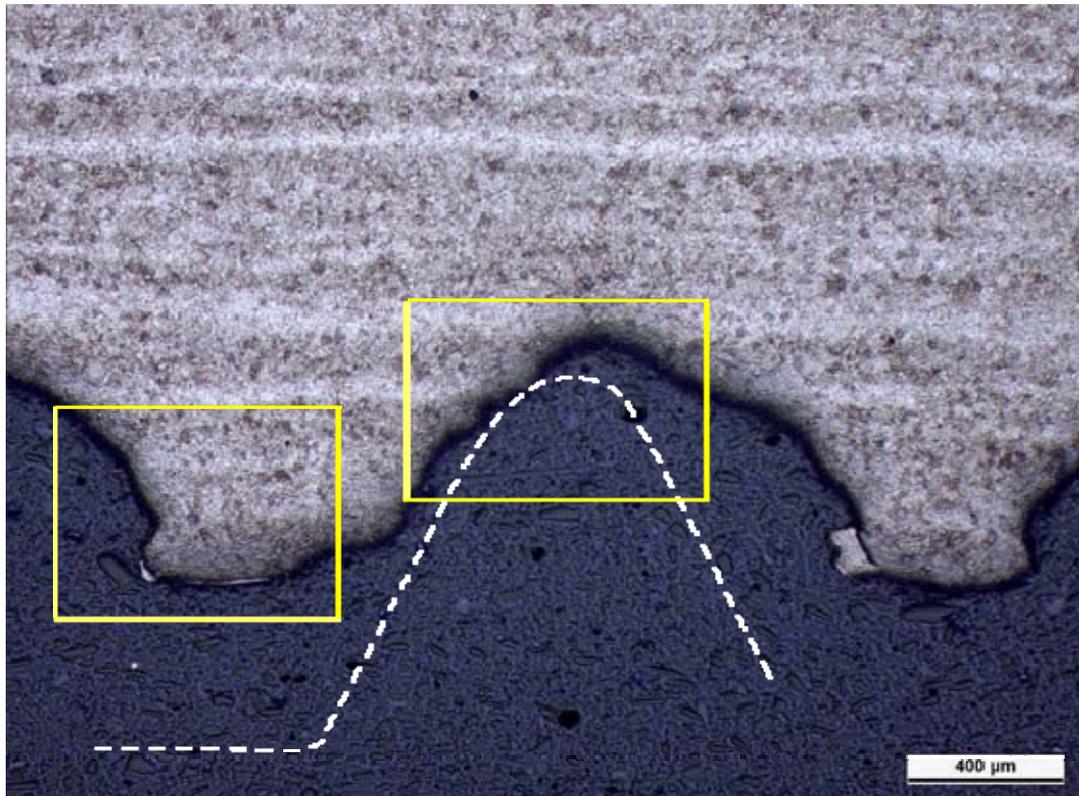
Figure 15: Metallographic section through remaining thread profile. The superimposed dashed line shows the nominal thread profile. The framed areas are shown in subsequent figures.

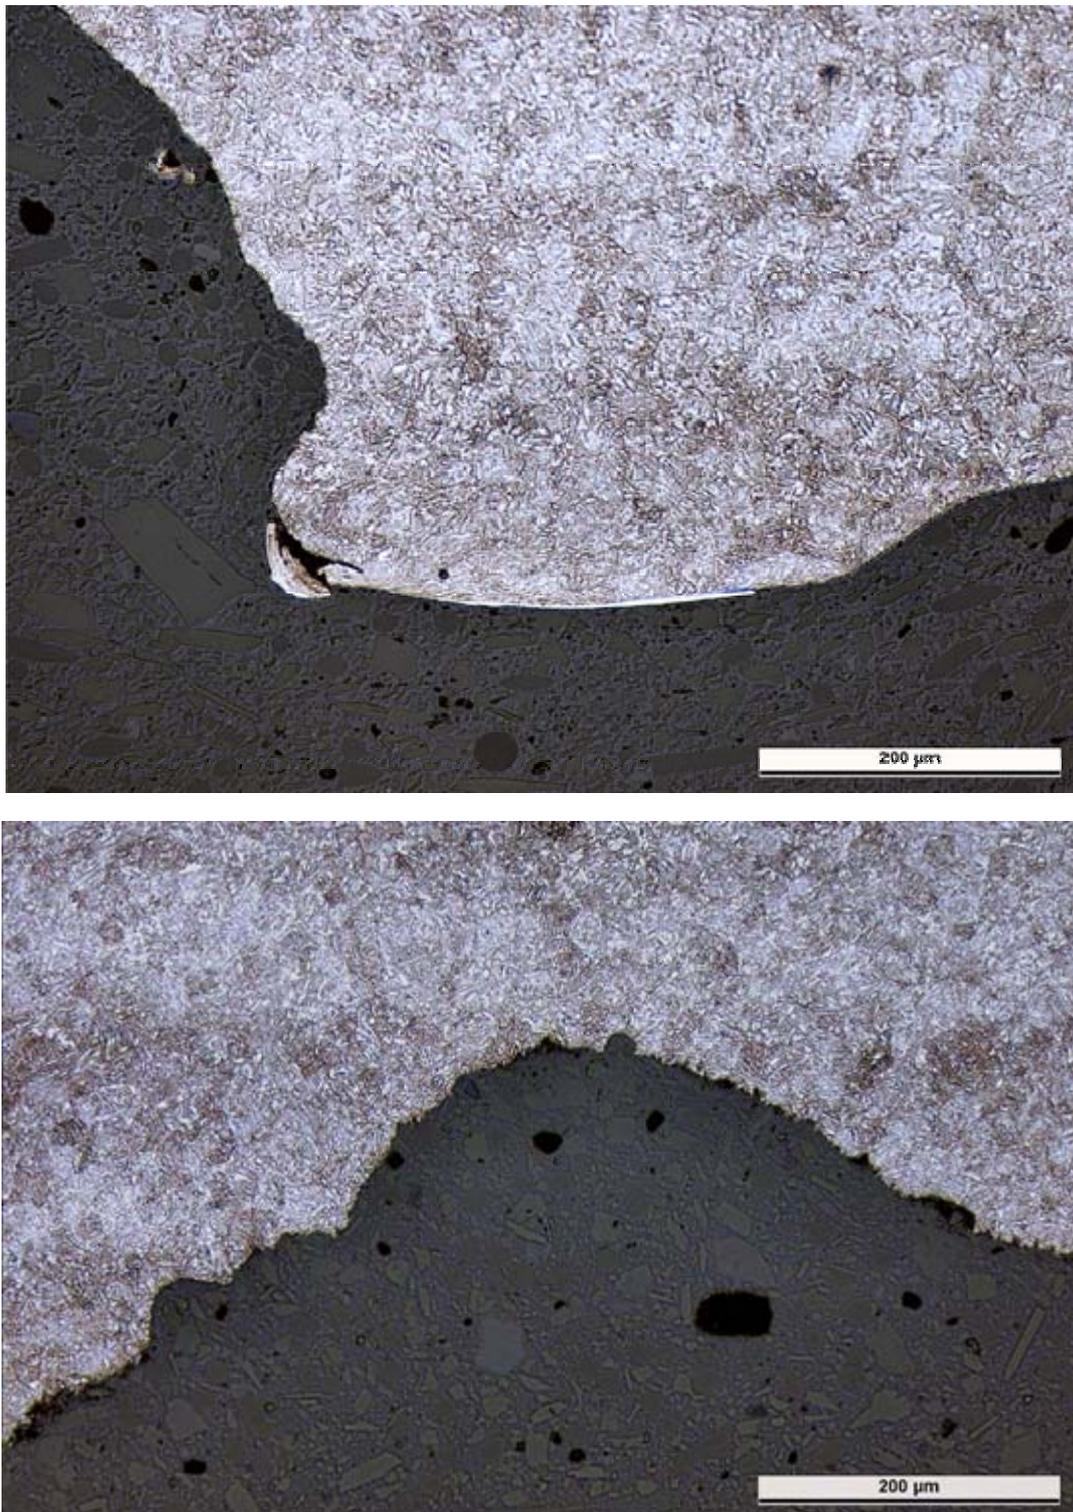
Figure 16: Metallographic images of thread top and bottom. Note the white etching layer from intimate adhesive wear contact with opposing threads during pull out. The contour at the thread bottom shows presence of severe corrosion.

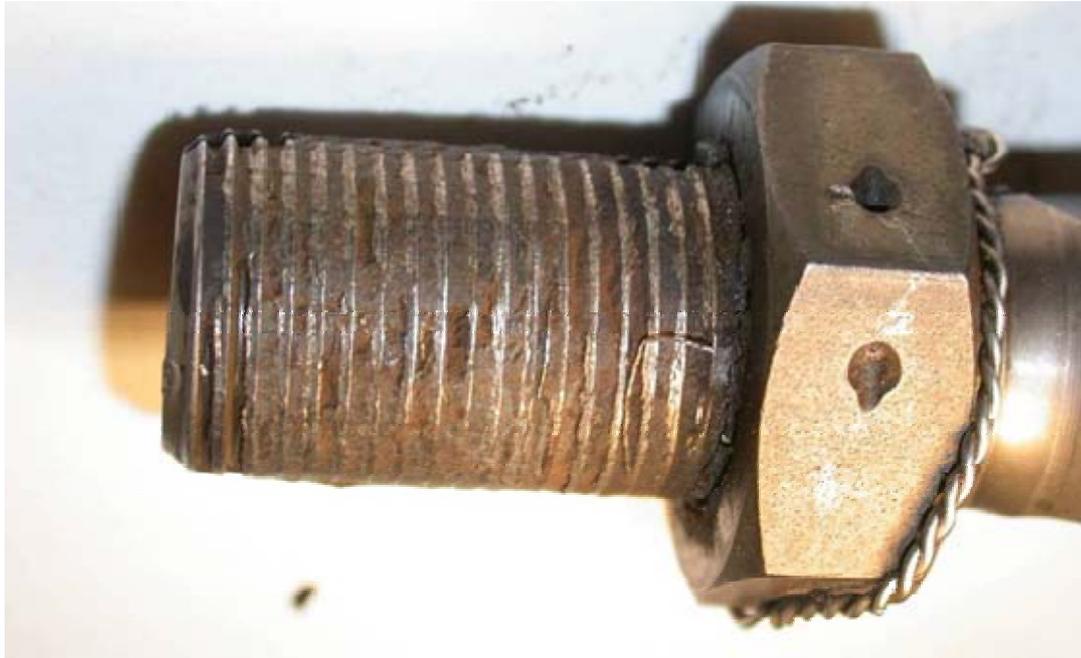
Figure 17: Right hand actuator rod end in as received condition.

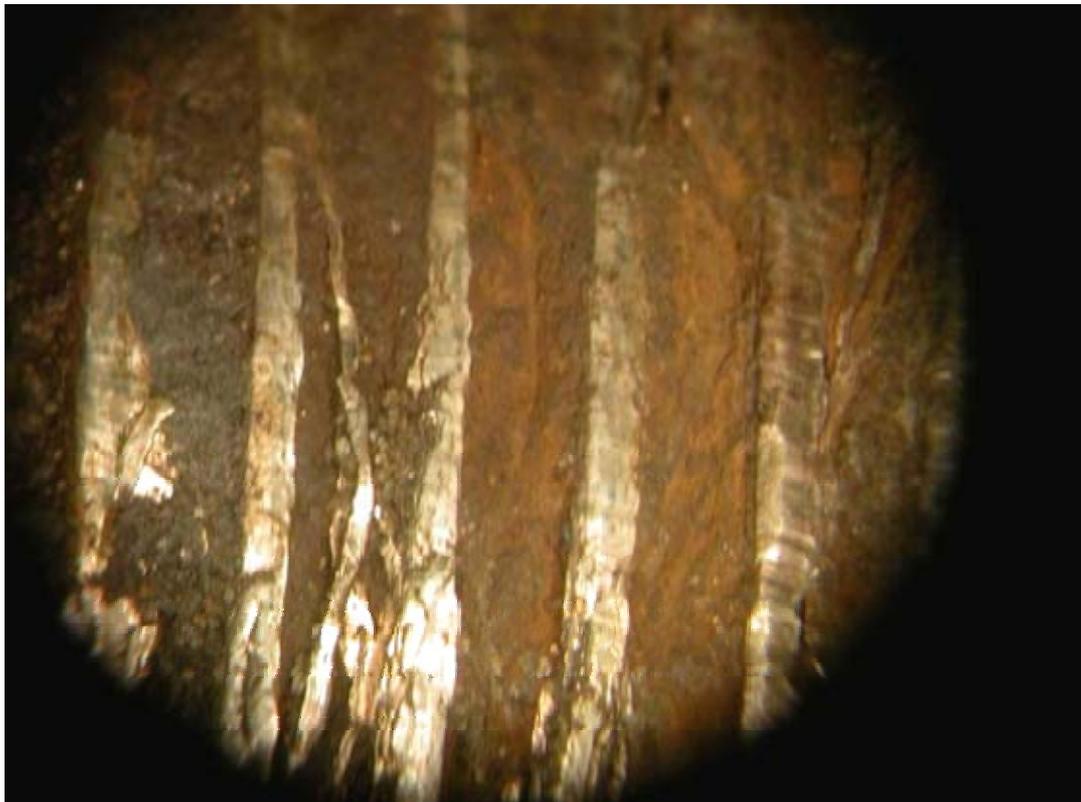
Figure 18: Close-up view of the male threads in Figure 17.

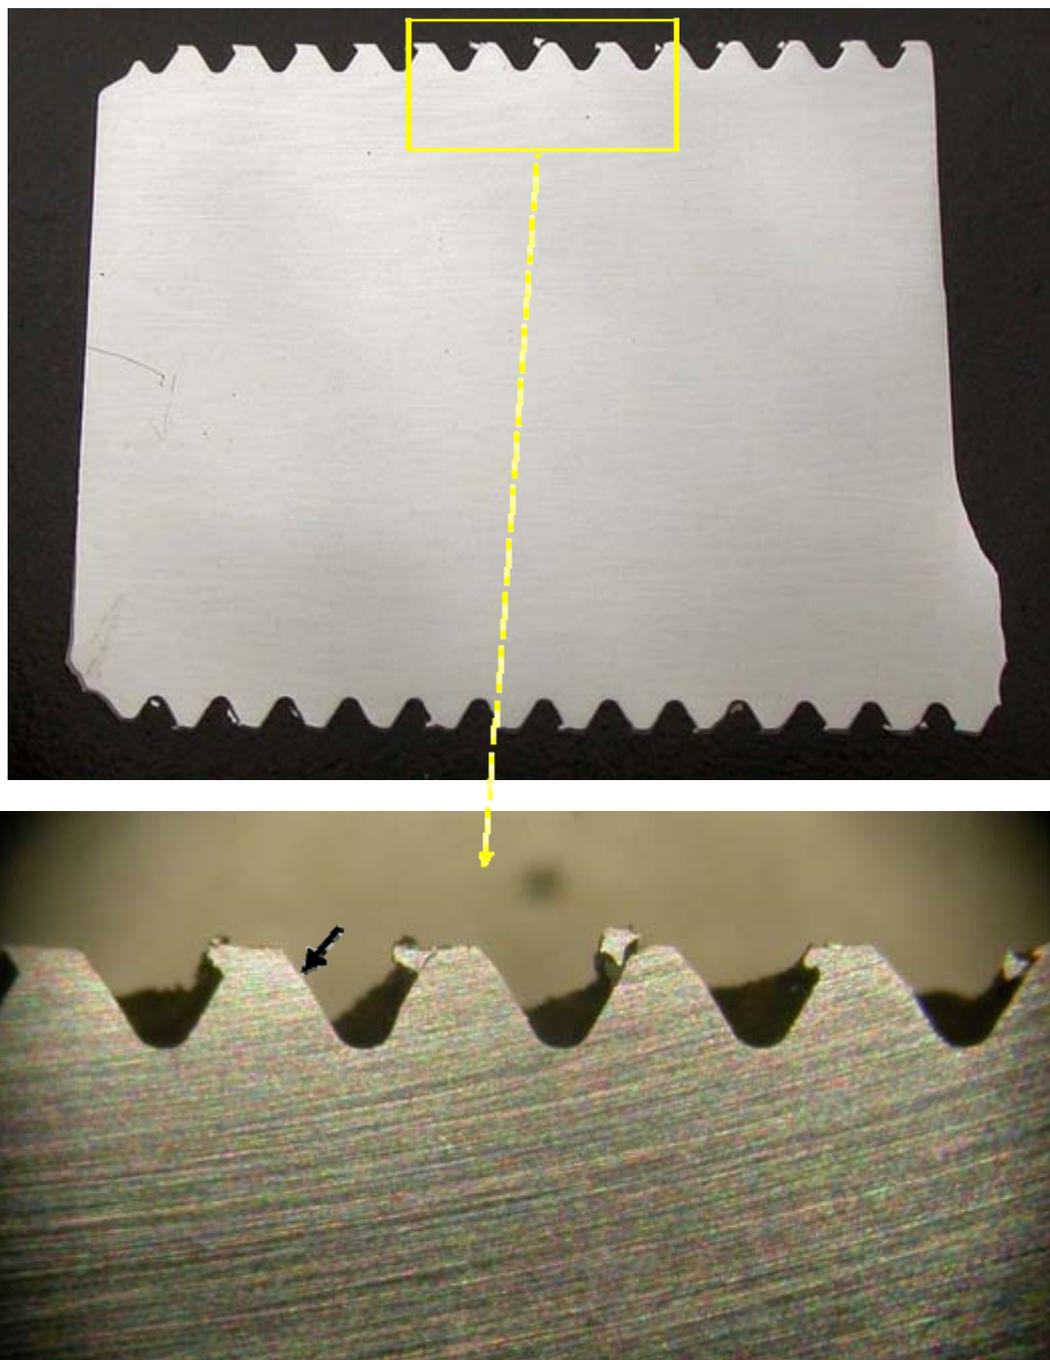
Figure 19: Longitudinal section of male thread showing some deformation/wear near top (example at arrow) and sheared off metal at the thread tip corners.

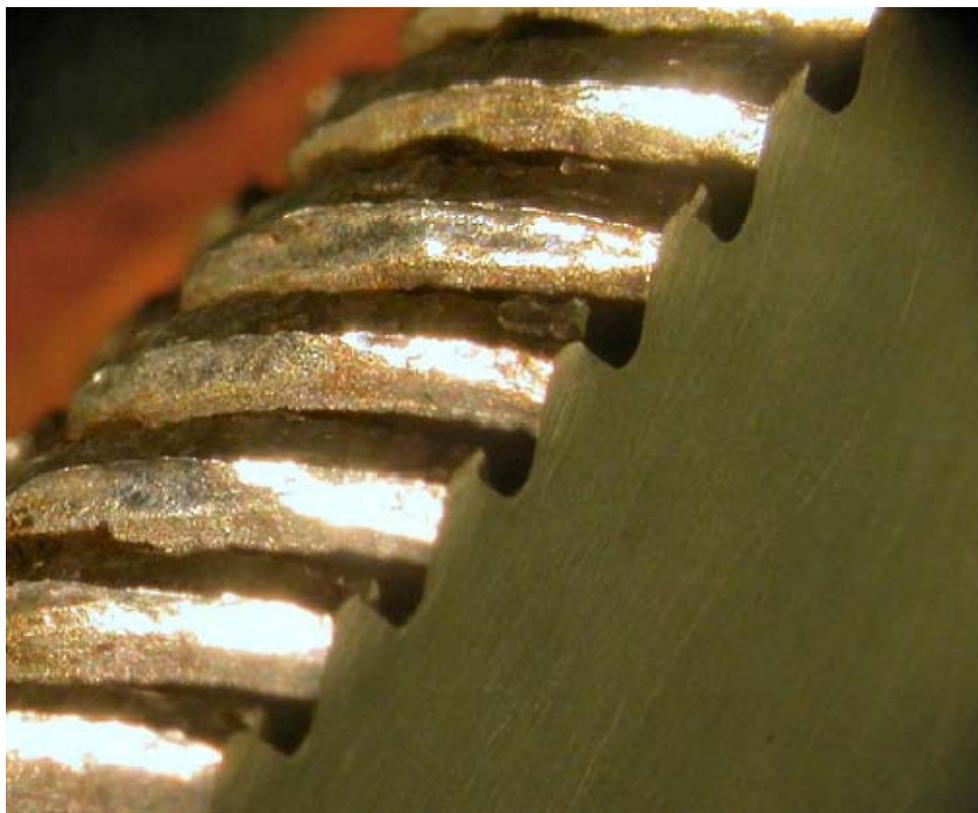
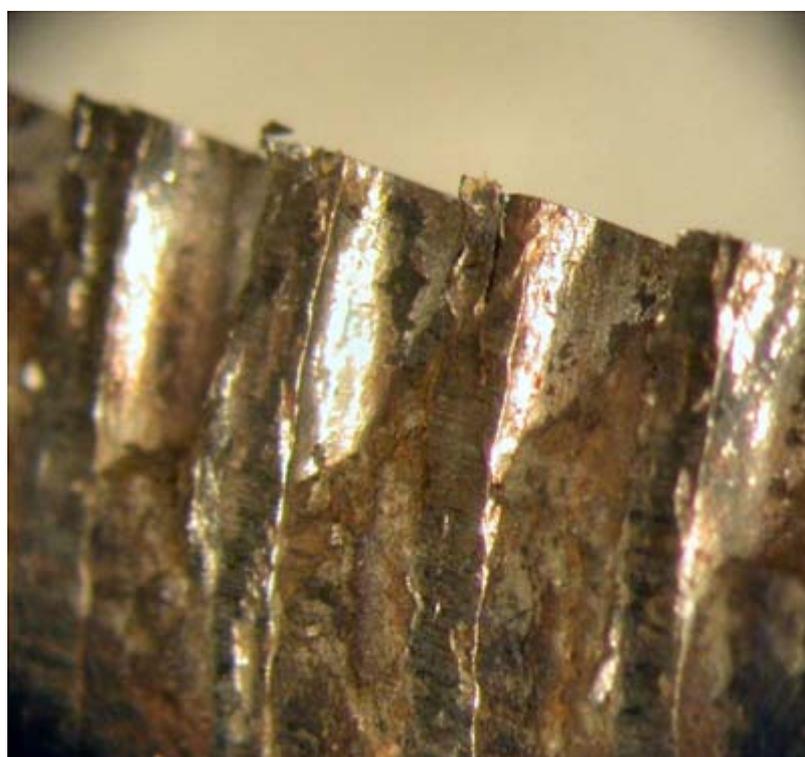
Figure 21: Light optical photos showing polishing wear contacts in upper part of thread flanks.

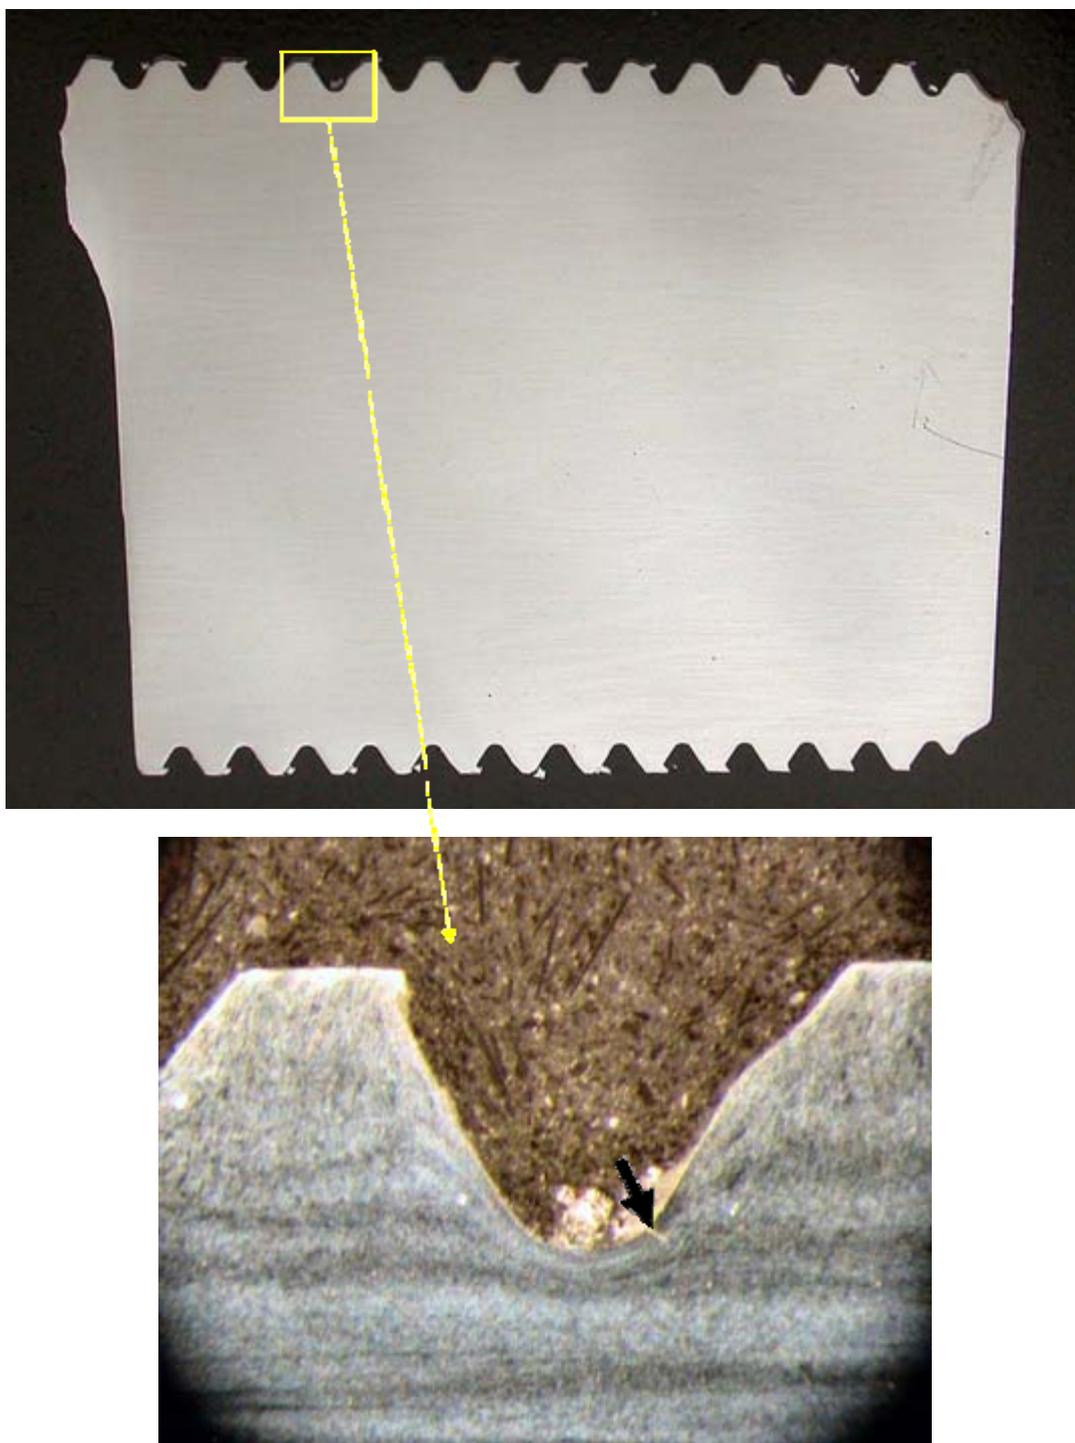
Figure 22: Minute crack in thread bottom.

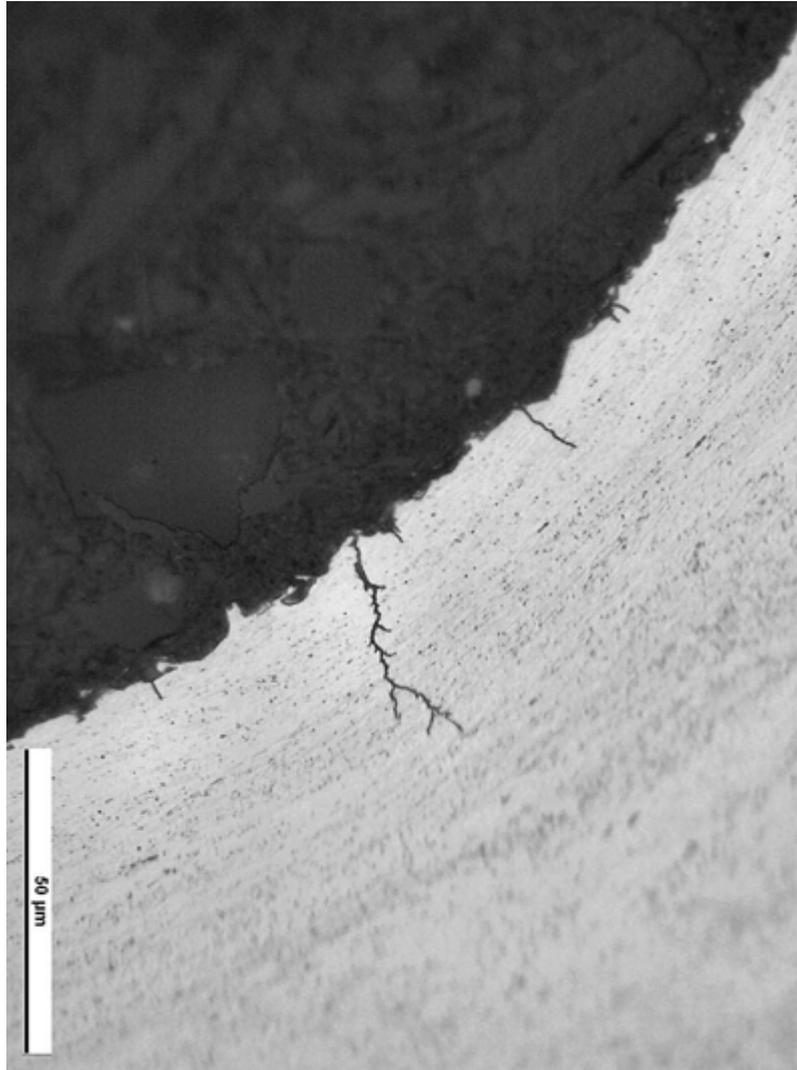
Figure 23: Example of crack in thread bottom.

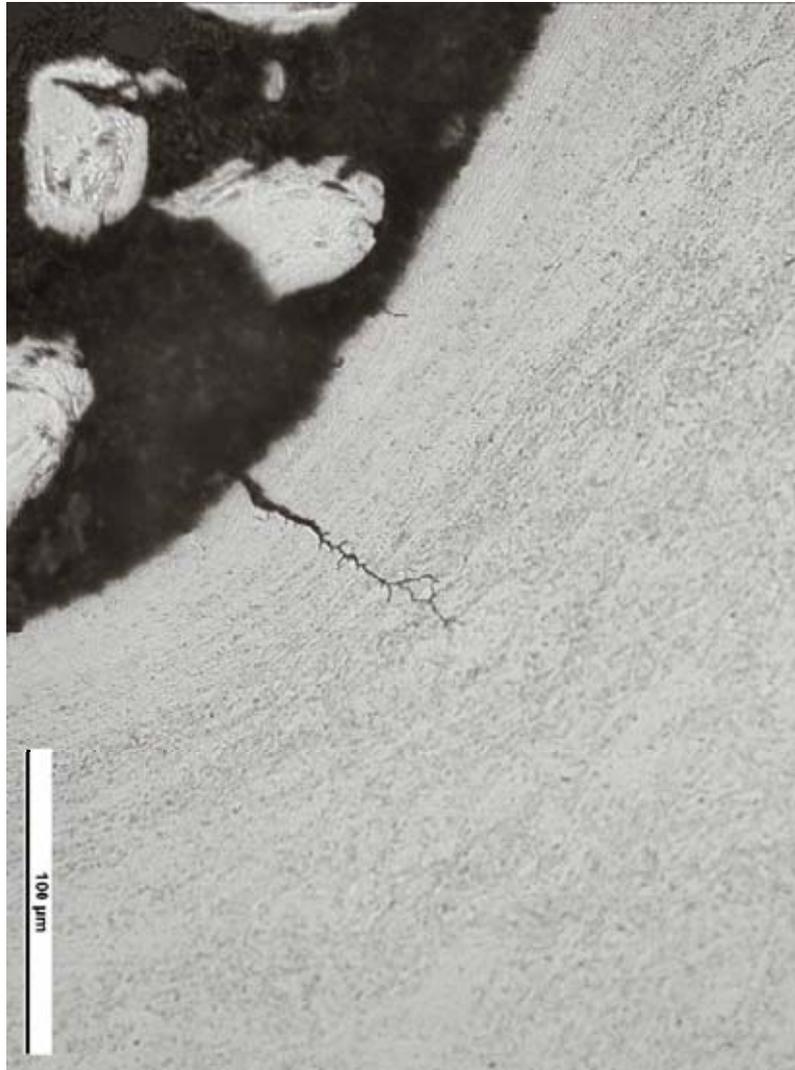
Figure 24: Example of crack in thread bottom.

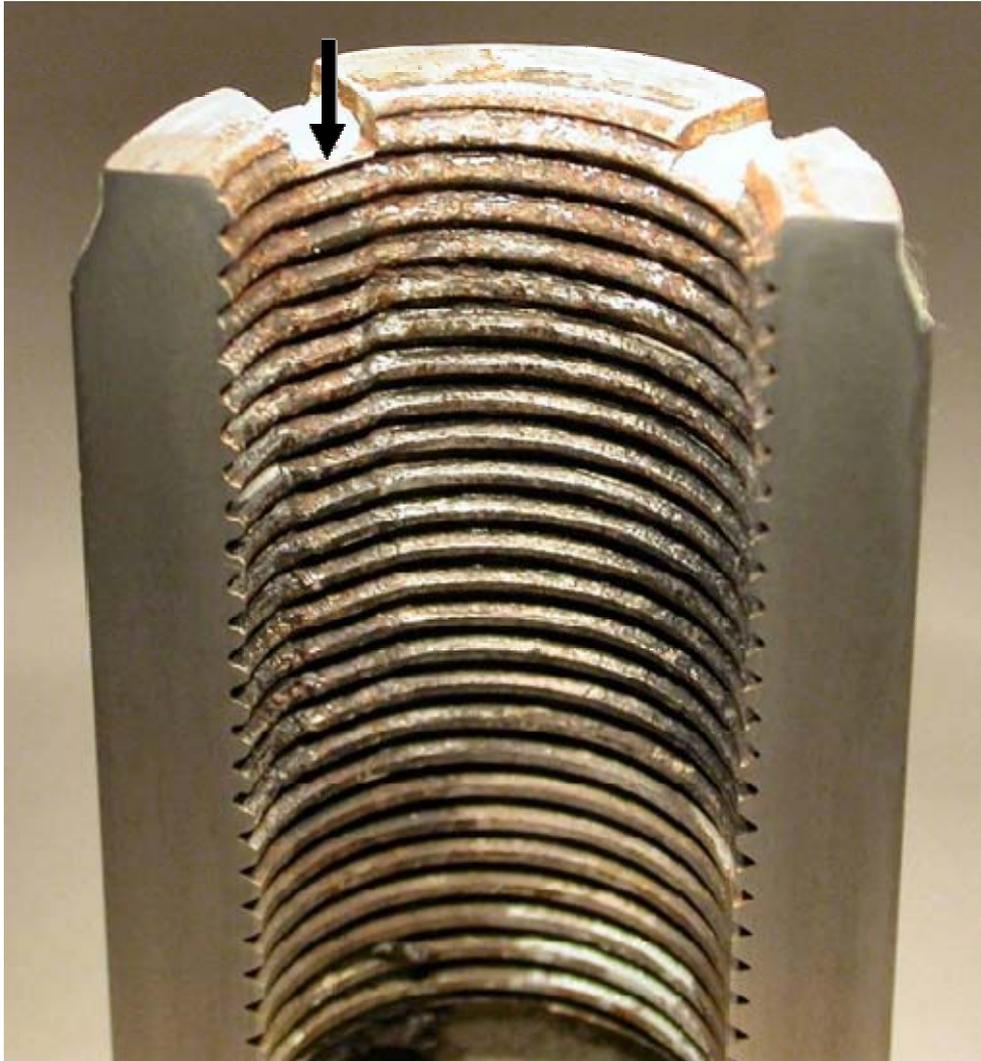
Figure 32: Overview of piston rod section showing less corrosion in the key way area (at arrow).

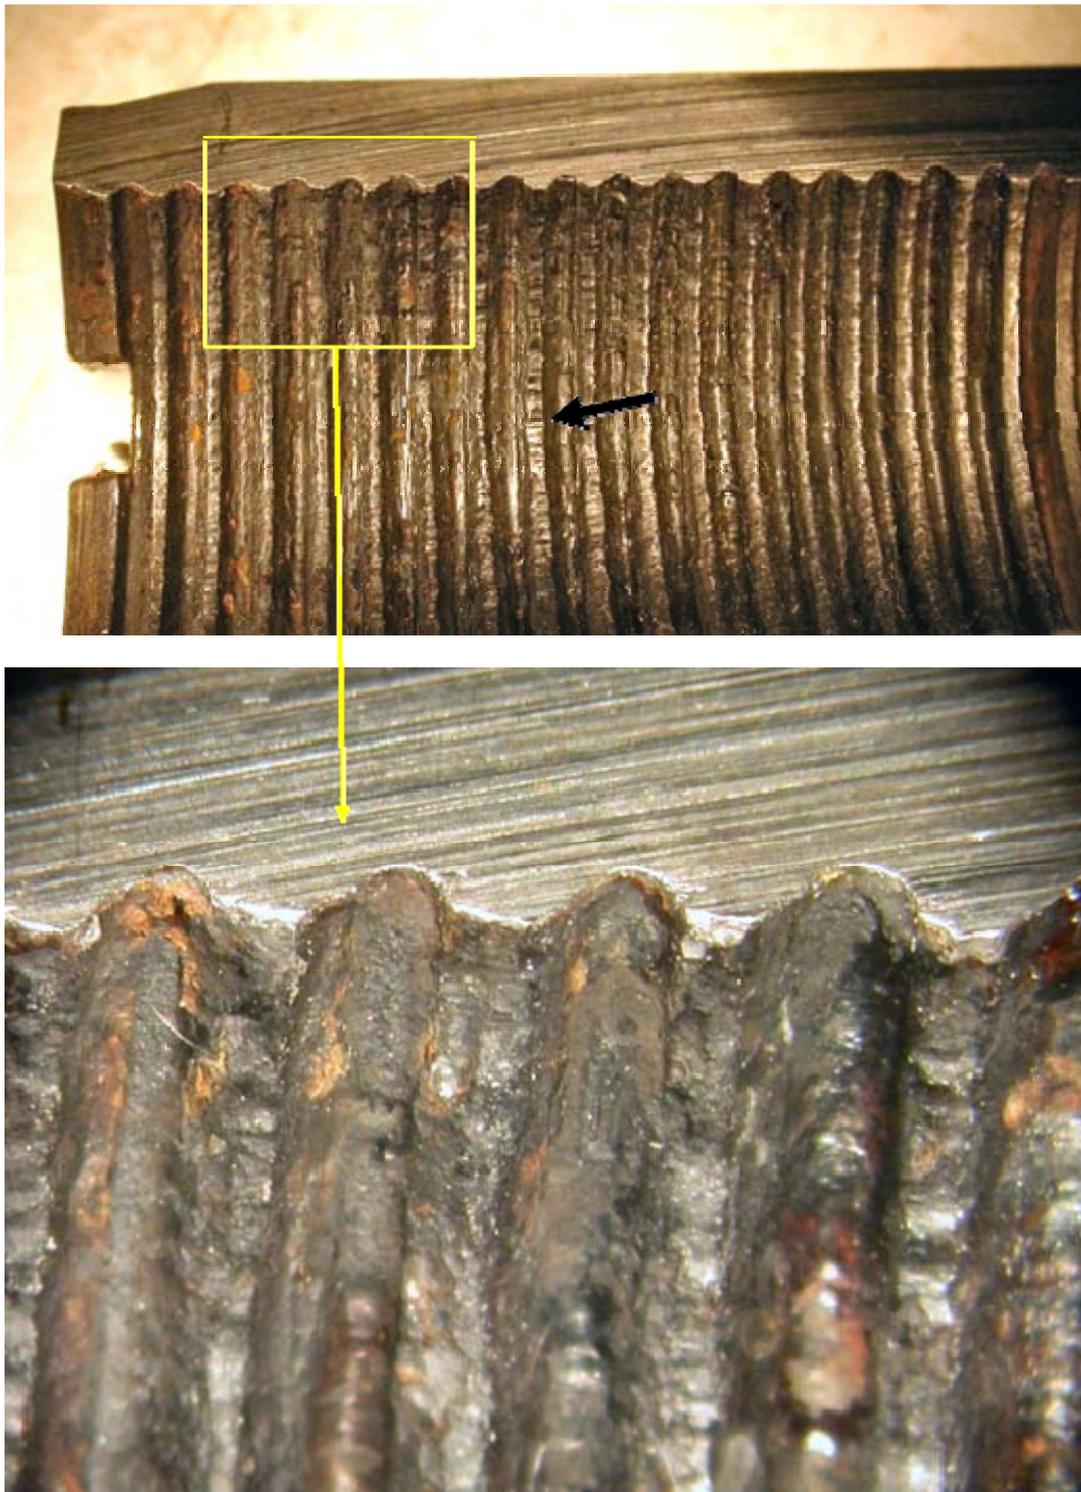
Figure 33: Corrosion attacks in piston rod threads. Note also the wear marks in thread top (example at arrow)

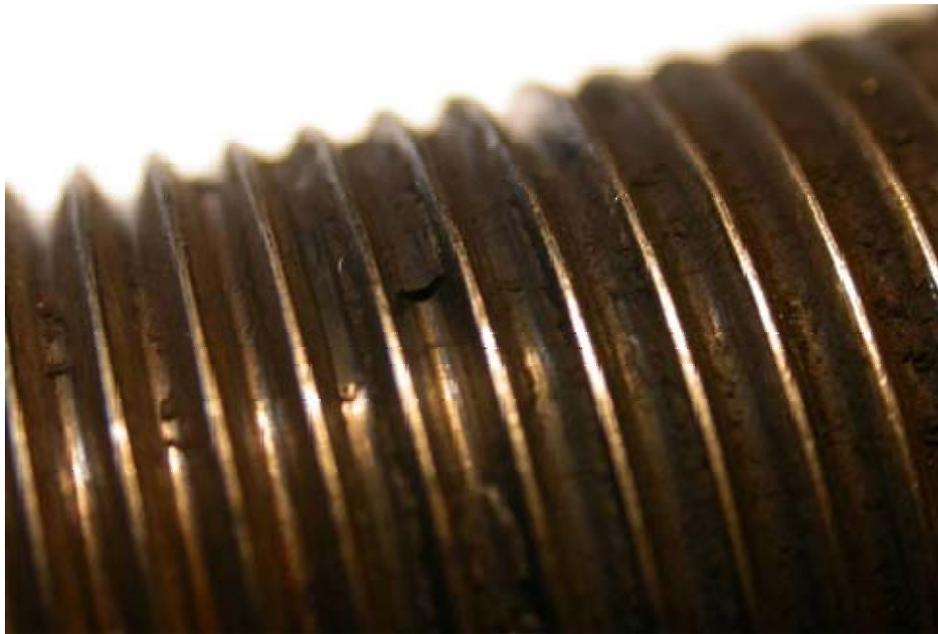
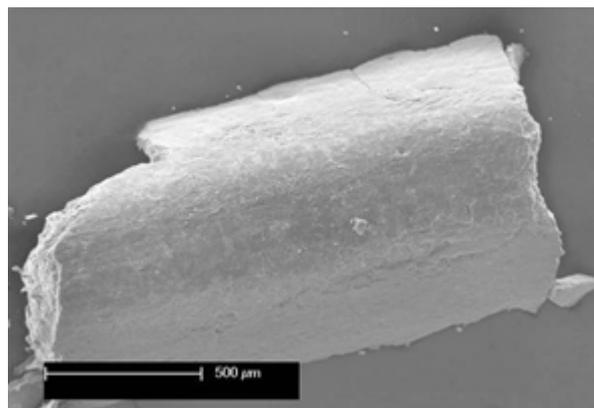
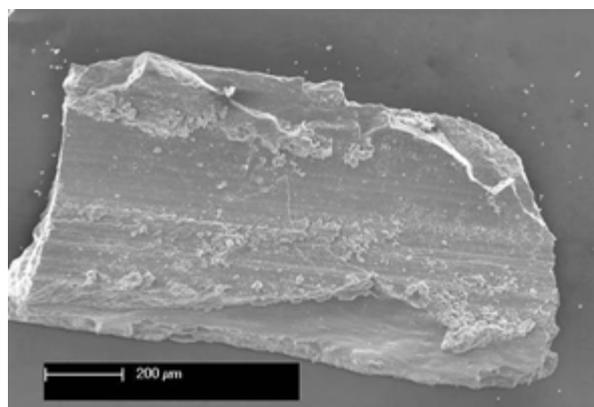
Figure 34: Left actuator piston rod end. The threads are partly filled with hard brittle scales that could be plied out easily. Bottom photos represent front and back sides of such plied-out scales.

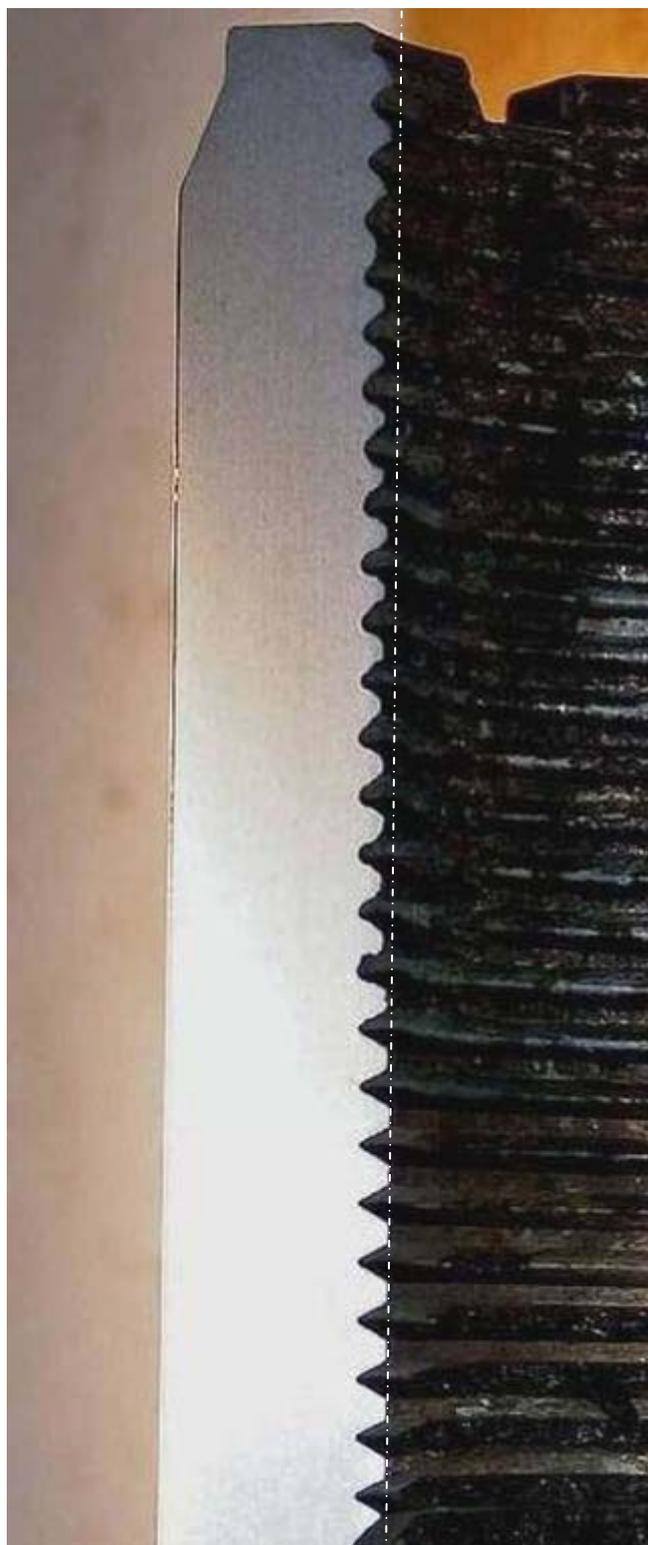
Figure 36: Longitudinal section of left actuator piston rod female thread showing distribution of corrosion along the threaded bore. The super imposed white line indicates the nominal thread top.

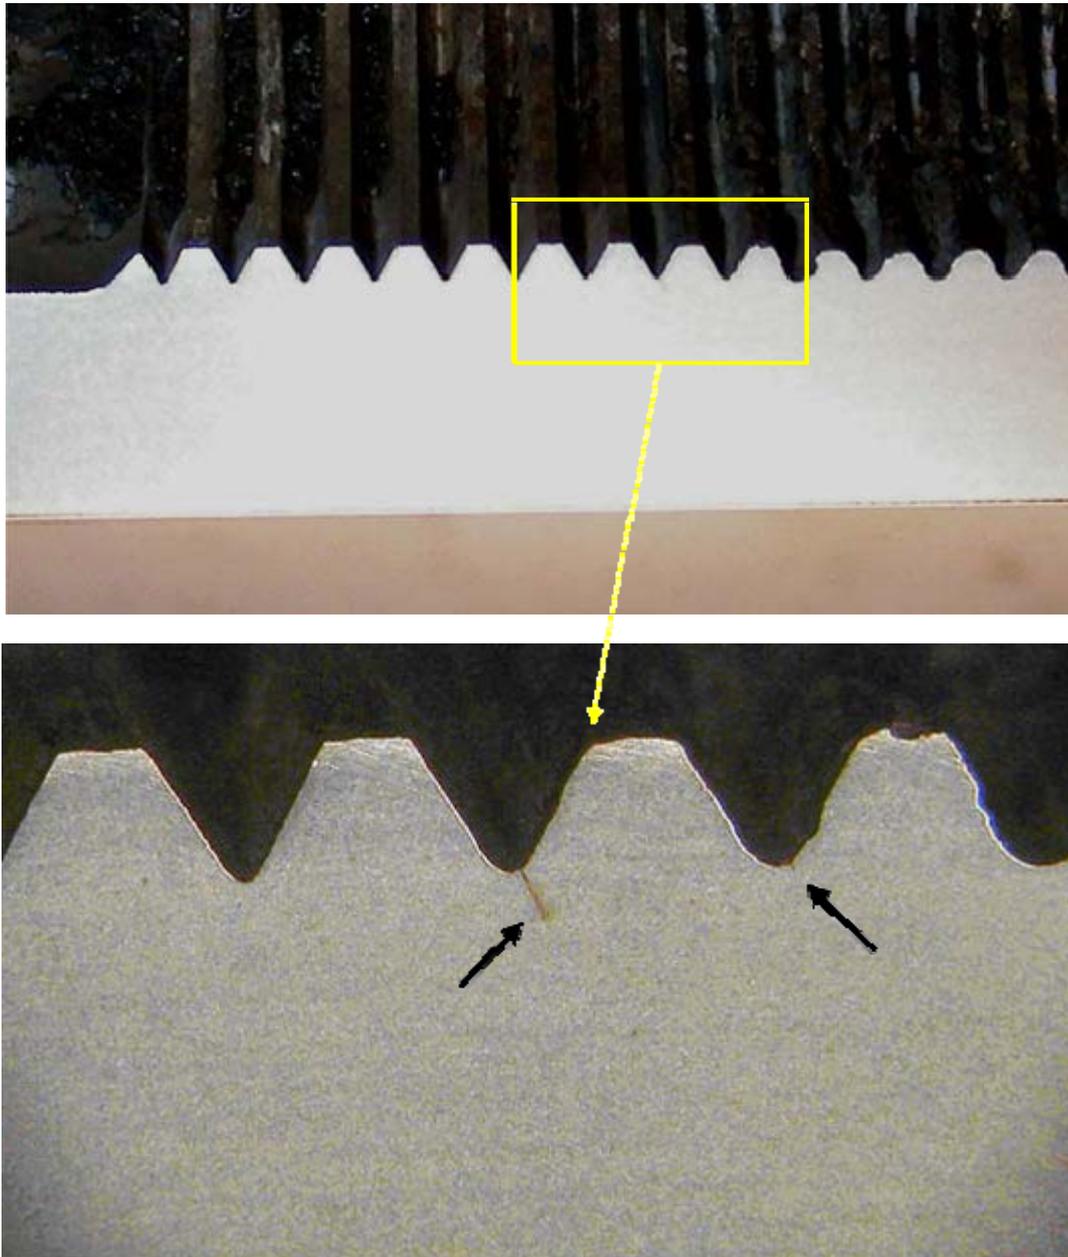
Figure 37: Left Retract Actuator Piston Rod. Small crack in last two engaged threads (at arrows).

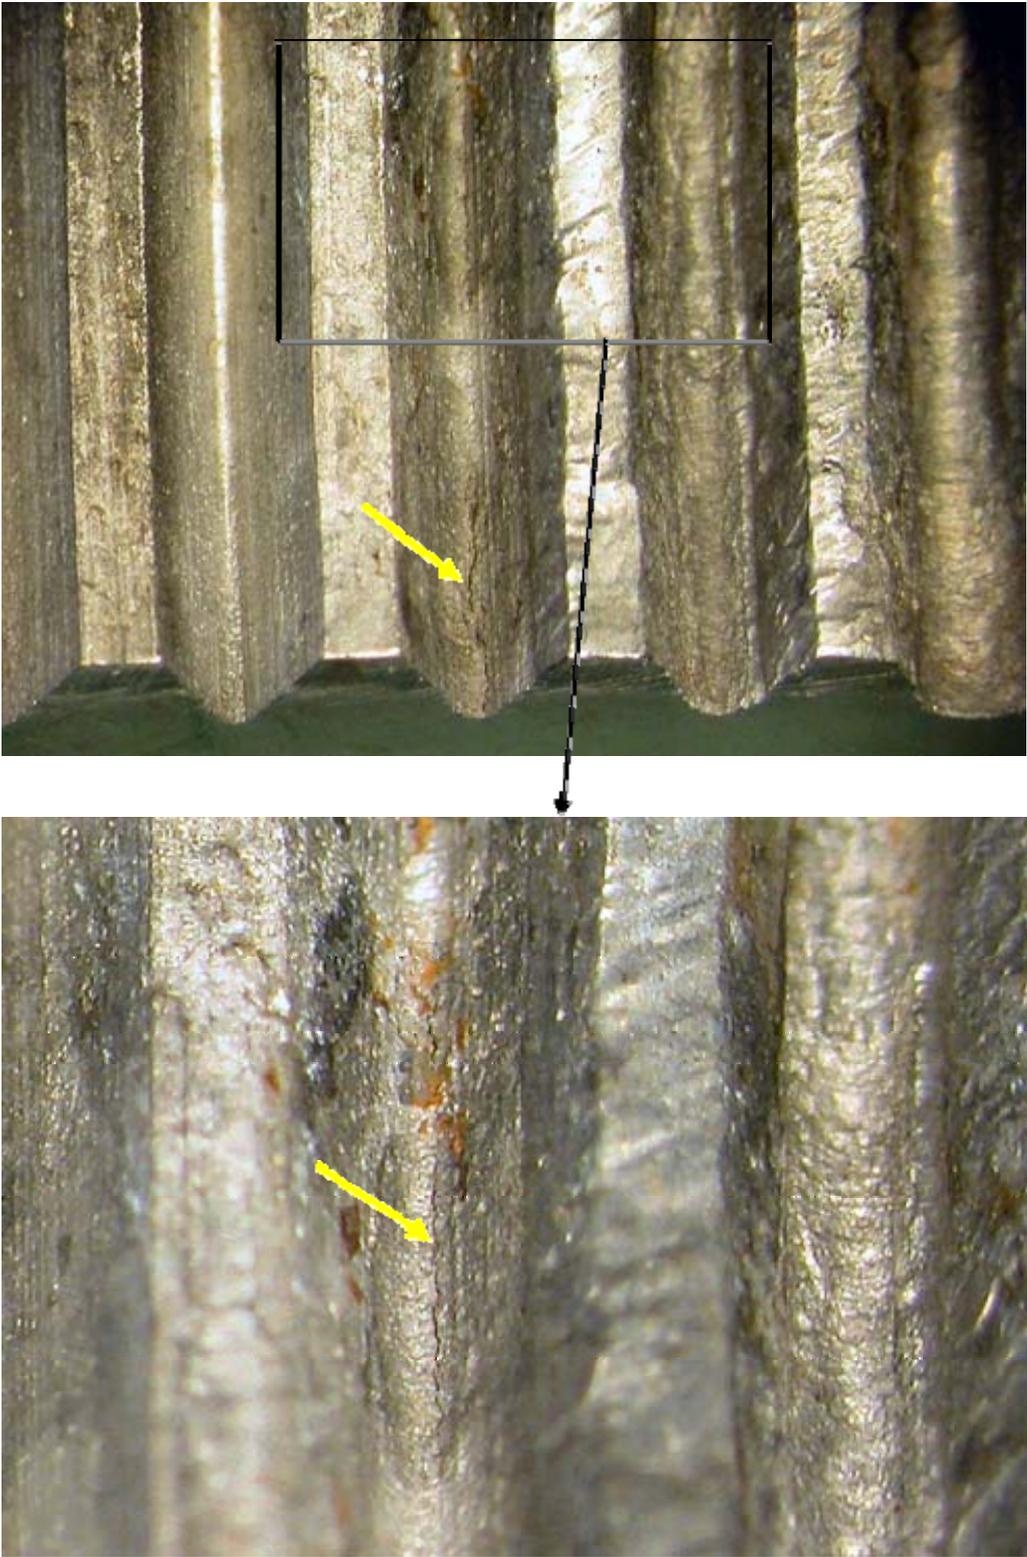
Figure 38: Light optical view of cracks in thread bottom of last engaged thread.

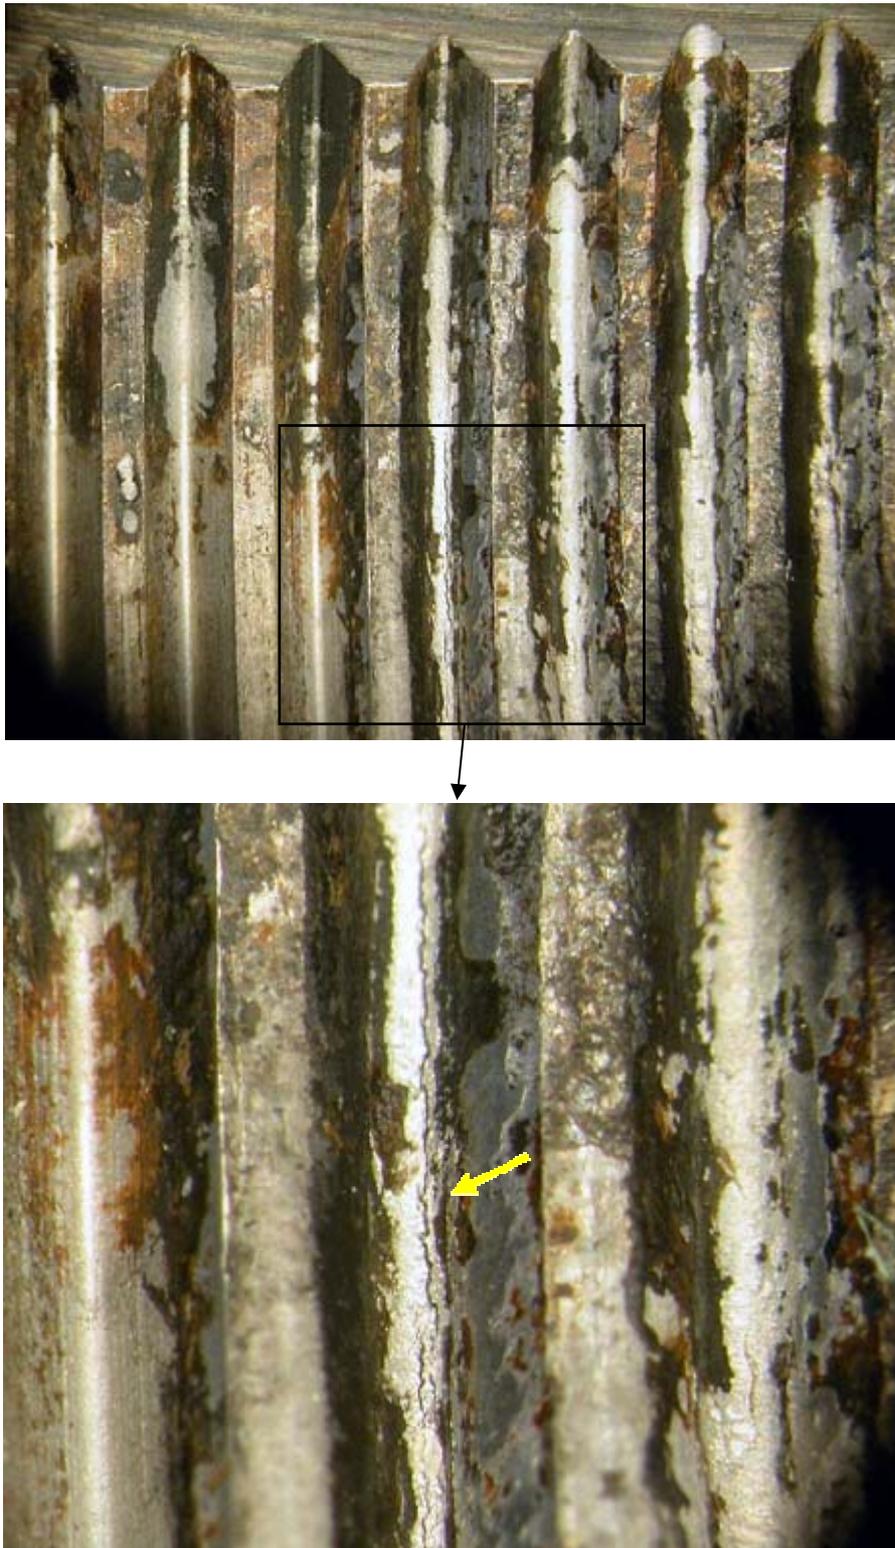
Figure 39: Light optical view of cracks in thread bottom of last engaged thread.

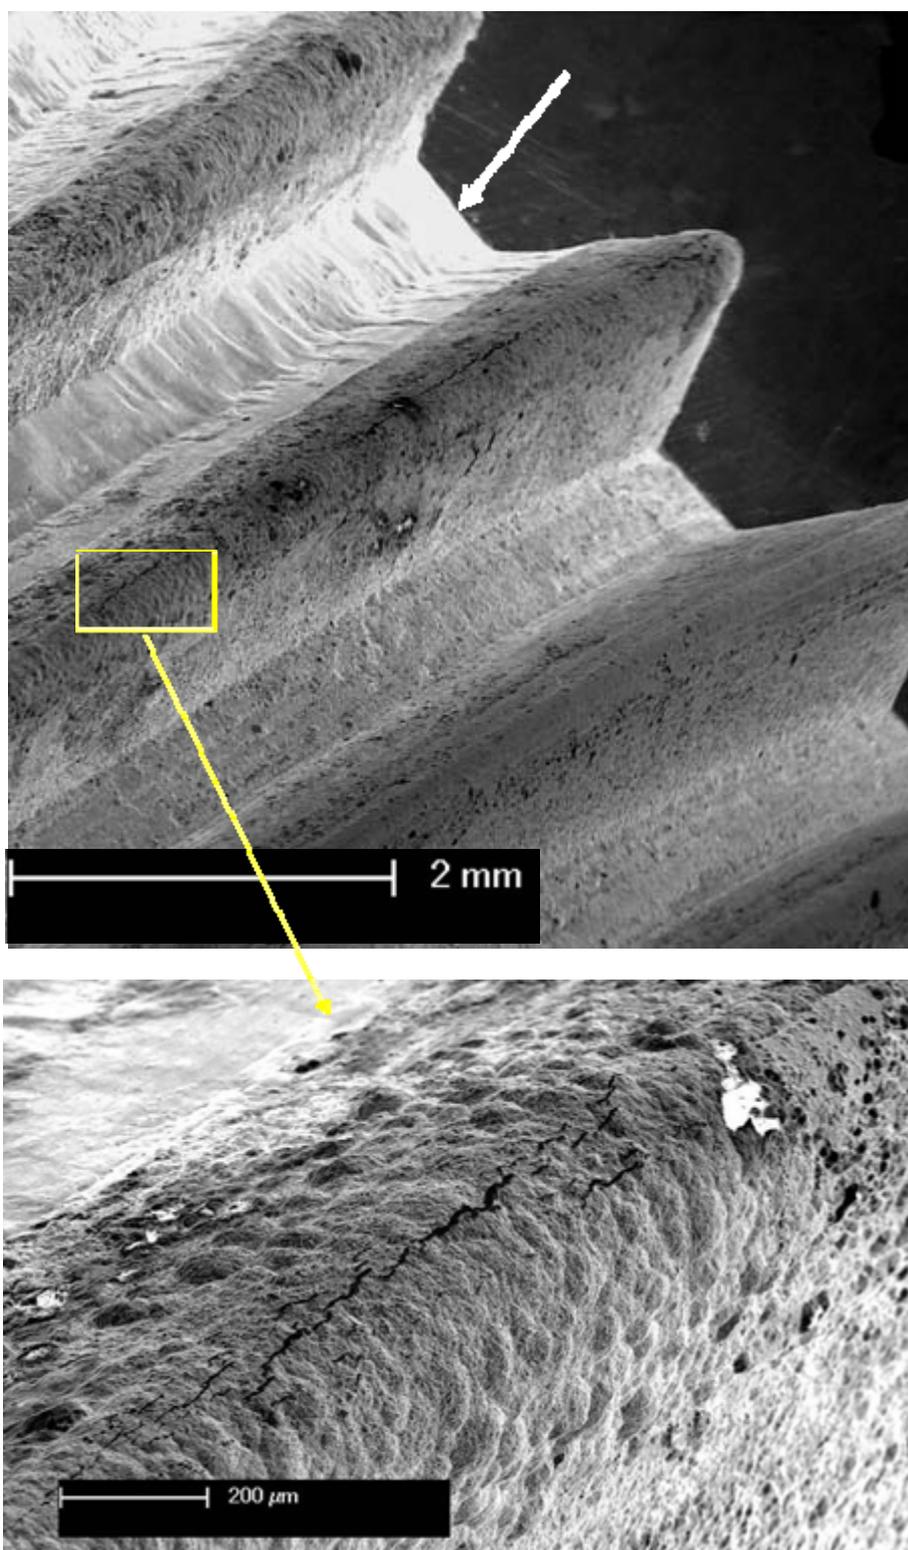
Figure 40: Scanning electron microscope images of cracks in last engaged thread. Note also the evidence of polishing wear in thread top at arrow in the top photo.
