**Accident Investigation Board
Denmark**

Report

HCLJ510-000433

Accident to Bombardier DHC-8-400,
registration LN-RDK,
at Aalborg Airport (Denmark),
on 9 September 2007

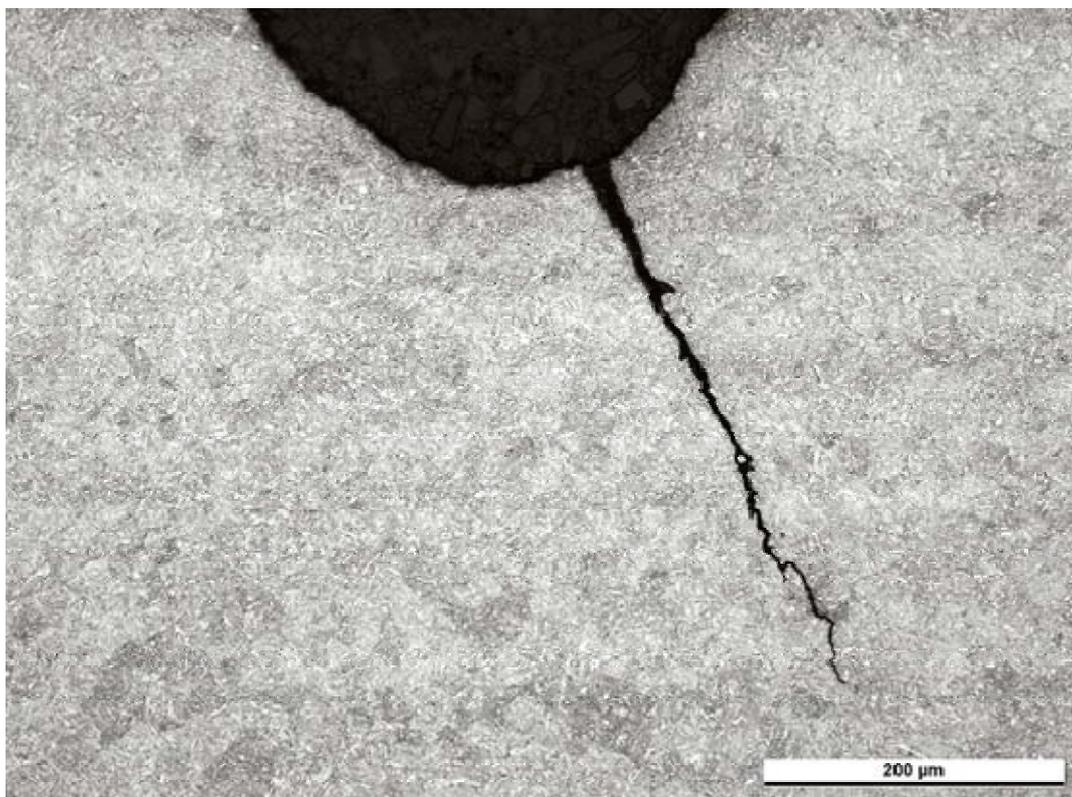
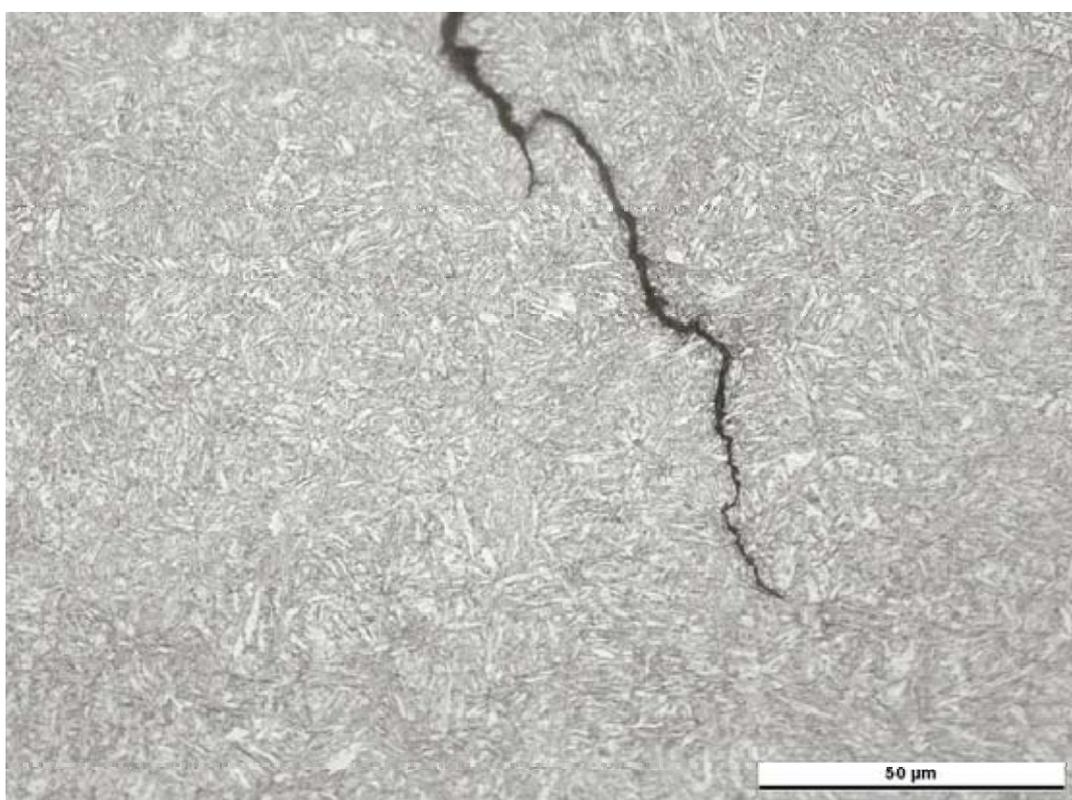
Figure 41: Metallographic section of crack in last engaged thread.

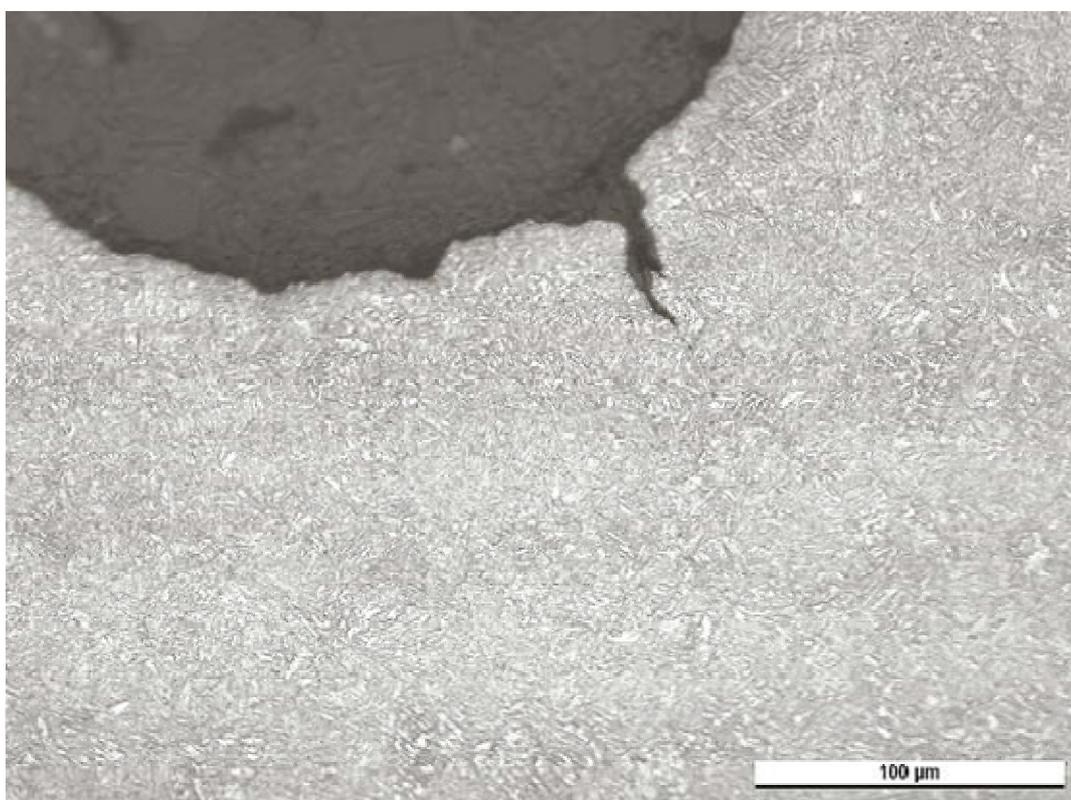
Figure 42: Metallographic section of crack in neighbour thread to last engaged thread.

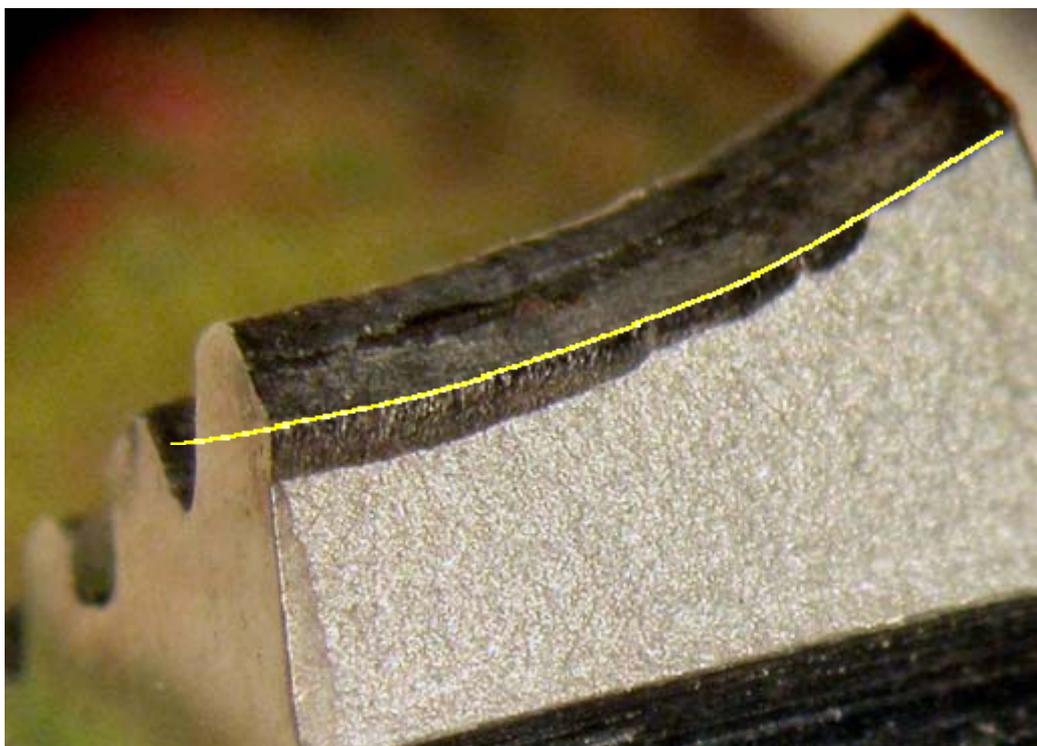
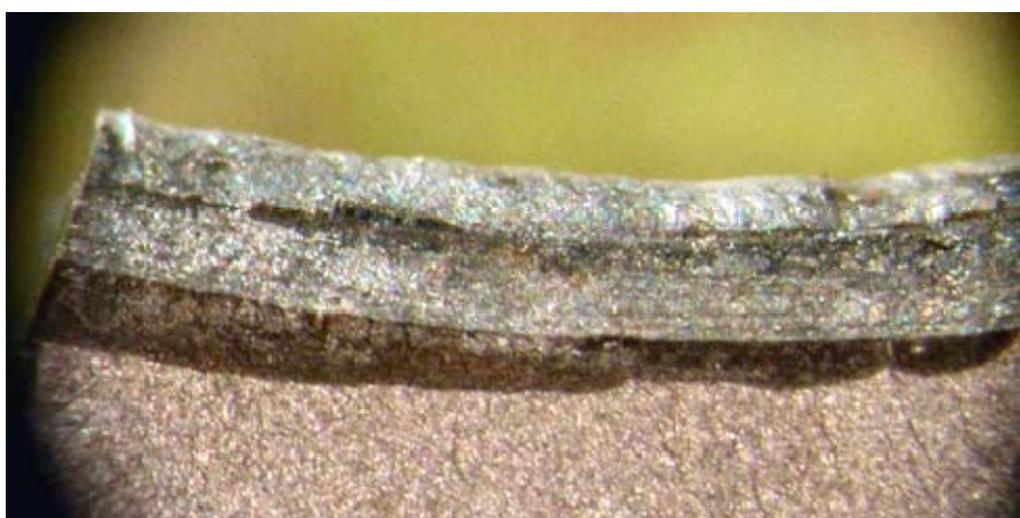
Figure 43: Free-laid crack surface. Yellow line indicates bottom of thread. The black occurring crack surface has the macroscopic appearance of fatigue cracking.

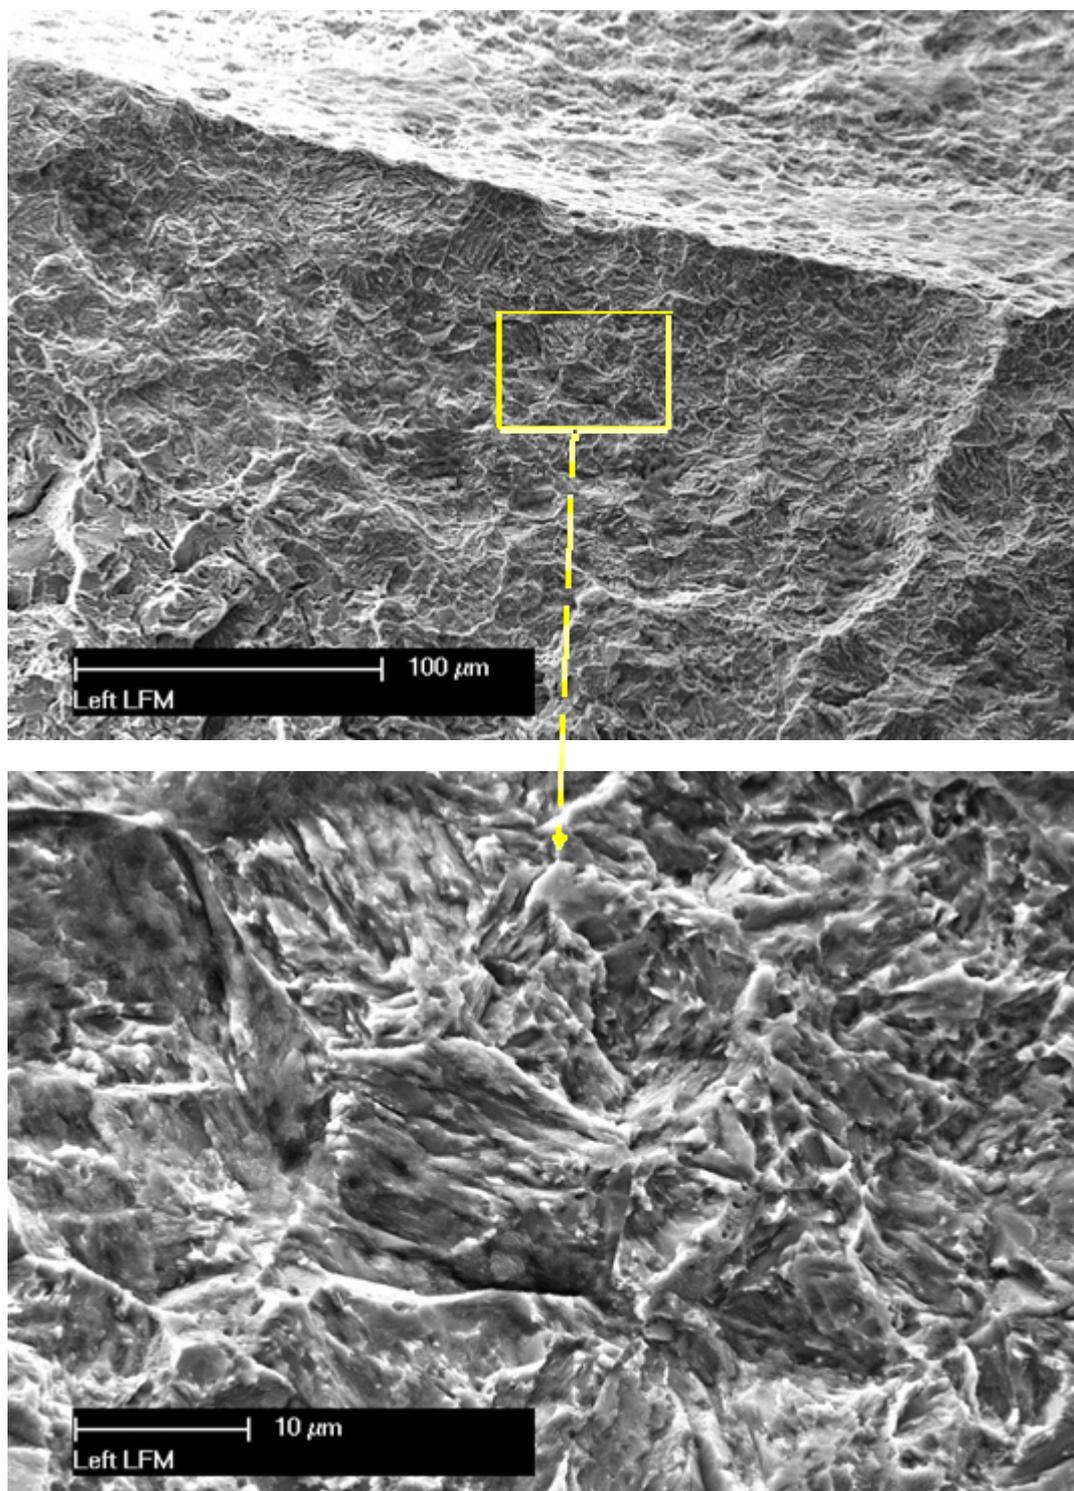
Figure 45: Typical area of crack near the surface. The appearance is typical of (low cycle) fatigue in high strength steel.

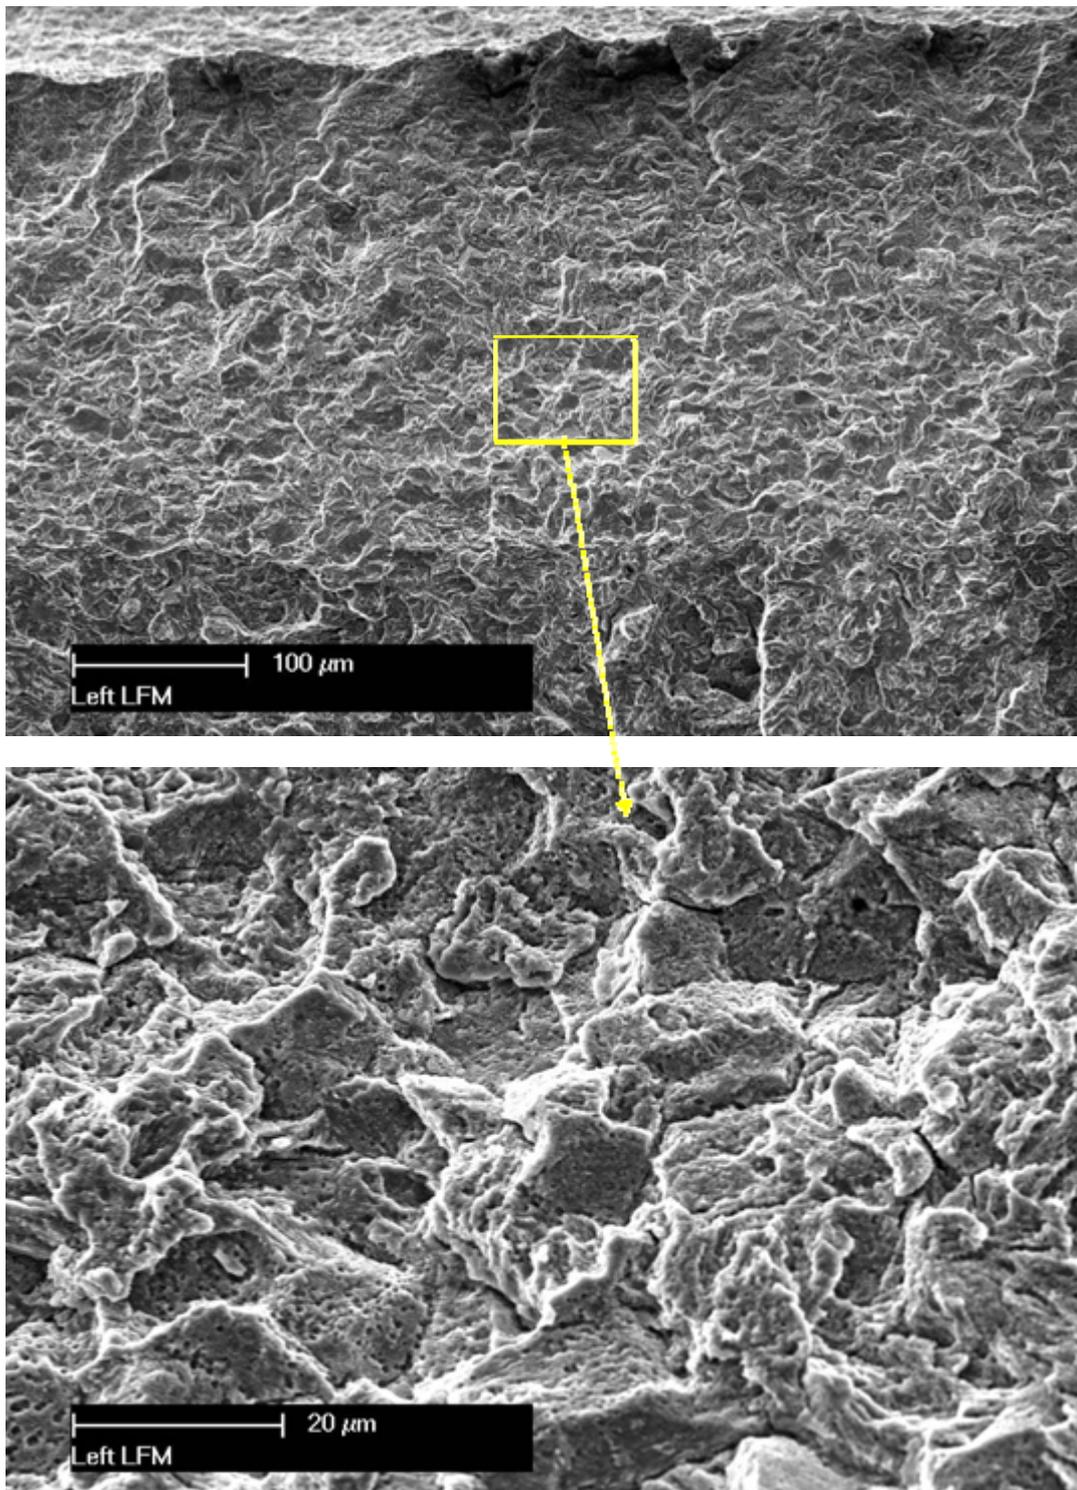
Figure 46: Scanning electron microscope images of crack surface at mid-depth of crack. A tendency towards intergranular cracking appears to be present.
