**Accident Investigation Board
Denmark**

**Final Report
HCLJ510-000449**

Accident to Bombardier DHC-8-402
Registration LN-RDI
At Copenhagen Airport Kastrup (Denmark)
On 27 October 2007

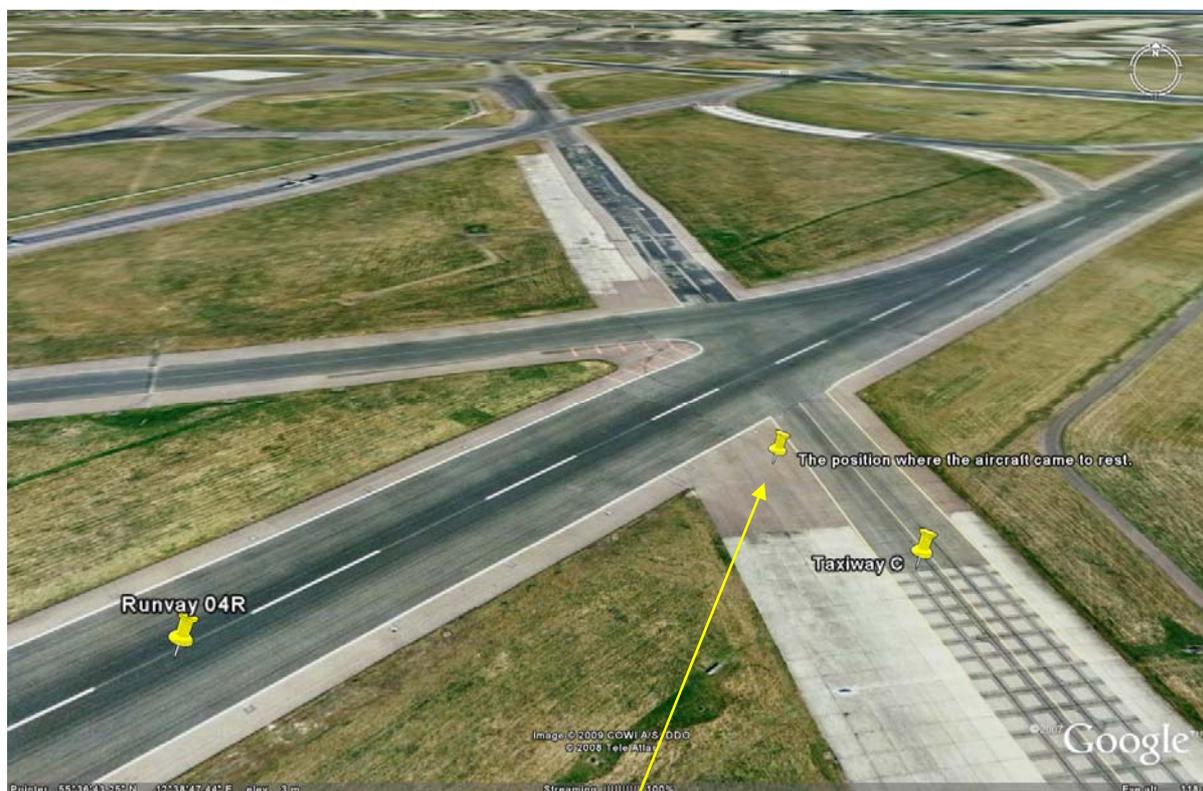
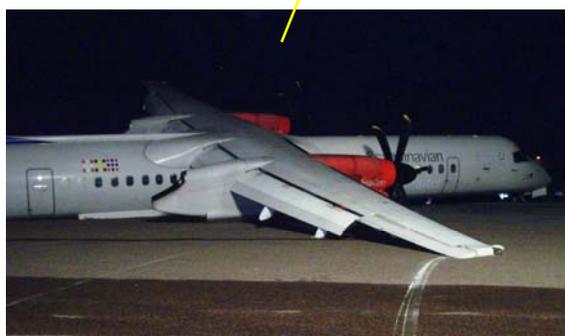
Before landing, the right engine was shut down. Four propeller blades were damaged as a result of ground contact. The aft lower fuselage was damaged while skidding on the runway asphalt. The NLG right tire deflated and the NLG was damaged when the aircraft side slipped into taxiway C. The right outer wing sustained minor damage while skidding on the runway asphalt and concrete. The fuselage surrounding the cabin area was undamaged.

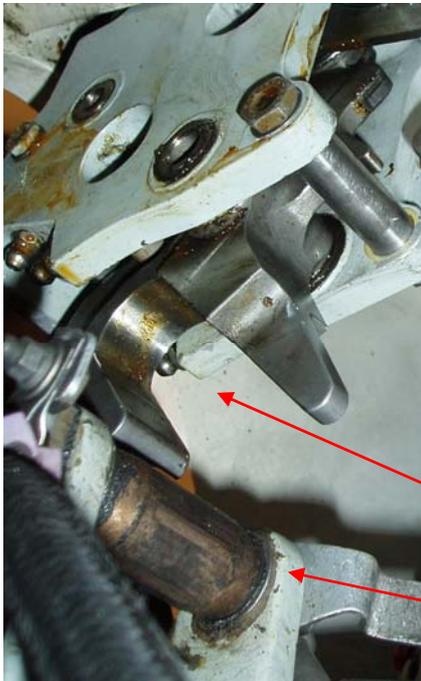
The MLG was found released from the up-lock hook but stuck in a position approximately 10 cm down from the hook.

MLG position in the right MLG wheel well

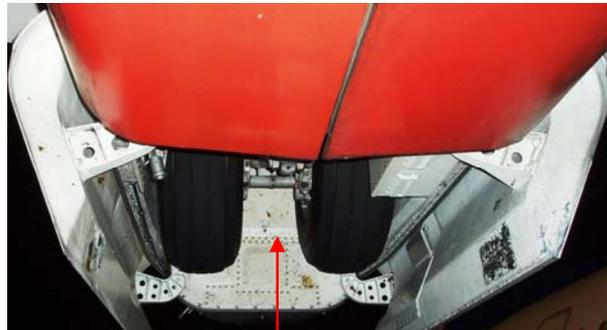
MLG up-lock hook found released

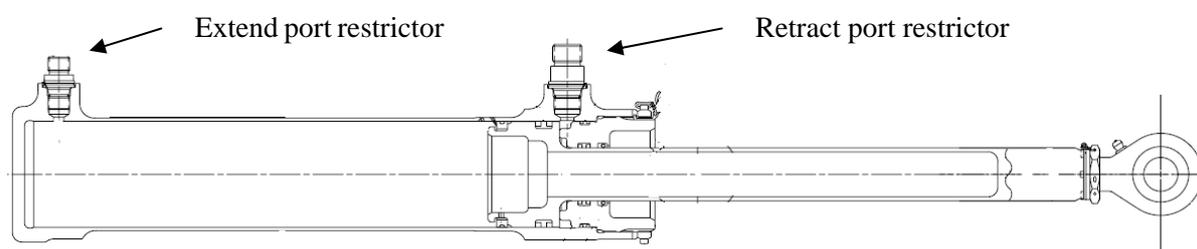
MLG Retraction/Extension Actuator

The extend port restrictor was removed and appeared to be clean as light could be seen through it. The Retract Port Restrictor was removed and appeared to be blocked, as light could not be seen through it.

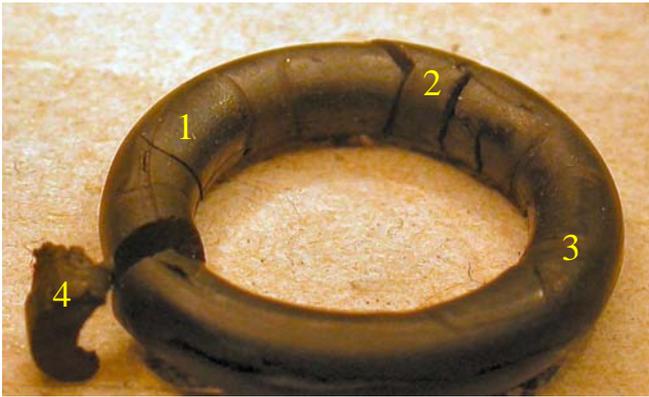
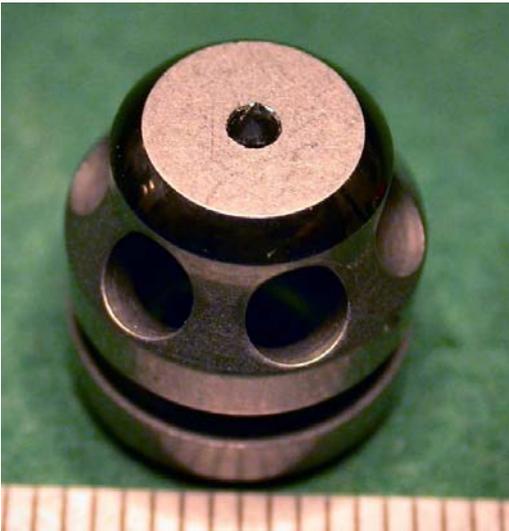
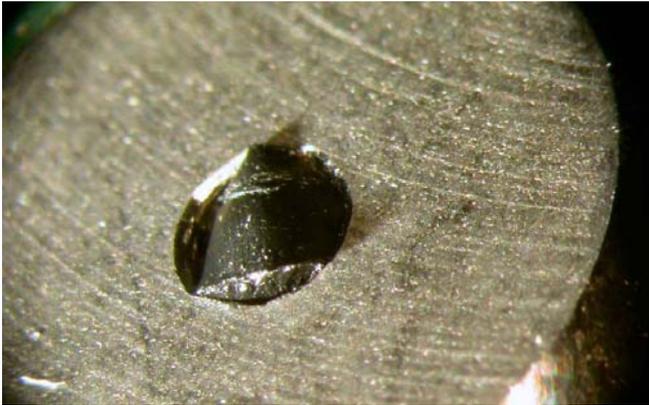
Removing the large orifice situated behind the Floating Valve in the restrictor allowed a view of the valve interior. A broken O-ring was partly emerging through one of the flow relief holes. When the Floating Valve was removed from the restrictor housing, a damaged O-ring was found in four pieces. The small orifice in the Floating Valve was blocked by a piece of O-ring material that matched the missing part of the No. 4 piece of O-ring (pictures below).

Top left: Reassembled O-ring from the four pieces found in the floating valve.

Top right: The small orifice hole in the floating valve is seen blocked by a piece of the O-ring.

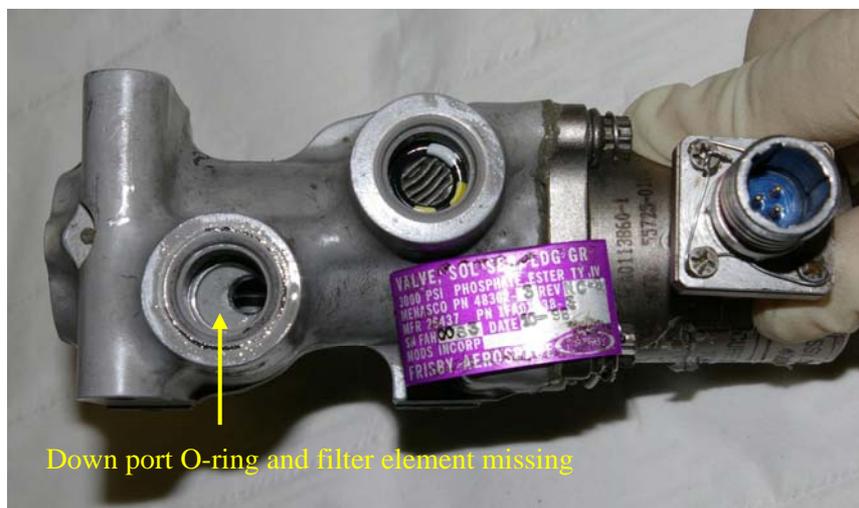
The examination revealed that the filter element and the O-ring were not present in the down port of the SSV (shown below).

The investigation found no information revealing that it was observed and/or reported that the filter element and the O-ring were missing from the down port of the replaced SSV S/N FAH-0083.

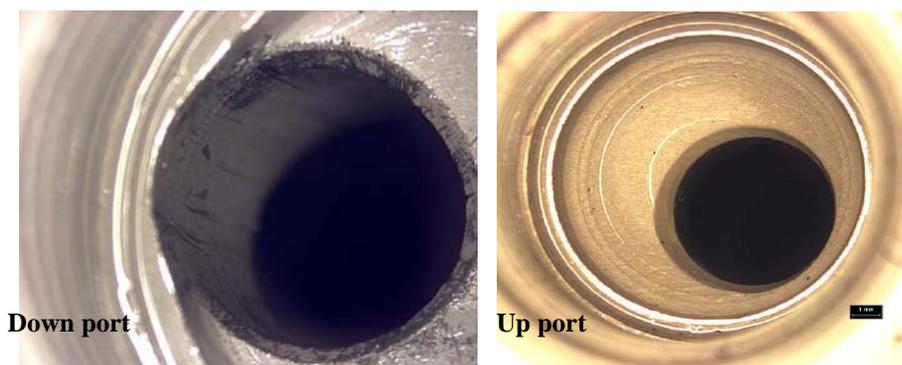
Microscopic inspection of the down port, from which the filter and the O-ring were missing, showed damage in form of linear score marks and nicks both inside the drill bore and around the entrance of the bore. For comparison, the up port O-ring and filter were removed and the up port inspected. This port showed no evidence of damage.

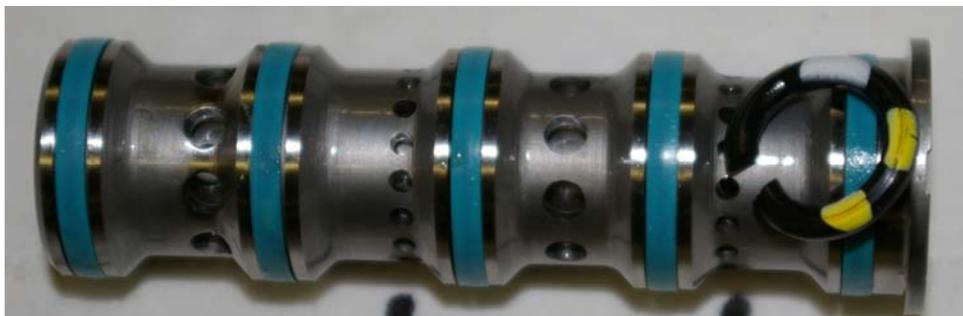
Examination of the SSV showed that passage of a cross section 0.103 +/- 0.003 inch O-ring (NAS1611-110) was not possible due to the sleeve hole diameter (0.069 inch/0.073 inch) inside the SSV.

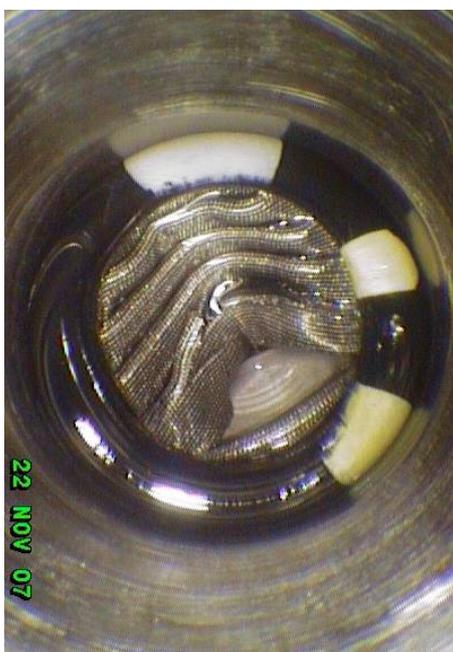
Left:
The filter element is damaged but still in place behind the o-ring.

Right:
Collapsed filter element and damaged o-ring.

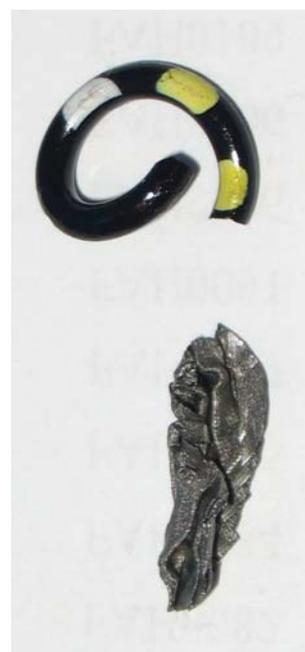
Below:
Collapsed filter element migrated into the SSV port drill bore.

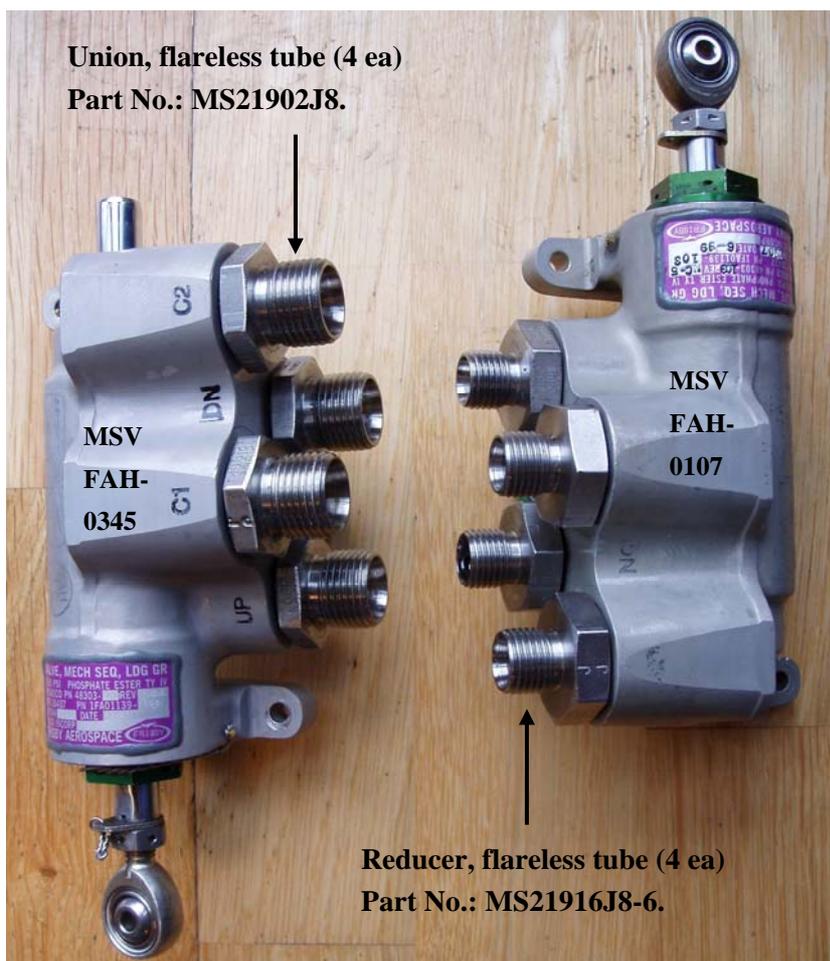
The MSV was found to be configured with unions different from these attached to MSV S/N FAH-0345. There were no other findings or remarks.

Note: The MSV FAH-0107 is shown as it was found by the investigation team in the storage system.

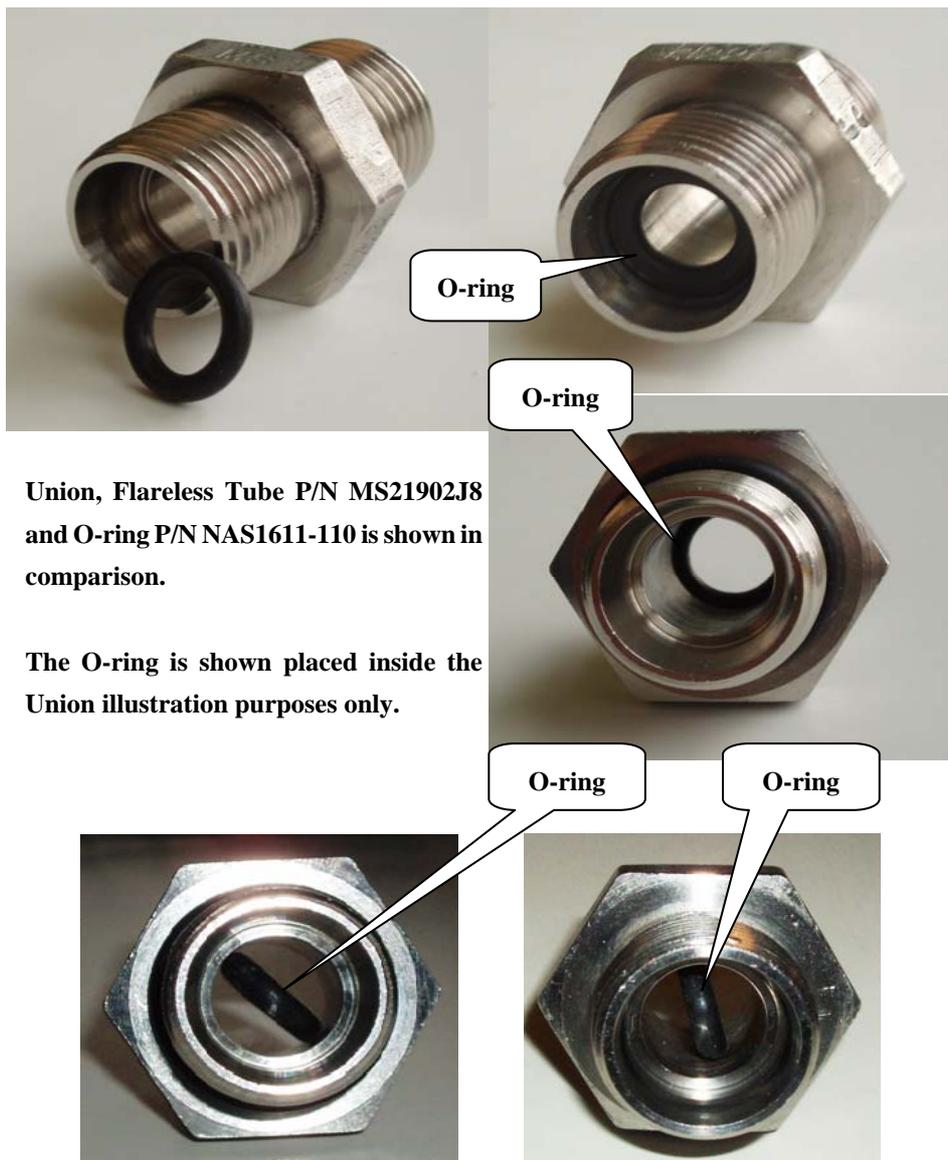
To illustrate that it was possible for an O-ring NAS1611-110 to be transferred via the Unions, the AIB placed an O-ring inside the Union as shown in the pictures below.

Union, Flareless Tube P/N MS21902J8 and O-ring P/N NAS1611-110 is shown in comparison.

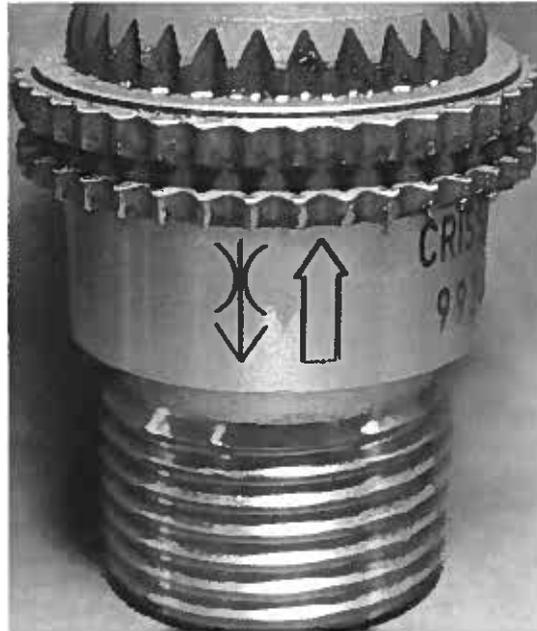
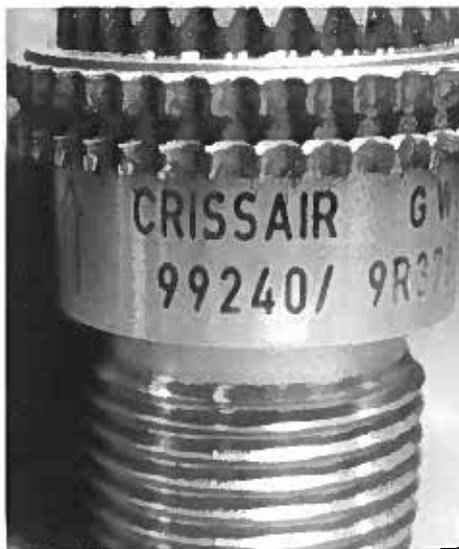
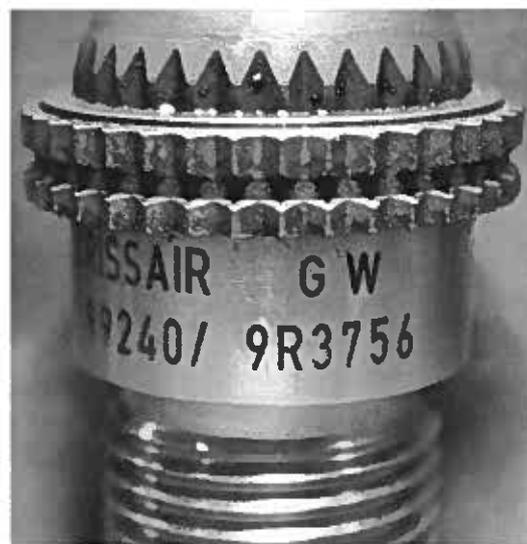
Figure 1: External views of the blocked flow restrictor (labelled SN 074).

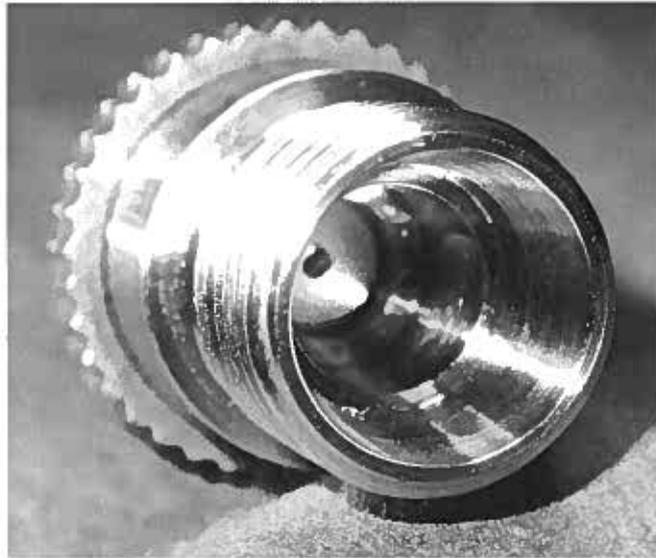
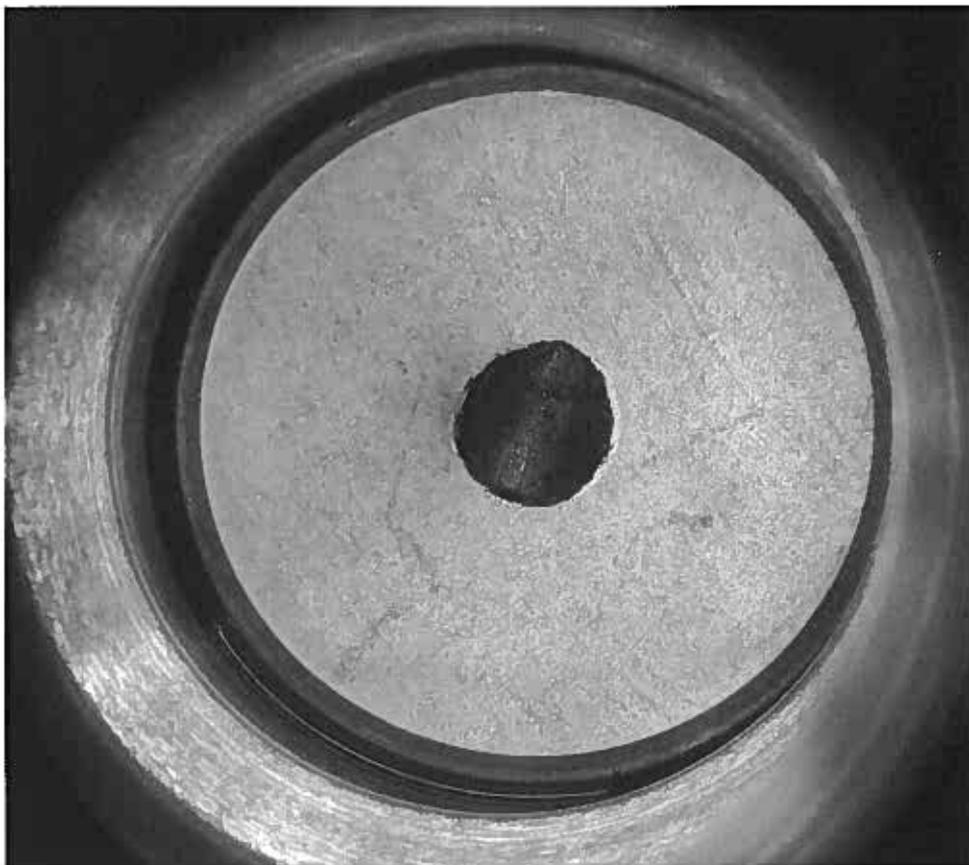
Figure 2: View down into the S port revealing the blocked orifice hole.

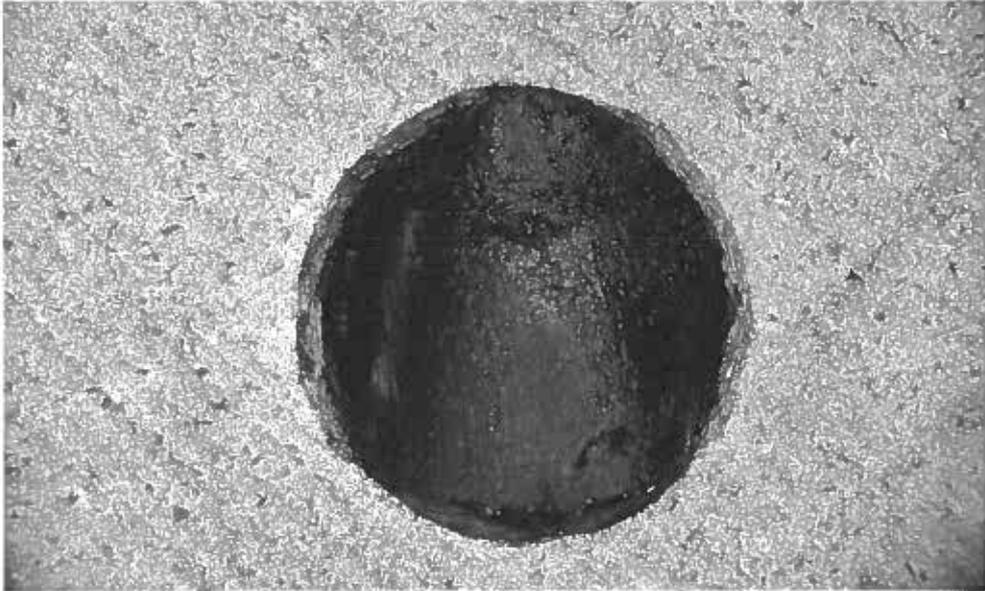
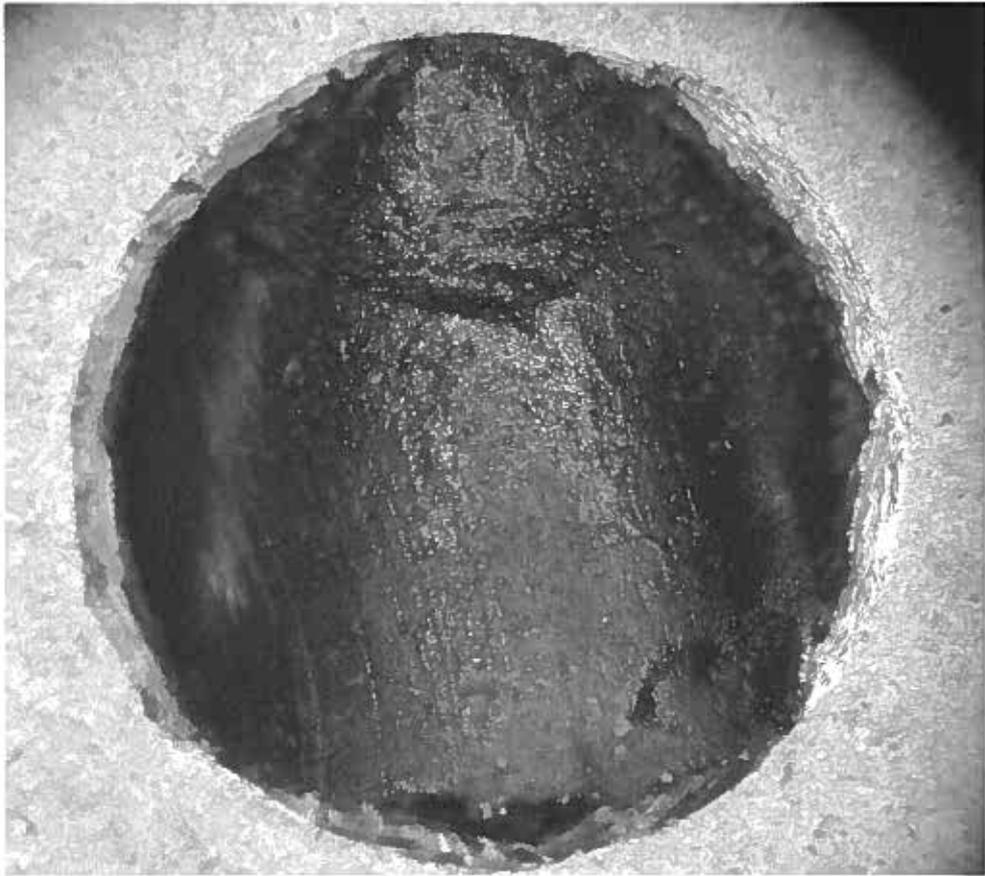
Figure 3: Higher magnifications of the blocked orifice hole as viewed through the S port.

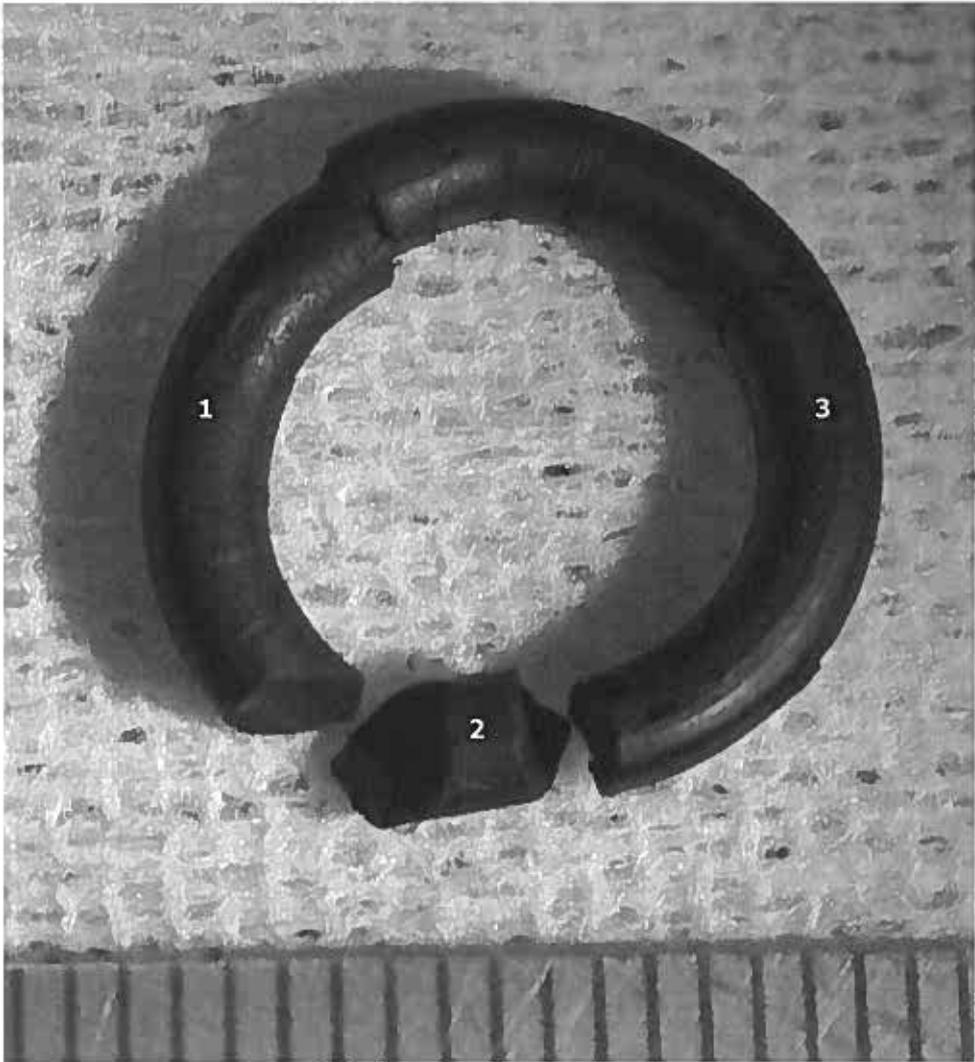
Figure 7: Retrieved parts of O-ring material trapped between cone and housing.

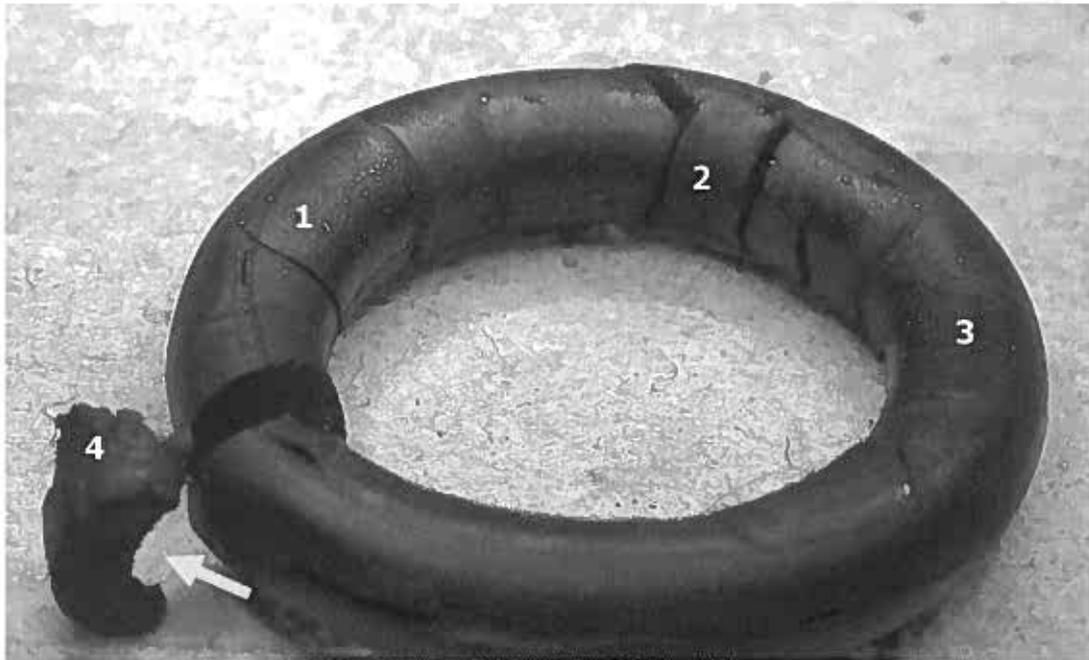
Figure 8: Reassemble of O-ring using all retrieved material except the small piece still residing in orifice hole. The arrow points to where the missing piece fits.

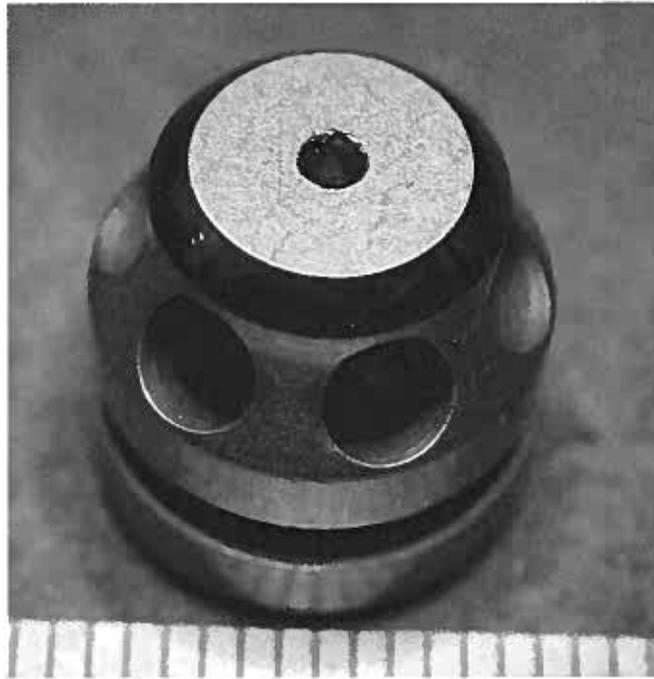
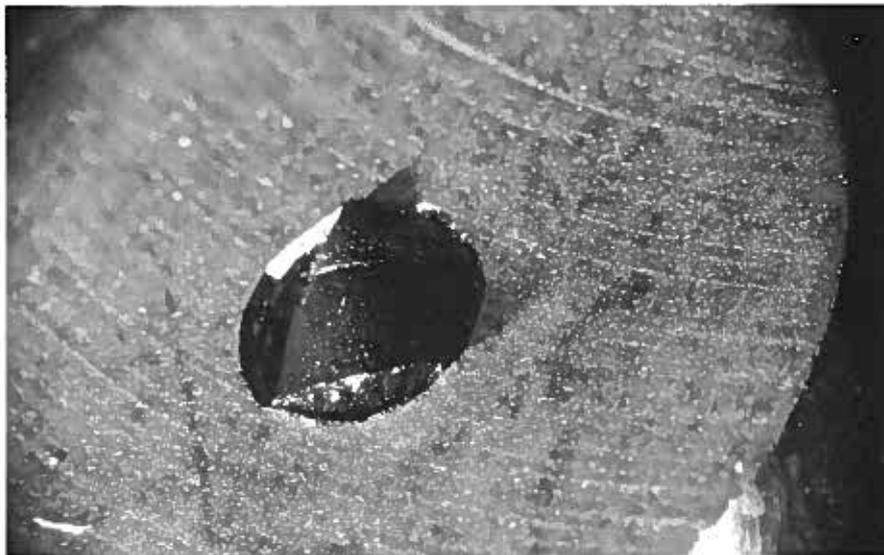
Figure 9: Missing piece of O-ring in Figure 8 still residing in orifice hole.

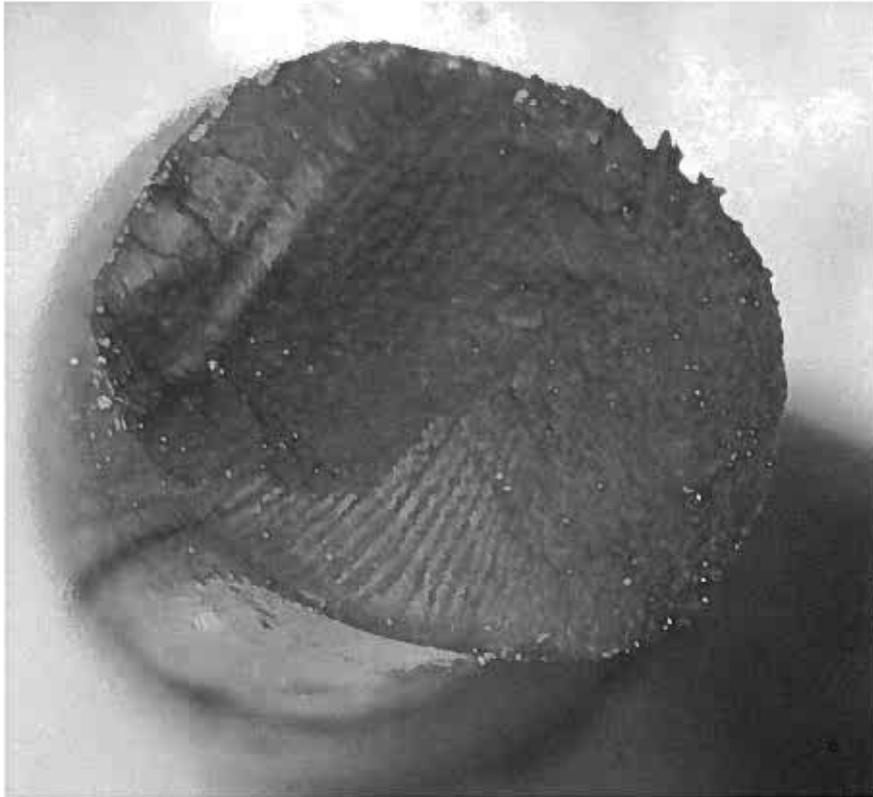
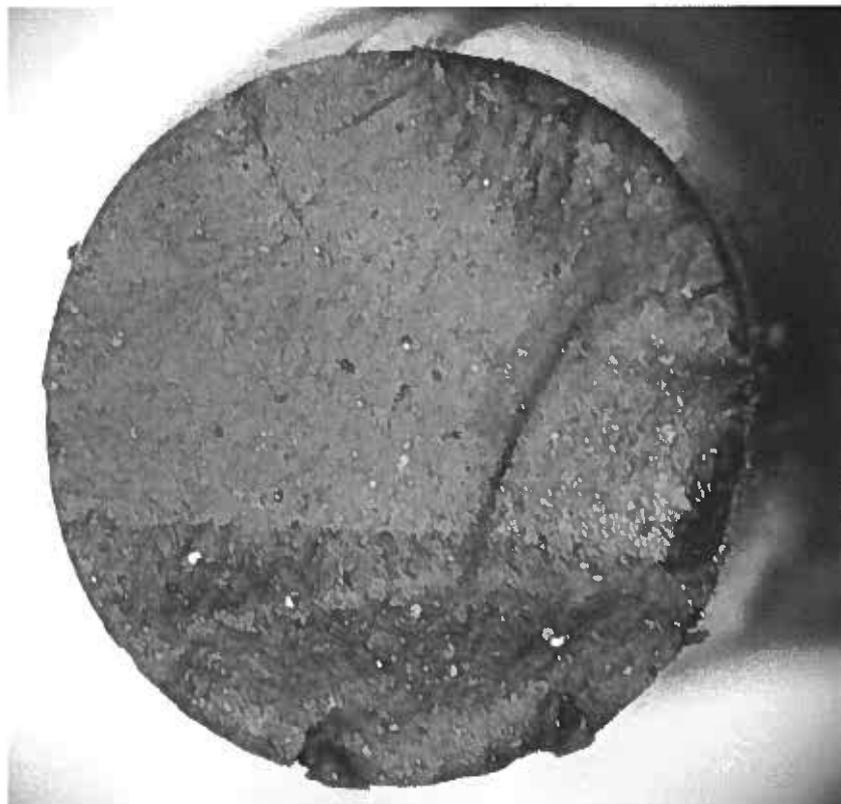
Figure 15: View of "free" ends of retrieved O-ring showing evidence of stepwise cutting.
