AIRCRAFT ACCIDENT REPORT AND EXECUTIVE SUMMARY

Reference:	CA18/2/3/8383	
Aircraft Registration	ZS-OEZ	Date of Accident	07 November 2007		Time of Accident	1400Z	
Type of Aircraft	B737-200		Type of Operation		Scheduled Domestic		
Pilot-in-command Licence Type		Airline Transport	Age	50	Licence Valid	Yes	
Pilot-in-command Flying Experience		Total Flying Hours	13860		Hours on Type	3277	
Last point of departure		Cape Town International Aerodrome (FACT).					
Next point of intended landing		O.R. Tambo International Aerodrome (FAJS).					
Location of the accident site with reference to easily defined geographical points (GPS readings if possible)							
On take-off Runway 01 at Cape Town International Aerodrome (FACT).							
Meteorological Information		Wind 340/20; Temperature 16°C; Visibility 3000 m; Light Rain; Cloud 800 ft Overcast					
Number of people on board	2 + 4 + 106	No. of people injured	0	No. of people killed	0		
Synopsis							
<p>During a take-off from Runway 01 at FACT, the right-hand engine separated from the wing. Following the engine separation, the aircraft continued to climb. The captain declared an emergency and his intention to land back on Runway 01. The aircraft w

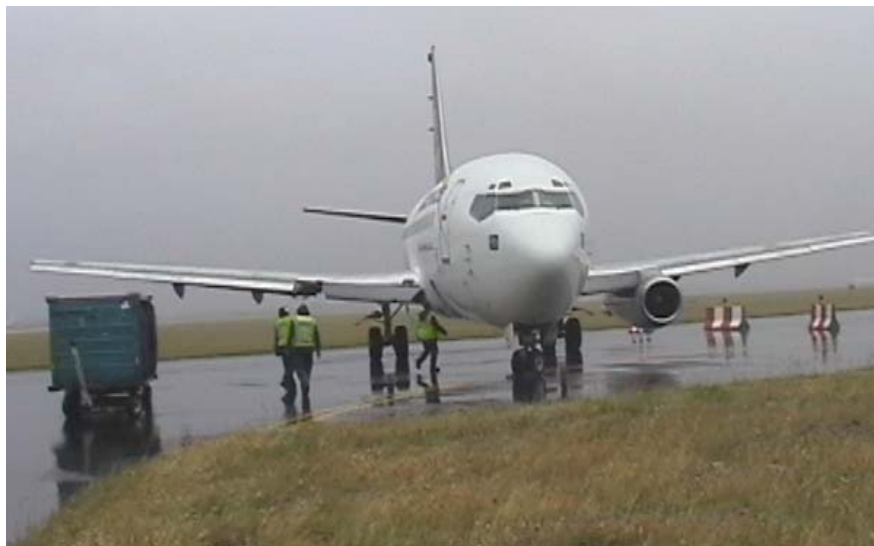
The engine sustained substantial damage; however the wing structural integrity was not affected.

Photo 1: Showing the aircraft without the right-hand engine and parked on the taxiway.

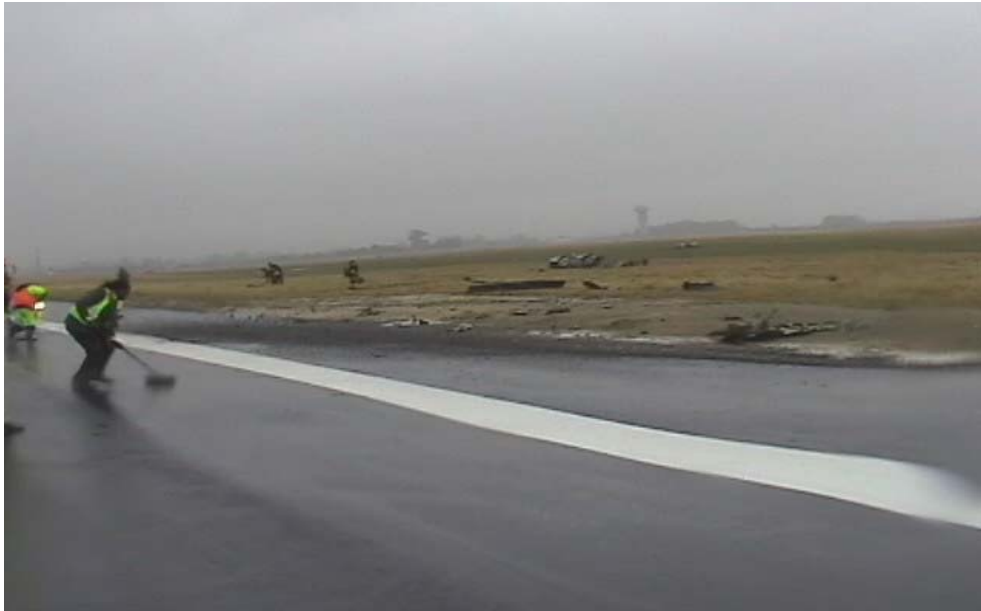
Photo 2: Showing the emergency personnel clearing debris from the runway.

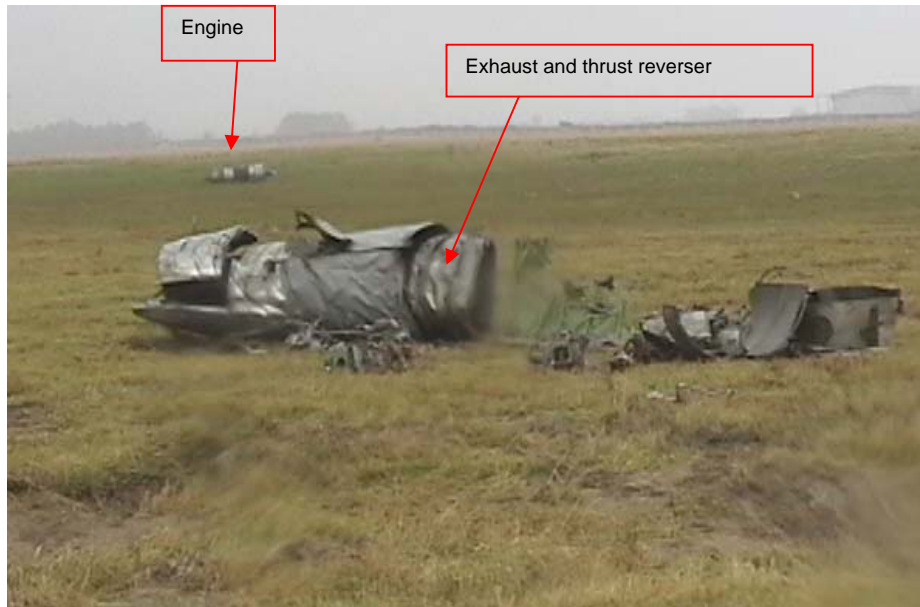
1.12.1 During the take-off and on rotation of the aircraft, the right-hand engine separated from the aircraft. The engine came to rest on the right-hand shoulder and short of the end of Runway 01. The accessory gearbox section made impact with the ground first at the six o'clock position and sustained the most damage. The fan Inlet Case was found further ahead.

Photo 3: Position of the engine and engine inlet casing.

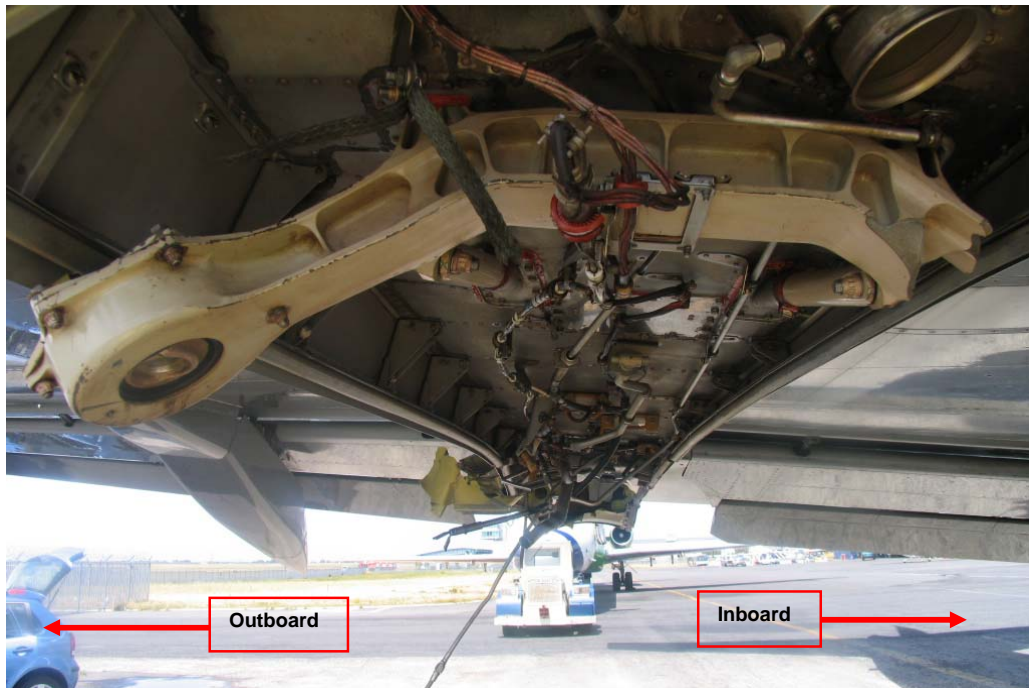
1.12.4 The forward engine mount support fitting (FEMS) failed at the inboard engine attachment point. The outboard engine mount cone bolt fractured at the shearing area and failed, while the inboard cone bolt did not fracture but remained attached to the failed inboard portion of the FEMS fitting.

Photo 4: Fracture of the Front Engine Mount Fitting (FEMS).

1.16.1.2 The forward engine mount support fitting (FEMS) was observed to have failed (broke off) inboard of the inboard attachment point. The outboard cone bolt fractured at its shearing area, while the inboard cone bolt did not shear but remained attached to the failed (broken) inboard portion of the FEMS fitting.

- 3.1.7 The imbalances on the front engine mounting structure, when assessed in relation to the engine torque force, had imposed rotational stress (upwards on inboard bolt and downward on outboard bolt, also gyroscopic force) loading to the front mounts. These loads were due to the engine lowering below its original horizontal plane, thus hanging only on the front mounts while subjected to a rotational force and a forward thrust which was not horizontally forward but slanted or pitched up due to the rear “hanging effect”. These loads caused the cracked forward engine mount to fail. The outboard forward cone bolt failed in overload due to the failure of the forward engine mount at the cracked location and as the engine swung forward during the separation sequence.

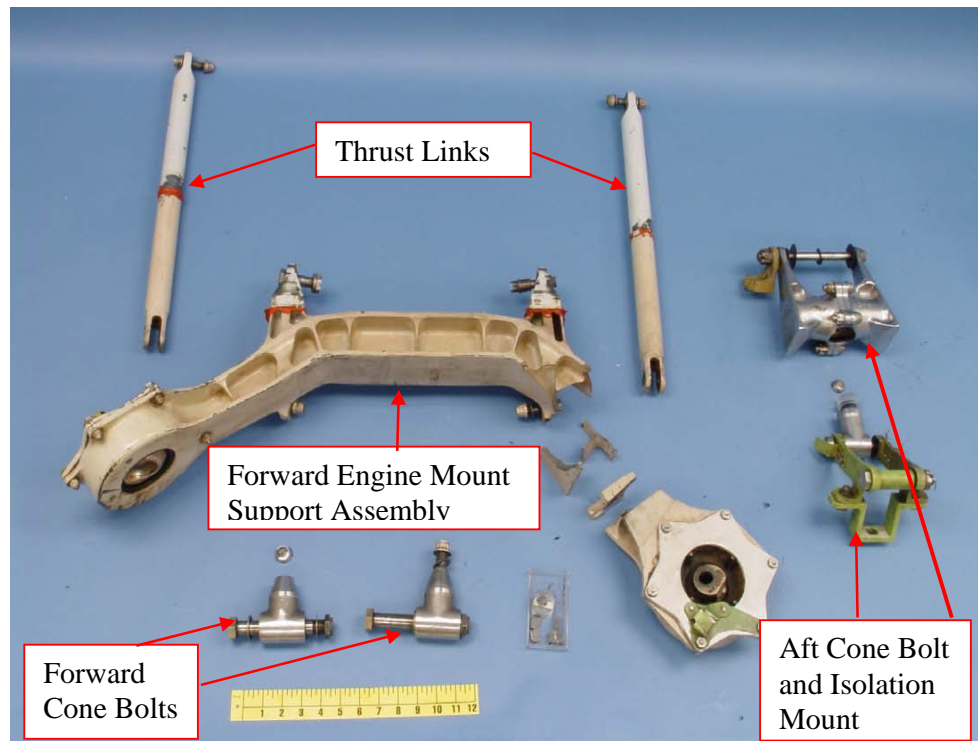
Photo 5: Overall view of the received components from the right-hand engine

- 1.16.2.3 The fatigue crack appeared to be very recent and its appearances suggested that it propagated under high stress conditions, resulting in rapid crack initiation and growth. Under high stress conditions due to the acceptable design conditions, a low number of cycles can result in fatigue failure. The failure occurred in the cone bolts' shear section. The failure surface of the shear section appeared to be a smooth turned surface with no indications of shot peening and no obvious damage or corrosion in the area of the fatigue origins.

- 1.16.2.4 The fatigue region covered an estimated 5% of the total cross section. Examinations of the fracture surface with the aid of a scanning electron microscope (SEM) revealed clear fatigue striations in the fatigue regions emanating from multiple surface origins. The remaining fracture surface was

composed mainly of cleavage facets with small areas of ductile dimple consistent with brittle overstress separation. Small shear lips were present around the periphery of the fracture outside of the fatigue regions.

1.16.2.5 The forward left (inboard) cone bolt was intact while the forward right (outboard) was fractured through the reduced diameter section, and the threaded section was not recovered (not located at the accident site).

- 3.2.1 The right-hand engine separated from the aircraft due to the failure of the aft cone bolt as a result of a pre-existing fatigue crack which was most likely caused by incorrect installation of the cone bolt.

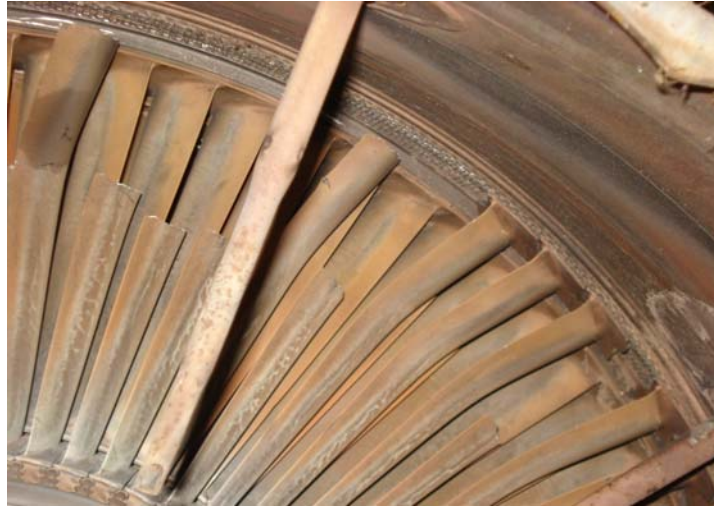
- (ii) The condition of the engine was inspected externally prior to disassembly, with external post-impact damage with terrain, particularly around the six o'clock position of the engine. As the engine had initially impacted with the terrain at that position, the accessory drive gear failed due to it being mounted in the same position.
- (iii) It is the consensus of the investigation team and its co-opted participants that the damage found on the engine is the result of the impact on the runway after separation from the aircraft. It is evident that the engine was rotating at the time of impact as indicated by the bent blades, shaving on the casing and broken blades in the Low Pressure Compressor (LPC), High Pressure Compressor

(HPC), and Low Pressure Turbine (LPT) in the opposite direction of rotation.

Photo 6: Turbine blade damage and some rubbing observed during the teardown inspection.

- 3.1.8 The damage found on the engine is the result of the impact on the runway after separation from the aircraft. It is evident that the engine was rotating normally at the time of impact as indicated by the bent blades and broken blades of the Low Pressure Compressor (LPC), High Pressure Compressor (HPC), High Pressure Turbine (HPT) and Low Pressure Turbine (LPT) in the opposite direction of rotation. There were no pre-existing failures of the engine prior to separation from the airplane.
