KNKT 08.01.03.04

Aircraft Accident Investigation Report

PK – MBP

Boeing B737-300

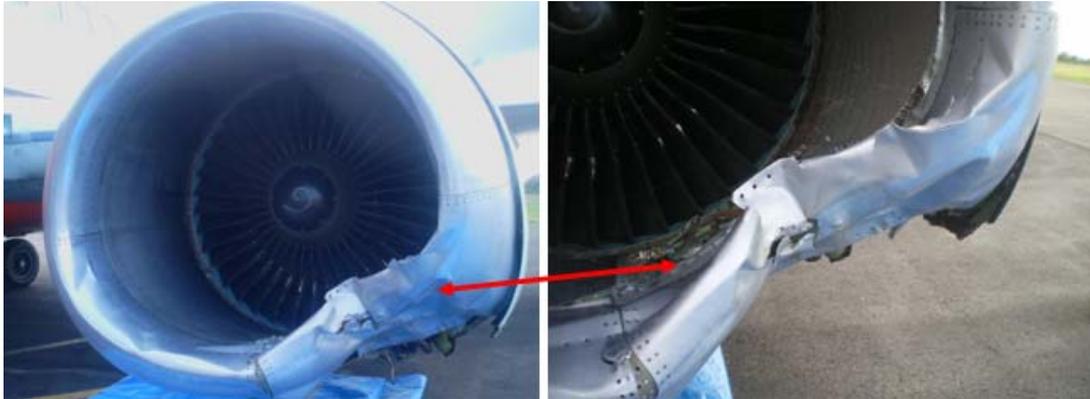
The left engine nose cowling, inner and outer cowling, and generator cowling substantially damaged. The left wing leading-edge kruger flap link was also

substantially damaged. The left inboard main wheel tire had a deep cut about 20 centimeters long.

Figure 2: Number One (left) engine damage

The substantially damaged left engine cowling was detached from the aircraft during the impact with the cow. The pilots reported that the impact with the cow was unavoidable.

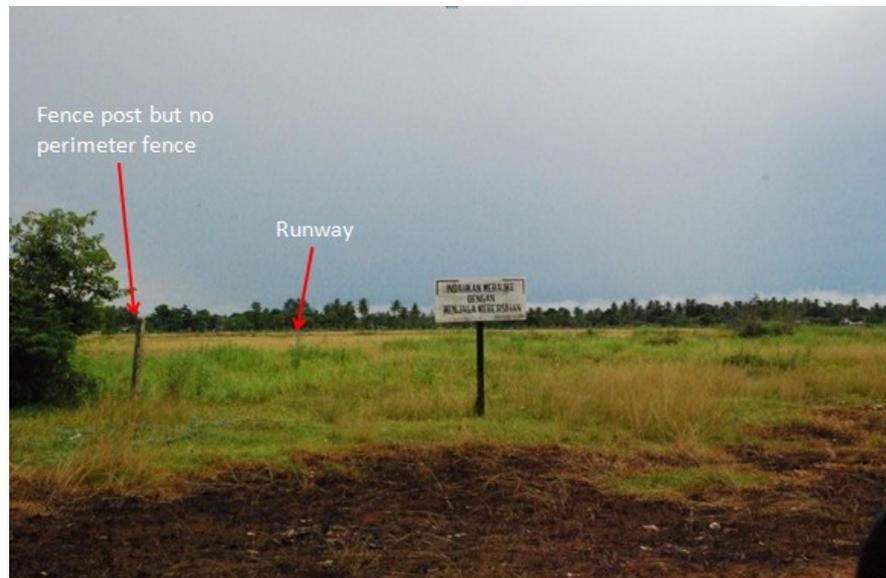
The airport perimeter was not fenced, and there was no other appropriate means of preventing animals, large enough to be a hazard to aircraft from entering the aircraft movement area of the airport.

Figure 3: View towards runway showing no perimeter fence

At the time of the accident only 30% of the Mopah Airport perimeter was fenced.

The investigation found that the airport did not meet the requirements of ICAO Annex 14, Volume 1, Paragraph 9.10.2, Standard, or the intent of Civil Aviation Safety Regulation (CASR) 139 Subparts 4.2 and 4.12.

The Directorate General of Civil Aviation's safety oversight programme had not ensured that the airport complied with ICAO Annex 14, Volume 1, Paragraph 9.10.2, Standard, or Civil Aviation Safety Regulation (CASR) 139 Subparts 4.2 and 4.12 requiring a fence or other suitable means to be provided on the aerodrome to prevent the entrance to the movement area of animals large enough to be a hazard to aircraft.

Following the accident, the airport operator conducted a program of work to fence the perimeter of the airport. A subsequent inspection by National Transportation Safety Committee investigators confirmed that the work was in progress.

The National Transportation Safety Committee recommends that the Directorate General of Civil Aviation take immediate action to control access and prevent unauthorized entry of persons, vehicles, equipment or animals, or other things that may endanger aircraft safety, onto the movement area of all its airports.

Specific attention should be given to complying with ICAO Annex 14, Volume 1, Paragraph 9.10.2, Standard, and Civil Aviation Safety Regulation (CASR) 139 Subparts 4.2 and 4.12.

The National Transportation Safety Committee recommends that the Directorate General of Civil Aviation ensure that Indonesian airport operators take immediate action to control access and prevent unauthorized entry of persons, vehicles, equipment or animals, or other things that may endanger aircraft safety, onto the movement area of all Indonesian airports.
