## AIRCRAFT ACCIDENT REPORT AND EXECUTIVE SUMMARY

Reference:	CA18/2/3/8453	
<b>Aircraft Registration</b>	ZS-LFU	<b>Date of Accident</b>	7 March 2008		<b>Time of Accident</b>	1710Z
<b>Type of Aircraft</b>	Beech B200		<b>Type of Operation</b>		Private	
<b>Pilot-in-command Licence Type</b>		Commercial	<b>Age</b>	52	<b>Licence Valid</b>	Yes
<b>Pilot-in-command Flying Experience</b>		Total Flying Hours	14 500.0		Hours on Type	4 650.0
<b>Last point of departure</b>		Bloemfontein Aerodrome (FABL)				
<b>Next point of intended landing</b>		Cape Town International Aerodrome (FACT)				
<b>Location of the accident site with reference to easily defined geographical points (GPS readings if possible)</b>						
On Runway 19 at Cape Town International Aerodrome						
<b>Meteorological Information</b>		Surface wind; 220°/15 knots, Temperature; 23°C, Visibility; Good				
<b>Number of people on board</b>	1 + 6	<b>No. of people injured</b>	0	<b>No. of people killed</b>	0

<b>CrashLAB</b>	PAGE 1 OF 1	
COMPILED FOR: <b>Civil Aviation Authority</b>		DOCUMENT NUMBER <b>MET-004-05-08</b>	
	<b>INVESTIGATION REPORT: UNDERCARRIAGE FAILURE, KING AIR, ZS-LFU</b>	DATE <b>2008-04-29</b>	ISSUE <b>1</b>

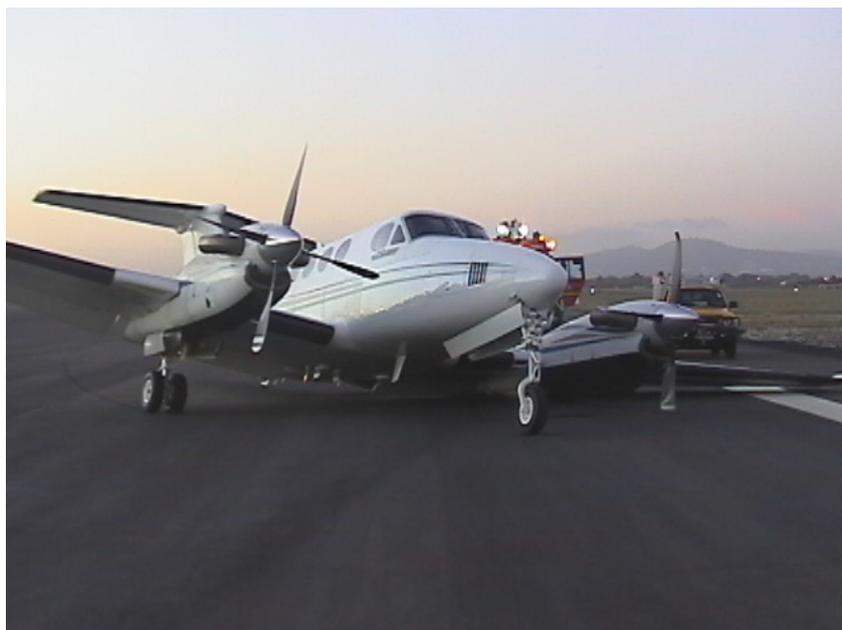
- 1.3.1 The aircraft sustained substantial damage to the left wing, flap as well as the propeller, which made contact with the runway surface.

**Figure 1.** A view of the aircraft as it came to rest on Runway 19.

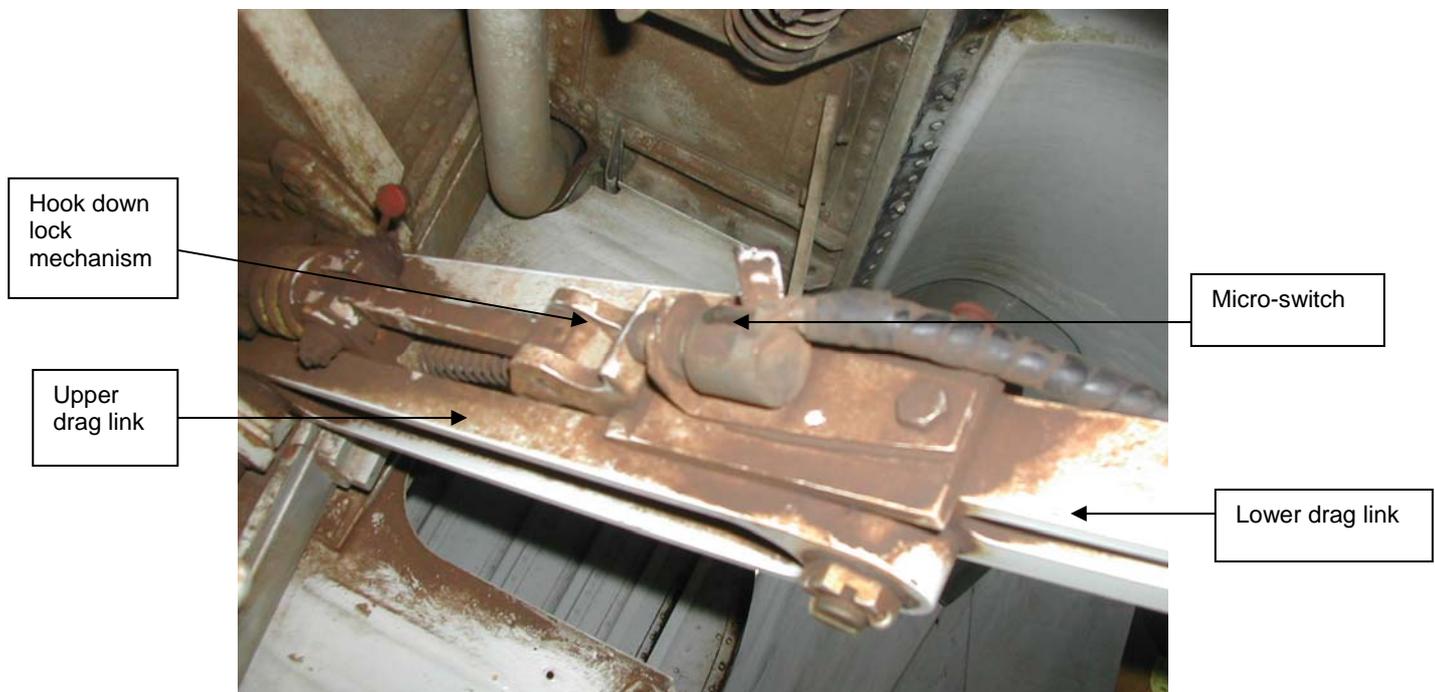
**Figure 2.** View of right main landing gear (ZS-LFU) looking aft and up into the wheel bay.

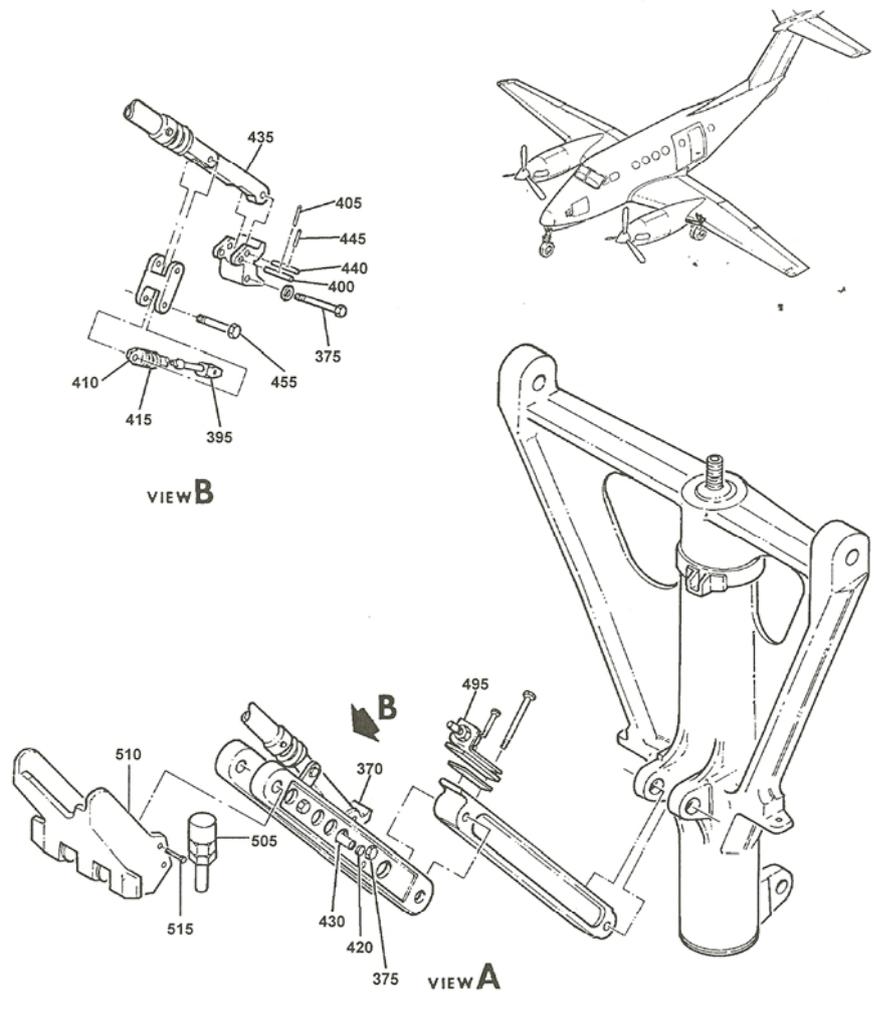
Figure 3. A view of the upper landing gear installation, including the hook down lock mechanism.

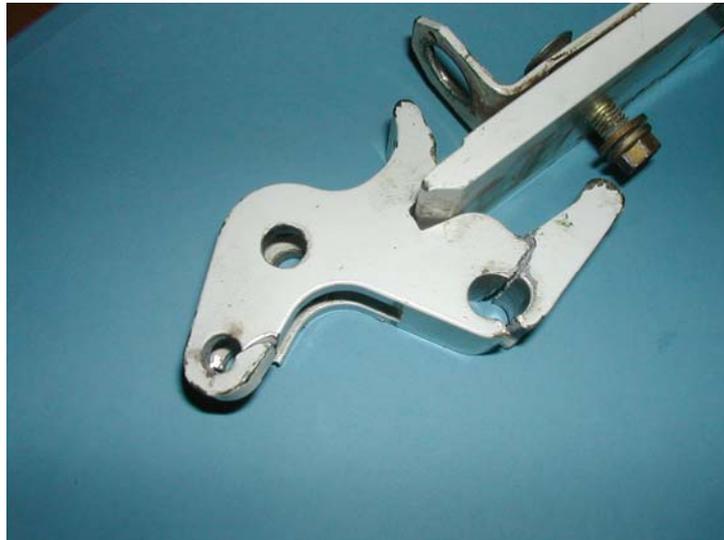
1.16.1 Following recovery of the aircraft it was found that the Hook Down Lock mechanism, Part No. 50-810338-5 on the left main landing gear assembly had failed during the landing roll.

**Figure 5.** A view of the hook down lock mechanism that failed.

The investigation revealed that the relevant component had failed over an undetermined period of time. The most probable sequence of events is a single overload incident that led to the propagation of a fatigue fracture until final failure during operation.

- (vii) The left-hand landing gear hook down mechanism was found to have failed in fatigue.
- (viii) There was no Airworthiness Directive or Service Bulletin issued by the aircraft manufacturer on the hook down lock mechanism. According to Hawker Beechcraft Corporation this was the first reported failure of such a nature on a Beech 200 series aircraft.

- 4.1 It is recommended in the interests of aviation safety, that the SACAA Airworthiness Department engage with the FAA (Federal Aviation Administration) and aircraft manufacturer Hawker Beechcraft Corporation by bringing the occurrence to their attention and recommending proactive measures to prevent a recurrence of this nature in the form of an Airworthiness Directive or Service Bulletin.
- 4.2 It is recommended that the remainder of the relevant aircraft's main and nose landing gear be inspected for related damage as per Original Equipment Manufacturer (OEM) specification before being certified as airworthy.

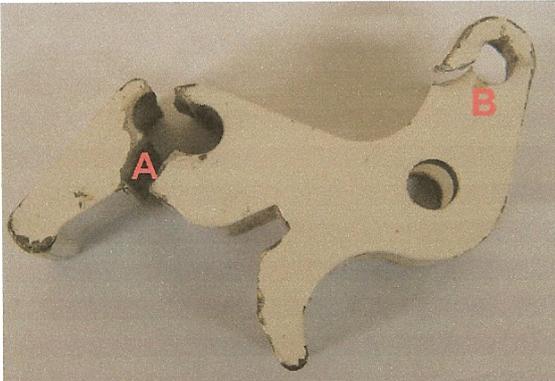
<b>Photo 1: Failed undercarriage component (digital)</b>

**6.1. Visual and Stereomicroscope Investigation.** The visual inspection revealed that the component failed at two positions as marked A and B (Photo 1). The fracture surfaces at point A displayed signs of fatigue (Photo's 2 and 3). The thin section fracture surface (Photo 2, blue arrow) showed clear signs of fatigue type geometry with beach marks (Photo 3, blue arrow) and an initiation point (red arrow) opposite to the thick section exit point (Photo 2, red arrow). The larger section revealed a clear 'lipped' area (Photo 2, red arrow) indicating the exit point on final fracture as well as indications of a smaller fatigue crack propagation area.

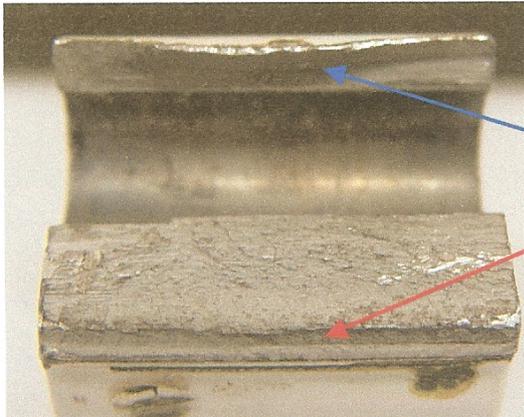
**Photo 2: Fracture surfaces at point A (digital)**

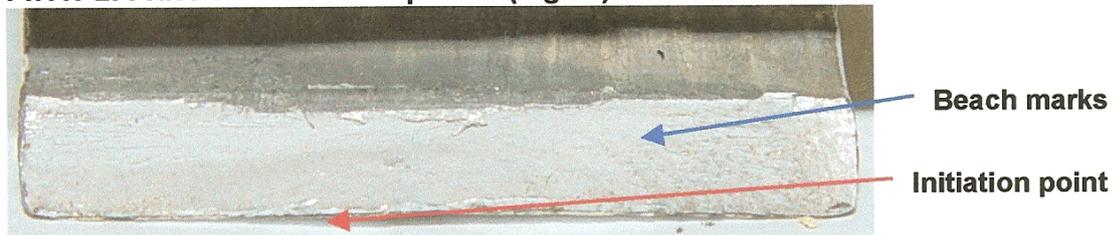
**Photo 3: Thin section fracture surface, point A (digital)**

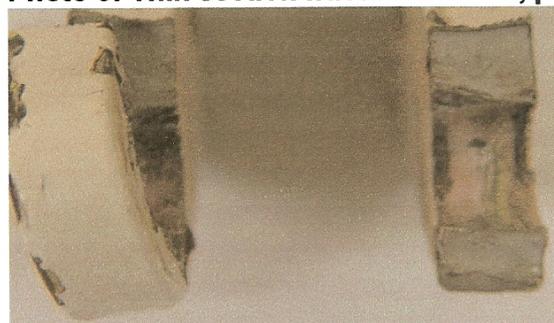
The fractures at point B displayed a small area of fatigue crack propagation with the remainder of the fracture surface that of final fracture (Photo 4). It can be derived that the fractures at point A be propagated prior to that at point B. The failure at point A resulted in the subsequent overload at point B.

**Photo 4: Fracture surfaces, point B (stereo)**

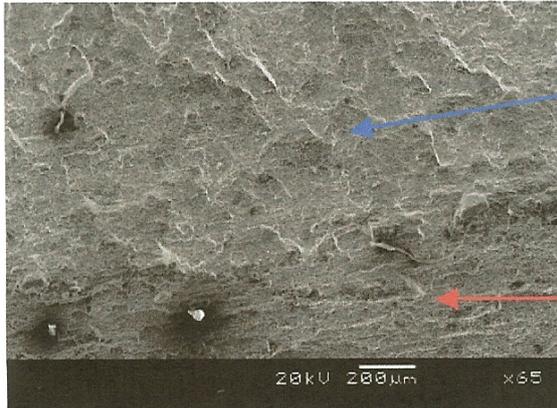
**6.2. Electron Microscope Investigation.** The SEM investigation of the thin section fracture surface at point A revealed a clear distinction line between the final fracture (Photo 5, blue arrow) and fatigue crack propagation (red arrow). At higher magnification the fatigue striations are more clear (Photo 6, red arrow). Smearing damages (Photo 7) on

**Photo 5: Thin section surface, point A (x65, SEM)**

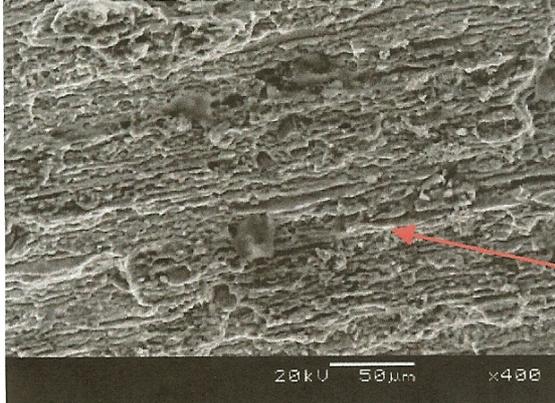
**Photo 6: Thin section surface, point A (x400, SEM)**

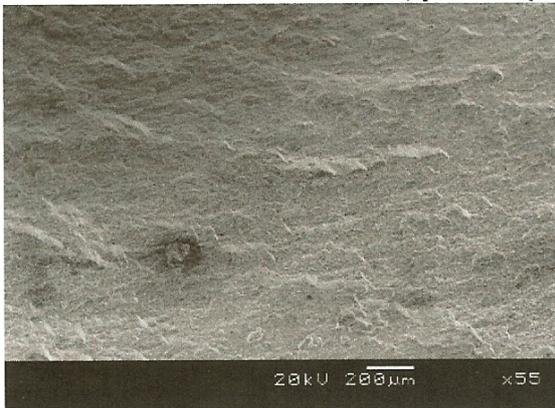
the fracture surfaces are an indication of a failure over a period of time. One fracture surface from point B revealed fatigue striations (Photo 8, red arrow).

**Photo 7: Thin section surface, point A (x55, SEM)**

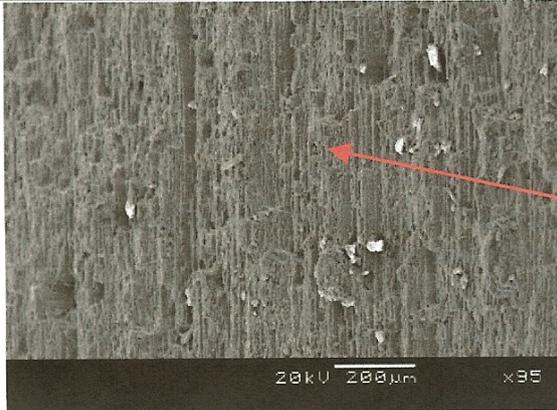
**Photo 8: Fracture surface, point B (x95, SEM)**

- 7.1 The investigation revealed that the relevant component failed over an undetermined period of time. The most probable sequence of events is a single overload incident that led to the propagation of a fatigue fracture until final failure during operation.

- 8.1. It is recommended that the remainder of the relevant aircraft's main and nose undercarriages be inspected for related damages as per OEM specifications before certified as airworthy.
