ATSB TRANSPORT SAFETY REPORT
Aviation Occurrence Investigation
AO-2008-026
Final

Loss of control
19 km SE Sydney Airport, NSW
9 April 2008
VH-OZA, Fairchild Industries
SA227 AC Metro III

Loss of control
19 km SE Sydney Airport, New South Wales
9 April 2008
VH-OZA
Fairchild Industries Inc. SA227-AC Metro III

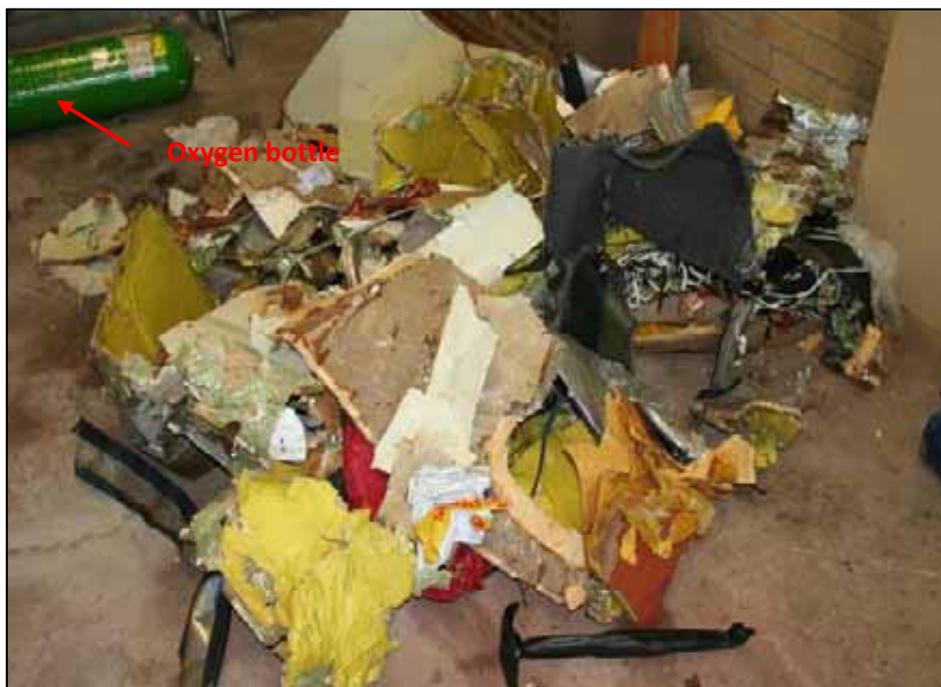
Figure 3: Recovered floating items

The nature of the damage of the recovered items indicated that the aircraft impacted the water at high speed (Figure 3). An examination of the cargo strap indicated that it had failed under gross overstress from exposure to impact loads. The metal medical specimen container displayed crush damage.

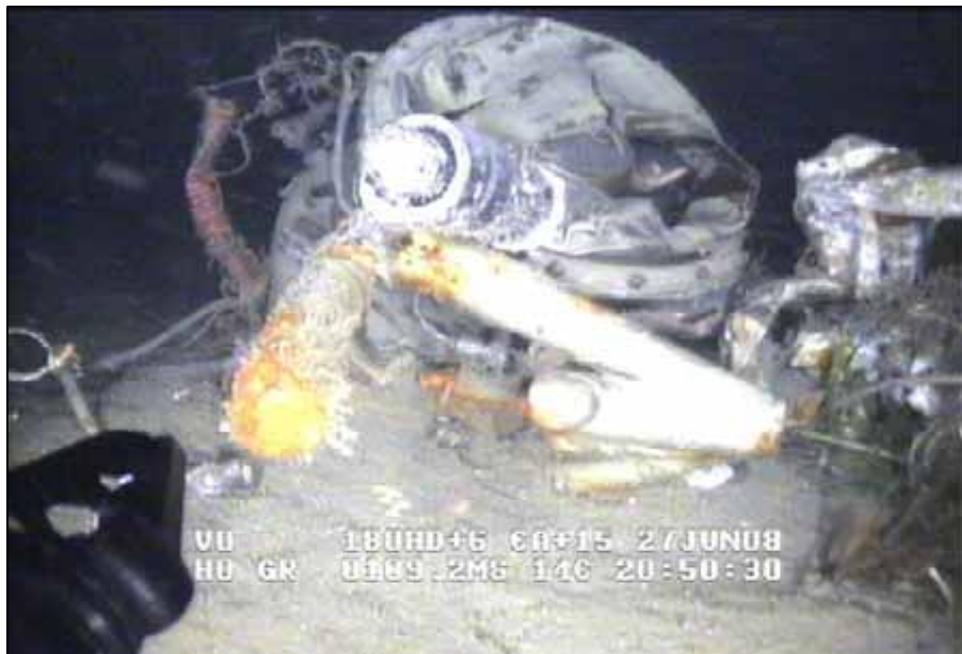
Figure 6: Engine on the ocean floor displayed on the ROV monitor

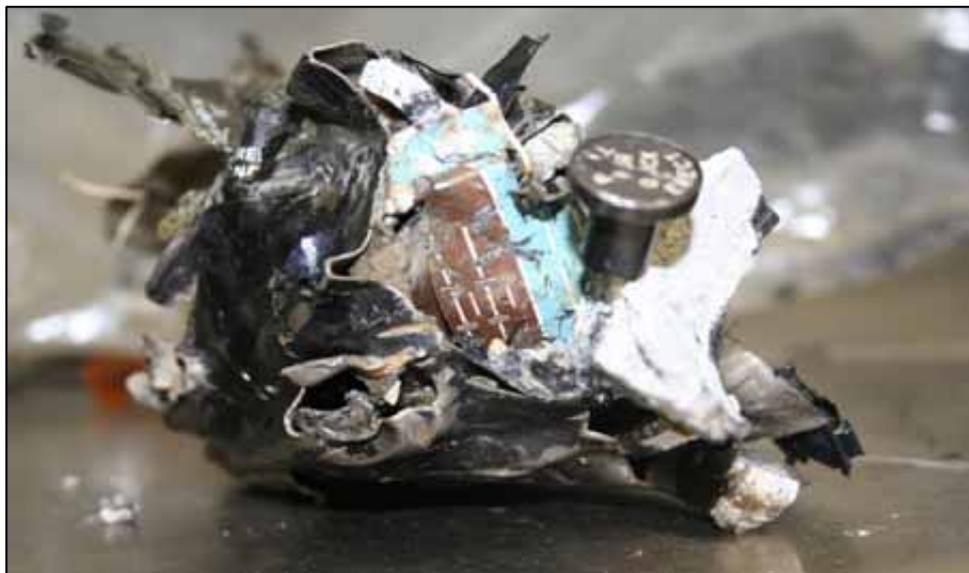
Figure 18: Recovered artificial horizon

Examination of the inside of the gyroscope casing end cap found rotor fan blade impact marks. Those impact marks displayed no evidence of rotational scoring from

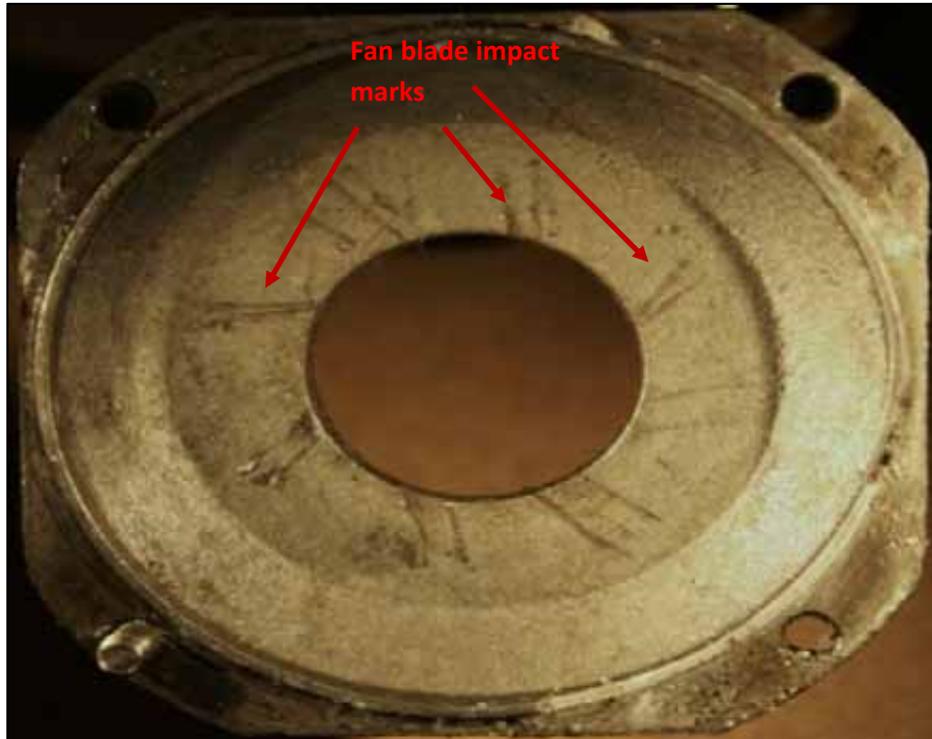
Figure 19: Gyroscope rotor casing fan blade impact marks

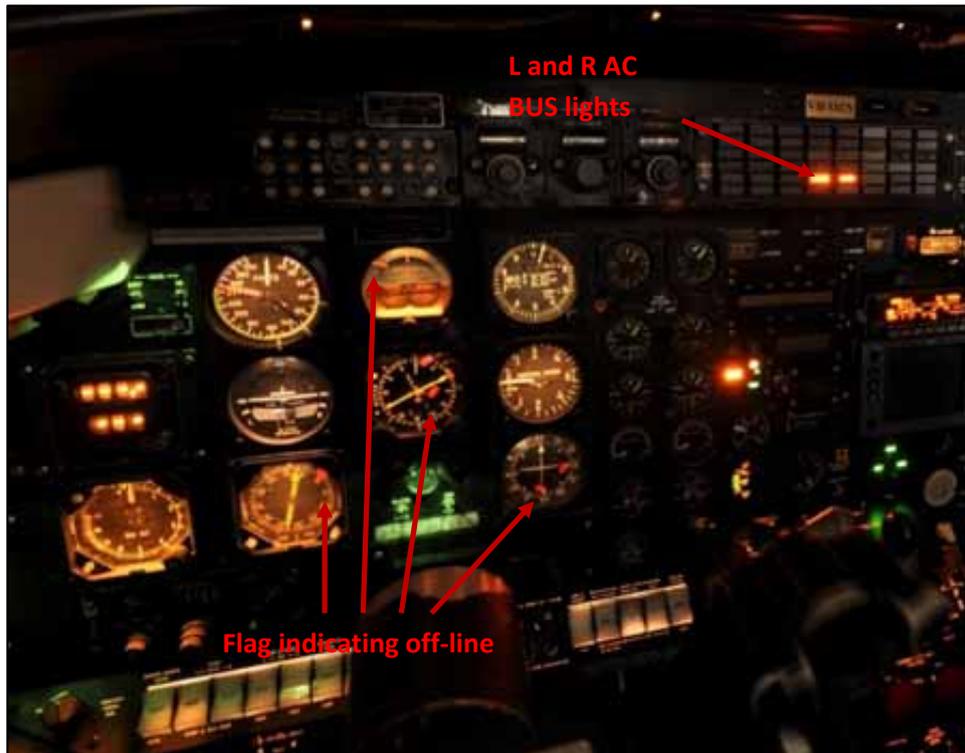
A loss of AC power meant that the pilot's and copilot's AHs would have been inoperative, with the effect that the pilot would have been deprived of any primary attitude information from his instrumentation (Figure 25). The autopilot would also not have been available for use.

Figure 25: VH-OZN instrument panel during simulated night operations (pilot side) with no AC power and showing the resulting annunciator lights and instrument flags

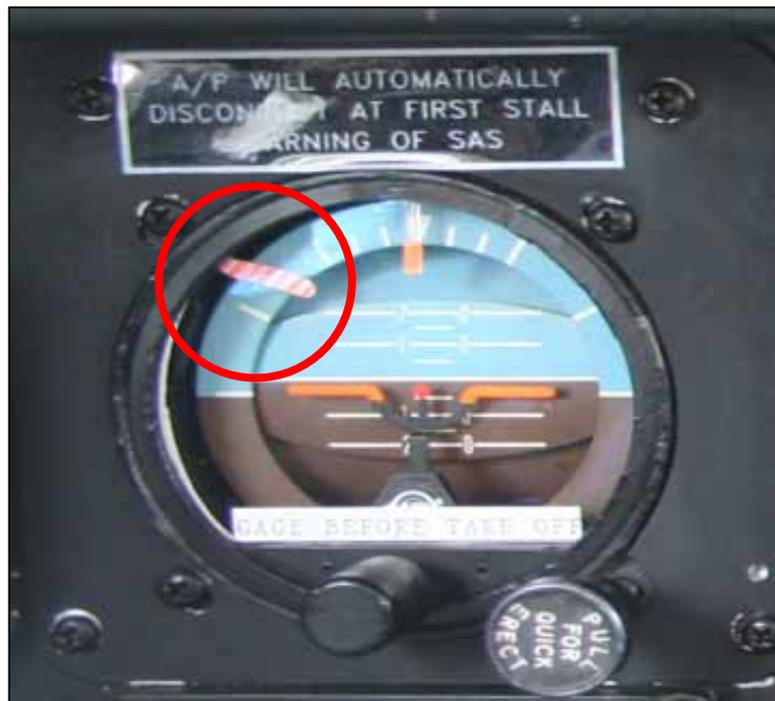
In addition, if the pilot's AH was not powered prior to takeoff, the pilot should have been presented with an orange and white warning 'off flag' on the AH as shown in Figure 26.

Figure 26: VH-OZN, pilot's AH with off flag visible (circled)

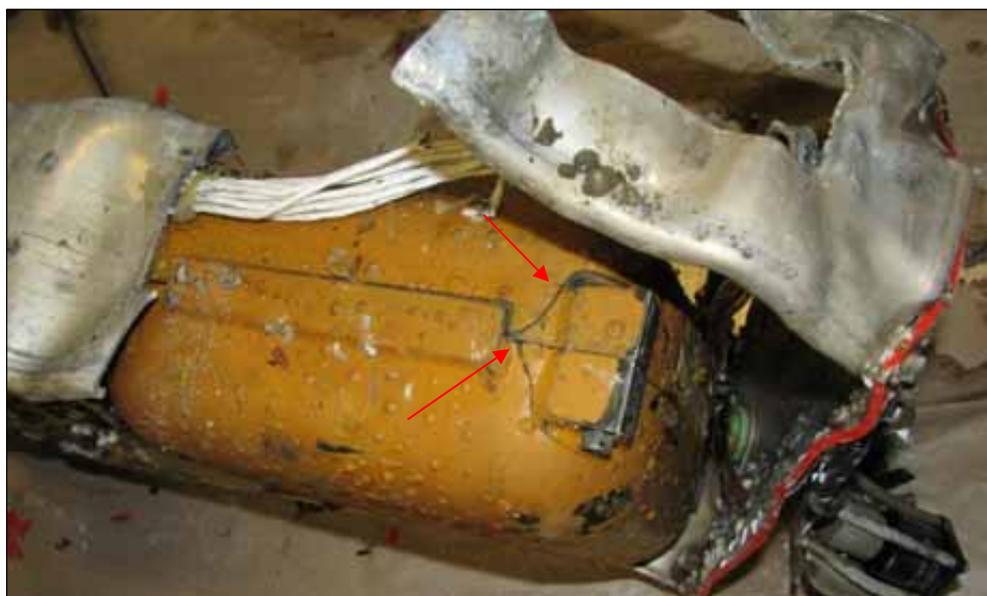
Figure B-7: FDR crash protected enclosure showing fracture damage (arrowed)

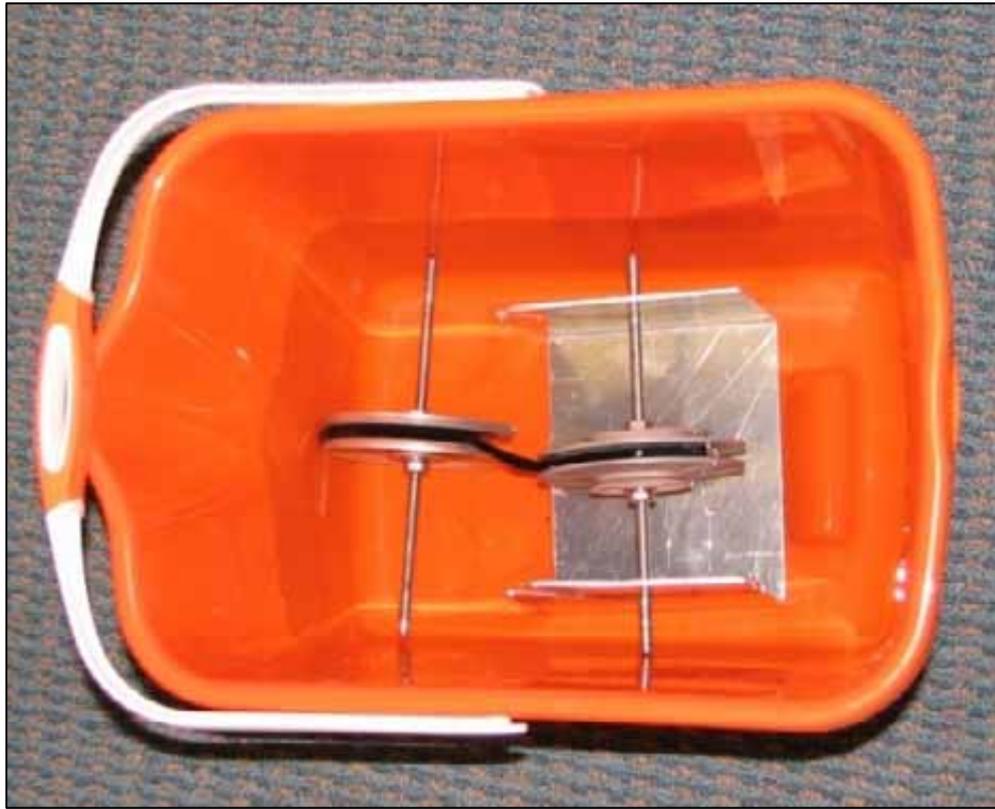
Figure B-12: Tape removed from FDR rinsed and cleaned and on spools

The tape was in reasonable condition and, after cleaning, was replayed using the ATSB's FDR analysis workstation. No evidence of heat or fire damage was found during disassembly of the crash protected module.

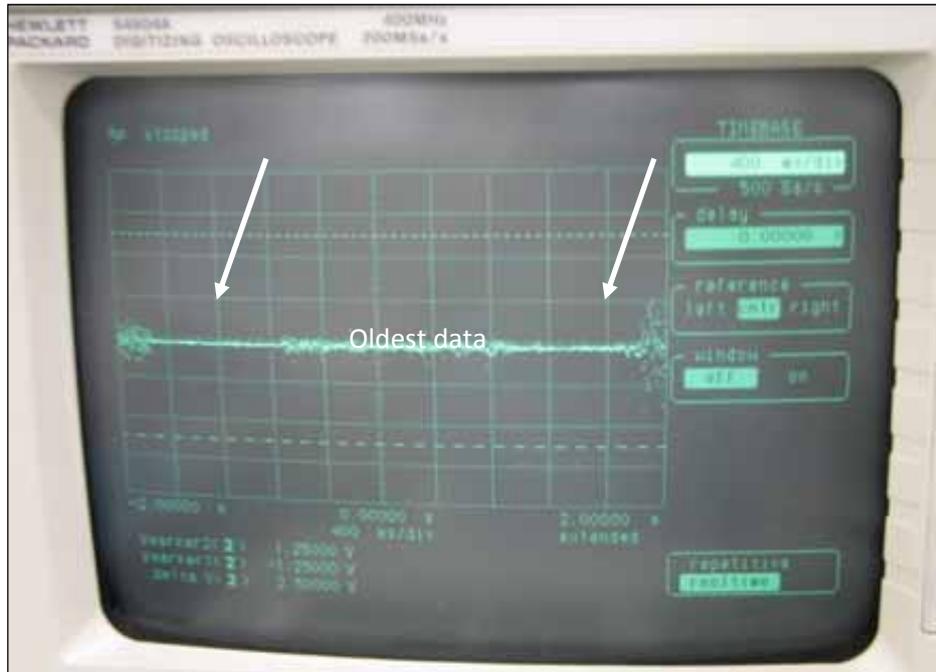
Figure B-14: Oscilloscope screenshot of Track 6 at location of tape stoppage (i.e. transition from newest to oldest data). Reduced signal strength arrowed. This was typical across all eight tracks

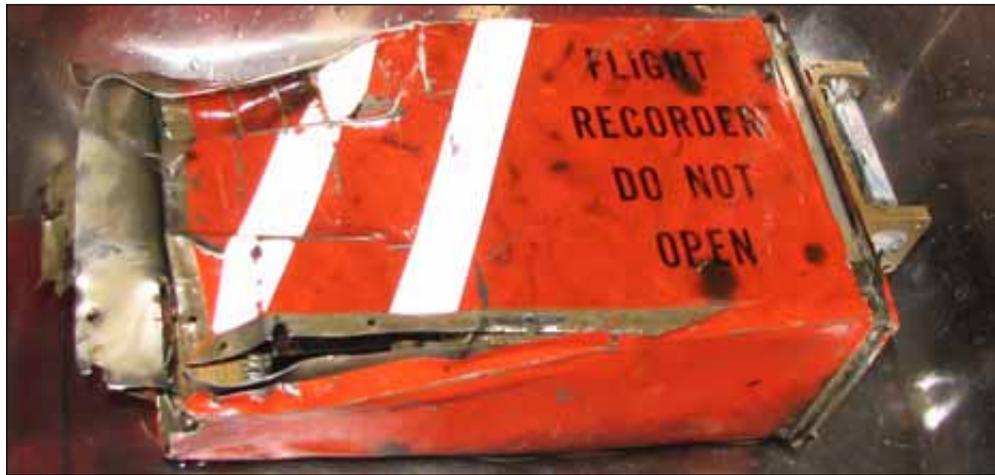
Figure B-21: Fairchild model A100A Cockpit Voice Recorder from VH-OZA following removal from shipping container on 1 July 2008

The CVR had been subjected to substantial impact forces and saltwater immersion, which had resulted in extensive damage to the recorder. The recovered CVR was identified from the manufacturer's data plate as a Fairchild model A100A CVR, part number 93-A100-80, serial number 55650 (Figure B-22). The maintenance records for VH-OZA confirmed that this CVR was fitted to VH-OZA at the time of the accident.

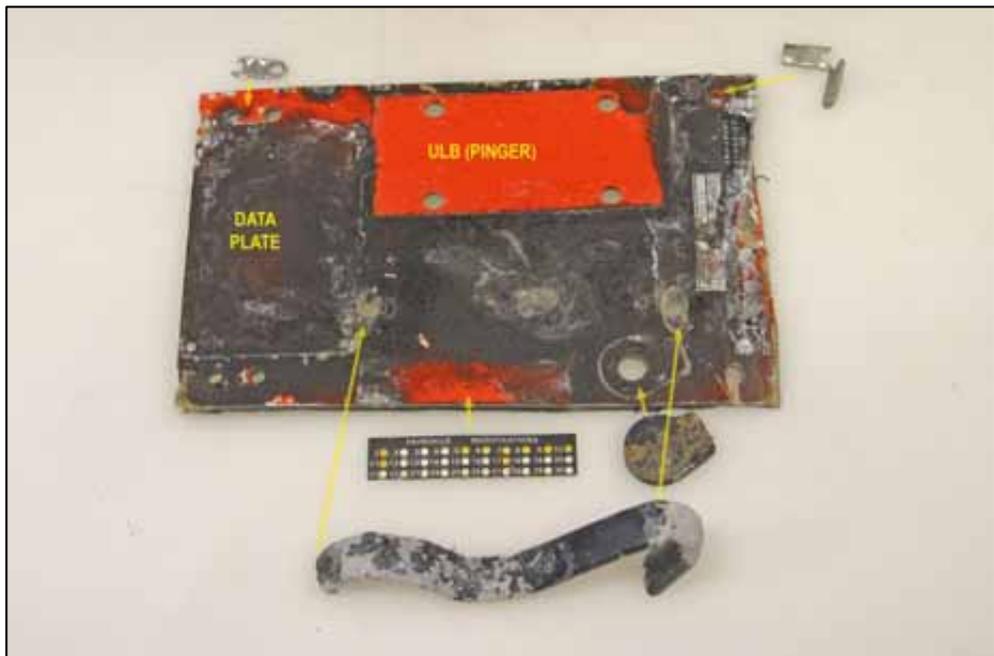
Fittings that had been attached to the front panel of the CVR (including the modification status plate, audio cap and the grab handle) were removed for the examination. The front panel of the unit was of particular interest because the majority of the surface displayed significant discolouration; having changed from orange to dark grey or black. In some areas, the painted surface underneath the fittings had also discoloured. However, in other regions, notably below the underwater locator beacon (ULB), the surfaces remained essentially unaffected (Figure C-3).

Figure C-3: CVR face plate showing the location of various front attachments

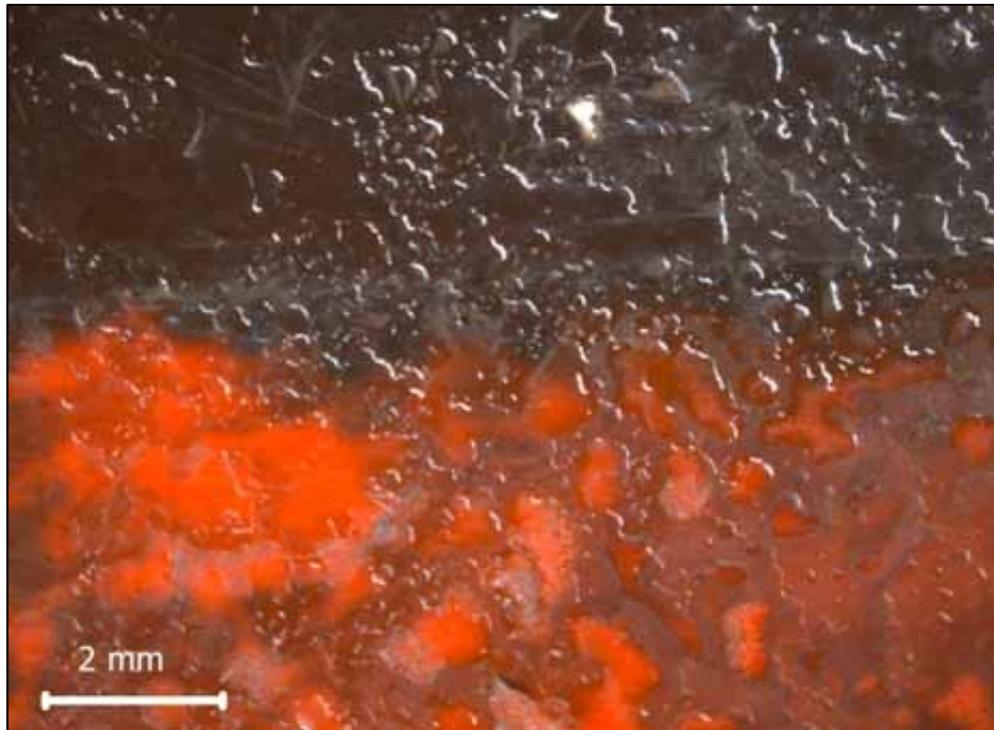
Figure C-4: Magnified view of the discolouration observed on the CVR face plate

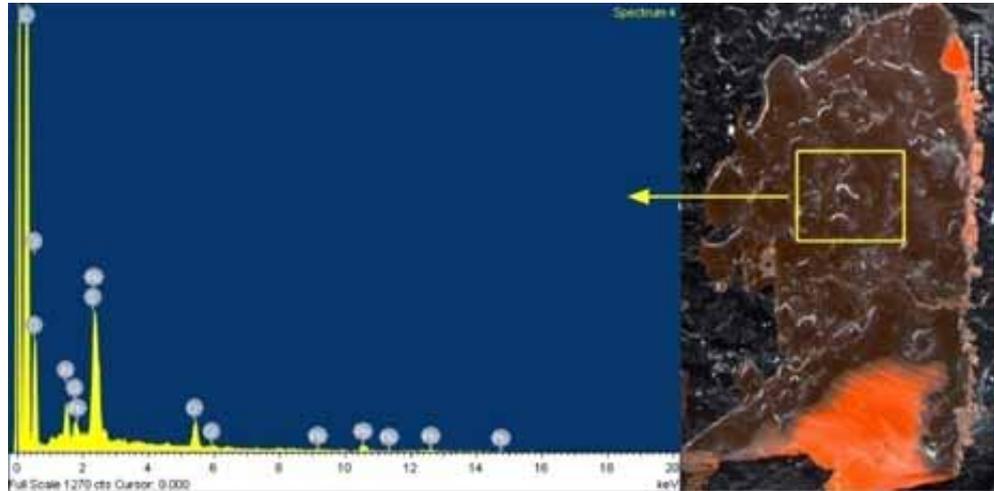
Figure C-6: Damaged paint sample from CVR and its chemistry

Note: A discoloured paint chip from CVR. Original colour can be seen on the lower right of the image where the paint has been sectioned with a scalpel blade.
