Islamic Republic Of Iran  
Civil Aviation Organization  
Deputy of Flight Standard  
Aircraft Accident Investigation Department

**Final Report**  
**Basic Information**

Type of occurrence: Serious Incident  
Date: 02.Jul.2008  
Location of incident: 45 NM inbound to the ZAHEDAN INTL Airport/ I.R of Iran  
and emergency landing in this airport  
Aircraft: Airplane  
Model: Ilyushin IL-76TD  
Registration: EK-76400  
Owner: CLICK AIRWAYS INTL  
Operator: CLICK AIRWAYS INTL

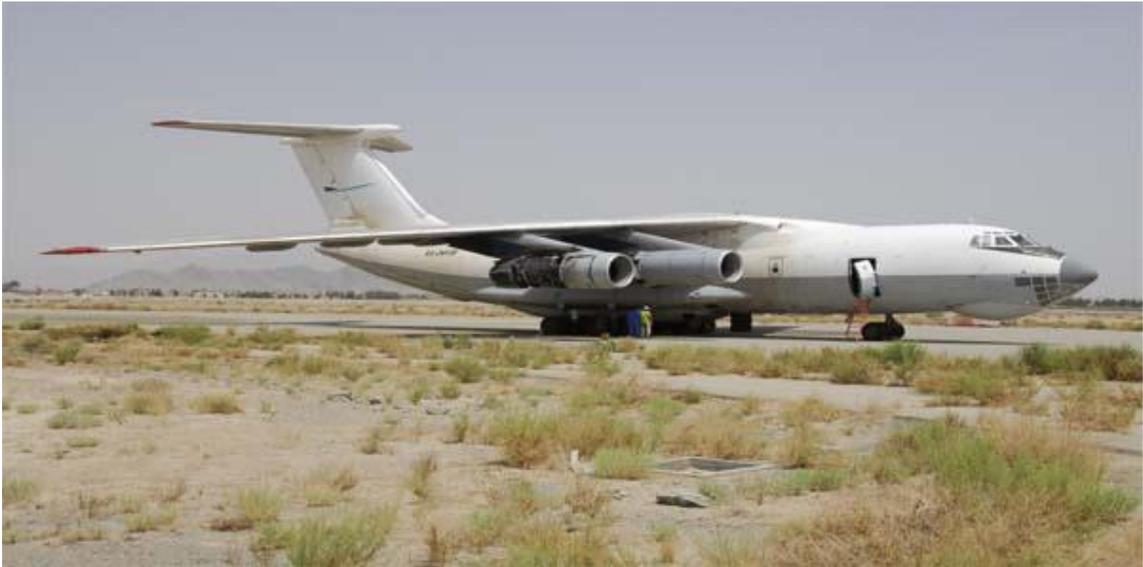
Completed Aircraft Fire Frightening

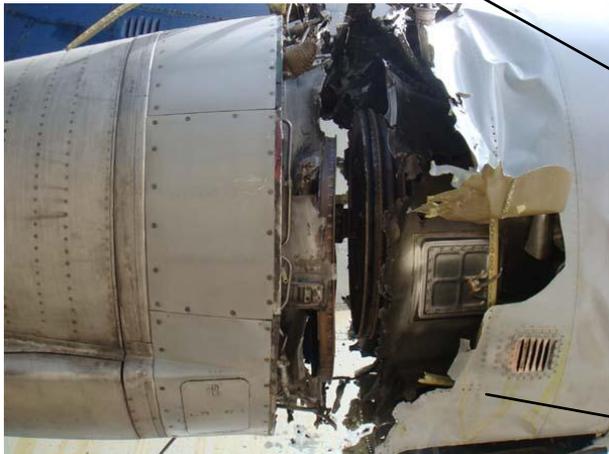
Engine #3 has its turbine unit fully destroyed with destruction of the outer Engine cover, as well as of the pods hoods and the units of Engine stud, located near the destruction area. At the destruction area the axle of the Engine, destroyed set of the nozzle diaphragm of the 4<sup>th</sup> turbine stage, remains of the straightened blade and the blade wheel of the turbine 6<sup>th</sup> stage are visible. Fragments of the 5<sup>th</sup> turbine stage along with the blade wheel disc are absent. Both rotors are jammed and can not be rotated.

It is believed that the incident was caused by fatigue failure of turbine main gear due to exceed time operation of engine #3, which led to the subsequent failures in engine turbine shaft to seize and it was broken.

Engine #3

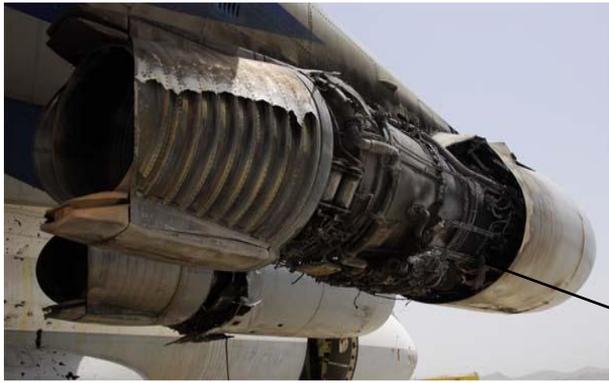
The Engine #4 damage was caused by the fire, which arose under the Engine cowling as a result of damage (crippling) of the fuel-oil radiator.

Engine #4 Damaged

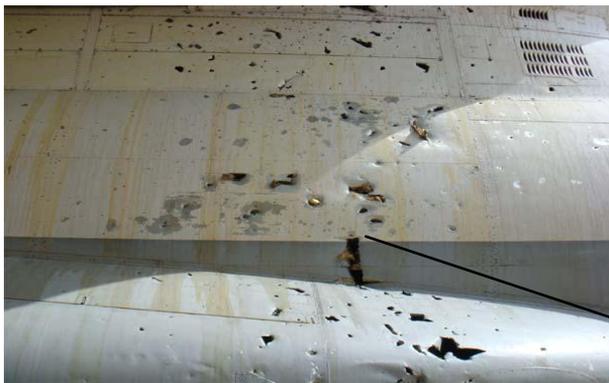
1. APU TA-6A is serviceable, free of damages.
2. The Hulls;  
The right side has numerous through breaches of the sheeting in the area of frames 27-33 (stringers 10-36).  
The left side has two through breaches of the sheeting in the area of frame 31 (stringers 25-26) and frames 32-33 (stringers 13-14).  
Inside the hull in the cargo compartment there are damages of the rigidity boxes along the left side (near frame 31) and along the right side (near frame 32).  
The cowl of the landing gear: along the left side a through breach in the upper sheeting near frames 31-32.  
Along the right side there are numerous breaches of the sheeting from frame No 2 to frame No 7.

Damaged Fuselage by thrown Engine parts

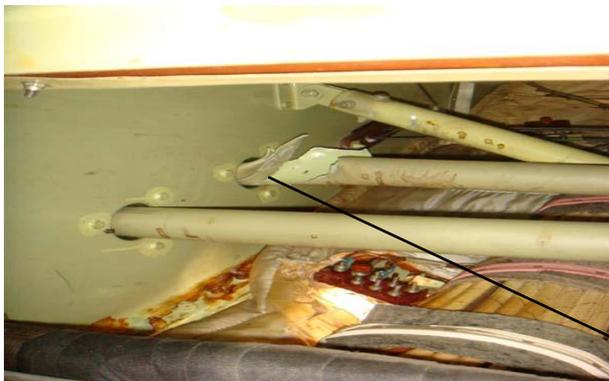
10. The Aircraft control system;  
Two rods of the Aircraft control system 1.7601.5170.800.020 damaged (in the channels of the rudder and the right half-system of the elevator).

Damaged Flight control column by Thrown Engine parts
