FINAL REPORT

**SERIOUS INCIDENT
involving the aircraft
type
MD 88**

**on 31.07.2008
at approx. 17:34 UTC at
Vienna Schwechat Airport (LOWW),
Lower Austria**

GZ. BMVIT-86.047/0001-IV/BAV/UUB/LF/2013

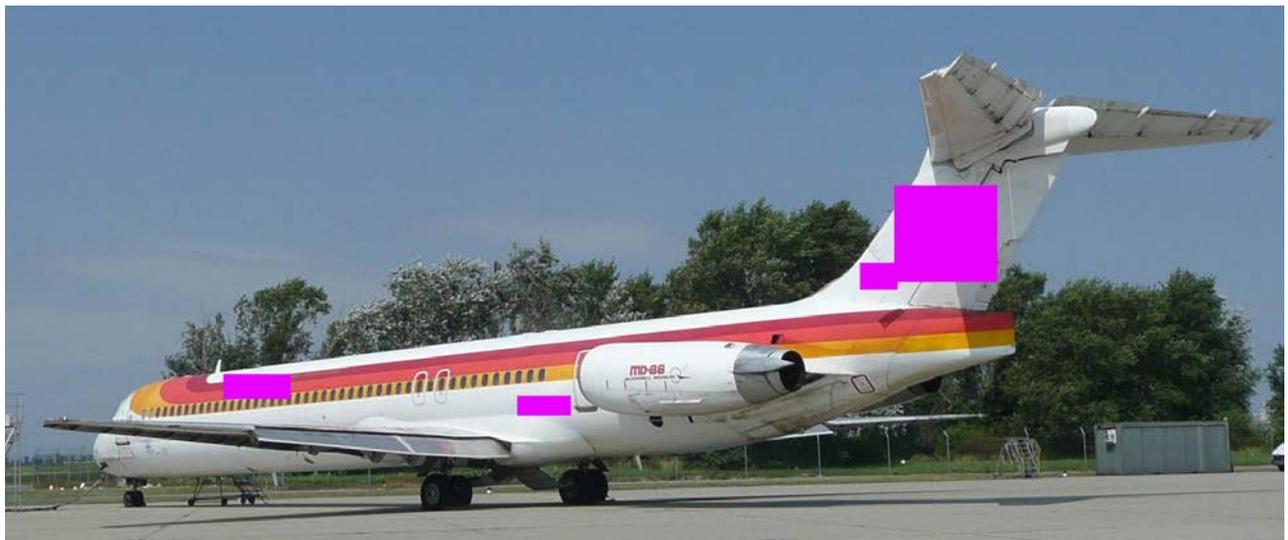
Photo of the aircraft at the incident site on 1.8.2008 with tied up inboard landing gear doors

The left engine was seriously damaged. The left landing flap, the left main landing gear, the two inboard landing gear doors and the area of the left main landing gear well were also damaged.

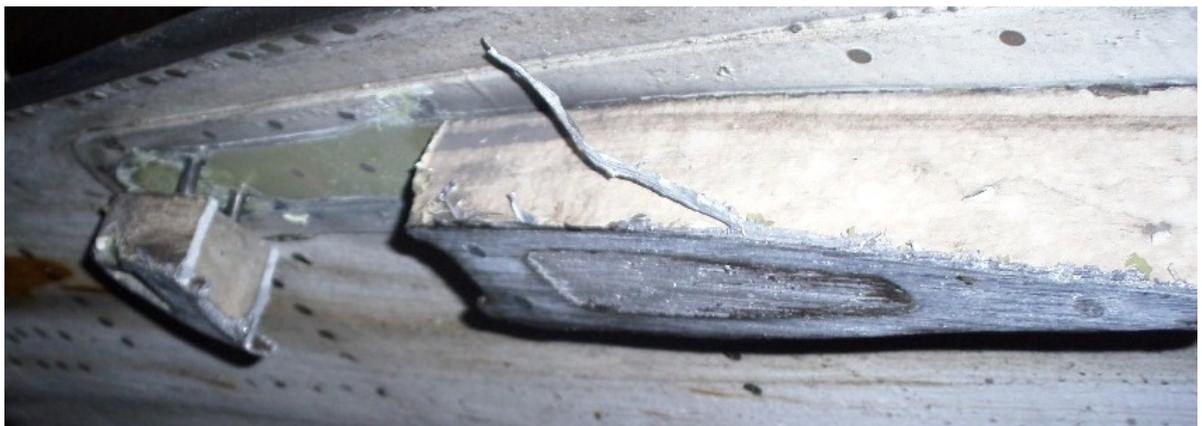
After the aircraft landed on runway 34, the runway inspection found two approx. 20 cm parts of the skid of the left inboard door of the main landing gear.

Photo: Skid on the left inboard landing gear door

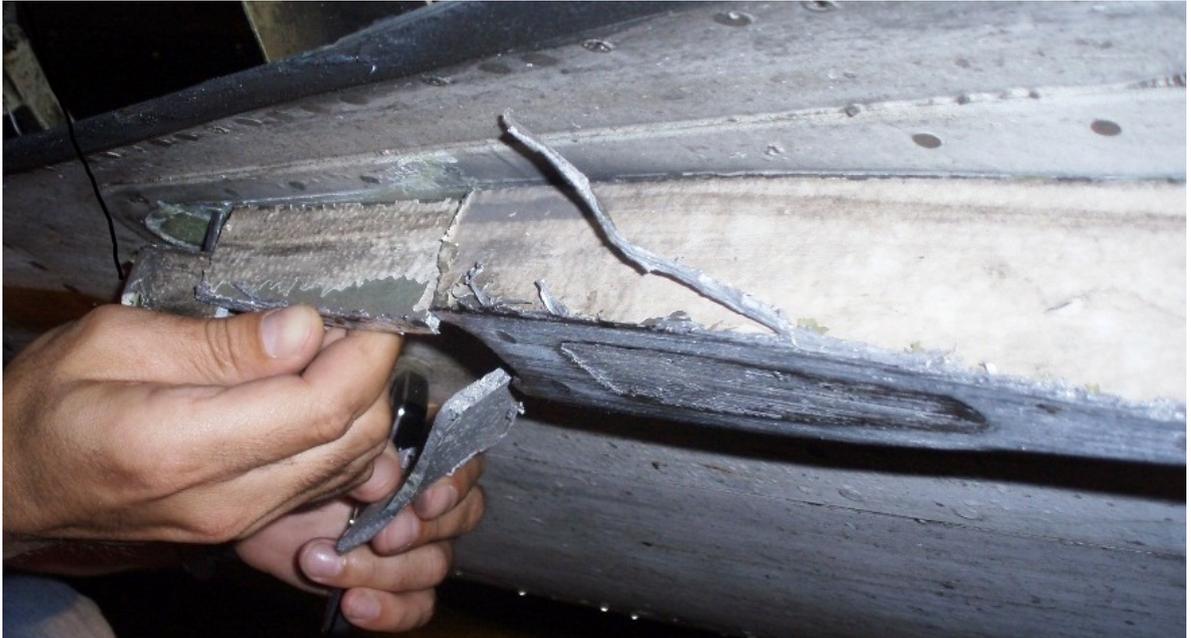
Photo: Skid on the left inboard landing gear door with broken off parts

The bottom of the fairing of the left landing flap was penetrated in the area of tyre 2, where two pieces of tyre tread were found. The skids on the inner landing gear doors of the main landing gear were abraded. The skid on the inboard left landing gear door was broken with two approx. 20 cm long parts missing.

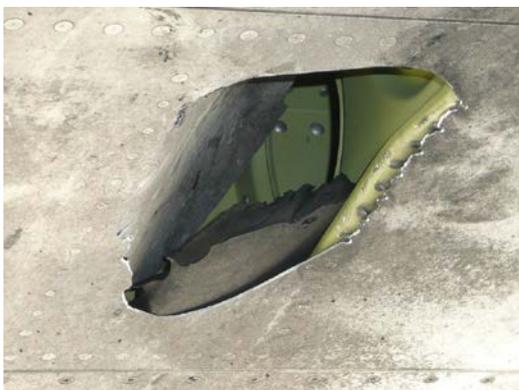
Bottom of punctured left landing flap with part of the tyre tread

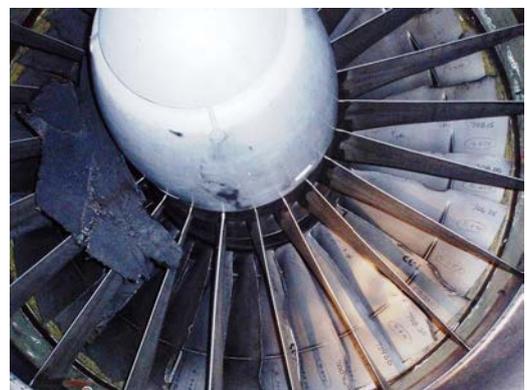
Part of the tread of a tyre was found in the area of the intake ring (FAN) of the left engine. All blades of the first compression stage were deformed or damaged, and the inner and outer intake ring was deformed in several places.

Compressor inlet of left engine with part of the tyre tread, damage to the blades of the blower stage

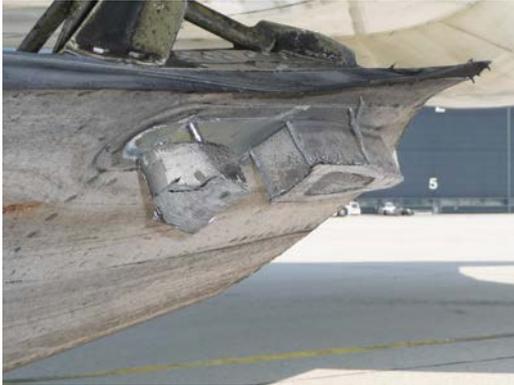
Bottom of the inboard left main landing gear door

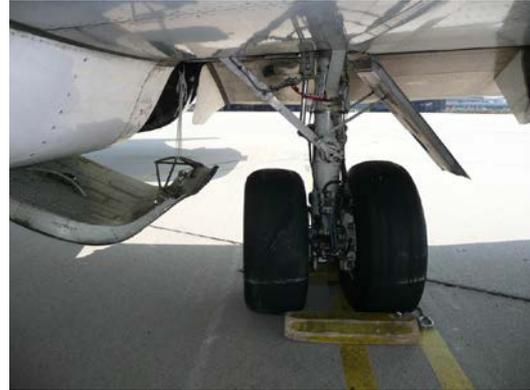
Left main landing gear with tied up, left inboard landing gear door

Tyre 2 was deflated with the tread detached. The water deflector was partly broken off. Tyre 1 had a pressure of 192 psi. The specified pressure is 200 psi. The lower tolerance limit is 190 psi.

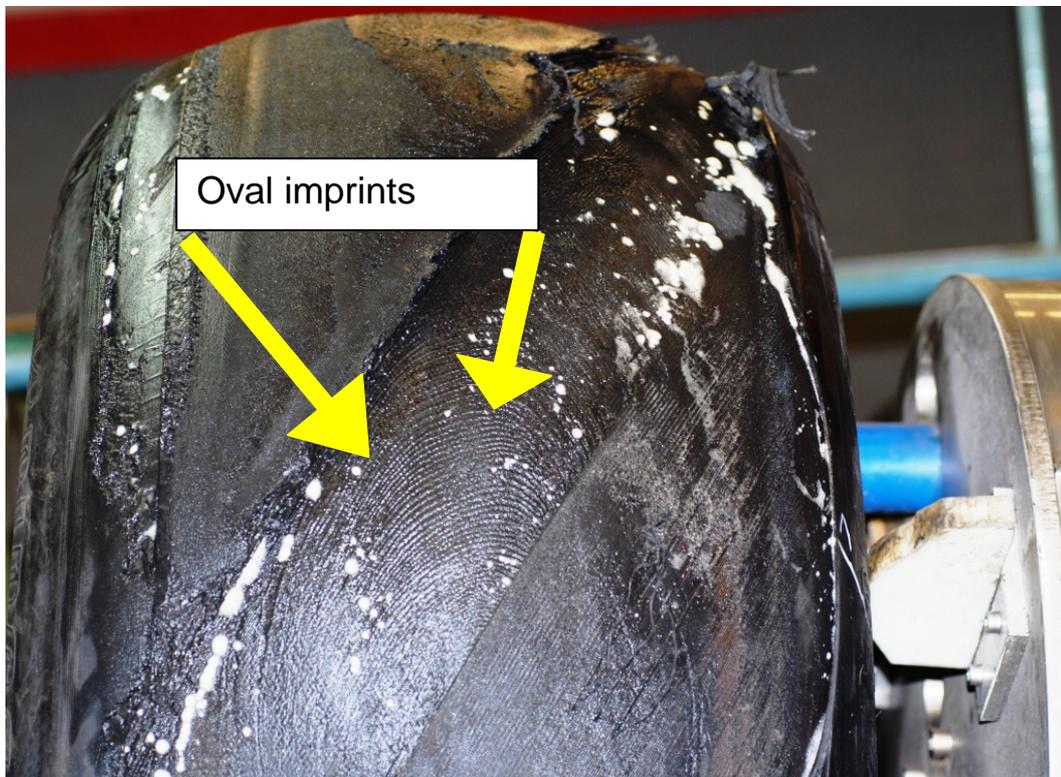
The inspection of the tyre showed that the vulcanised retread had become detached up to and over the shoulders of the tyre.

After the tread of the faulty tyre 2 had become detached, oval, almost concentric imprints were found at a position on both external layers.

Photo: Damaged tyre 2 with typical traces upon detachment of the tread.

The type of detachment of the tread, the oval imprints, the imprint pattern with the oval, almost concentric rings and the cracks in the inner lining on both shoulders of the tyre are typical signs occurring after a loss of pressure. The tyre manufacturer also noted that serious pressure loss in the tyre is sufficient to cause damage to the tyre such as that noted here after **one single take-off** of the aircraft.

The type of detachment, the oval imprints, and the fracture pattern with the oval, almost concentric rings are typical signs of the consequences of loading of a tyre after a loss of pressure. The indications of overload on tyre 1 of the left main landing gear confirm these findings.

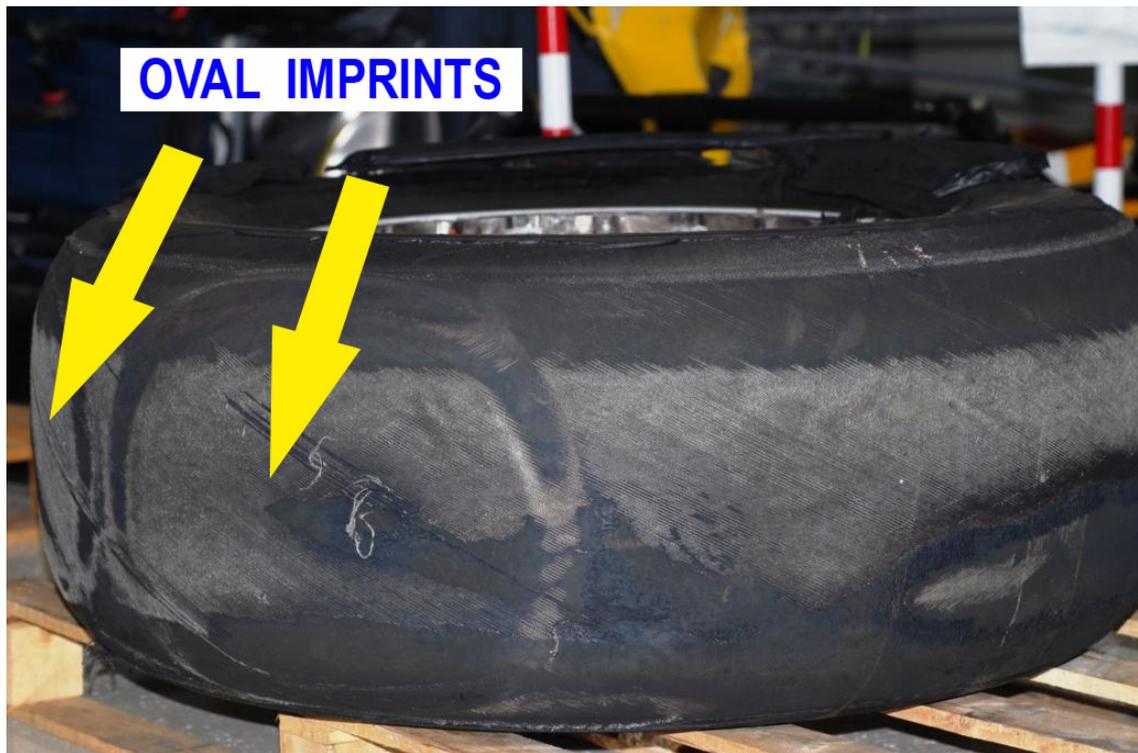
Additional oval imprints were found on this surface of the damaged tyre 2:

Damaged tyre 2 with typical traces of damage from touch down with a deflated tyre.

Oval imprints, which were only formed during final landing, were found on the remaining surface. An oval-shape fracture pattern could also be found, from the centre of which the tread detachment started.

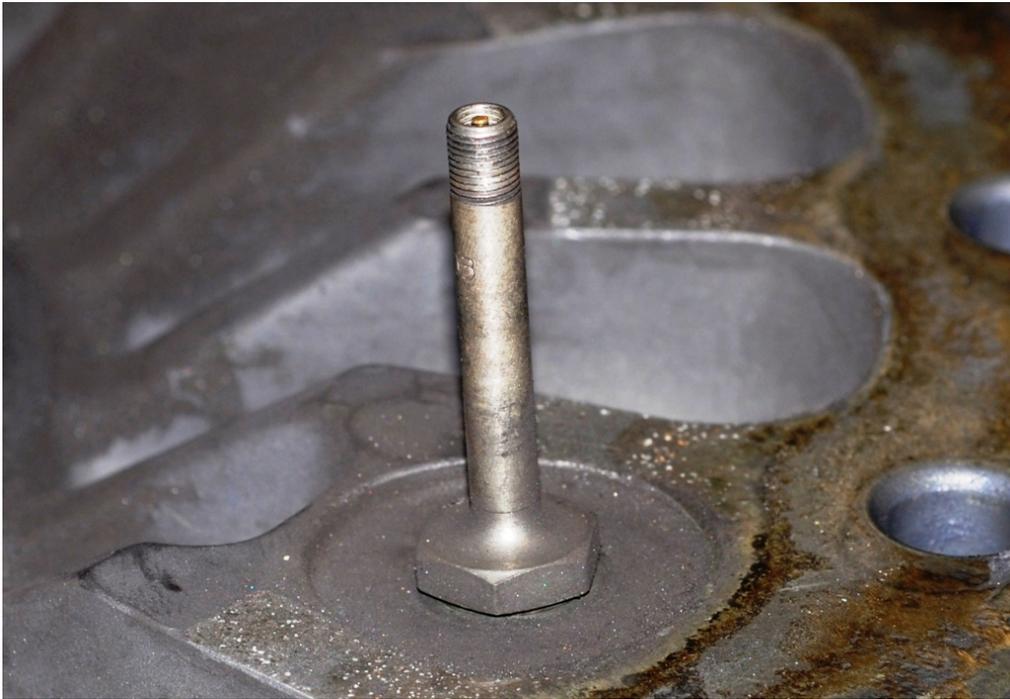
Rim part of tyre 2 with valve stem screwed in

It was found that the thread of the valve stem with P/N TR761-3 was not locked to prevent unscrewing. Locking is not specified or planned.

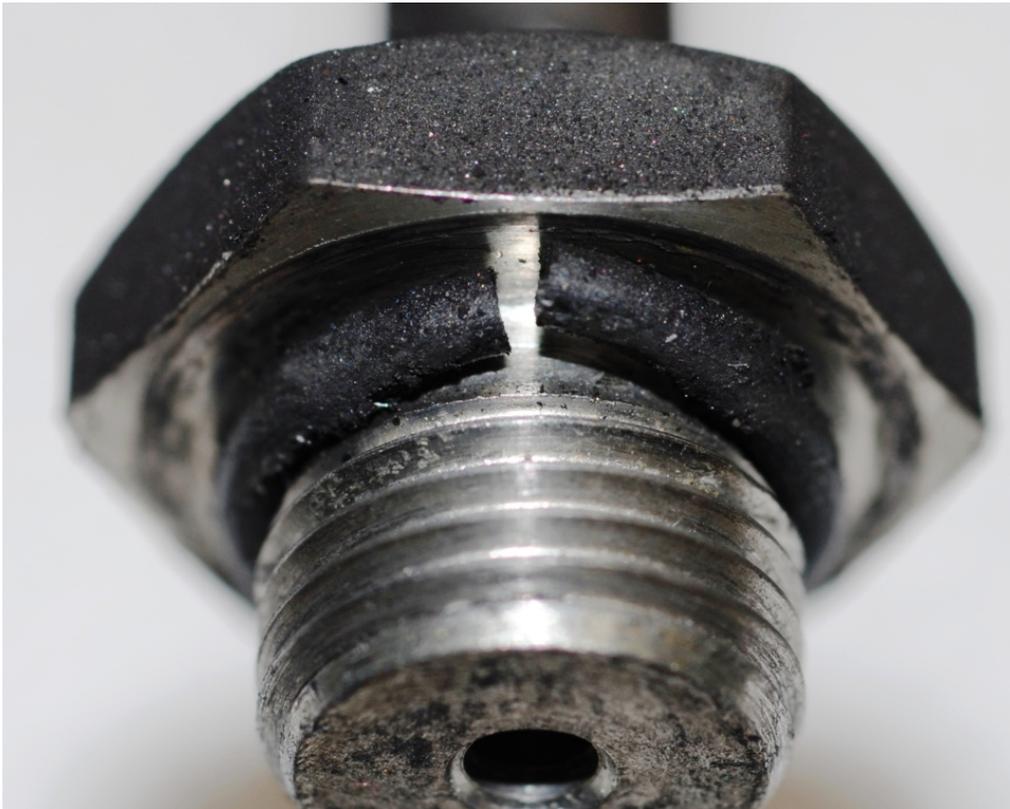
After landing, the valve stem was found to be only hand-tight, and the O-ring beneath it was porous and broken.

Photo: Bottom of the valve stem of tyre 2 with porous, broken O-ring

The microscopic inspection of the O-ring showed that it was brittle and slightly greased on one side only. Impurities (probably brake dust) were found on the outer part.

The inspections after the incident showed that the unsecured valve stem could be unscrewed manually. The O-ring under the valve stem was broken, brittle, virtually ungreased and contaminated on its outside, probably with brake dust.

Because the O-ring was porous, probably due to ageing, it can be concluded that the O-ring was not replaced when the tyre was mounted. This is contradictory to the statements of the company regarding the alleged replacement of the O-ring when the tyre was replaced on 11.7.2008.

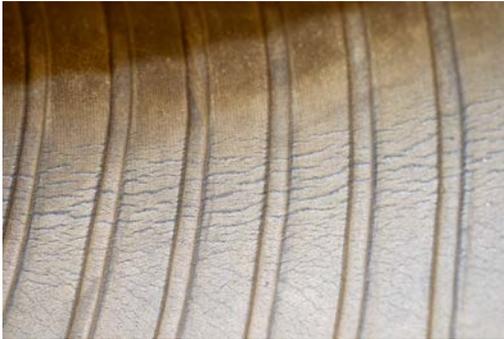
The visual inspection of the sidewalls of the tyre found cracks, also on the inside and outside shoulder of the inside liner. The visual findings were confirmed by shearography.

The cracks are typically found in tyres mounted in pairs if a single tyre is required to support the load of both tyres.

Detail view of inside layer of outer
(left) shoulder

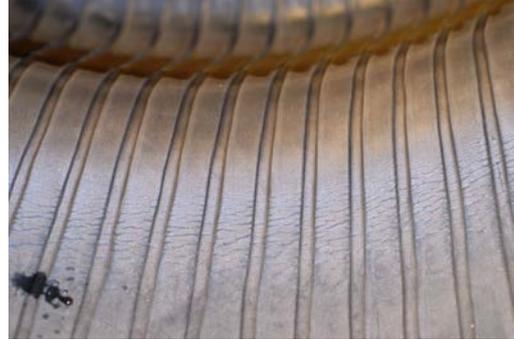
Detail view of inside layer of inner
(right) shoulder
