CIAIAC

Report A-032/2008

Accident involving a McDonnell
Douglas DC-9-82 (MD-82)
aircraft, registration EC-HFP,
operated by Spanair,
at Madrid-Barajas Airport,
on 20 August 2008

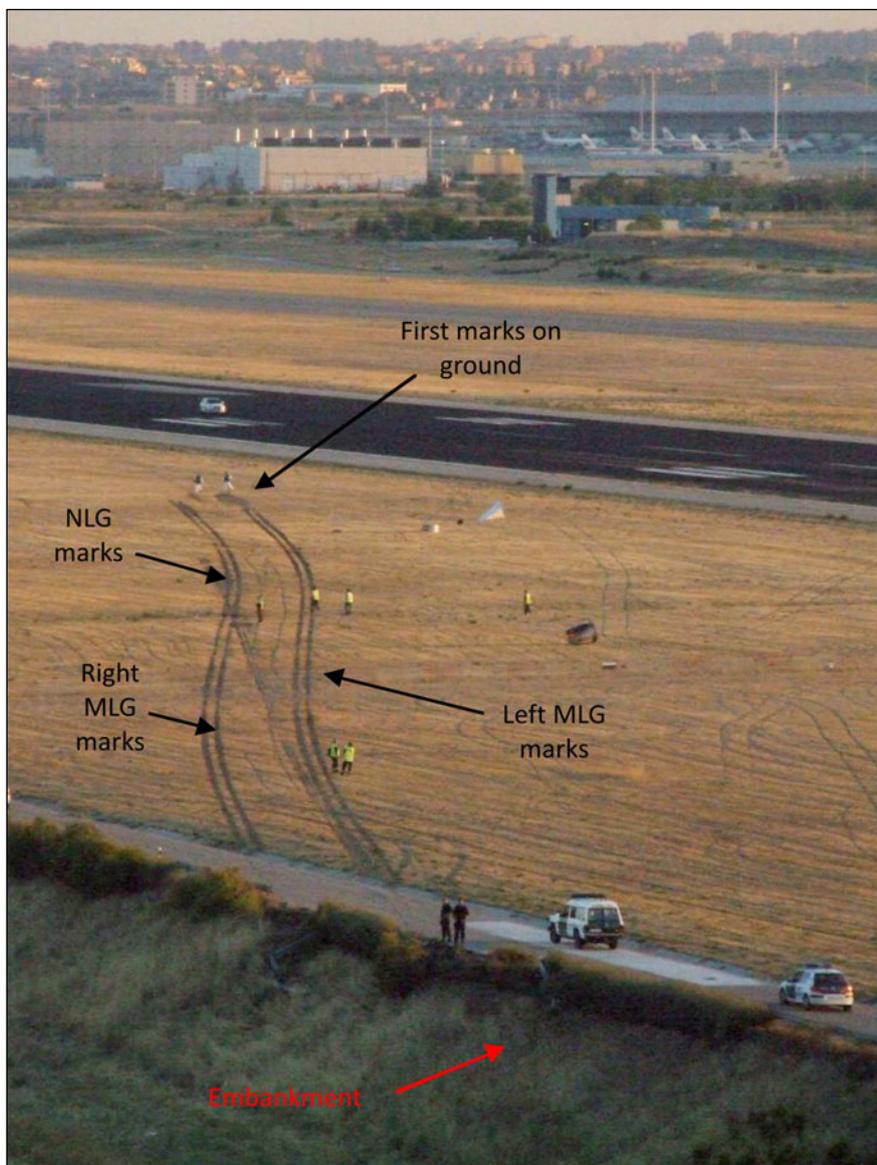
The aircraft continued to travel along the ground for 448 m until it reached the edge of the runway strip. The tracks left by the main legs veered slightly to the right first, then to the left. The nose gear track, which was initially to the right of the right main gear track, remained straight practically throughout its entire length, crossing the MLG right track and almost meeting the left gear track at the end of the run. The path of the aircraft on the ground was at a 16° angle with respect to the runway centerline.

Figure 12. Tracks left by the aircraft as it traveled over the runway strip

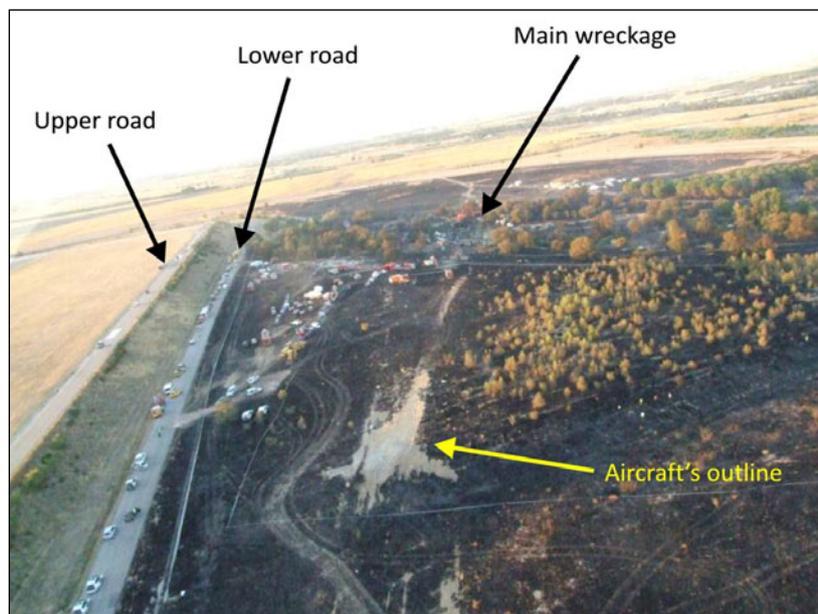
The airplane continued moving and a bit further forward the nosegear dug into the ground, which caused the aircraft to rotate first to the right about the gear, and then immediately about its longitudinal axis. During this rotation the aircraft disintegrated.

Figure 13. Aerial view of the path taken by the aircraft, showing the outline left by the aircraft on the ground

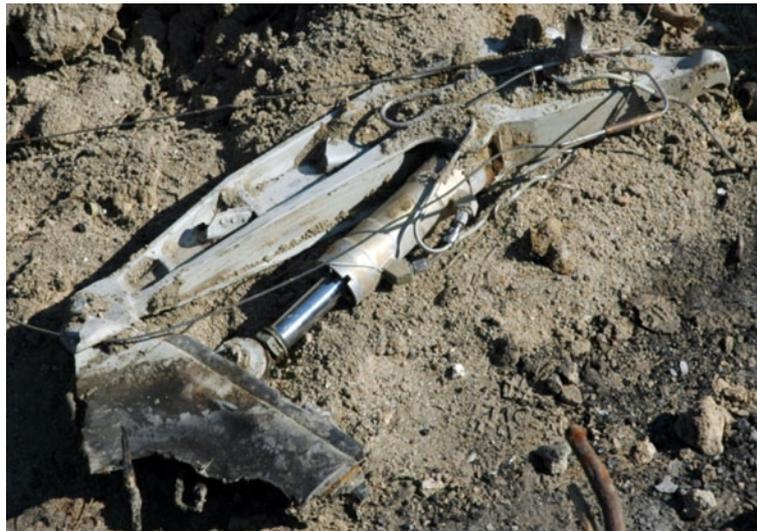
Five (5) flaps actuators, three (3) from the right wing and two (2) from the left, were found and identified at the crash site. Since they had lost hydraulic pressure, four (4) of these actuators could be extended and retracted by hand, while the fifth exhibited significant damage from the fire that engulfed it after it detached from the wing structure. Though it was not jammed, it did not move freely and could not be moved by hand.

Figure 14. Part of outboard left flap and central actuator

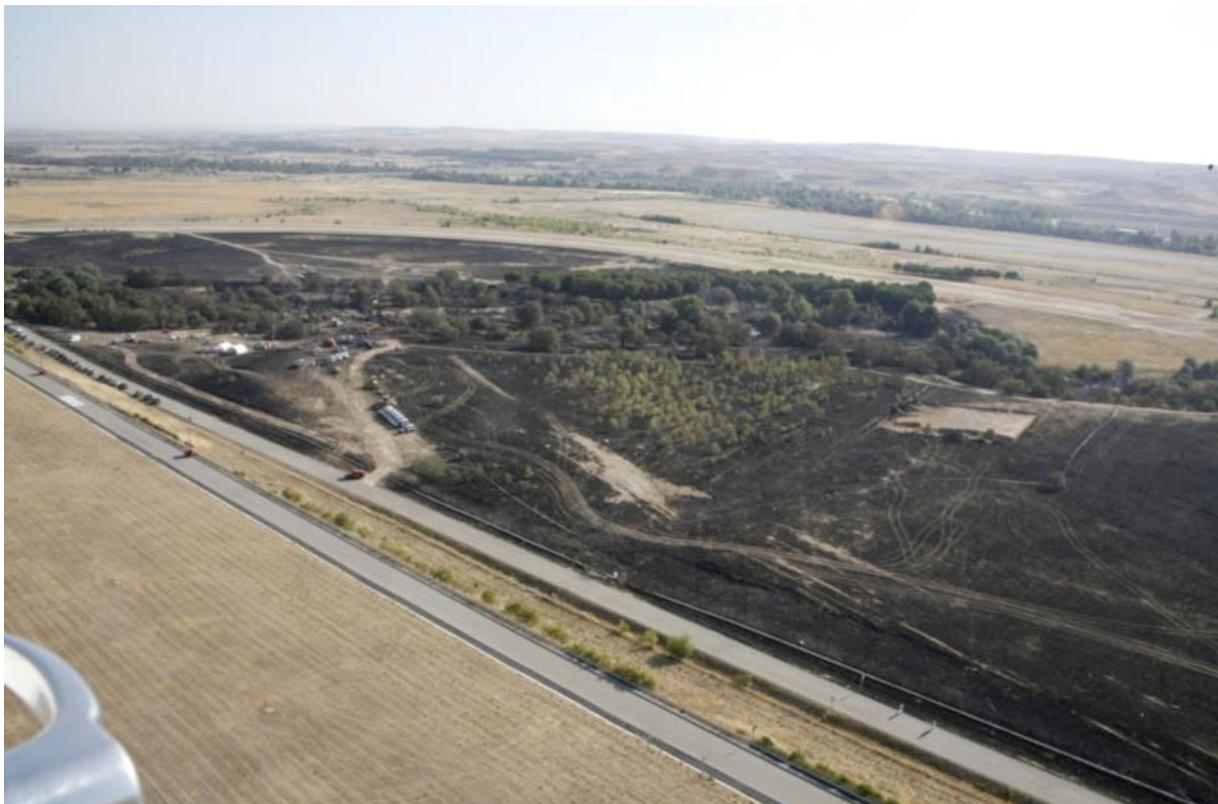
The affected terrain held a total of 817 trees scattered over a 26-Ha area. Mixed among the trees were smaller shrubs with woody trunks and grasses. The area was fringed by a network of roads that acted as a fire barrier.

Figure 17. Aerial view of burned area

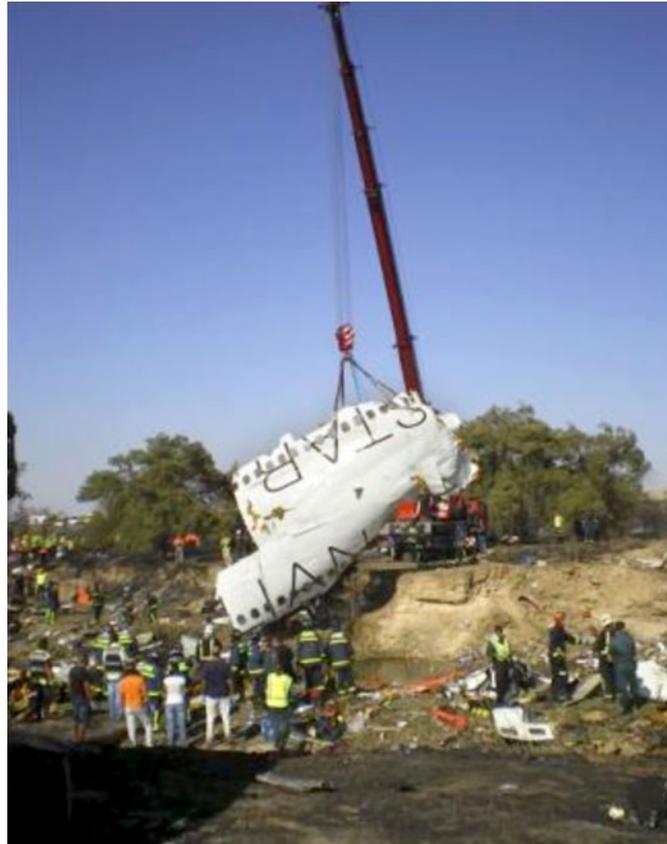
Most of the forward section of the passenger cabin, corresponding to the front third of the fuselage (first 17 rows), was found overturned in the stream. The internal components had been crushed vertically and the seats were upside down. It was the only part of the aircraft that retained its shape (see Figure 18). The aft two-thirds of the aircraft all the way to the pressure bulkhead were destroyed by the fire (see Figure 19). Only the lavatory and aft galley sections were recognizable (see Figure 20).

Figure 18. Top front part of the aircraft

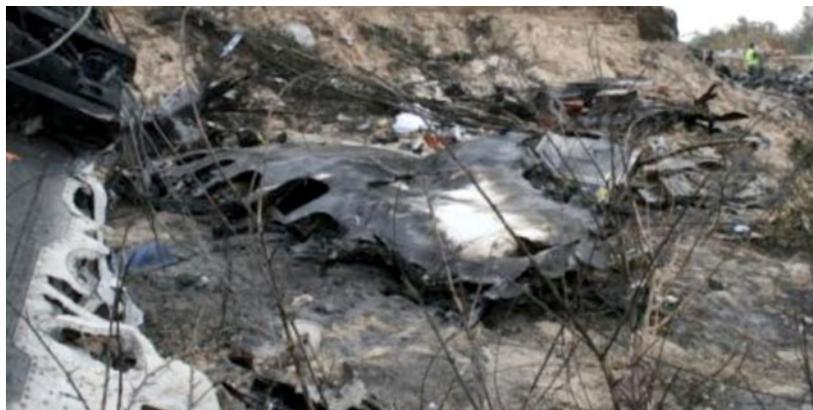
Figure 19. Passengers cabin wreckage

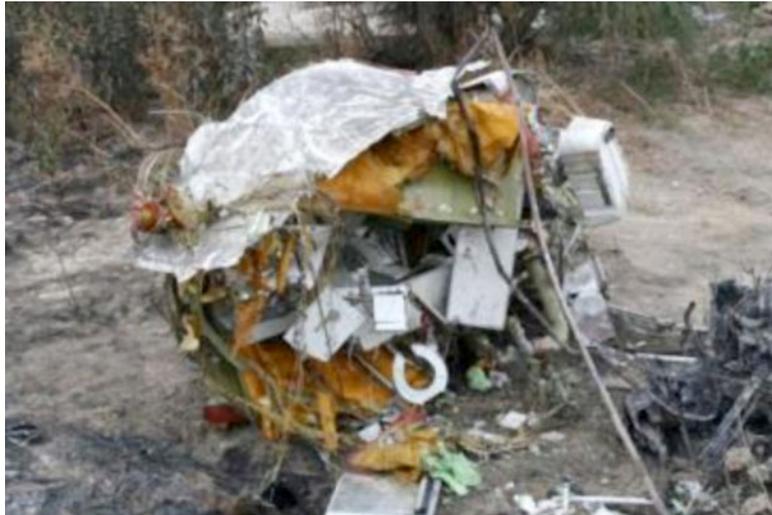
Figure 20. Aft galley

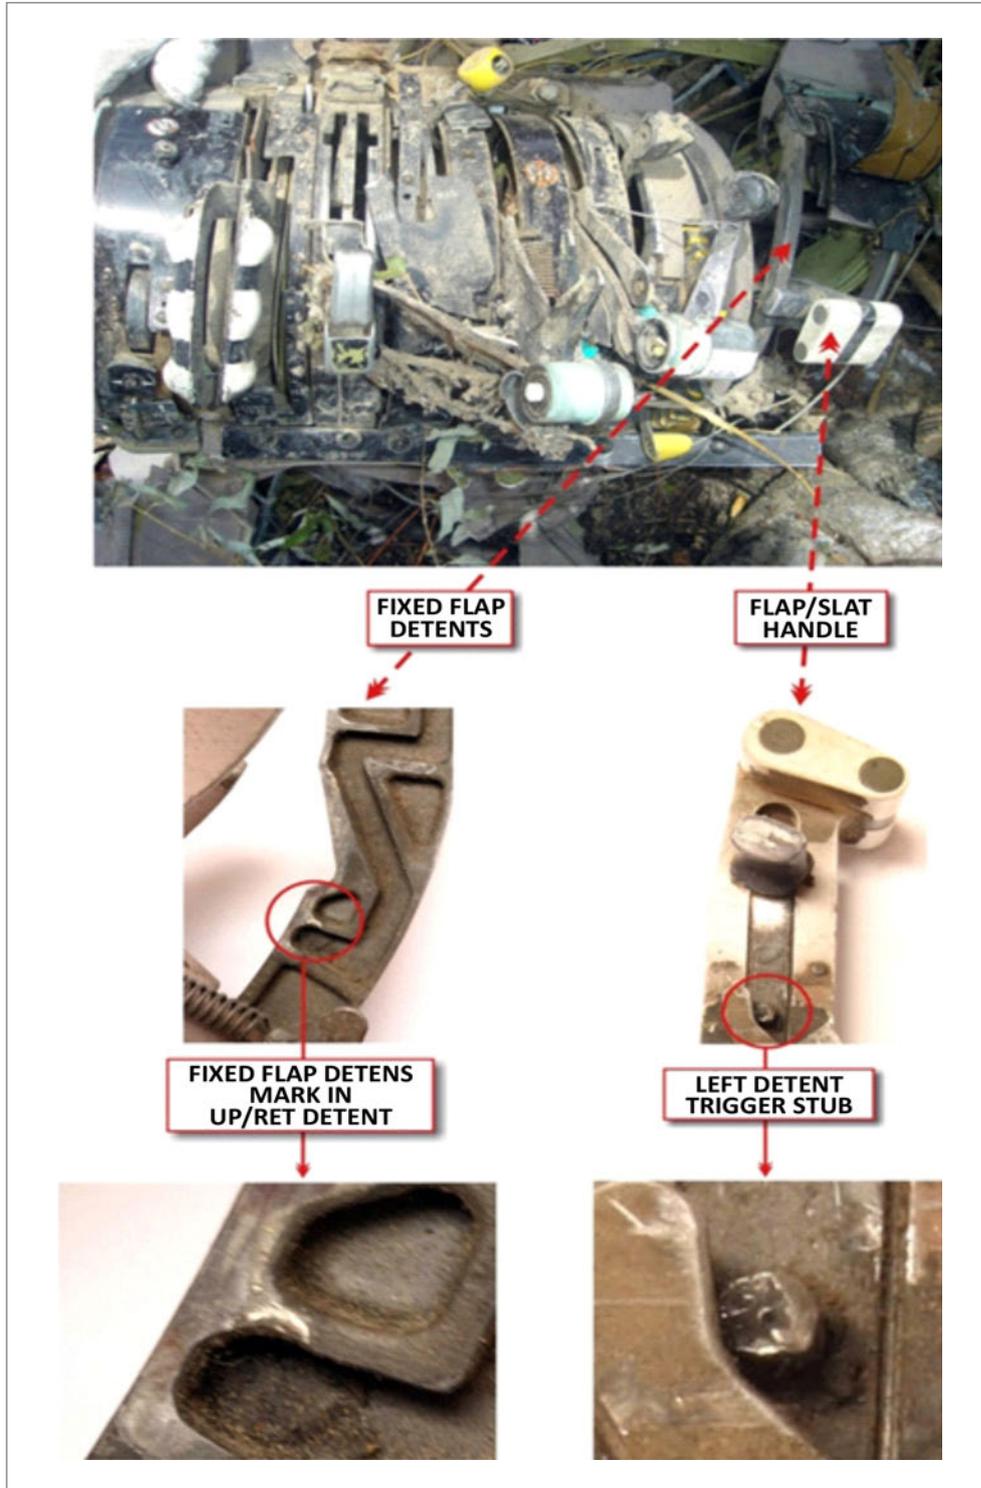
There was damage to the various components that comprise the flap/slat control lever. In particular, the stub that marks the fixed positions exhibited significant damage to its flat outer surface and to its cylindrical surface.

After both components were studied, it was determined that the mark evident on the track probably resulted from a strong impact of the stub that marks the fixed positions on the flap/slat lever against the track and subsequent relative movement between the stub and the track.

These signs are consistent with the flap control lever being in the UP/RET position at the time of said impact between the stub and the track.

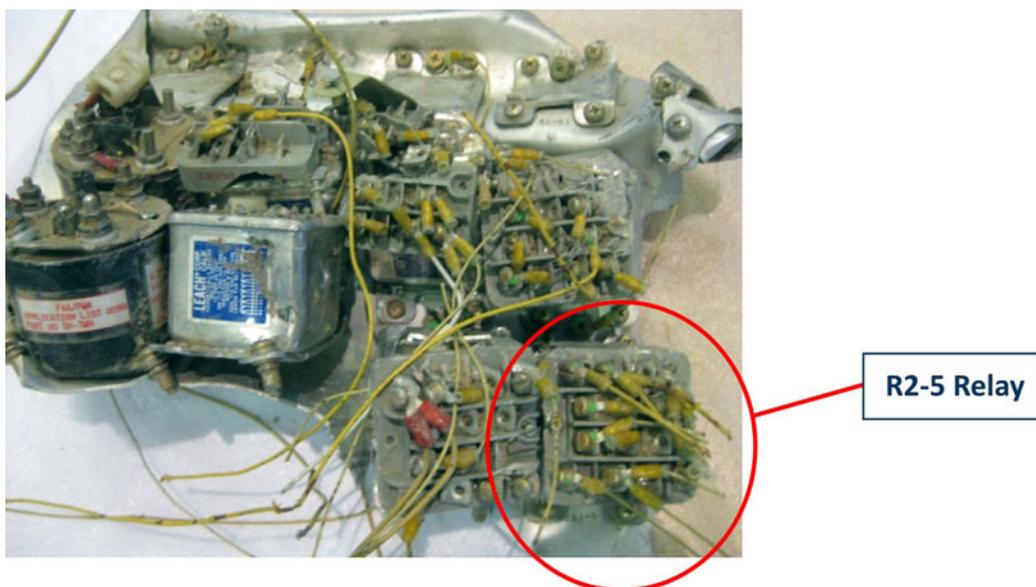
The R2-5 relay was inspected to determine if it could have failed. During the initial analysis, it was subjected to a visual inspection, a borescope inspection and a radiographic test. It was also subjected to continuity and functional tests. During a subsequent analysis, involving the CIAIAC and conducted under judicial oversight, the outer casing was opened so that its internal components could be studied in detail. The continuity and functional tests were repeated, before and after the casing was opened, and the internal components were subjected to a visual inspection. The electrical characteristics of these components were also measured. During a third analysis, in which the CIAIAC also took part and also under judicial oversight, continuity and functional tests were carried out in a thermal chamber. The material on contacts C2 and C3, where possible deposits had been observed, was also studied.

Figure 23. Recovered relay assembly housing R2-5

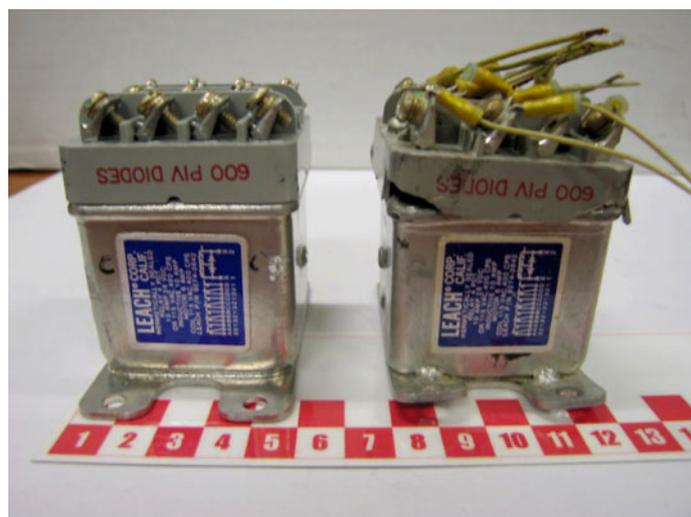
Figure 24. Comparison between the recovered relay and a new one of the same model

during the conduct of this test, the relay installed in the R2-5 position of the aircraft's ground sensing system operated abnormally.

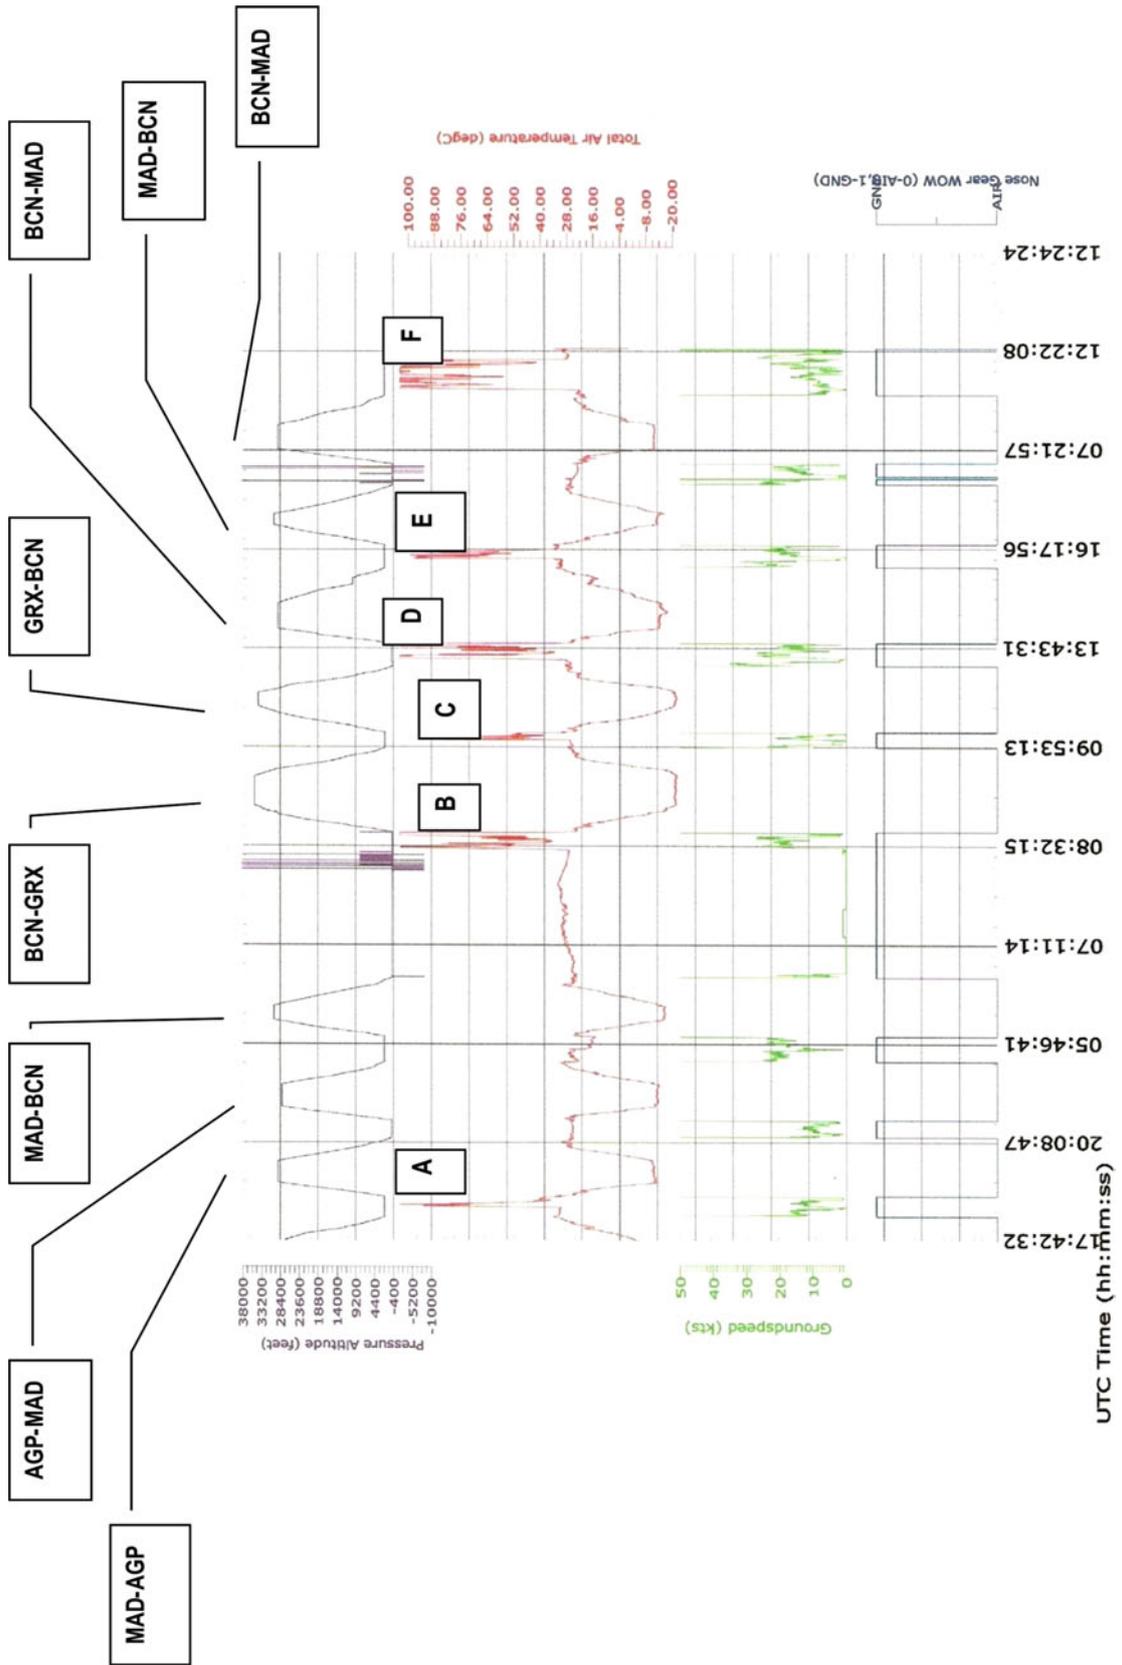
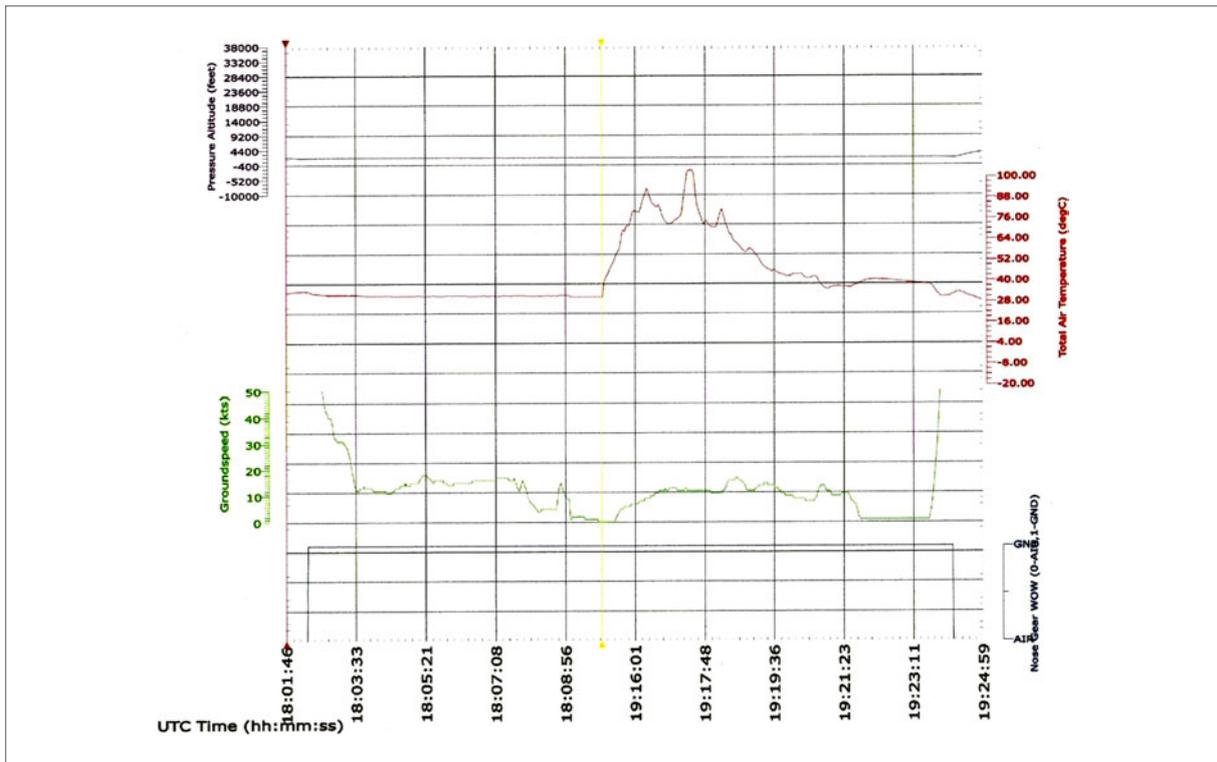
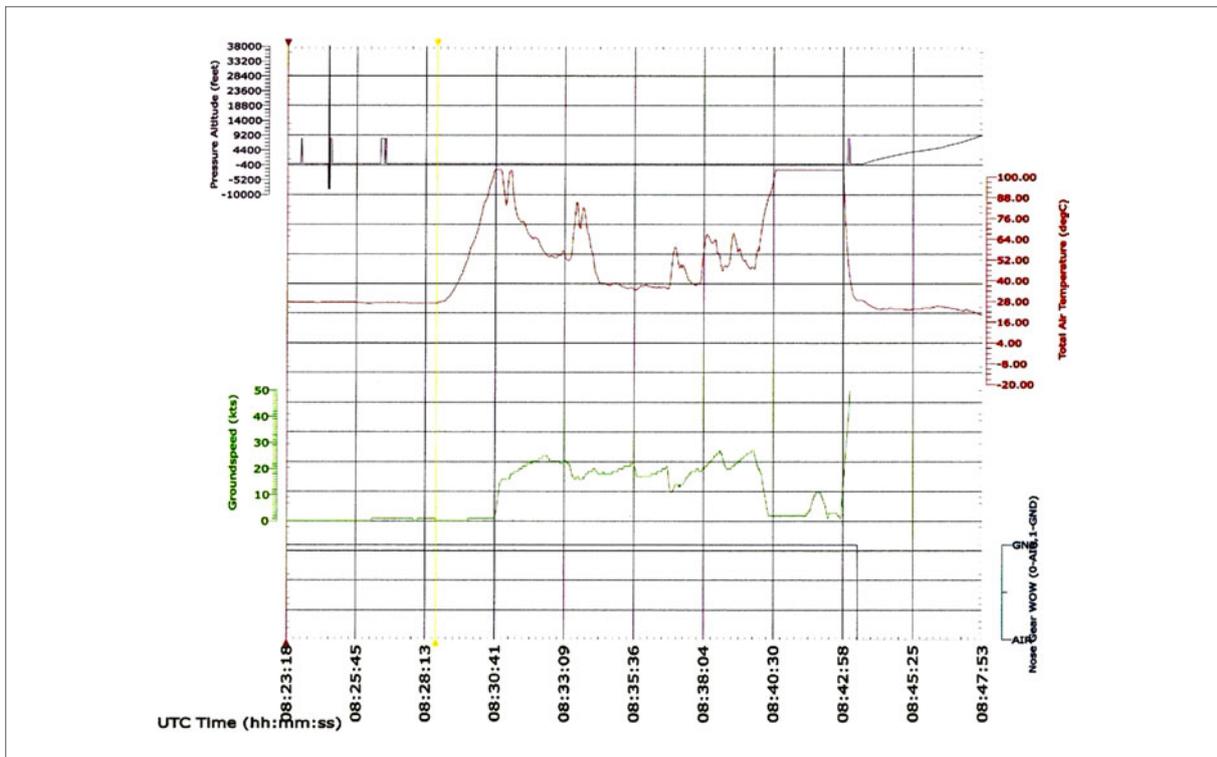
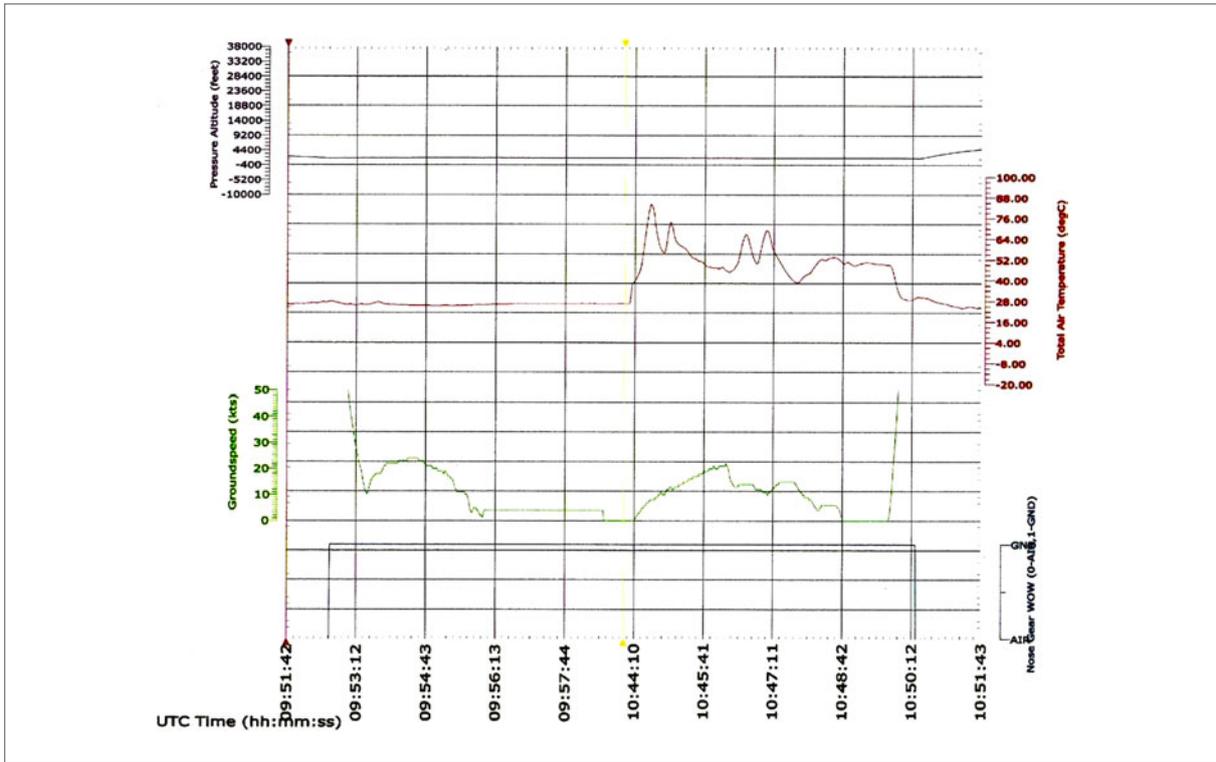
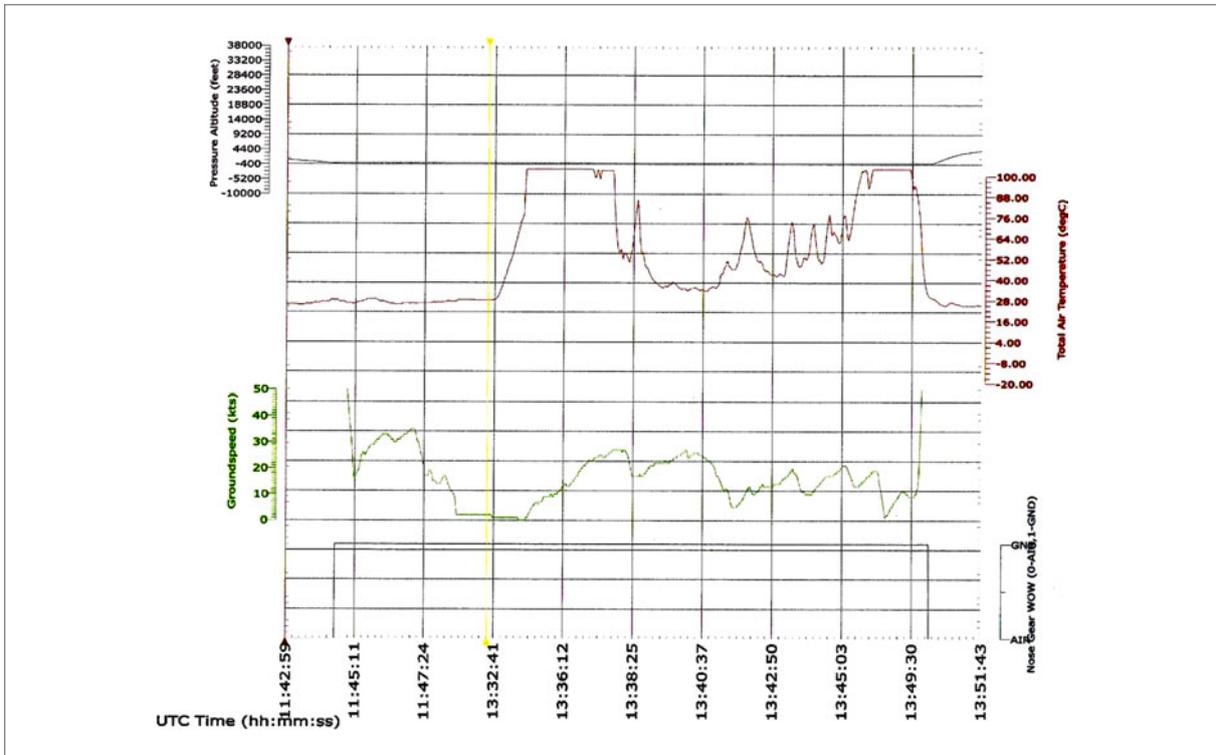
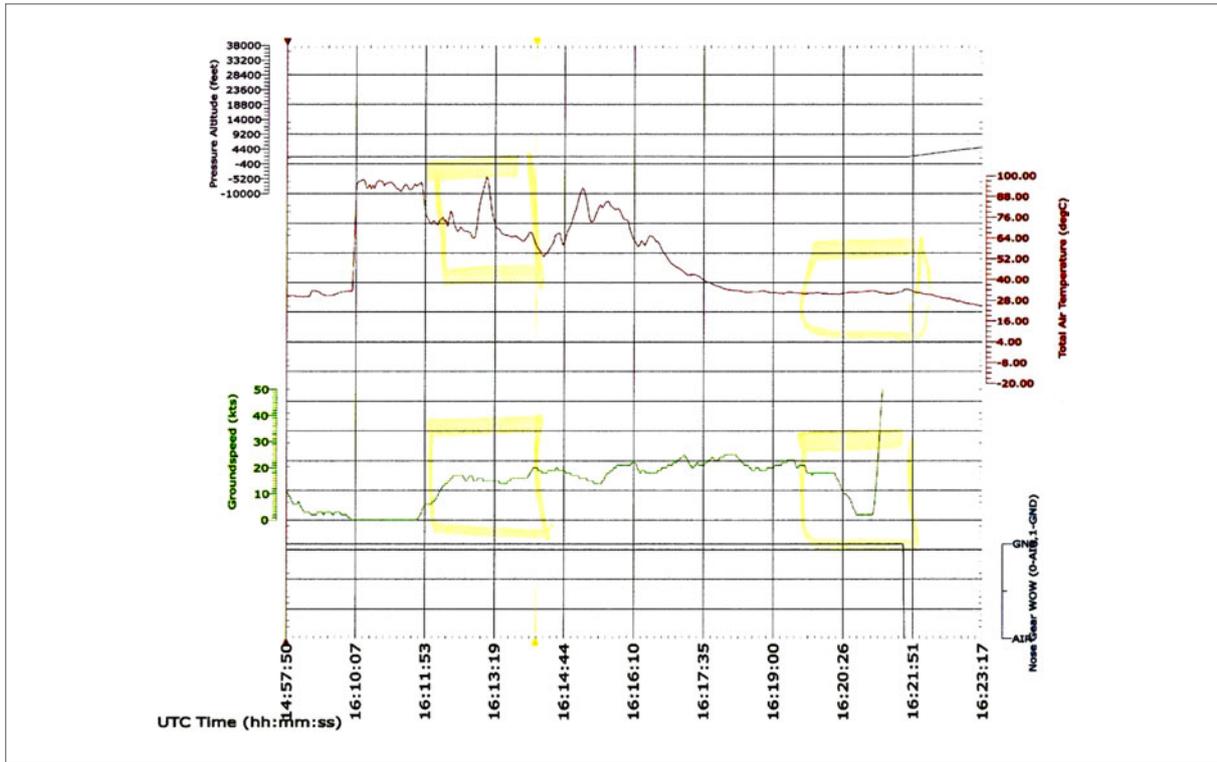
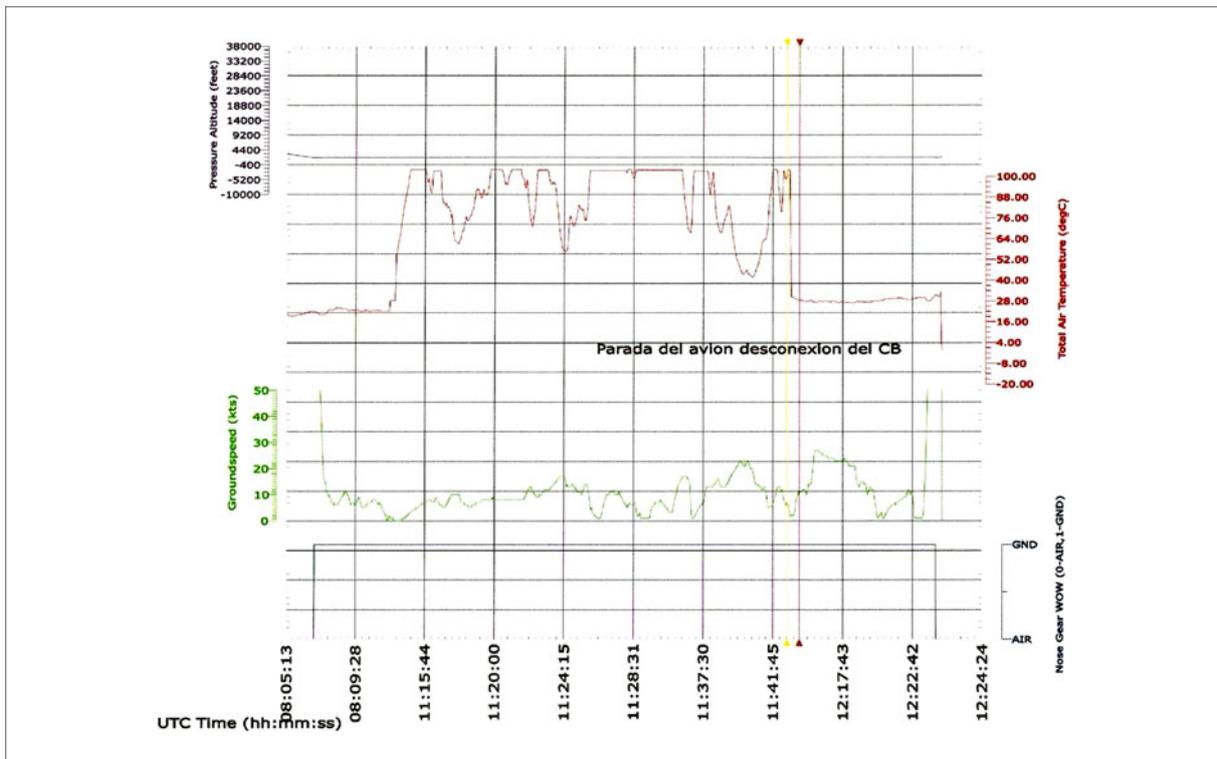
As already noted in Section 1.6.4.2.1, “Excessive RAT probe temperature indications”, between 18 and 20 August 2008, six instances of high RAT probe temperature indications were recorded on the DFDR with the airplane on the ground. In the remainder of the DFDR recording, corresponding to days prior to 18 August, no high temperature readings were recorded. These six cases have been identified with the letters A through F, both in the table showing the chronological analysis in the section “Excessive RAT probe temperature indications” and in the figures shown below. The time used in the graph is UTC.

Figure 25. High RAT probe temperature events recorded on the DFDR

The crews only logged three of the six high temperature indications in the airplane's ATLB. Each of these entries was made by different crews. The first two were made on 19 August and the last on 20 August 2008.

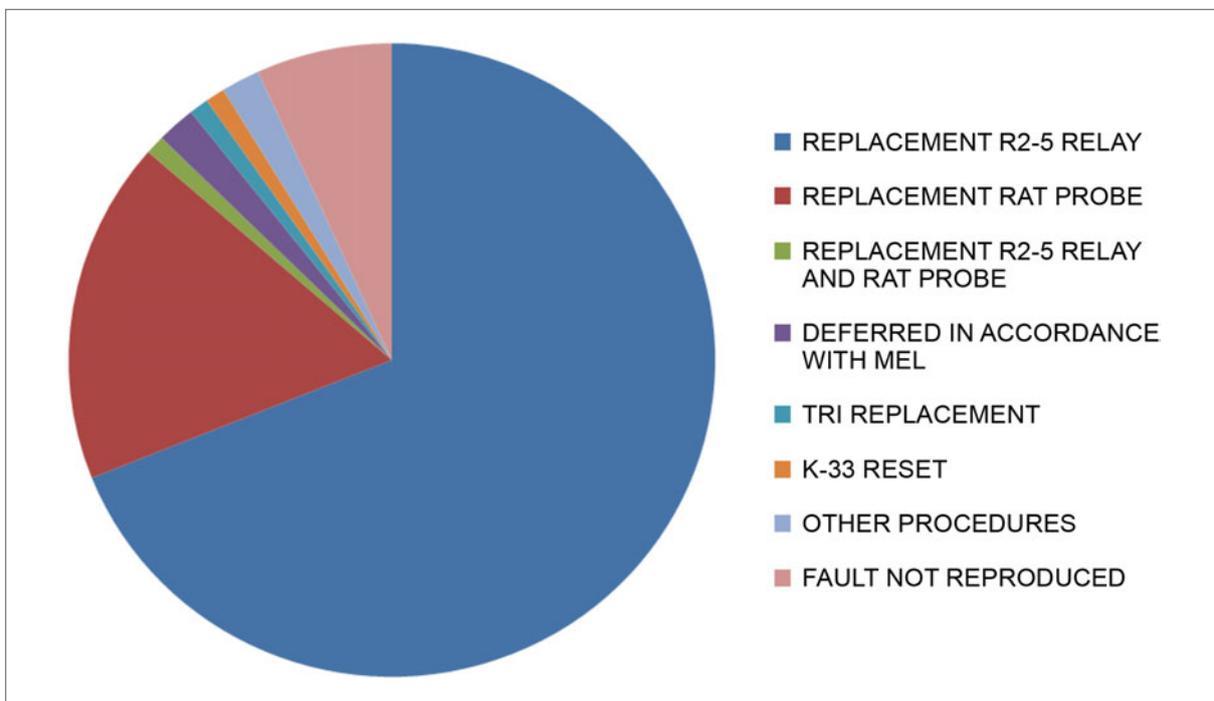
- 71 were solved by replacing the R2-5 relay.
- 18 by replacing the RAT probe.
- 1 by replacing both R2-5 and the RAT probe.
- 2 were deferred in accordance with the MEL.
- 1 by replacing TRI (*Thrust Rating Indicator*)

Figure 29. Previous high RAT probe temperatures on the ground. Cases compiled by Boeing (from 2000-2008)

- 1 by resetting the LH Ground Control relay (K-33).
- 2 by way of other maintenance procedures, and
- In the remaining seven cases the fault could not be reproduced.
