FINAL
KNKT.08.08.12.04

Aircraft Serious Incident Investigation Report

PT. Sriwijaya Airline
PK-CJG
Boeing Company 737-200
Sultan Thaha, Jambi,
Republic of Indonesia
27 August 2008

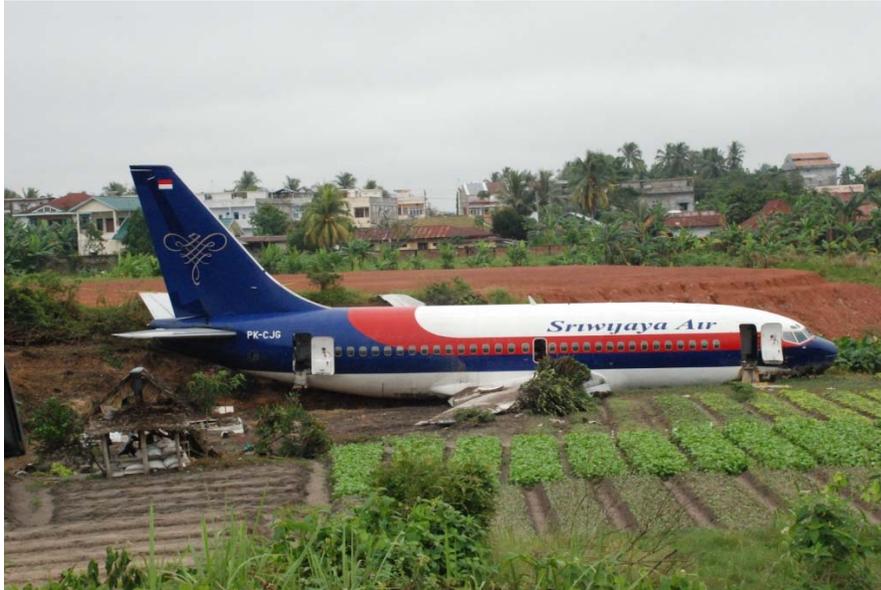
Figure 2: The last aircraft position and condition

All crew and passengers safely evacuated the aircraft. No significant property damage was reported.

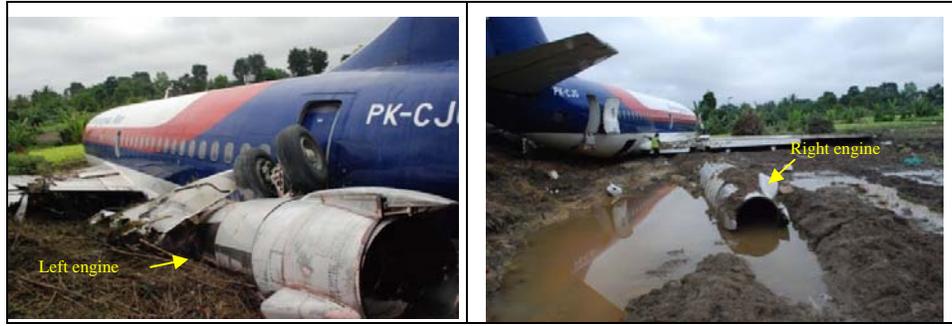
Figure 3: Showing both engines detached

The aircraft was substantially damaged. Both engines had detached from the pylons, and the left main landing gear had separated and blocked the left rear door. The nose raddome and the nose landing gear also detached.

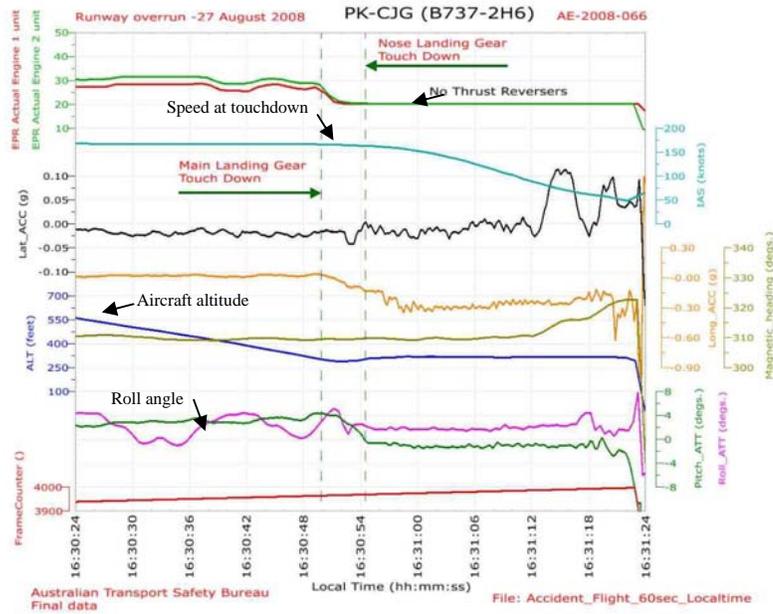
Figure 5: FDR data graph from aircraft altitude 500 feet until end of recording

The FDR graph shows that, when the aircraft was 550 feet, the aircraft speed was 171 kts and slight rolled to the left and right in average to 4°. At touch down the aircraft speed was 165 kts (Figure 6).

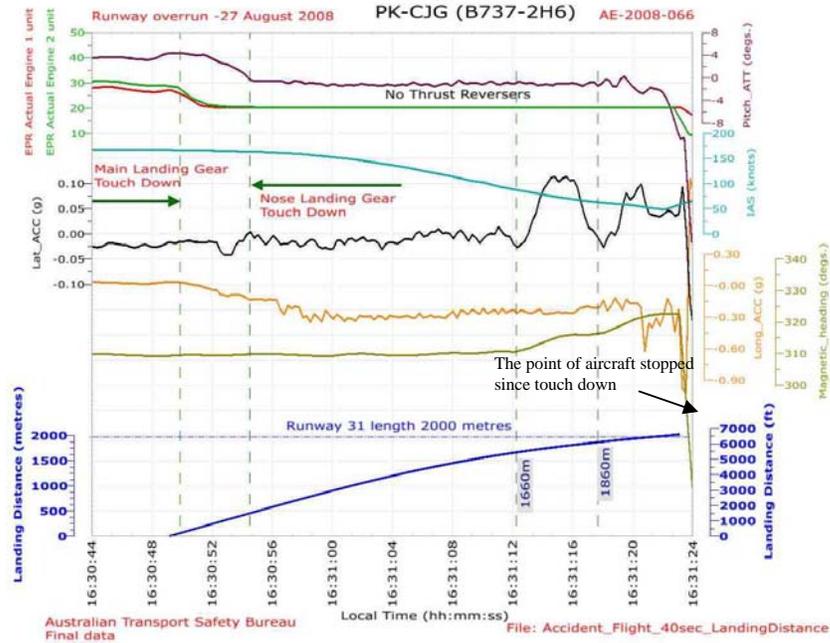
Figure 6: The FDR data graph indicated the distance from touchdown to stop

The graph shows that after the aircraft main and nose landing gear touched down, there was no reverse thrust, the heading remained relatively steady on 310° and then changed to approximately 320° after the aircraft rolled 1660 meters and then stopped at 2020 meters which was the end of the recording.

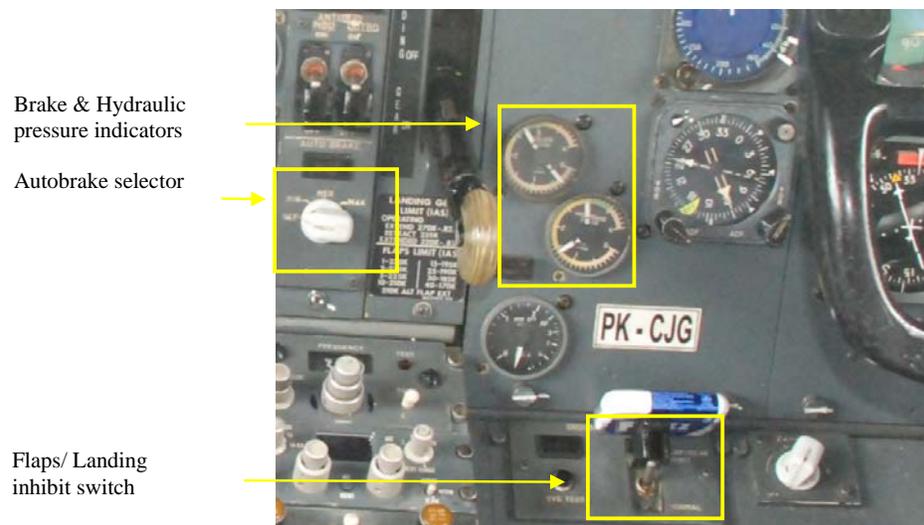
Figure 7: **Hydraulic system indicator and auto brake selector**

The yellow boxes in Figure 7 shows the Auto brakes off, flap/ landing gear inhibit guard switch opened and brake pressure and hydraulic pressure system B on green band while on system A loss.

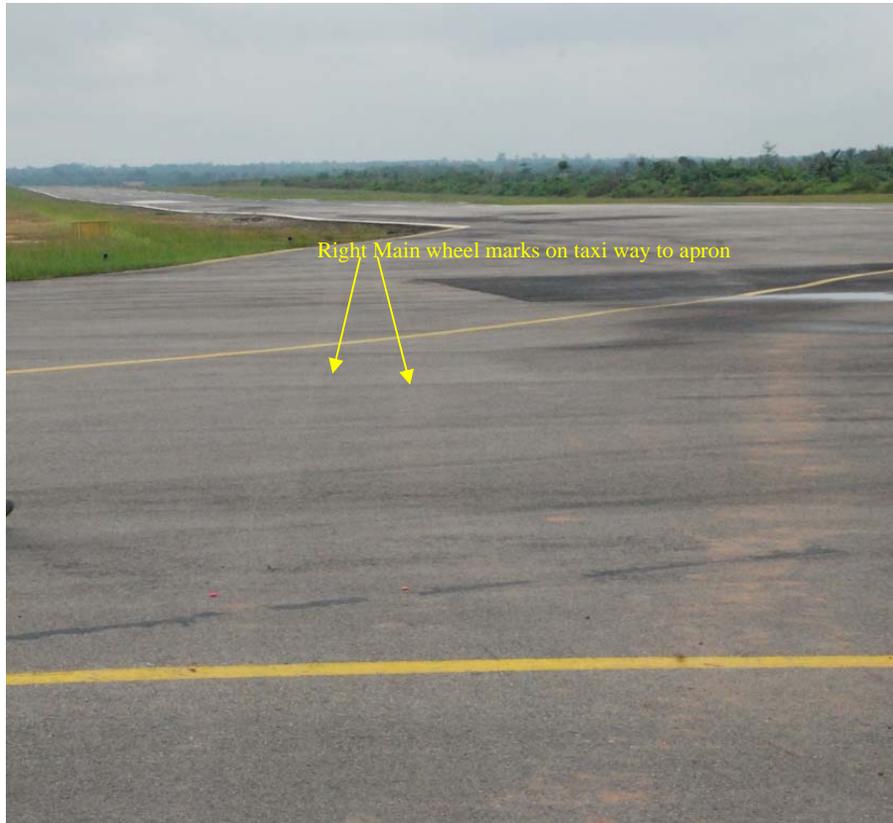
Figure 8: Main wheel marks on the taxiway to apron

Wheel marks were found at about 200 meters before the runway end and continued 120 meters past the Runway End Safety Area (RESA) until the aircraft came to rest (Figures 7 to 9).

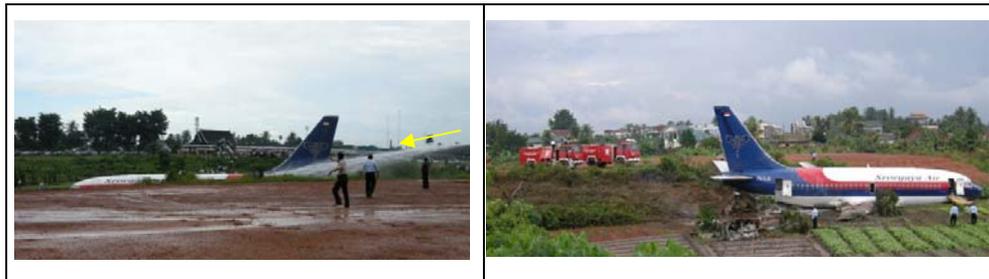
Figure 5: Shows during and after the ARFF operation

The Airport Rescue and Fire Fighting (ARFF) arrived at the crash site during the passenger evacuation and sprayed extinguisher agent to the tail section of the aircraft at 09:38 UTC.

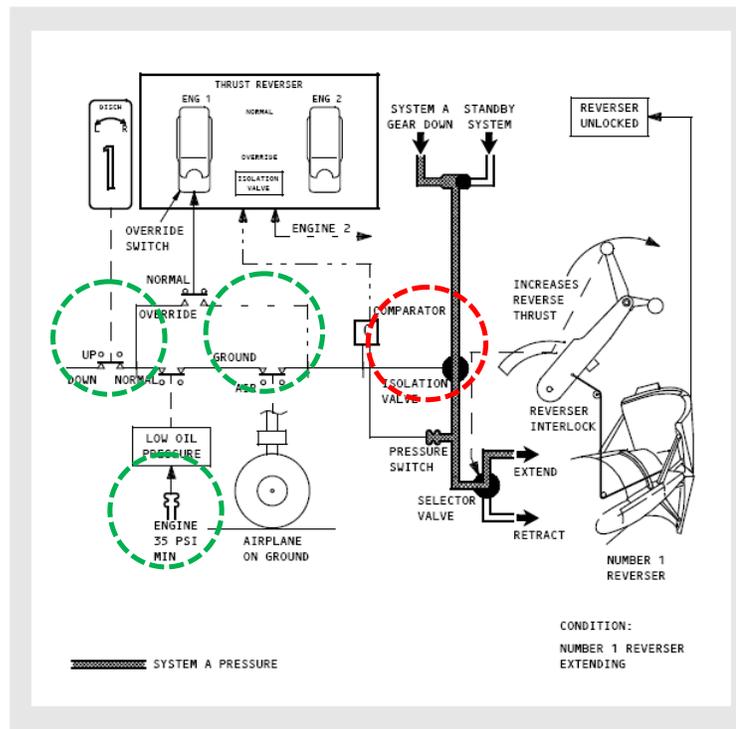
Thrust Reverser Schematic

circuit including the nose gear, or main gear air/ground safety sensors (the three green circles). If all three electrical conditions are satisfied, the solenoid will be held in the open position (red circle) and allowing the thrust reversers to deploy.

Referring to FCOM 7.20.8 the Reverse thrust is accomplished by two doors which block engine exhaust and deflect the exhaust flow forward. The doors operate by system A hydraulic pressure through the gear down hydraulic line. Alternate operation at a reduced rate is available with the standby hydraulic system (the reverser may not stow). With the engine fire warning switch down and the engine low oil pressure switch sensing pressure, an electrical circuit including the nose gear, or main gear air/ground safety sensors, allows the thrust reversers to deploy. When all three electrical conditions are satisfied, the isolation valve will be solenoid-held to the open position. Loss of any electrical condition will cause the isolation valve to spring closed. The selector valve is controlled by the reverse thrust lever and directs hydraulic pressure to unlock, extend, retract or lock the doors.

The condition of the spoilers stowed, smooth landing and higher landing speed created less stress on wheels which led to the reversers could not be deployed.
