**INTERSTATE AVIATION COMMITTEE**

**FINAL REPORT**

Type of occurrence	Accident
Aircraft type	Airplane, Boeing 737-505
Registration	VP-BKO (Bermuda)
Registered owner	ARN 737 Limited, Clarendon House, 2 Church Street, Hamilton HM 11, Bermuda
Operator	Aeroflot-Nord Airline, Russia
Regional Aviation Authority	Arkhangelsk Regional Office, FTOA
Place of Occurrence	Russian Federation, near Bolshoye Savino Airport, Perm (N57°58,255', E056°12,632')
Date and Time	13 September 2008, 2310 hrs UTC, local time 0510 hrs, 14 September 2008.

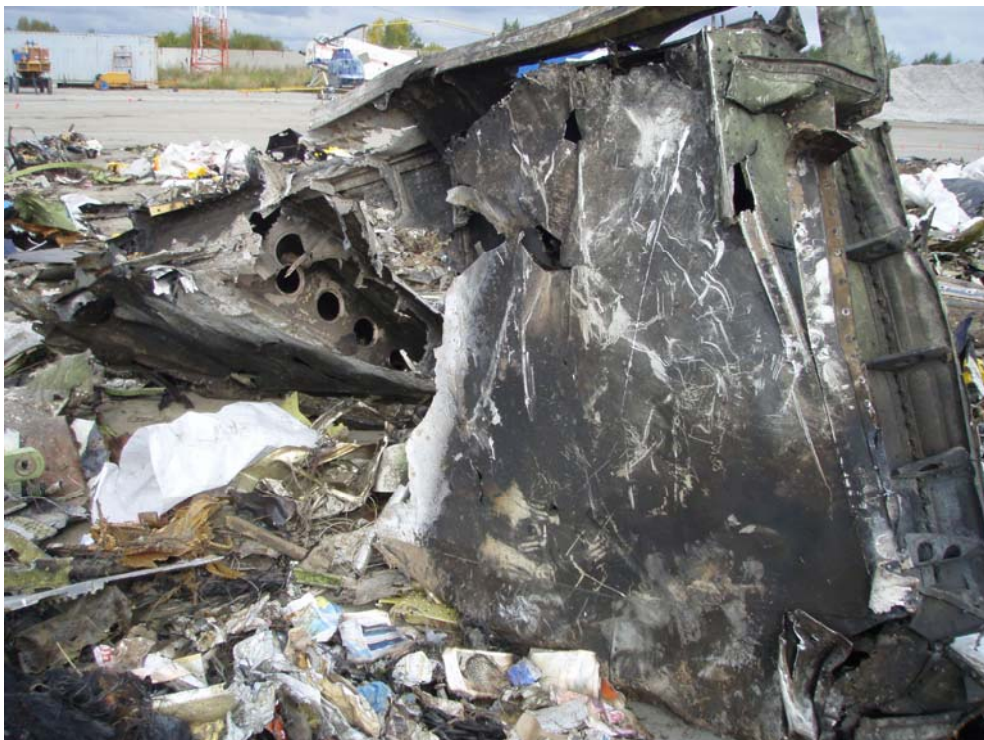
Remained portion of vertical fin

The lower 12 feet portion of vertical fin wreckage remained after the accident. The upper half was ripped and twisted almost 90 degrees to the right in relation to the lower half. All rudder hinges were ripped off except one on the upper portion. The vertical fin has evidences of severe burn in ground fire.

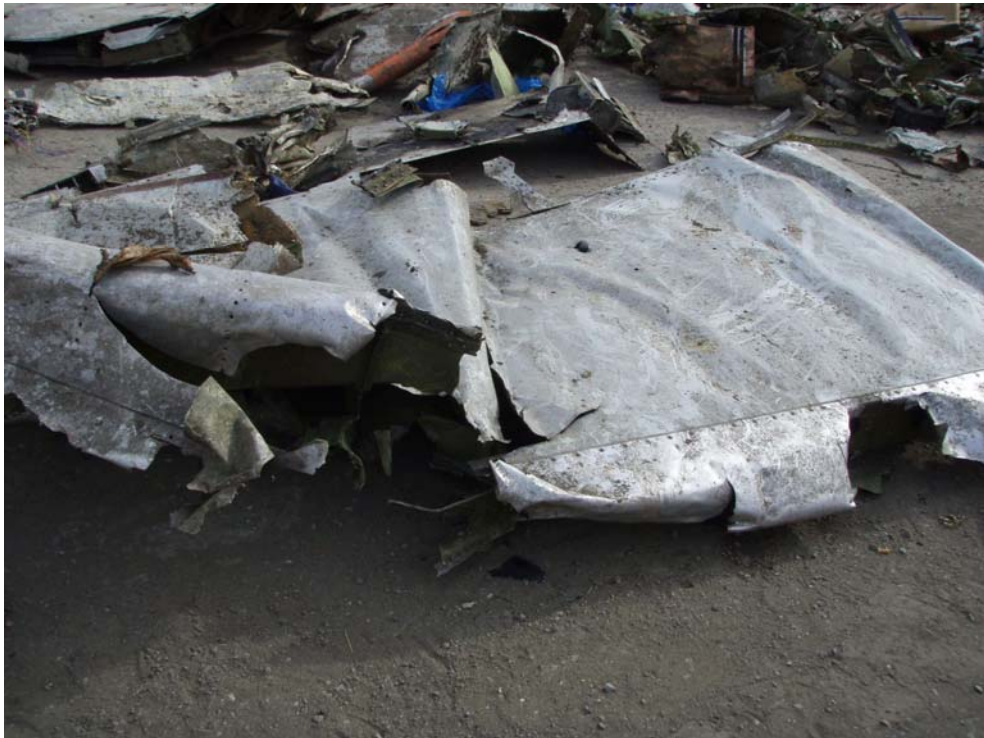
Inboard section of right horizontal stabilizer

The right horizontal stabilizer was ripped in two pieces (see the pictures), which were twisted and crumbled from post-impact. Trailing edges were ripped off.

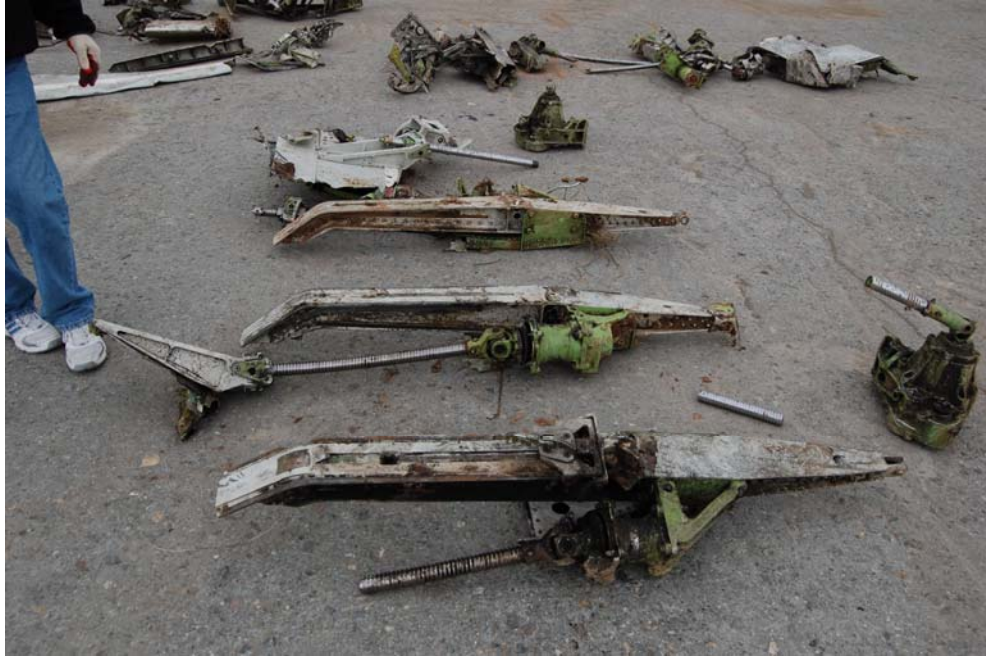
Outboard flap tracks

All four outboard flap drive screws as well as all four inboard flap transmission assemblies were identified. The distance from the up-stop to the top of the gimbal was measured for each, which showed the Flaps 30 position.
