AIRCRAFT ACCIDENT REPORT AND EXECUTIVE SUMMARY

Reference:	CA18/3/2/8576	
Aircraft Registration	ZS-PCM	Date of Accident	1 November 2008		Time of Accident	0900Z
Type of Aircraft	Cessna 208B		Type of Operation		Charter	
Pilot-in-command Licence Type		Commercial	Age	21	Licence Valid	Yes
Pilot-in-command Flying Experience		Total Flying Hours	1371.1		Hours on Type	390
Last point of departure		Wonderboom Aerodrome (FAWB) - Gauteng				
Next point of intended landing		Njala Lodge – Limpopo				
Location of the accident site with reference to easily defined geographical points (GPS readings if possible)						
GPS position S 24° 23.41' E027° 53.56'						
Meteorological Information		According to the pilot, fine weather conditions prevailed at the time of the accident. The wind was 090/5-20 kts and the temperature was approximately 30°C with no cloud cover.				
Number of people on board	1+5	No. of people injured	1	No. of people killed	0	
Synopsis						
<p>On 1 November 2008 the pilot, accompanied by 5 passengers, departed from Wonderboom aerodrome to Njala Lodge in the Limpopo Province on a chartered flight.</p> <p>The coordinates used by the pilot were insufficient for the purpose and resulted

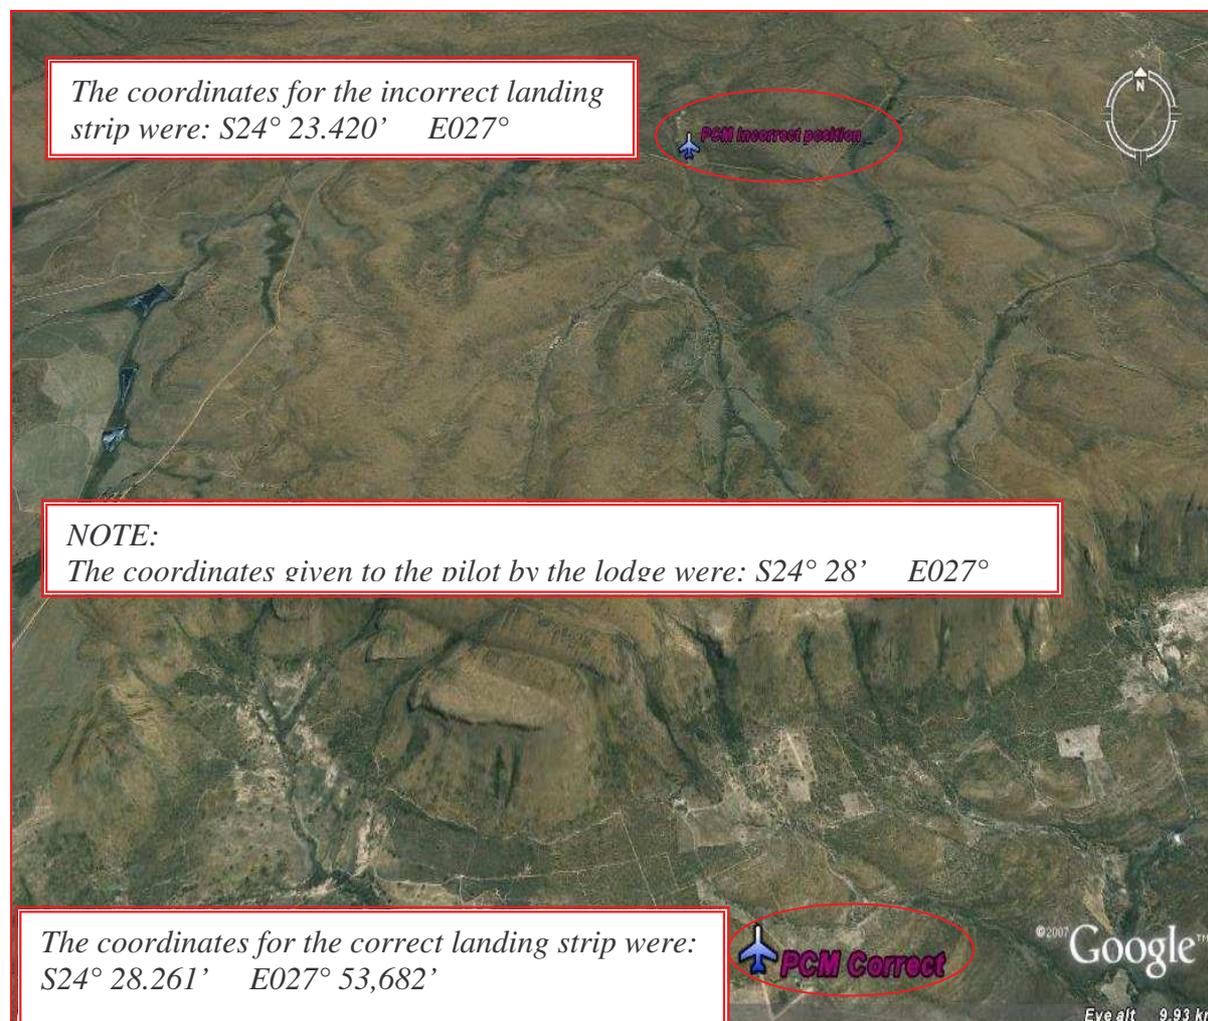
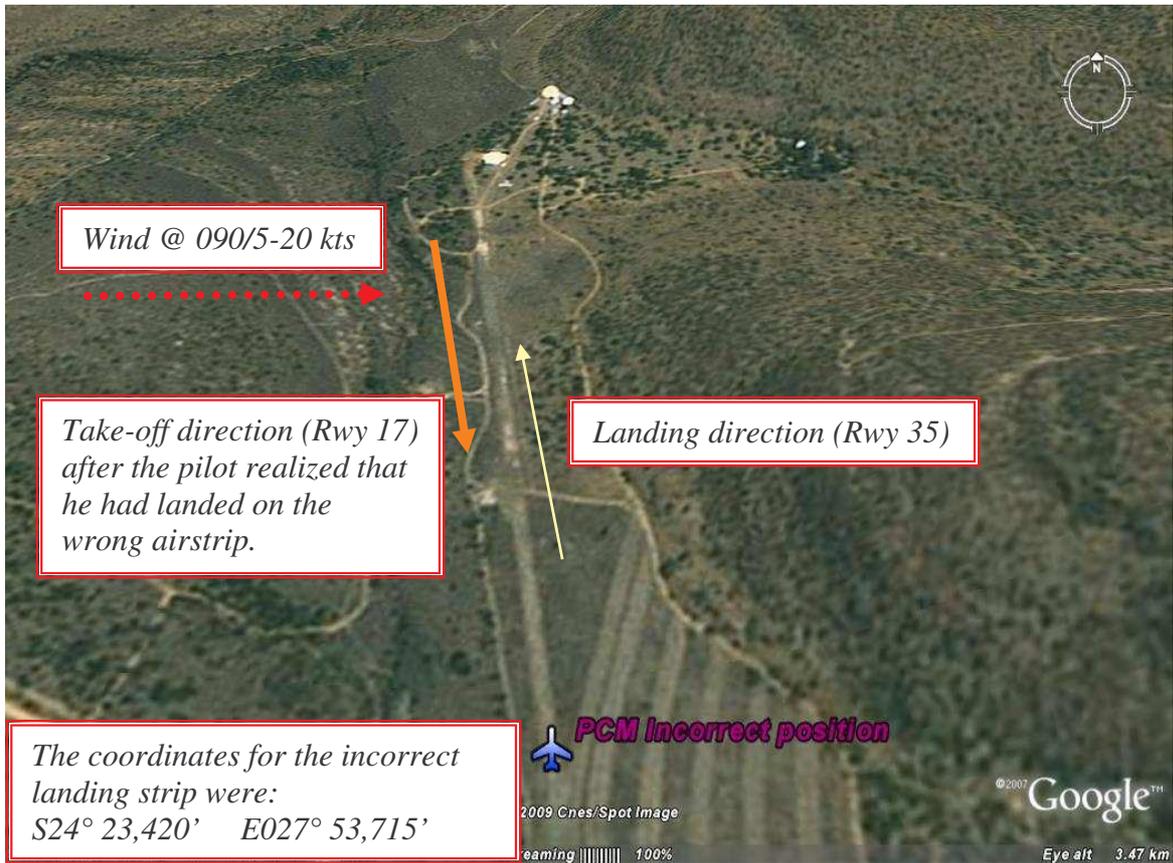
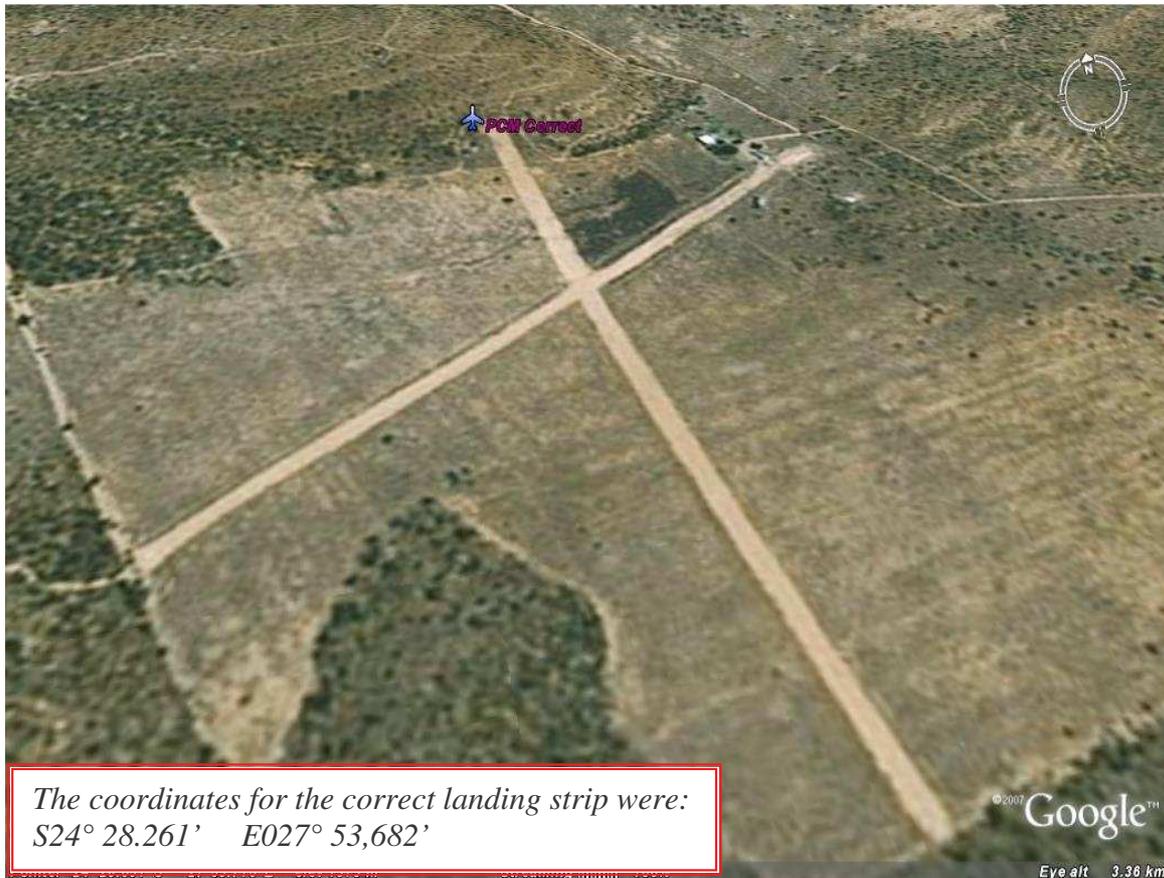
The runway surface is a combination of grass and gravel with a significant amount of minor bumps and holes. In addition, the runway ends are lower than the centre section of the runway.

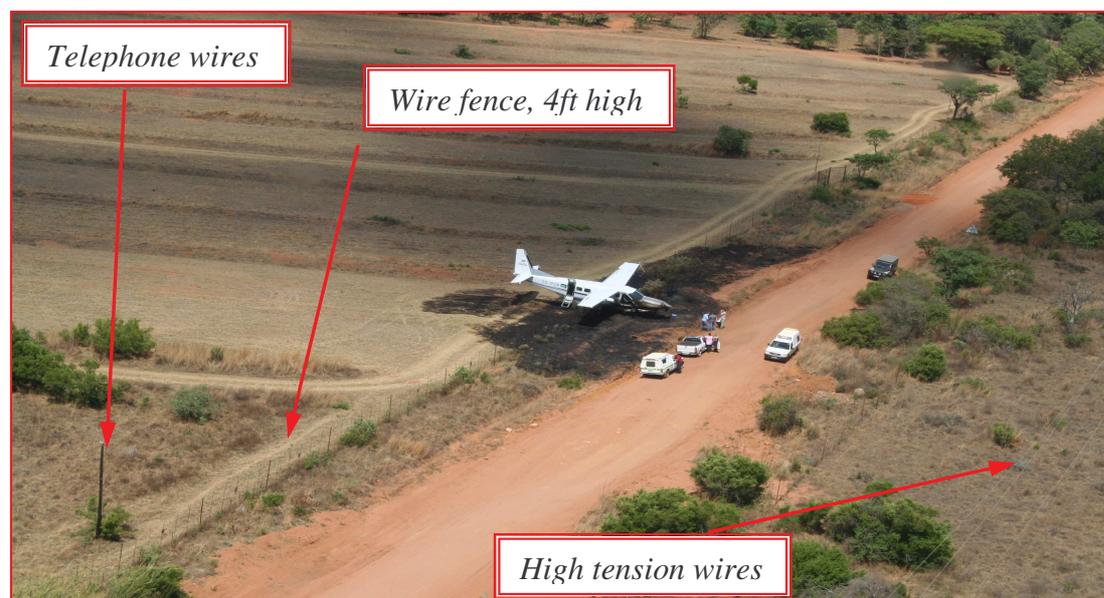
1.12.3 However, the remaining runway length was too short to safely stop the aircraft in time and a collision with the surrounding fence and telephone wires followed.

1.12.4 The accident occurred in the day, during take-off from Rwy 17. The site elevation was determined as 4550 ft AMSL.

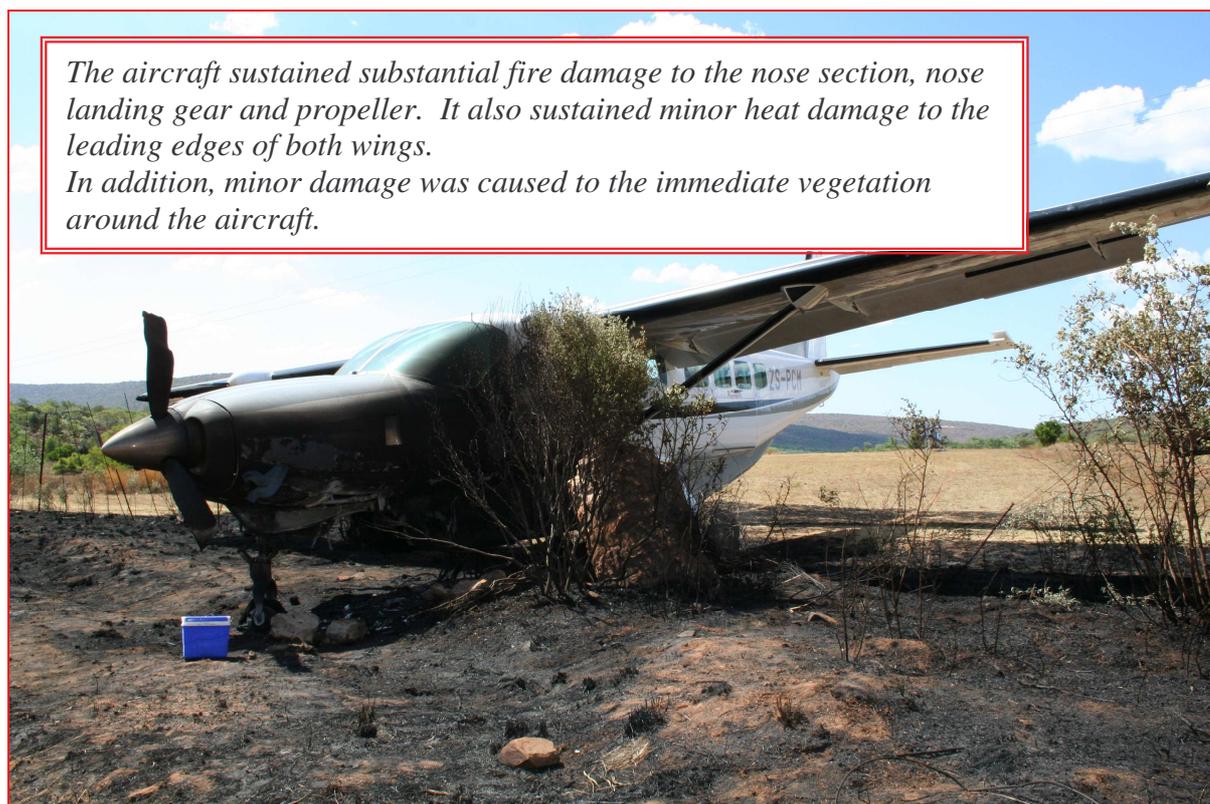
1.3.2 The aircraft sustained substantial damage to the left-hand main landing gear, propeller, nose landing and both wings as a result of the collision and the ensuing fire.

1.14.1 The aircraft sustained substantial damage after the exhaust had set the grass alight. The fire was quickly extinguished by a fire truck that was on the airfield at the time of the accident.

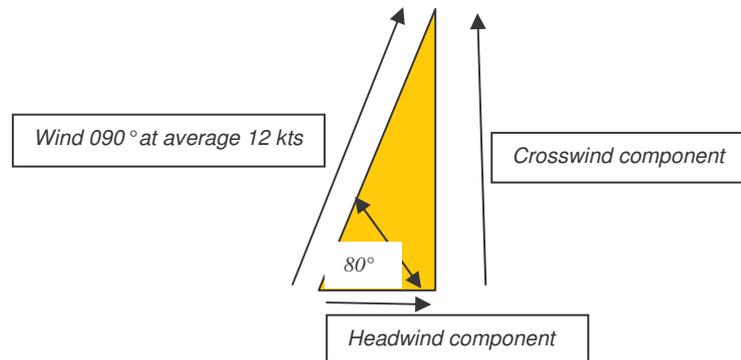
- 2.1.4 If the wind direction was 010° and variable as reported by the pilot, the aircraft took off with a headwind. Even if the wind direction was 090° at 5-20 kts, the aircraft took off with a minor headwind component as illustrated below:

$$\begin{aligned} \text{Crosswind component} &= 12 \times \sin 80^\circ = 12 \times 0.984 = 11.817 \text{ kts} \\ \text{Headwind component} &= 12 \times \cos 80^\circ = 12 \times 0.174 = 2.084 \text{ kts} \end{aligned}$$

The above suggested that the crosswind was strong enough to cause the aircraft to drift to the left once it became airborne. In addition to this, there is a possibility of a down draft causing a loss of lift, necessitating the pilot to abort the take-off. It would appear that the pilot did not make a proper assessment of the wind conditions at the time of taking off.
