AIRCRAFT INCIDENT REPORT AND EXECUTIVE SUMMARY

Reference:	CA18/2/3/8597	
Aircraft Registration	ZS-NXH	Date of Incident	18 December 2008		Time of Incident	1119Z
Type of Aircraft	King Air 200		Type of Operation	Charter		
Pilot-in-command Licence Type	Air Transport	Age	23	Licence Valid	Yes	
Pilot-in-command Flying Experience	Total Flying Hours	1900		Hours on Type	400	
Last point of departure	Mafikeng Aerodrome (FAMM)					
Next point of intended landing	Lanseria Aerodrome (FALA)					
Location of the incident site with reference to easily defined geographical points (GPS readings if possible)						
On Runway 06L at Lanseria Aerodrome (FALA)						
Meteorological Information	CAVOK, Wind: 090/10kts, Temperature: 28, Due Point:06, QNH:1019					
Number of people on board	2 + 2	No. of people injured	0	No. of people killed	0	
Synopsis						
<p>On 18 December 2008 the SACAA was informed of a King Air 200 aircraft that just had a landing gear collapse during landing on Runway 06 at FALA. The SACAA investigators were dispatched to FALA and they arrived within an hour following the accident.</p> <p>Onsite visual inspection of the aircraft revealed no visible failures thus the aircraft was recover

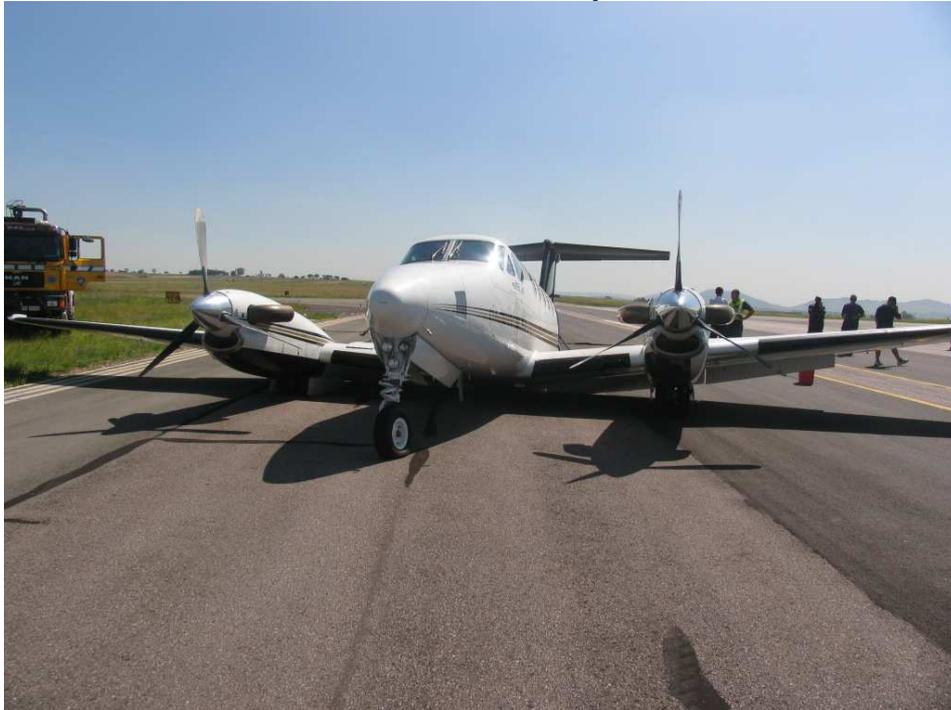
- 1.1.8 Both pilots and passengers sustained no injuries as a result of this accident and damage to the aircraft was limited to the rear fuselage under surface, port side landing gear doors, starboard and port side flaps. See Photo1 bellow.

Photo 1: Identifies the aircraft and the position it came to a halt.

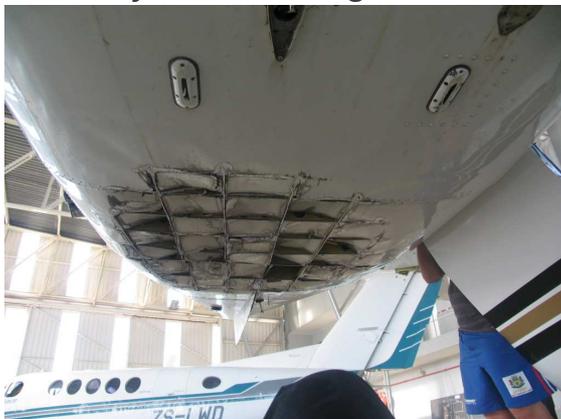
- 1.3.1 The damage to the aircraft was limited to the rear fuselage under surface, port side landing gear doors, starboard and port side flaps.

Photo 2: shows the damage on the rear belly of the fuselage.

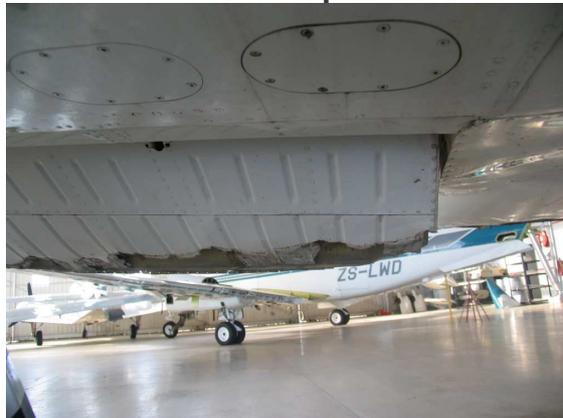
Photo 3: shows the damage to the starboard inboard flap.

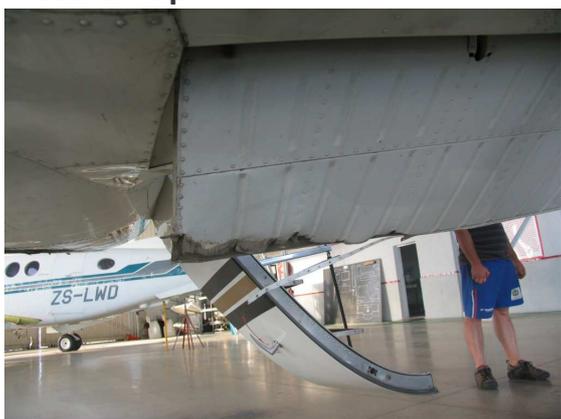
Photo 4: shows damage to port side inboard flap.

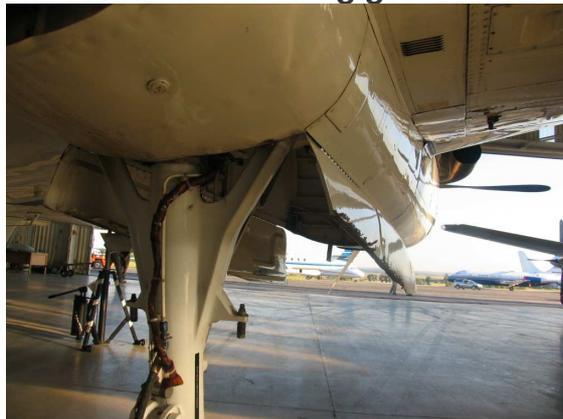
Photo 5 shows damage to the starboard main landing gear doors.

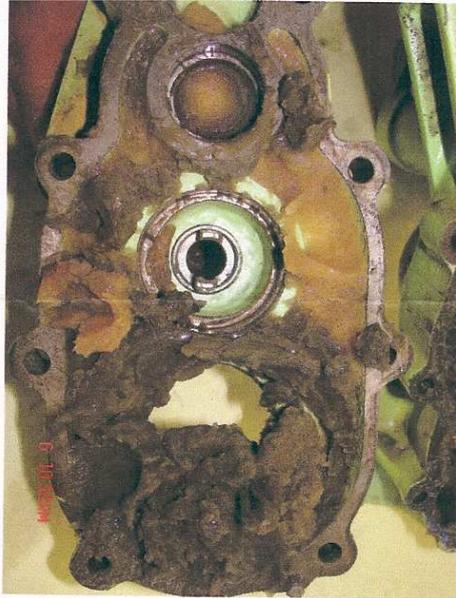
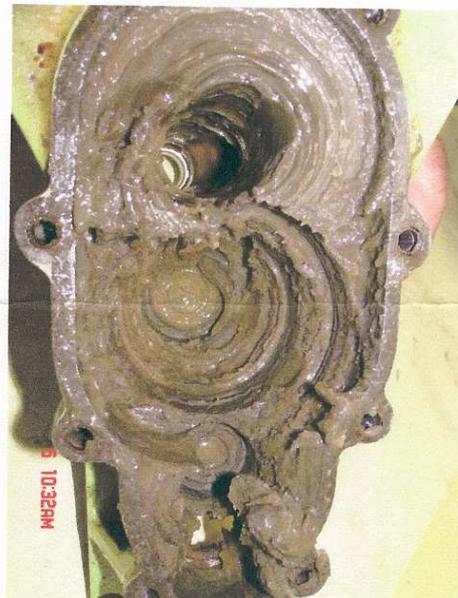
Photo 7

1.16.5 During investigation of the landing gear – gearbox (Part Number: 115-811020-13, Serial Number: E 033) it was noted that the gearbox was filled to capacity with grease see photo 7 and 8 bellow. Though the motor being filled with grease would not cause the failure of the landing gear, this was contrary to the requirements of the overhaul manual Which states:

- a. All inside surfaces of the gearbox housing should be brushed slightly with grease.
- b. Do not pack the cavities of the gearbox assembly with grease.
- c. Coat all surfaces of the clutch components sparingly with grease.

- a. The gear box was filled to capacity with grease. This fact however, would not have necessarily caused the failure of the landing gear system. The fact was in contrast with the requirements of the overhaul manual used to overhaul this component in that, it requires that the grease should be applied sparingly to the cavities of the gearbox.

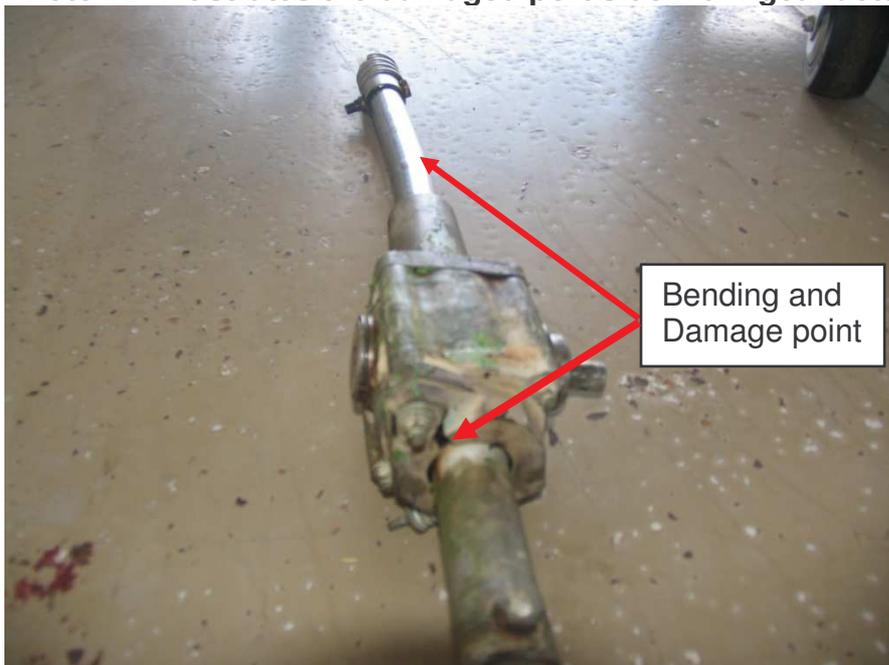
1.18.3 Following the recovery of the aircraft to an AMO, it was discovered that the landing gears could not be cycled as the port hand gear actuators was bent as a result of the accident. See Photo 9 below.

Photo 12: Illustrates the damaged port side main gear actuator.

The reason why the emergency system could not get the gears down and locked could be attributed to the left gear actuator. The left gear actuator was bent probably as a result of an attempt by the crew to land the aircraft on the left gear first during their second landing attempt. Emergency manual extension and retraction of the landing gear was controlled by a floor mounted lever centrally located between the left and right pilot seats. When the lever was manually operated, the landing gear electric motor and gearbox drive mechanisms were overridden, thus allowing extension or retraction of the landing gear system. Manual operation is attained through an input sprocket which engages directly to the output end of the internal clutch assembly.

- 2.7 As all landing gear drive systems will rely on being operated through the input sprocket which engages directly to the output end of the internal clutch assembly. The bending of the left hand actuator was identified as the cause of the emergency landing gear system malfunction or failure.
- 2.8 The POH requires that the crew should use the emergency landing gear system should there be a problem with the main landing gear system. The crew failed to use the system and only used it on the third and final attempt for a landing.
