**Report 09-001, BN2A-20 Islander, YJ-RV2 impact with terrain Espiritu Santo,
Vanuatu, 19 December 2008**

**BN2A-20 Islander
YJ-RV2**

impact with terrain

19 December 2008

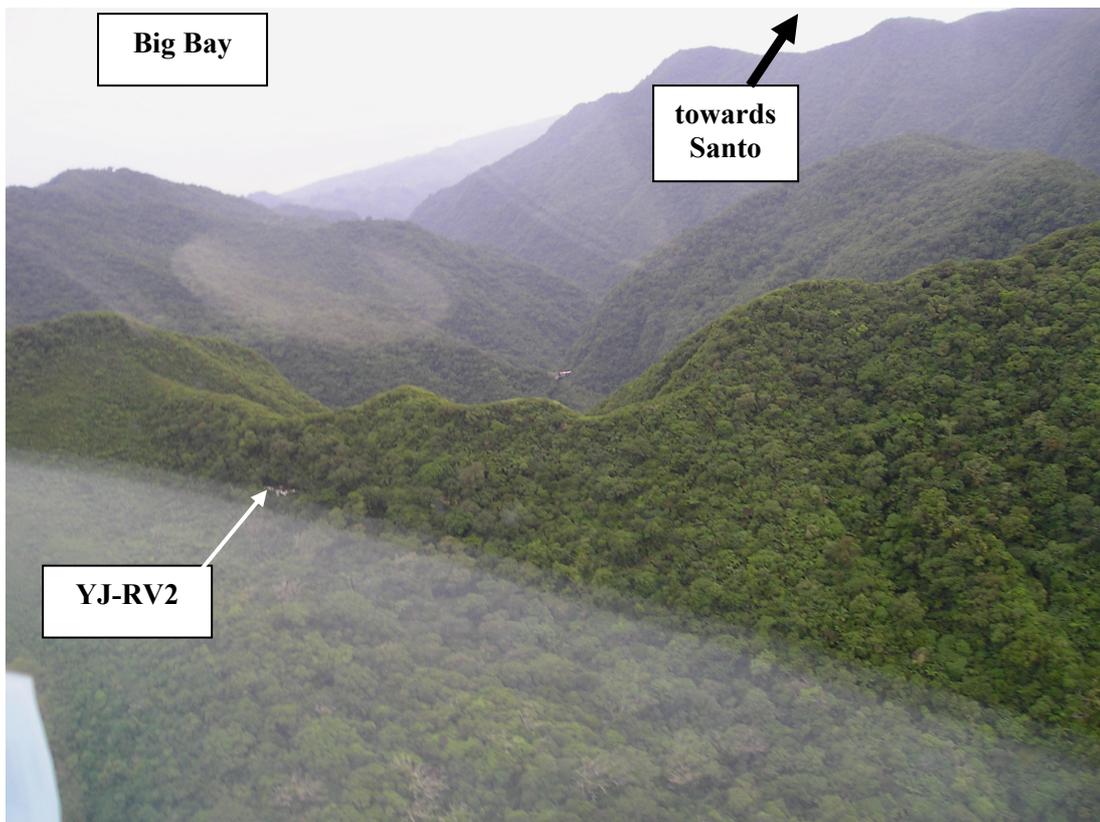
Figure 3
Accident site

1.12.2 Damage to the vegetation showed that RJ-RV2 had struck the bush in a wings-level attitude on a heading of about 055° magnetic. The initial impact was on the right wing, which slewed the aircraft right through about 45° where it struck the ground and slid backwards nearly 2 m before coming to rest (see Figure 4). The distance between the initial impact with the bush and the aircraft coming to rest was calculated to be less than 20 m. All aircraft components were accounted for at the site.

1.12.4 The fuel tanks, one located in each wing, had been punctured, with the right tank completely drained of fuel. Some fuel remained in the left tank. The fuel lines running to each engine were checked and fuel was found in the gascolators for both engines. It was observed to be of the correct type. A check of the fuel filters found them unobstructed and free of contaminants. A check of the fuel supply at Santo where the aircraft had last been refuelled, found the fuel to be appropriately stored and of the correct specifications.

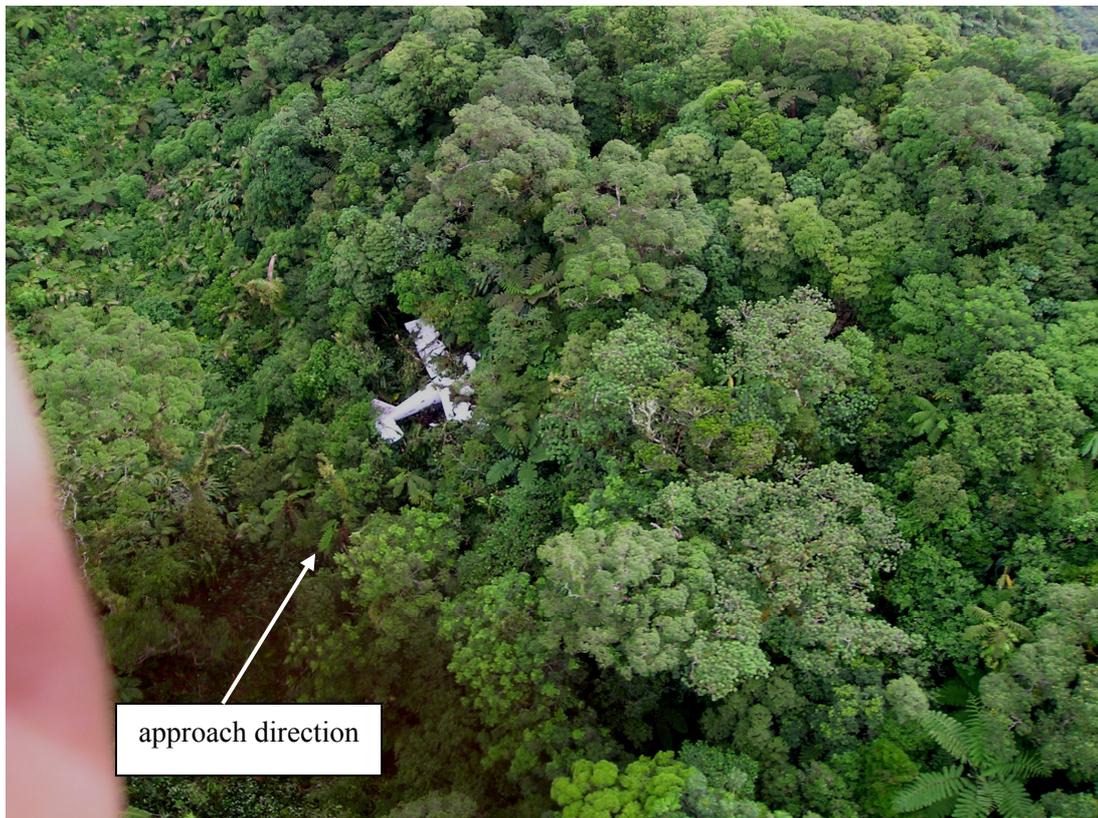
Figure 4
YJ-RV2

- 1.12.7 The seats were all found still attached to the aircraft floor with the seat belts in place. However, the seatback for row 2 had partially broken at its base, probably from the passengers behind being thrown forward during the impact.¹¹ The 10 seat belts were checked and found to function as intended with one exception and 2 limitations. The front-seat passenger's diagonal belt could not be used as there was no mount or attachment on the lap belt to which the diagonal strap could connect. The lap belts for 2 of the seats were found to be shorter than the rest, allowing only a small adult or child to be secured. The passenger seated in one of these 2 seats later commented that he had been unable to do up his seat belt and had held onto both loose ends during the flight. He sustained head and leg injuries during the accident.

- 1.12.9 The cargo net securing the baggage in the rear compartment was found partially unhooked. Several passengers later commented that some items may have entered the cabin during the impact. However, the passengers also commented that after the accident some passengers had entered the cargo compartment and retrieved several personal items, including laptop computers, before starting to walk downhill. The pre-impact condition of the cargo net could, therefore, not be accurately determined.
