Final Report No. 2074 by the Aircraft Accident Investigation Bureau

concerning the accident involving
the Marcel Dassault/Bréguet Aviation Falcon 10/100, registration VP-BAF
operated by Laret Aviation Ltd.
on 12 February 2009
Samedan Airport, municipality Samedan/GR

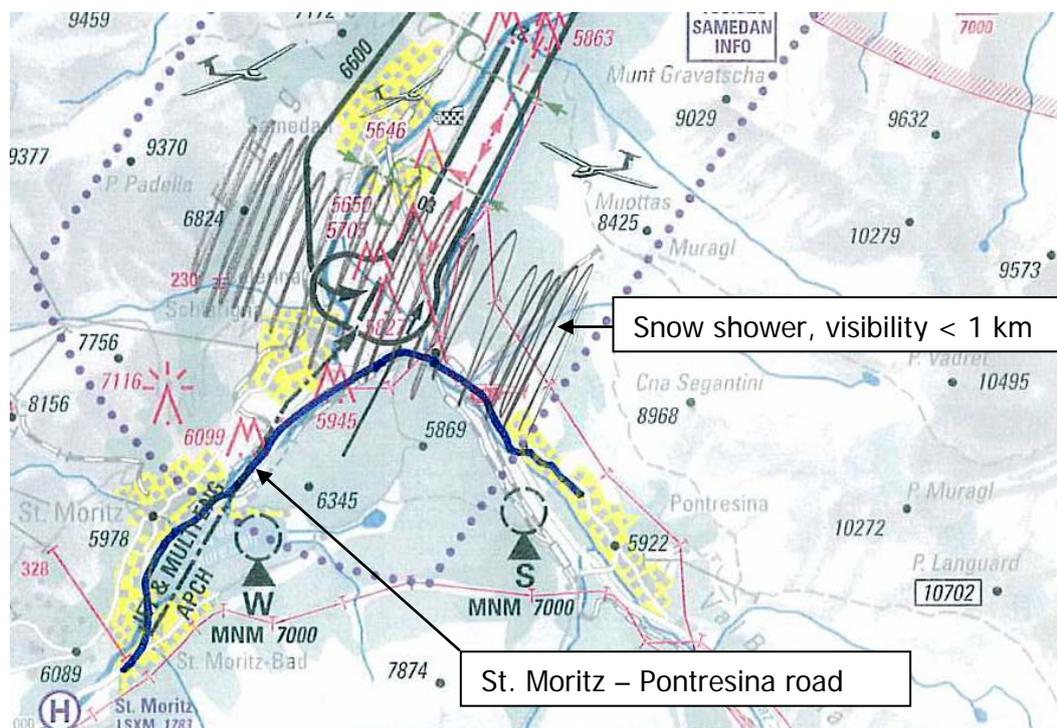
Figure 1: observations sketched by an eye witness

"(...) From San Gian church one couldn't see Muottas Muragl, so I also came to the conclusion that visibility was below 1 km. The road was covered with snow; there was massive snowfall, like a dark curtain, not just a light snowfall. (...) A dark, very thick shower curtain became visible [on the final approach to runway 03]. So not just rather poor visibility."

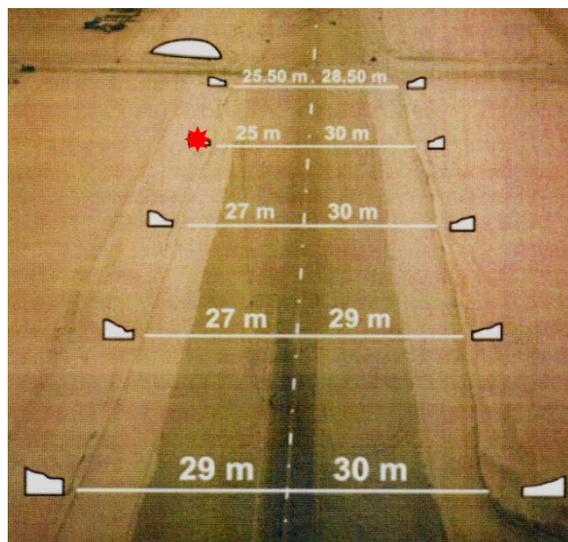
Figure 2: Diagrammatic representation of the snowbanks along runway 03

After the accident runway 03 was photographed in the direction of landing and the snowbanks running along the runway were measured. The entire surface of the runway was covered with a layer of snow which along the runway centreline was only a few millimetres thick at a width of seven to eight metres and which therefore appeared somewhat darker. From the runway threshold to the final position of the wreck, a maximum of 30 metres and a minimum of 25 metres were measured between the runway centreline and the snowbanks on the left and right of the runway. The cross-section of the snowbanks, measured at a width of 4 metres, was between 90 and 150 centimetres high on the runway side and between 2.5 and 4 metres on the outside.

* Point of contact of the left wingtip with the snowbank.

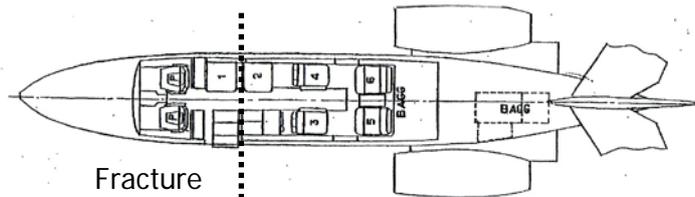
Figure 4: Seat arrangement in the aircraft and the fracture position

The aircraft broke into two pieces as a result of the force of the impact. The fracture occurred behind the aircraft's entry door. On the aircraft fuselage the right landing gear was buckled and at the cockpit the nosewheel had sheared off. The fuselage, at the left edge of the runway, was rotated 90° clockwise in relation to the runway centreline and the cockpit, at the right edge of the runway, was rotated about 180 degrees. The thrust reversers on the engines were retracted.

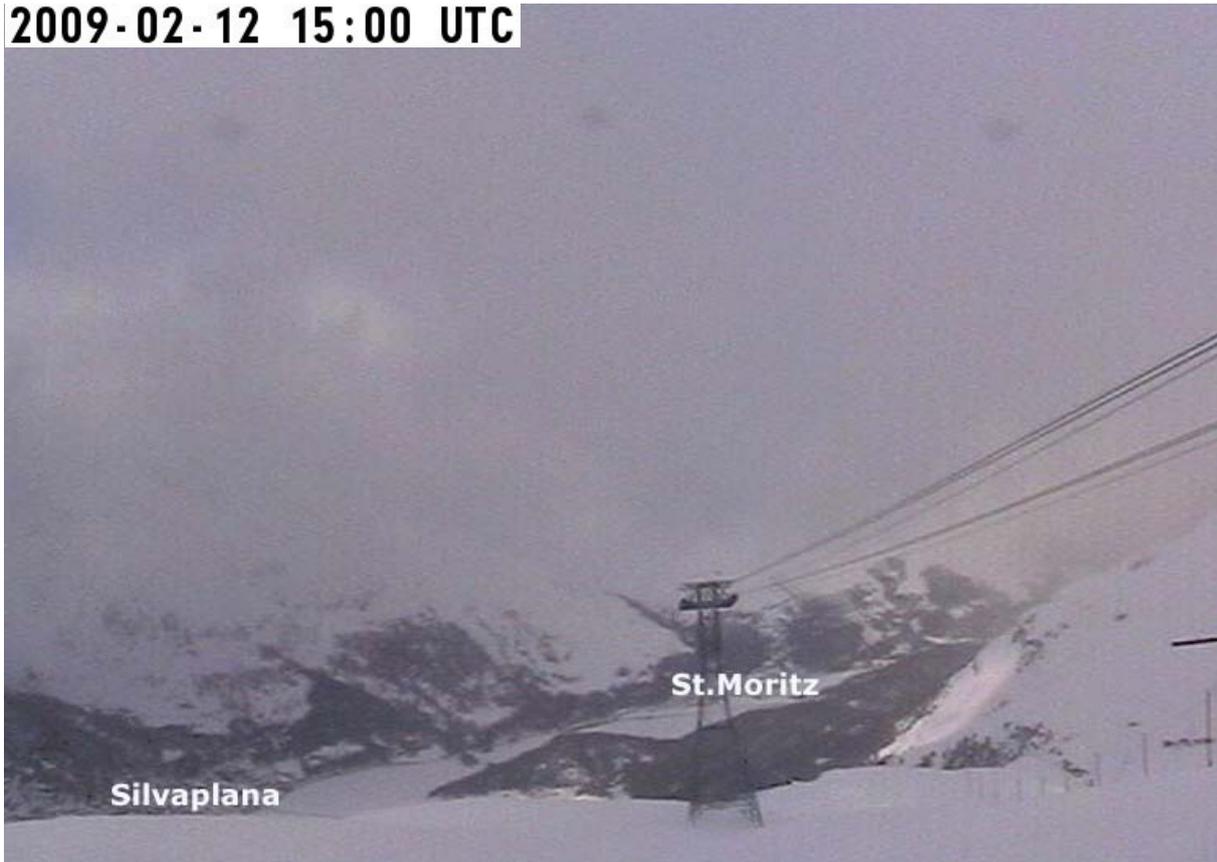
2009-02-12 15:00 UTC

15:00 UTC: twelve minutes before the accident. At this time the aircraft VP-BAF was between Silvaplana and St. Moritz on an altitude of about 11 000 ft AMSL.

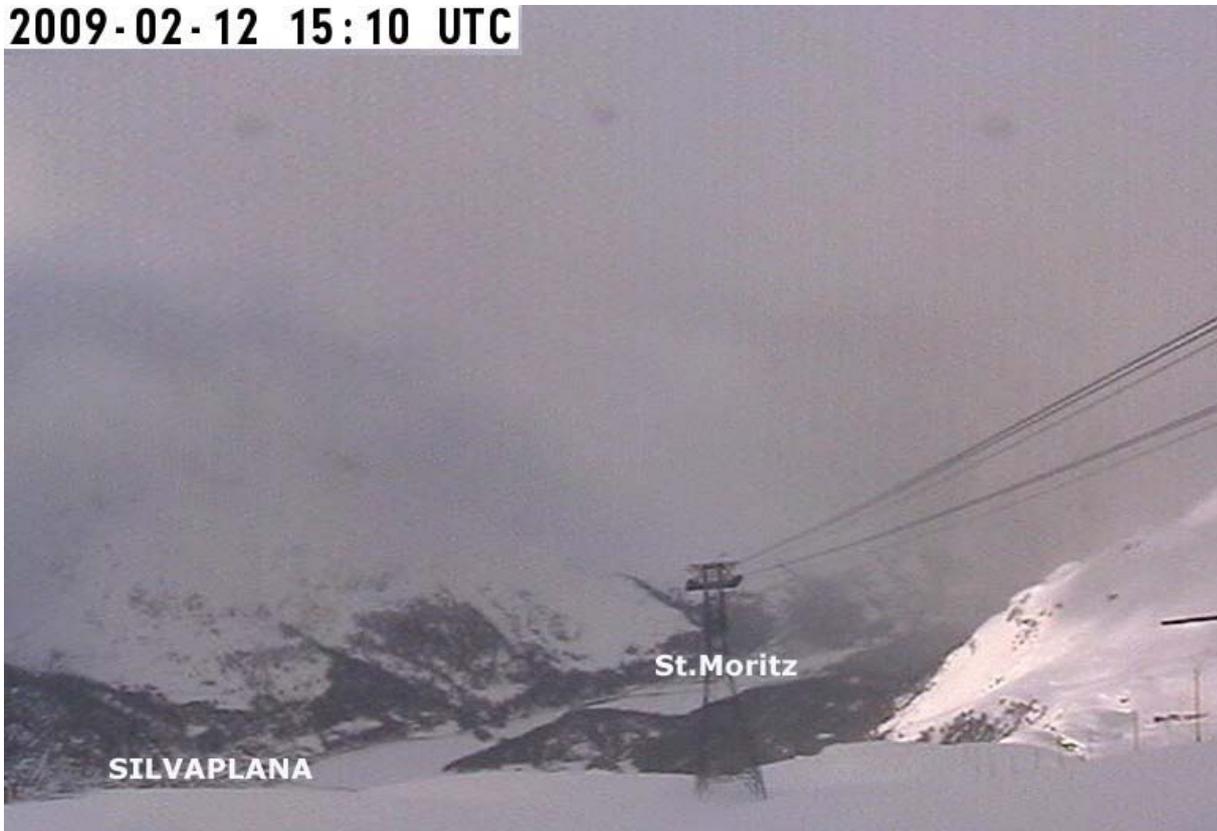
2009-02-12 15:10 UTC

15:10 UTC: two minutes before the accident. At this time the aircraft VP-BAF was between Silvaplana and St.Moritz and on the final approach to runway 03 in Samedan.

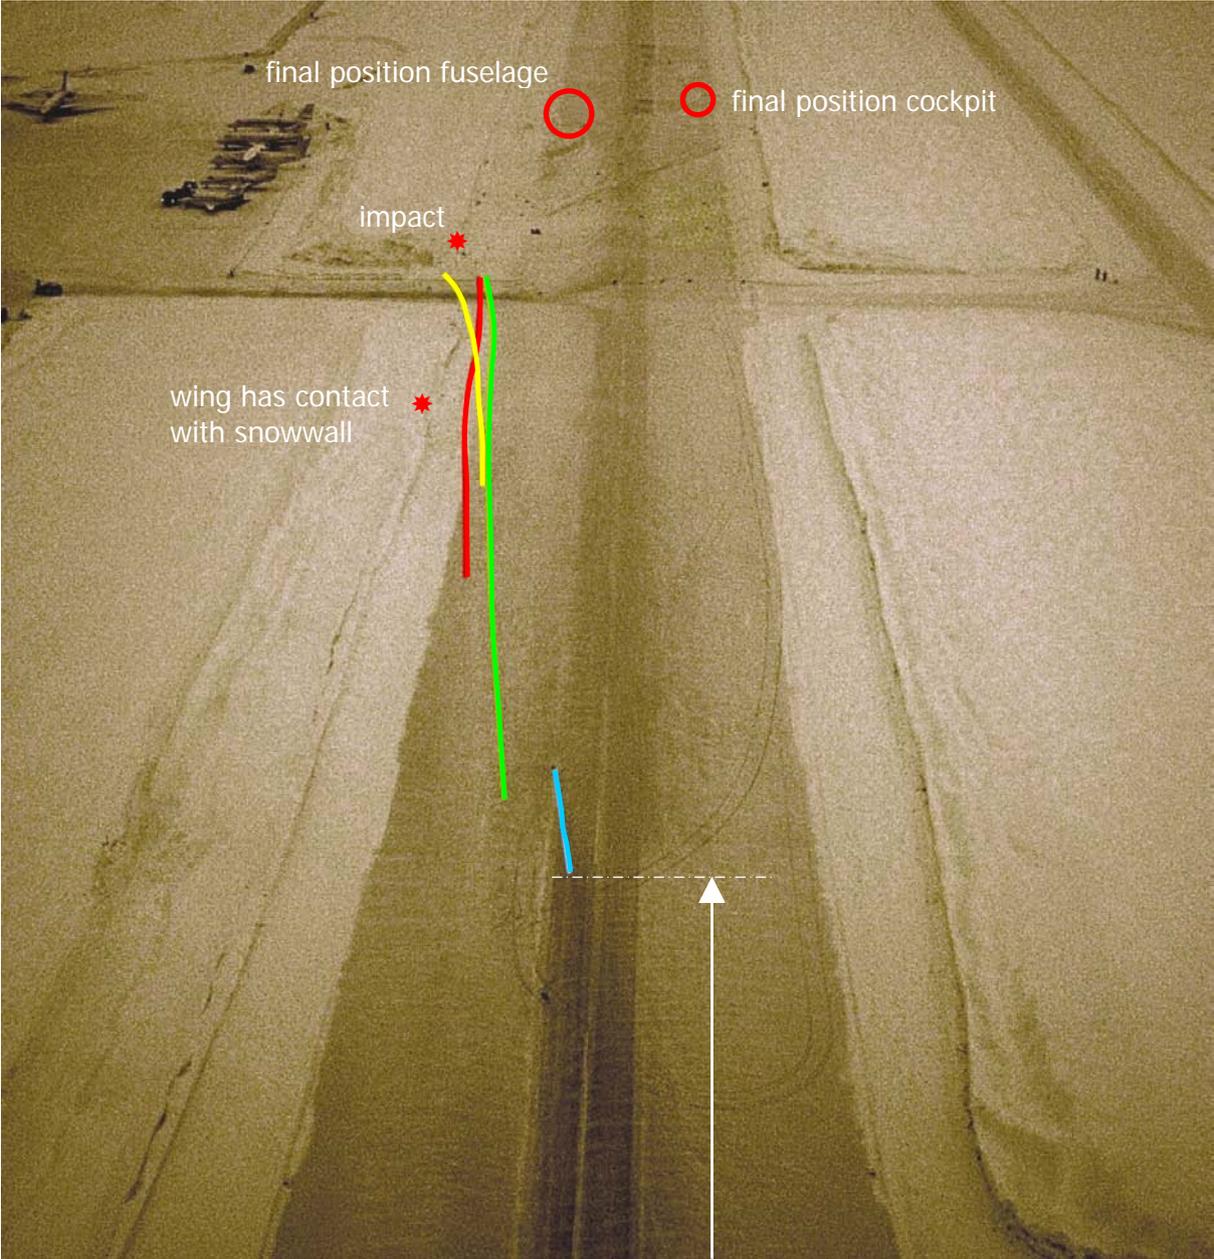
Annex 4: Landing and accident sequence on the runway

distance to runway threshold 135 m

- trace of the right wingtip
- trace of the right main gear
- trace of the nose wheel
- trace of the left main gear
