Aircraft Accident Investigation Report

PT. Lion Mentari Airlines (Lion Air)

Boeing McDonnell Douglas MD-90 ; PK – LIL

9 March 2009

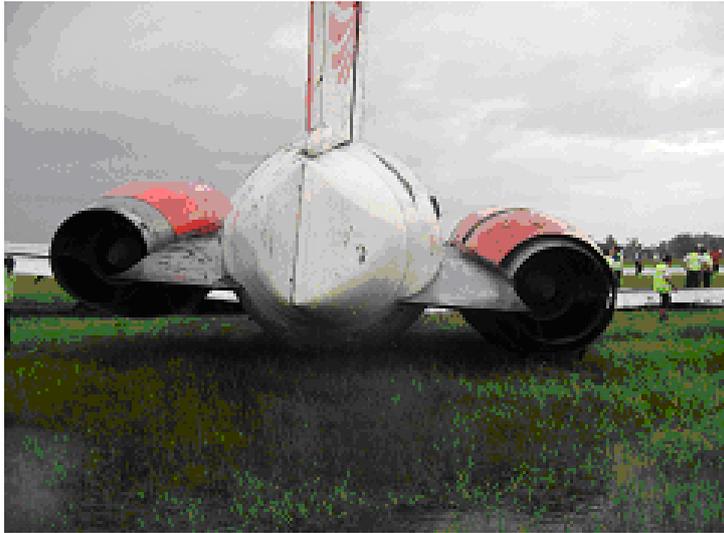
The aircraft stopped at 0835 on the right side of the runway 25L, 1,095 meters from the departure end of the runway on a heading of 152 degrees; 90 degrees to the runway 25L track. The main landing gear wheels collapsed, and still attached to the aircraft, were on the shoulder of the runway and the nose wheel was on the runway.

Figure 1: PK-LIL at Soekarno-Hatta Airport, Jakarta after accident

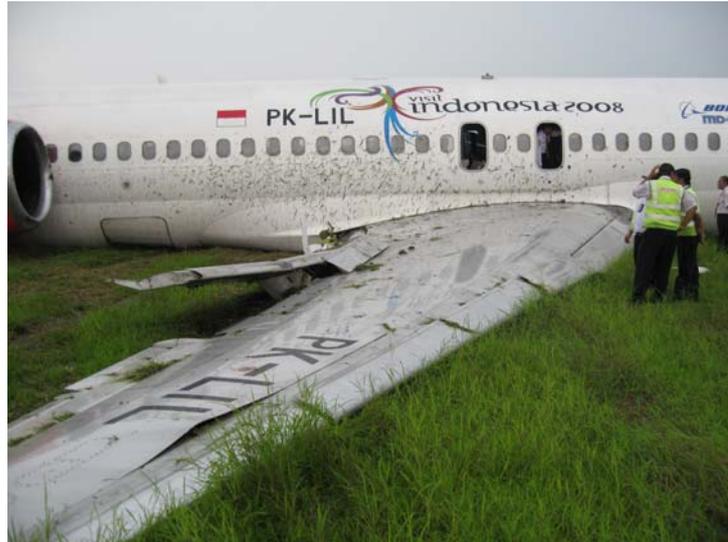
Both main landing gear assemblies collapsed and were significantly damaged. Tire number 3 (inboard right main wheel) exploded. The aircraft's right-wing landing light was found 45 meters from the runway 25L threshold mark, and the right wing tip was damaged.

The right wing, and the right flaps were damaged.

Figure 2: Right fuselage showing emergency exits opened, the damage of right wing and flap

The investigation also found the right wing tip was damaged, and landing light was broken, and found behind the touch-down zone. This indicated that the right wing tip touched the ground before the touch-down zone, and wheel marks on the touch-down zone, showed the aircraft conducting an un-stabilized approach before touched the ground.

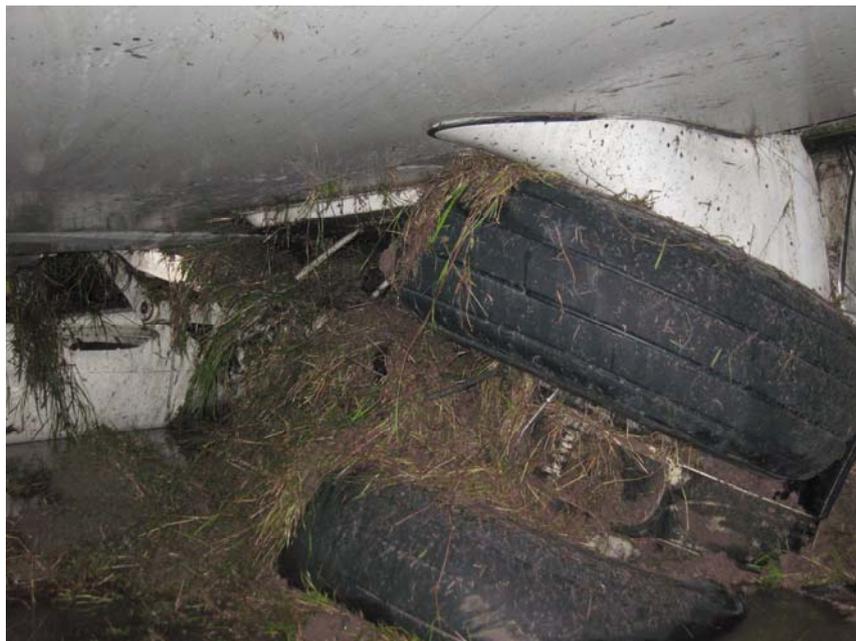
Figure 3: Left Main Landing Gear collapse sidewise

The aircraft remained intact. The main landing gear assemblies collapsed and were substantially damaged. Tire number 3 (inboard right main wheel) exploded.

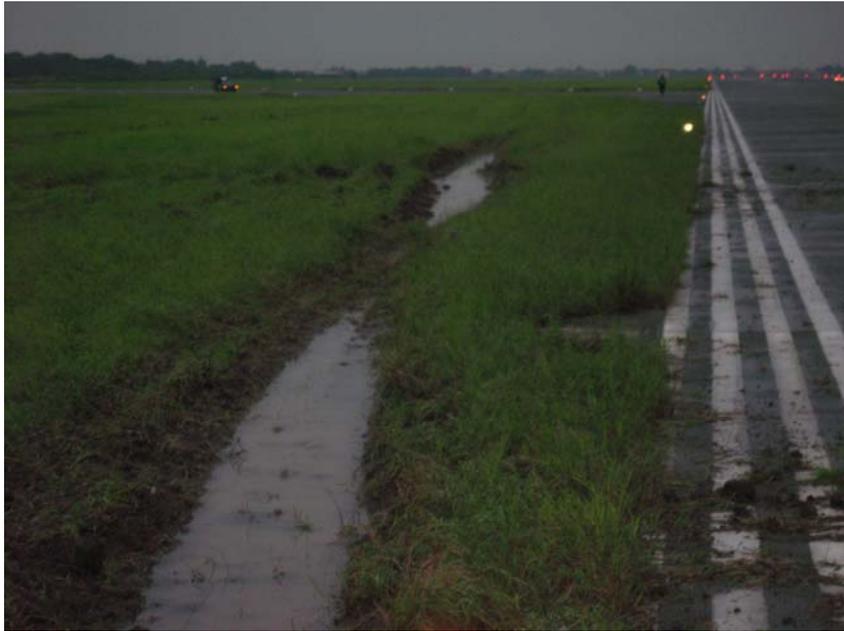
Figure 5: Nose tyre mark outside of the runway

The nose wheel mark on the shoulder of the runway was an evidence of the aircraft was drifted out of the runway, and back again into the runway, to the final position of the aircraft 90 degrees to the runway.

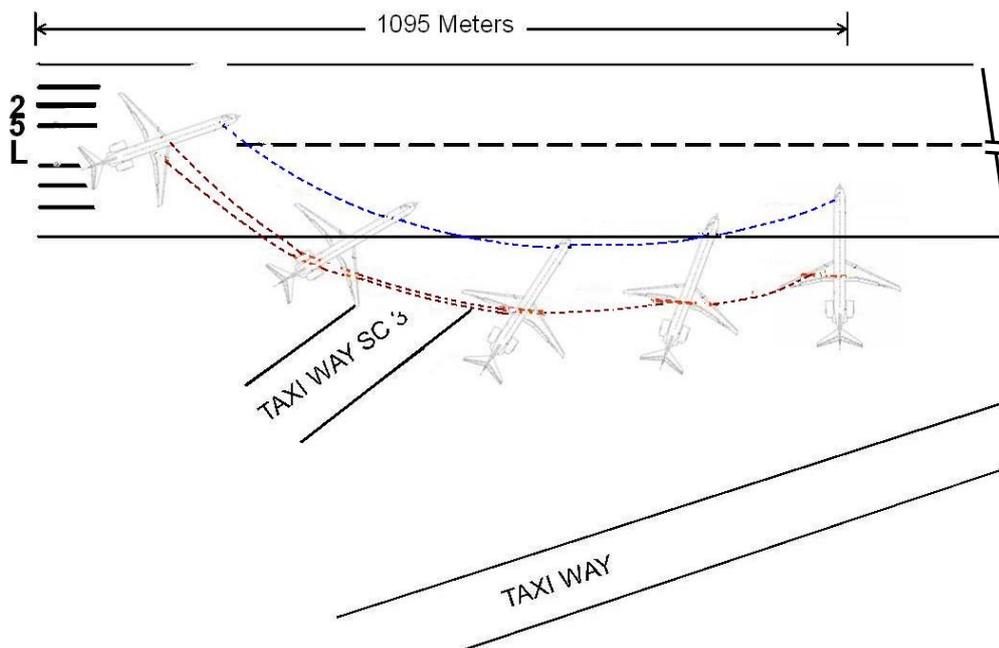
Figure 6: Sketch the accident sequence

9. The investigation also found right landing light broken off and laid down at the runway surface before touch-down zone.
10. Scraped on the ground surface, the damage of right wing tip, and right landing light broken off, indicated that the wing tip hit the ground before the main wheel touched the runway, then the aircraft continued ground drifted to the right, nose and main wheels were on shoulder, to the final position.
