AIRCRAFT ACCIDENT REPORT AND EXECUTIVE SUMMARY

Reference	CA18/2/3/8663	
Aircraft Registration	ZS-PNZ	Date of accident	10 June 2009		Time of accident	1155Z
Type of Aircraft	King Air 200C	Type of Operation		Mercy		
Pilot-in-command Licence Type		Airline Transport	Age	24	Licence Valid	Yes
Pilot-in-command Flying Experience		Total Flying Hours	2 650		Hours on Type	200
Last point of departure		Cape Town International Aerodrome, Western Cape Province (FACT)				
Next point of intended landing		East London Aerodrome, Eastern Cape Province (FAEL)				
Location of the accident site with reference to easily defined geographical points (GPS readings if possible)						
On runway 06R at Lanseria Aerodrome (FALA) at an elevation of 4 339 ft (GPS co-ordinates: S 25° 56.43' E 027° 55.537')						
Meteorological Information		Visibility not good, temperature 13°C, wind calm, cloud overcast, cloud base 800 ft				
Number of people on board	2 + 2	No. of people injured	0	No. of people killed	0

Name of Owner/Operator : Aerocare
Manufacturer : Beech Aircraft Corporation
Model : King Air 200C
Nationality : South African
Registration Marks : ZS-PNZ
Place : Lanseria Aerodrome (FALA)
Date : 10 June 2009
Time :

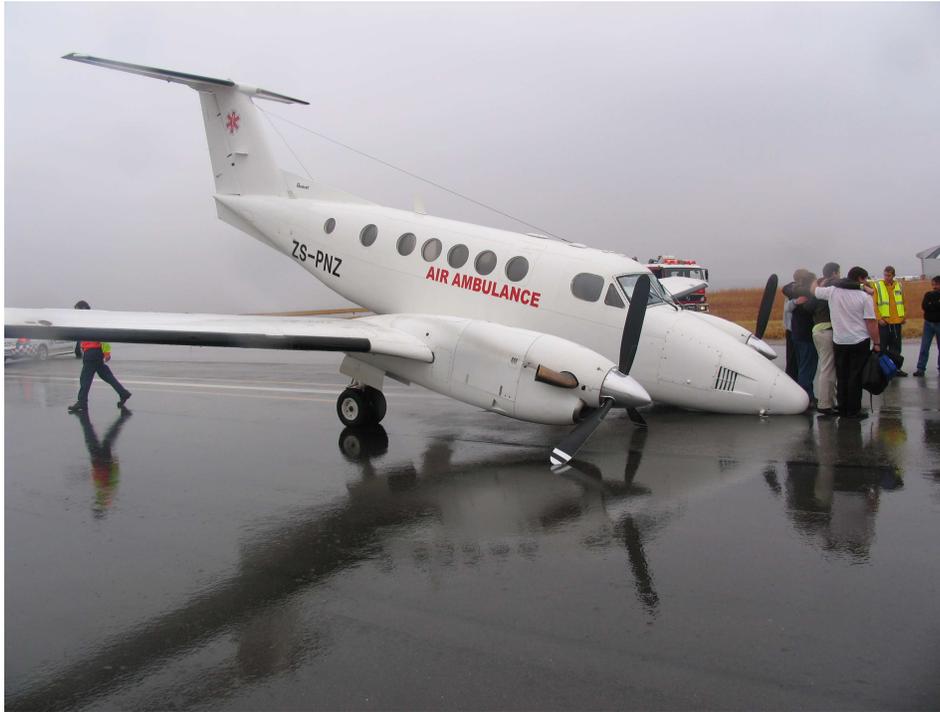
- 1.3.1 The damage to the aircraft was limited to the nose landing gear doors, pitot tubes, the two propellers and the radome.

Figure 2: The aircraft as it came to rest after executing the emergency landing

1.12.2 The aircraft approached, descended and touched down, and after approximately 350 m of landing roll, the nose landing gear slowly collapsed. Both propellers and the nose section made contact with the runway surface. As a result, the propellers, pitot tubes, the nose landing gear doors and the random were damaged.

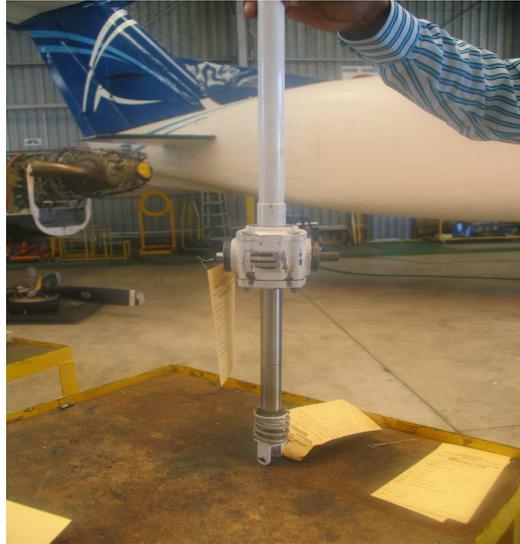
- 1.16.1 After securing the nose gear in the down position, the aircraft was towed to the hanger in the presence of SACAA investigators. The nose of the aircraft was jacked off the ground, and the gear assembly and the actuator were removed from the aircraft.
- 1.16.2 The nose gear retract chain was found serviceable and intact. The nose gear assembly was removed. The nose gear actuator was removed, inspected and function tested. During function testing and inspection of the actuator, it was noted that the retract shaft internal threads were worn beyond limits.

Figure 3: Nose gear actuator

- 2.7 A retraction test on the undercarriage was not considered necessary. The nose gear assembly was removed. The nose gear actuator was removed, inspected and function tested. During function testing and subsequent inspection, it was noted that the actuator retract shaft internal threads were worn down, which restricted the nose gear extension and locking capabilities. No further tests were done or found necessary.

- 3.3.1 The retract shaft internal threads were worn beyond limits.
