KNKT.09.06.12.04

# NATIONAL TRANSPORTATION SAFETY COMMITTEE

*Aircraft Accident Investigation Report*

**Dornier 328-100 ; PK-TXN**

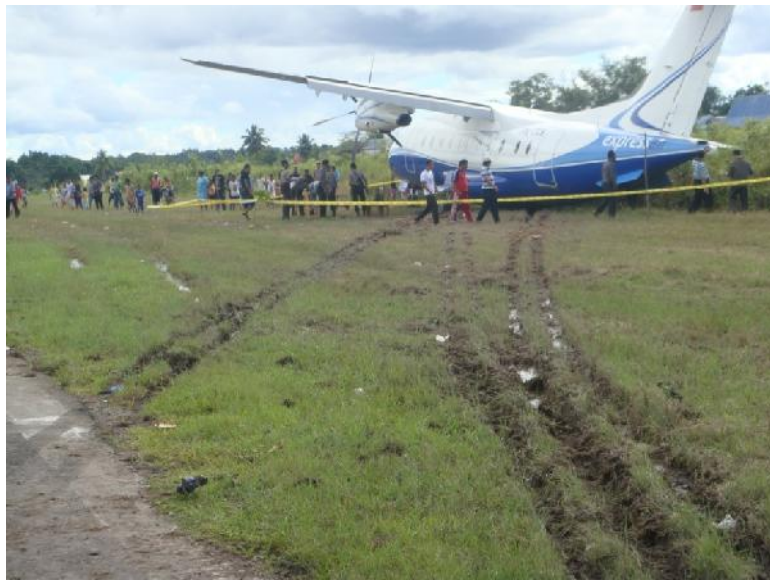
**Figure 2: Wheel marks on the muddy runway shoulder**

The investigation found the tire marks from touchdown area and along the center line of the runway up to approximately 500 meters, the aircraft swung to right, skidding and out of the runway at 600 meters and stopped.

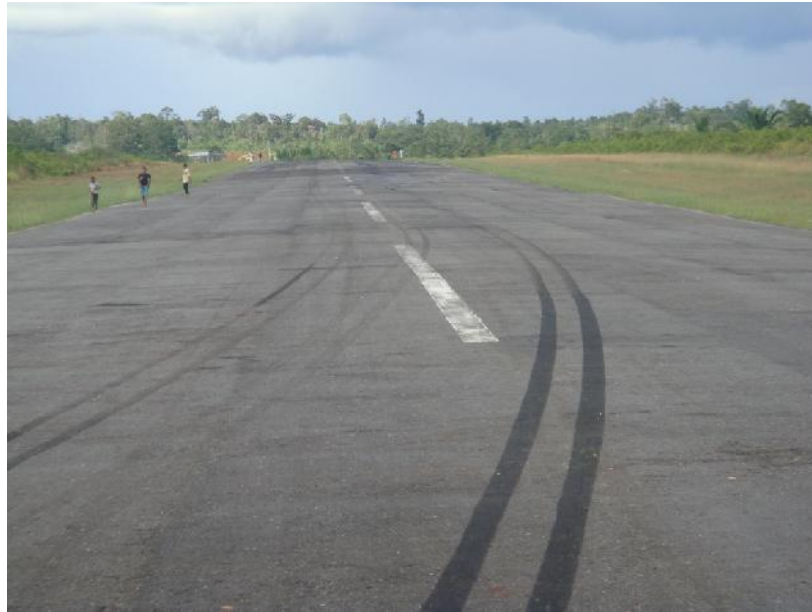
**Figure 3: Tire marks on runway starting to roll to right**

The investigation revealed that the condition lever should be selected to minimum position at the aircraft speed not more than 30 knots. PIC called for condition lever to be selected to minimum position at aircraft speed at 60 knots, higher than 30 knots, that was not in accordance with procedure laid down in the “Operation Manual”. The aircraft could not be maintained straight roll at the runway, but it continued pull right, off the runway.

- a. technical knowledge of the Dornier 328 engine and propeller systems, with particular attention to the procedure of reducing the condition lever.
- b. PIC should have been check properly by Flight Instructor, including line check at Papua routes, before assigned as PIC.
- c. Experience at the same type rating in the recent past year.

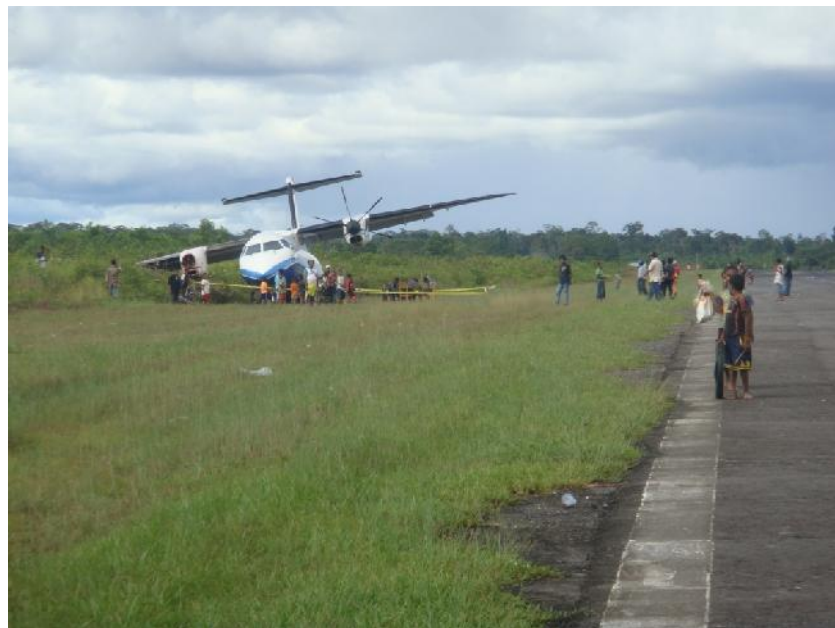
The right wheels sank into the soft ground of the runway shoulder, and the left wheels and the nose wheels were on the shoulder. The right propeller blades fractured as they struck the ground and the propeller assembly was torn from the engine and came to rest approximately 4.5 meters from the right engine. The right engine was substantially damaged.

**Figure 4: Final position of the aircraft**

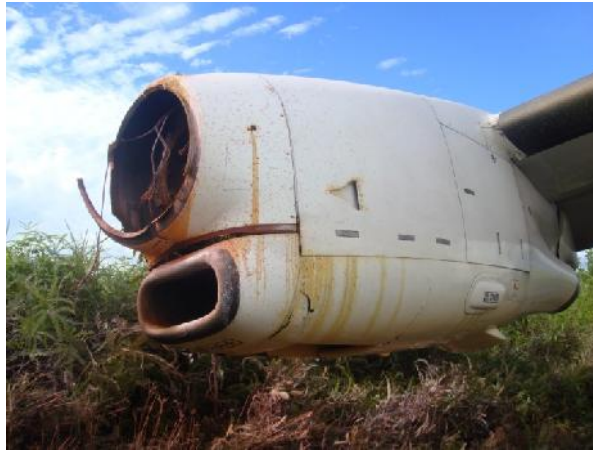
The right hand engine and propeller were substantially damaged and right hand wing tip rest on the ground, suspected to be damage.

**Figure 5: Right engine without propeller**

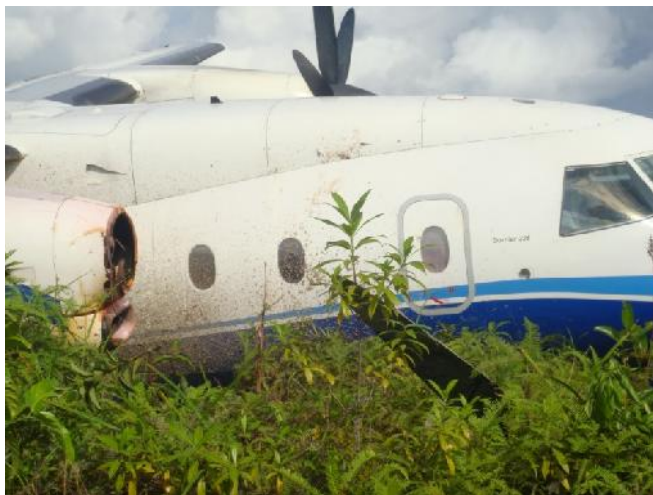
**Figure 6: Propeller position 4.5 meters away from the engine**

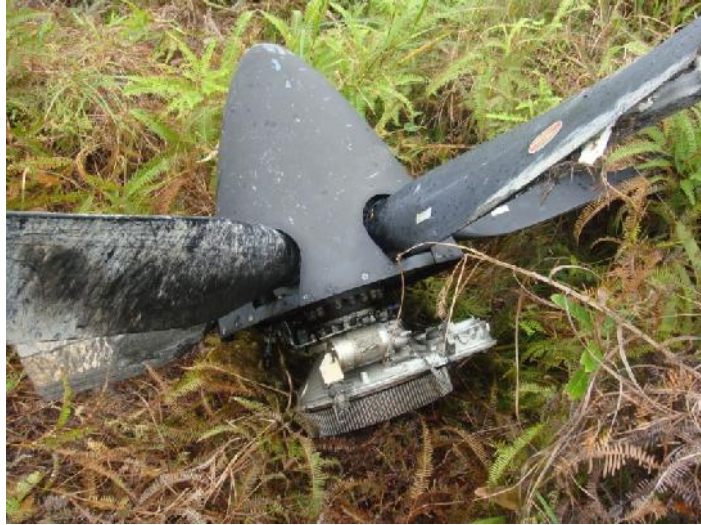
**Figure 7: The Right Propeller and part of gear box**

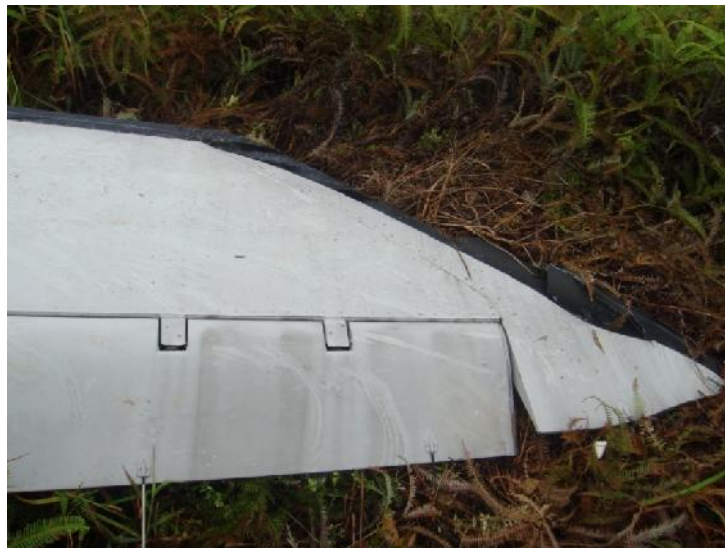
**Figure 8: The right wing tip damage, no wrinkles on wing**

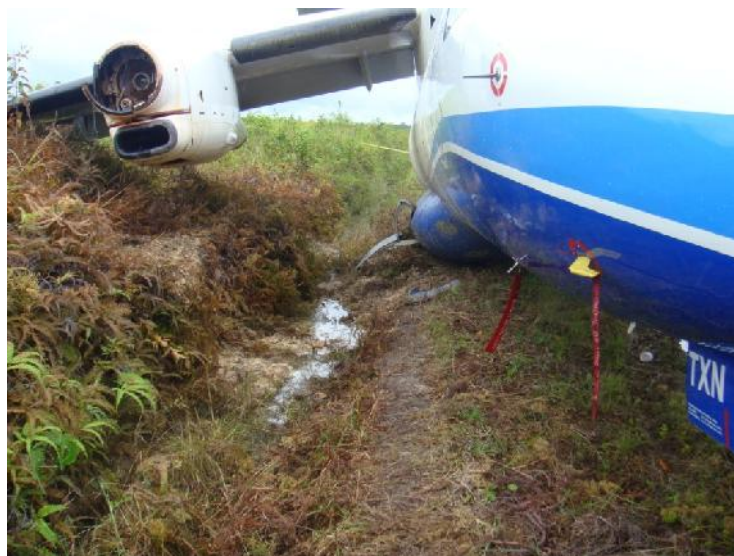
**Figure 9: The right side of the aircraft**

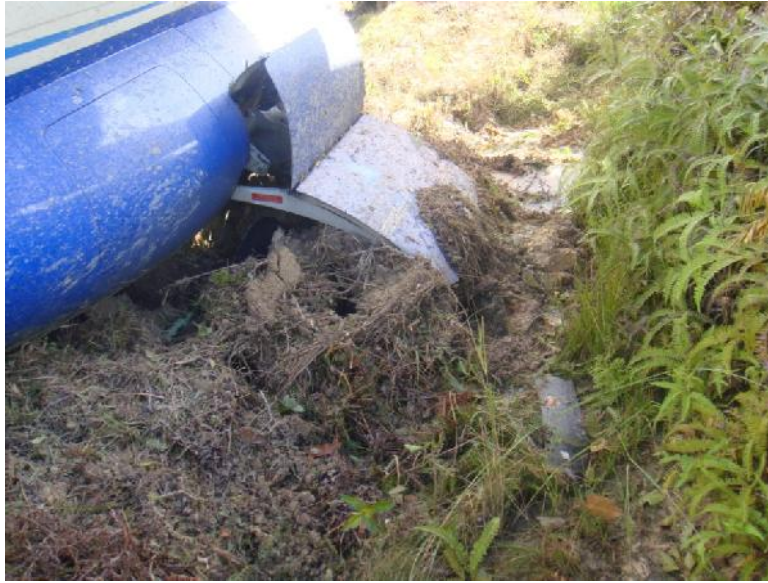
Figure 10: Propeller hit the mound, underneath the front of right gear

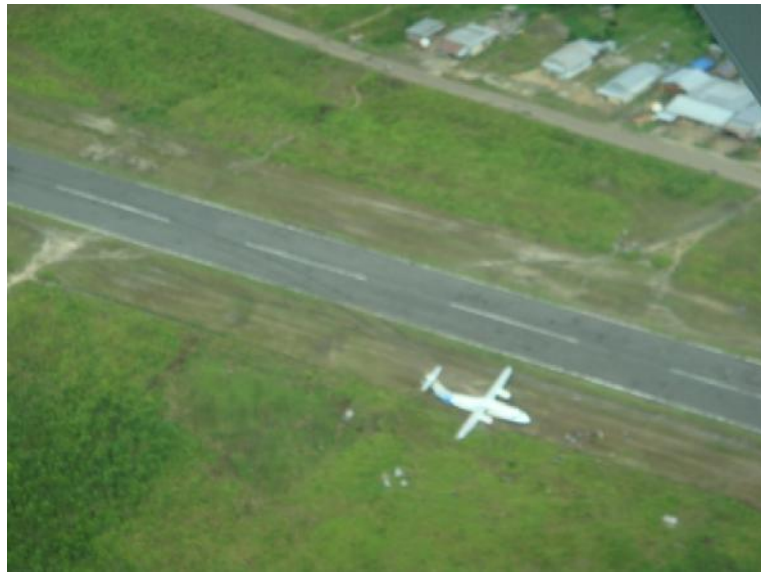
Figure 11: Wreckage taken from the air

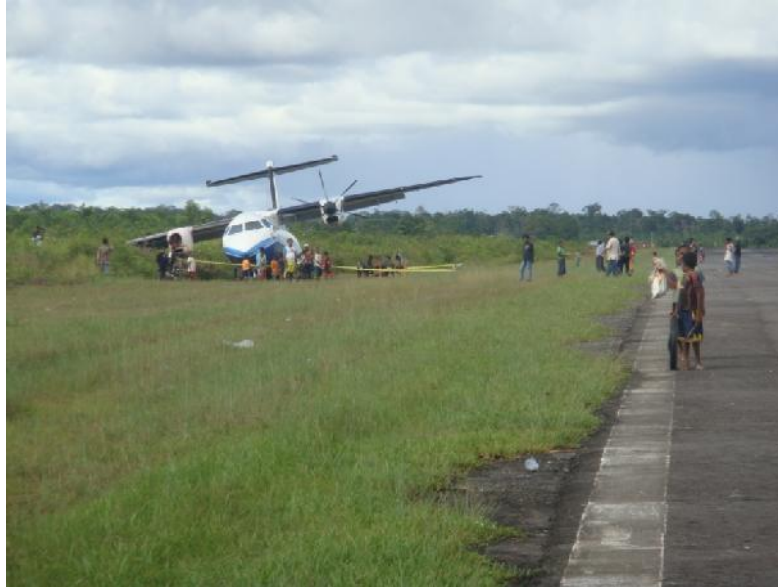
**Figure 12: Final position 600 meters from touch down area**
