Report 09-004, Britten Norman BN2A-Mk III Trislander, ZK-LOU loss of engine
propeller assembly, near Claris, Great Barrier Island, 5 July 2009

Report 09-004

Britten Norman BN2A-Mk III Trislander

loss of engine propeller assembly

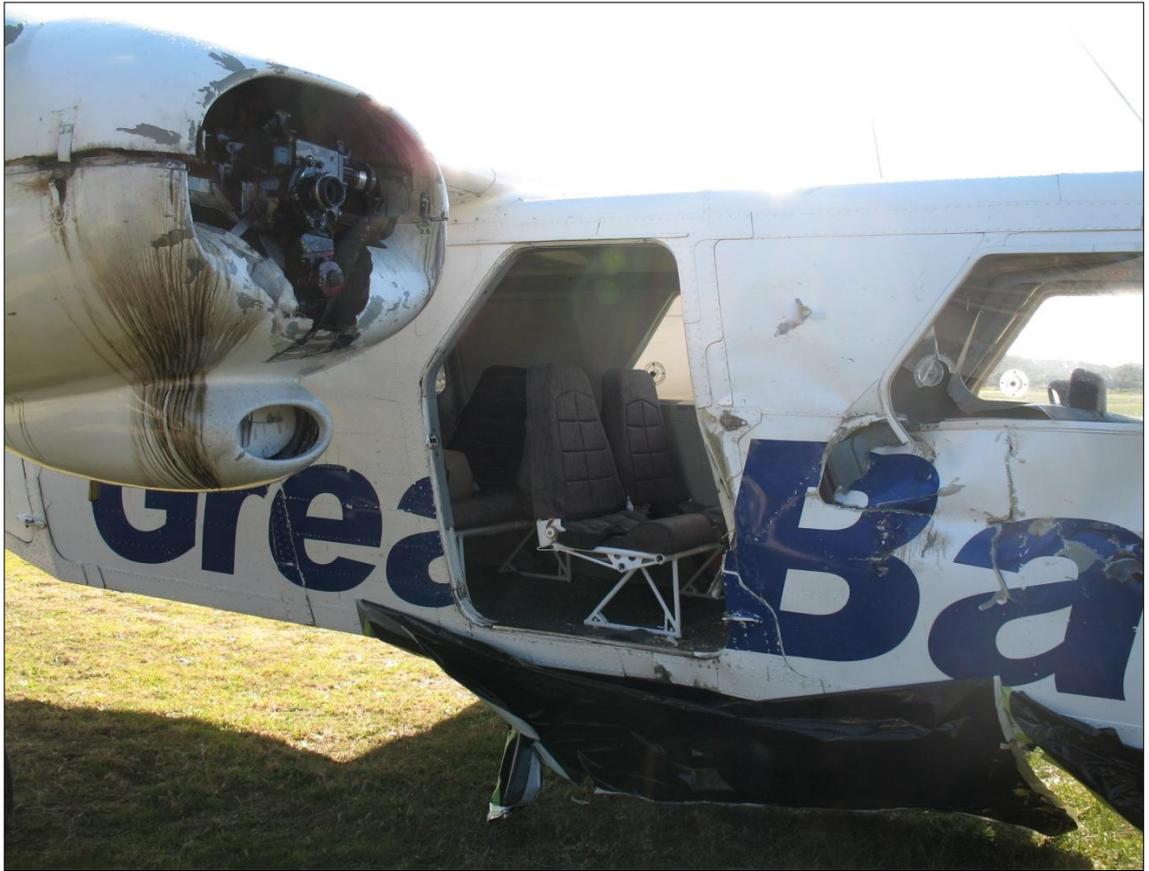
1.2.1 The right engine crankshaft flange that attached to the propeller hub had fractured through lightening holes in the flange. The complete propeller assembly had released from the fractured crankshaft flange and struck the side of the fuselage adjacent to the engine, substantially damaging the fuselage. The fuselage skin had been penetrated in places and a passenger window Perspex had shattered, but nobody was seated in that passenger row. Immediately behind the window the propeller assembly struck a passenger door next to which a passenger had been seated. The door hinges were damaged and the door fell from the aeroplane, leaving a large hole in the side of the fuselage by the passenger (see Figure 2).

Figure 2
ZK-LOU right side showing damage and missing propeller

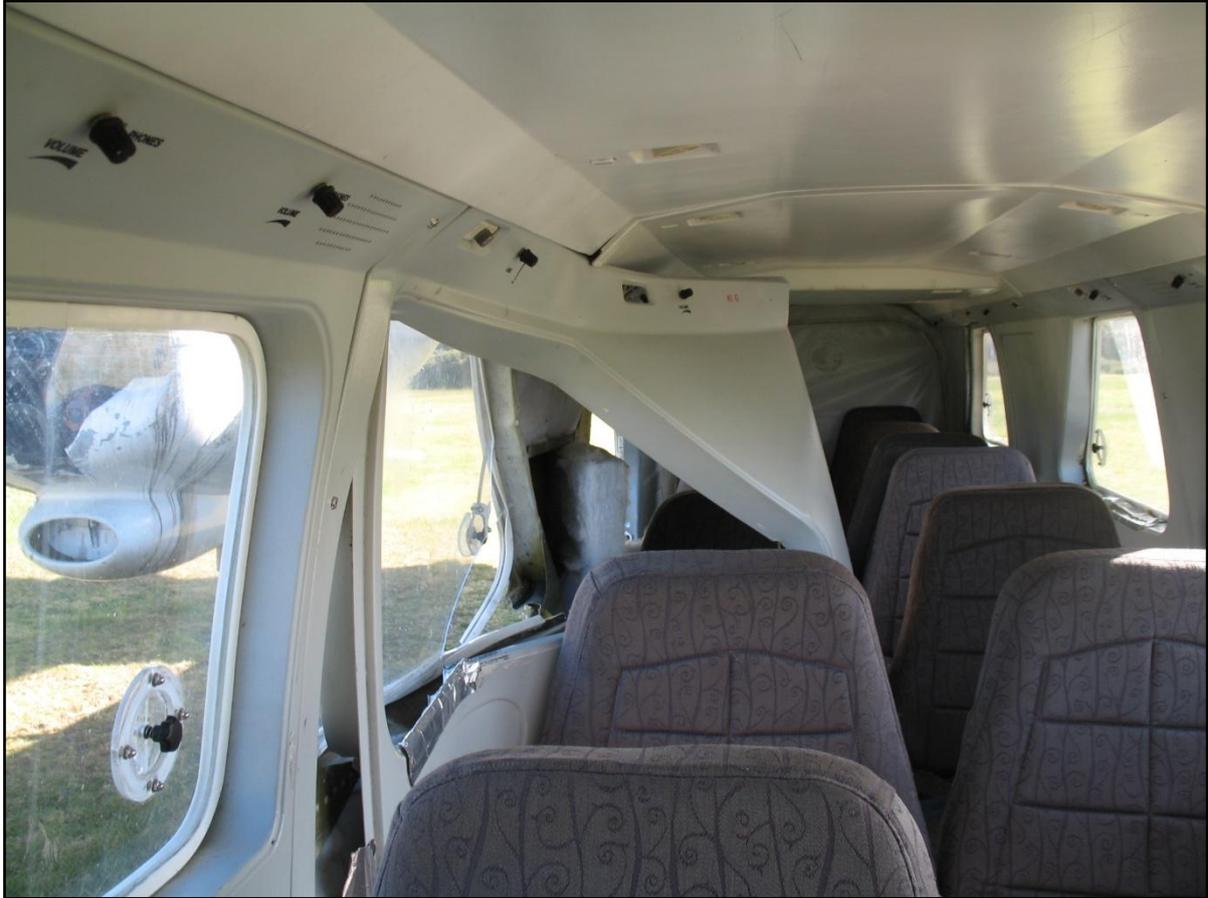
1.2.2 No part of the propeller assembly entered the cabin, but the cabin interior lining and insulation were damaged and pushed inwards onto some of the passengers (see Figure 3).

Figure 3
ZK-LOU interior showing cabin lining damage

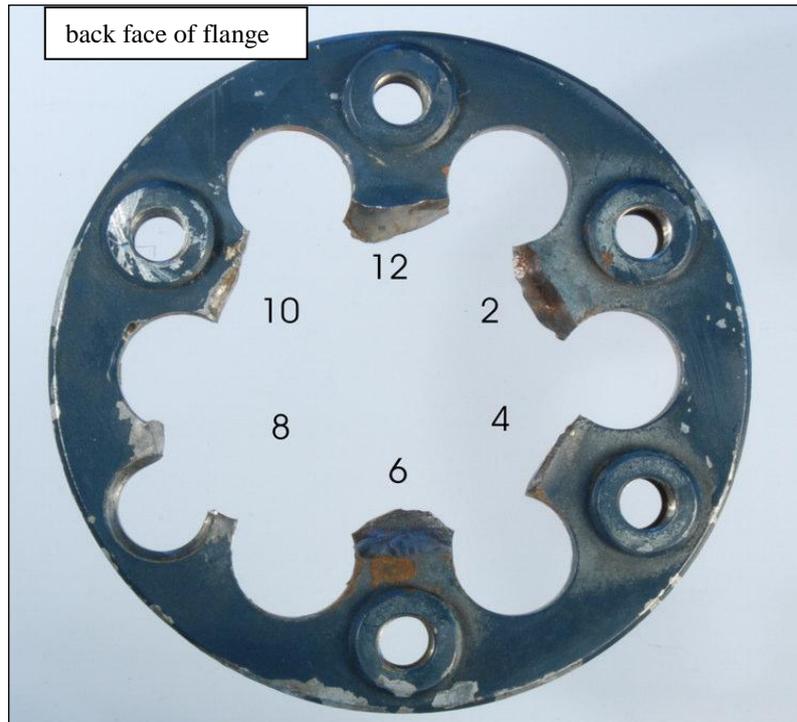
The flange had fractured through the spoke web sections separating the 6 lightening holes [see Figure 5]. Five of the webs had fractured at or near the fillet between the flange and the crankshaft. The rear face of the flange retained its paint coating but some corrosion was evident on the webs near and in some of the lightening holes. The corrosion, visually evident as patches of rust, had penetrated the cadmium protective plating beneath the paint and affected the underlying steel surface. Close inspection indicated that the corrosion had pitted the steel in places. The forward face of the flange was also rust-stained in isolated areas. Cadmium plate covered much of the surface but it had been abraded and fretted locally. Traces of paint were also present in a few places on the front surface. The crankshaft stub section projecting forward from the flange was extensively and irregularly fretted and its rim was bent inwards across one sector. This deformation was likely to have occurred as the propeller pitched and rotated off the flange in the final stage of the failure sequence.

Figure 5
Broken crankshaft flange that was attached to the right engine propeller hub
(DTA 2009)

Two of the fatigue fractures, at Positions 6 and 2 [see Figures 5 and 6] appeared relatively old, being discoloured and fretted to the point of having lost all microscopic surface detail. However, crack surface beach-markings indicated that the cracks had initiated on the rear face of the flange, at the fillet between the flange and shaft. Both cracks had grown forward and inwards towards the fillet at the front of the flange. The fracture at Position 6 had initiated in a region of extensive corrosion pitting. Multiple corrosion pits up to 0.2mm in size were found in this area. Some corrosion was also evident at the initiation point of the fracture in the Position 2 web.

Two other fractures, at Positions 4 and 10, had received severe surface damage during the final phases of flange breakup. Both had some signs of fatigue crack development from the rear face of the flange but one of them (at Position 10) showed extensive crack growth rearwards from the forward face towards the top of the fillet blend on the rear face. The fracture in the web at Position 4 had a similar configuration.

The fatigue crack surfaces at Position 12 were relatively fresh. The fractures were only locally fretted and were largely uncorroded. Clearly-defined beach marks were evident in places. These markings showed that the crack had initiated at the rear of the flange from the web corner loaded in tension by crankshaft torque. This fracture also ran inwards towards the front web/shaft fillet.

Detailed inspection of a zone of corrosion damage near the blend radius on the web at Position 8 showed that while the corrosion had initially seemed to be relatively superficial, there was widespread pitting in the area. Numerous small cracks had developed in these corrosion pits. Similar corrosion pitting was associated with cracking initiation sites on other flange webs.

All the cracked webs showed signs of defect initiation on the rear of the flange at or near the point where the fillet intersected the flange surface. Three of the defects had grown forward and inwards to intersect the front fillet on the flange while the two other cracks had cut across the web.

The form of the oldest cracks indicated that the crankshaft flange had been subjected to loads with a significant fore-aft bending component which induced cracking primarily from the rear face of the flange. The configuration of the cracks also indicated that they were caused by high cycle fatigue from relatively high frequency load fluctuations rather than low cycle fatigue from engine start/max power/stop cycles.

The corrosion pitting damage on rear faces of the some of the webs most likely triggered crack initiation. The corrosion had evidently occurred after local failure of the paint coating, followed by penetration of the cadmium plate covering the surface. The observed corrosion pitting would have compromised the fatigue resistance of this highly loaded area of the crankshaft.

- 2.7 Because corrosion can lead to cracking, as demonstrated in this case, any corrosion that is found around crankshaft flanges should be removed and the area specifically checked for cracking and protected as advised in the Continuing Airworthiness Notice.

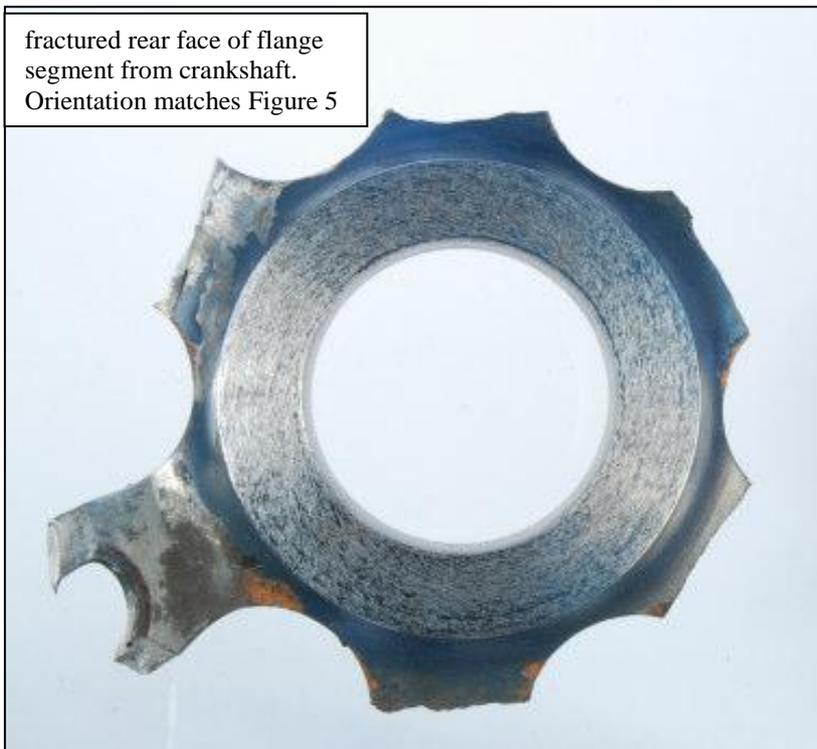
Figure 6
Fractured rear face of flange centre (machined off the crankshaft)
(DTA 2009)

Inspection showed that 5 of the 6 fracture surfaces had clear signs that metal fatigue had played a critical part in their failure. The remaining web element that also went through a bolt hole [see position 8 in Figures 5 and 6] had failed by ductile shear which was likely to have occurred during the final stages of propeller separation.
