KNKT.09.10.16.04

Runway Incursion Investigation Report

**PT. Aviastar Mandiri
DHC-6; PK-BRS
Soedjarwo Tjondronegoro Airport
Serui - Papua
Republic of Indonesia
14 September 2009**

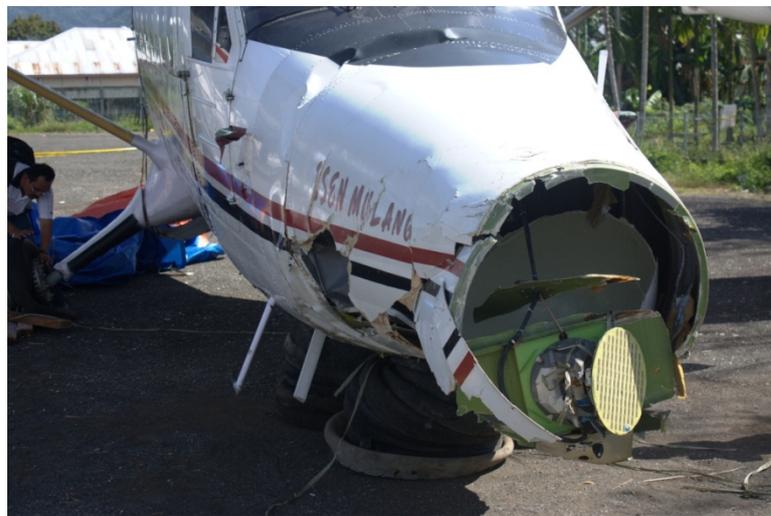
- The nose wheel was folded backward to 8 o'clock position relatives to aircraft facing forward;
- The right wing tip dent;
- Lower part of nose section broken;
- All propeller blade tips of the right engine bend;
- Right main wheel tire detached from the hub.

Figure 1: Damage on the nose section

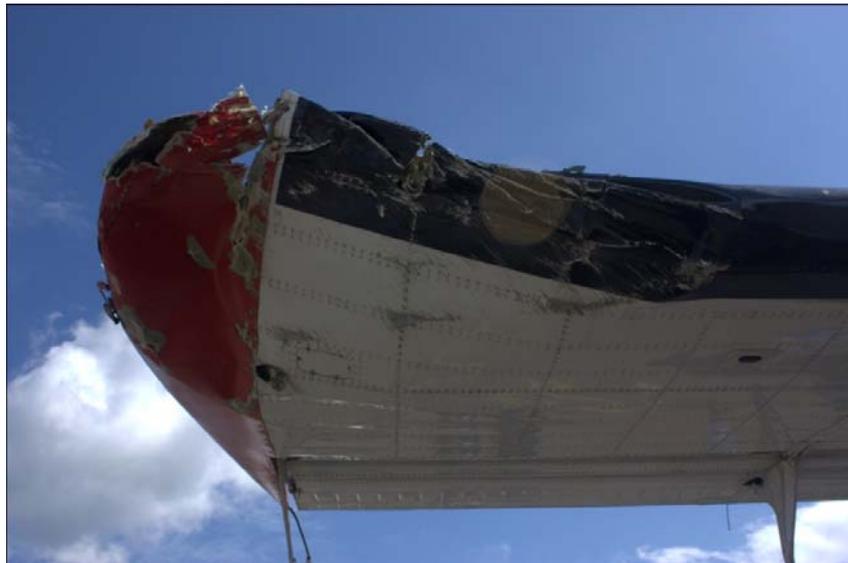
During the ground loop and the aircraft turning 90°, the forward inertia in combination with the tail wind component had made the left wing lifted up and the right wing tip and right engine propeller touched the runway. The forward inertia also collapsed the nose landing gear to 120° to the left relative to the aircraft longitudinal axis.

Figure 2: Right Wing Tip.

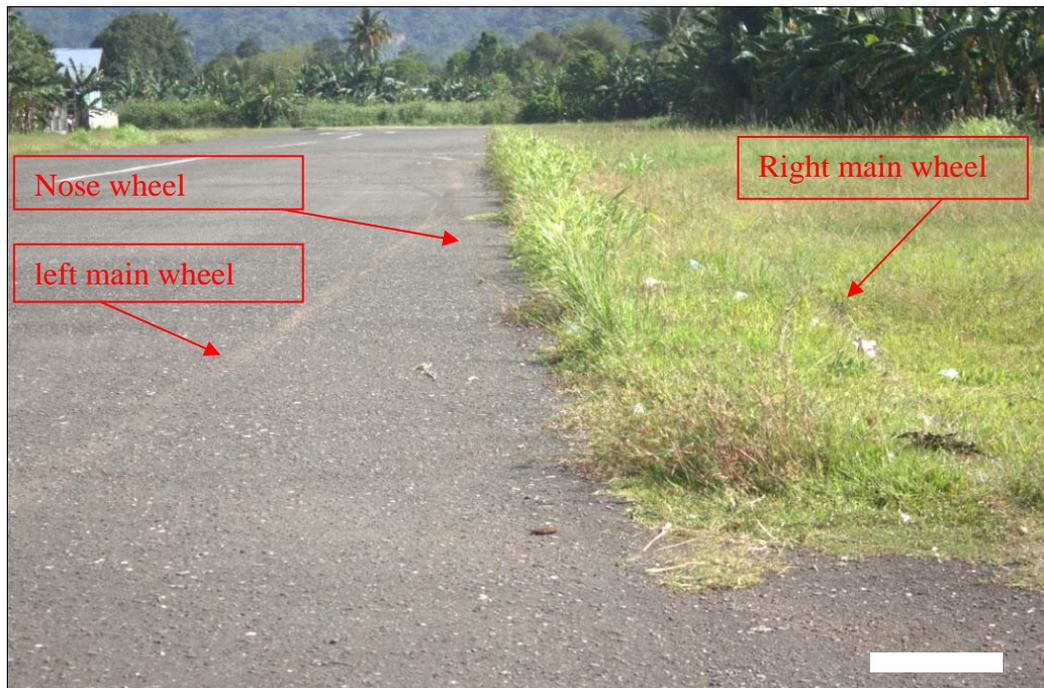
Aircraft stopped at approximately 400 meters from the beginning runway 36 or approximately 250 meters from the beginning runway 18 on heading 090°.

Figure 3: Touchdown marks on taxiway SP2
