SOUTH AFRICAN CIVIL AVIATION AUTHORITY  
(SACAA)

## FINAL REPORT

### **Jetstream Aircraft 4100 ZS-NRM: Loss of control after engine failure and misidentified engine shutdown after take-off from Durban Airport, South Africa on 24 September 2009**

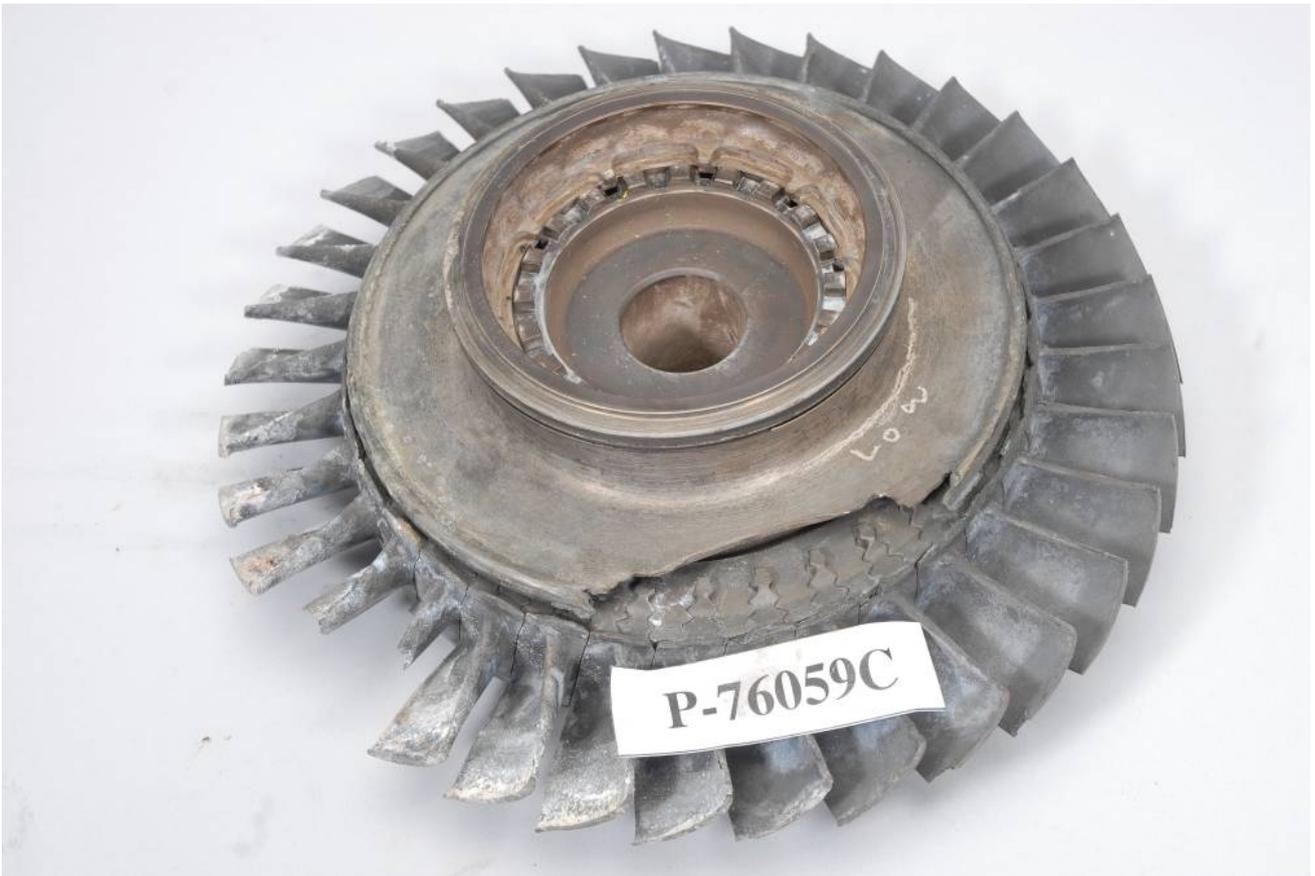
Examination of the wreckage confirmed that the right-hand engine (engine 1) had suffered a catastrophic failure of the second-stage turbine seal plate and that subsequently the serviceable engine had been shut down, resulting in a forced landing.

**Figure 1. The failed seal plate.**

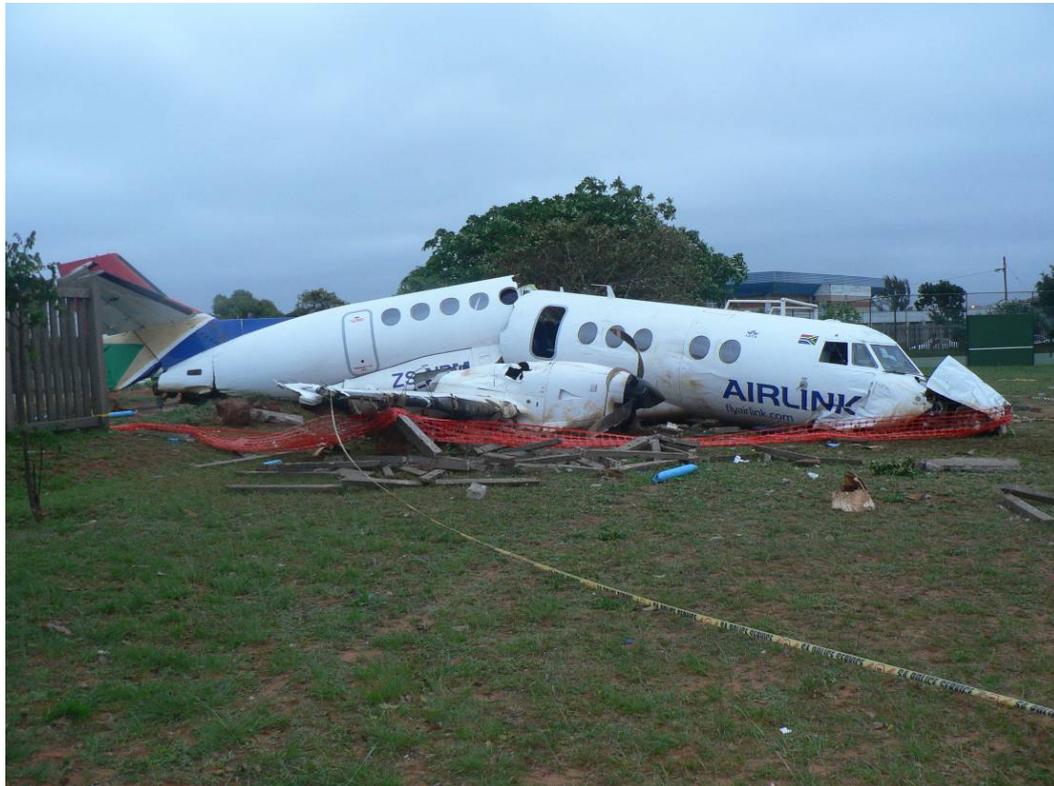
1.3.1 The aircraft was destroyed during the forced landing due to impact forces.

**Figure 3.** The main wreckage.

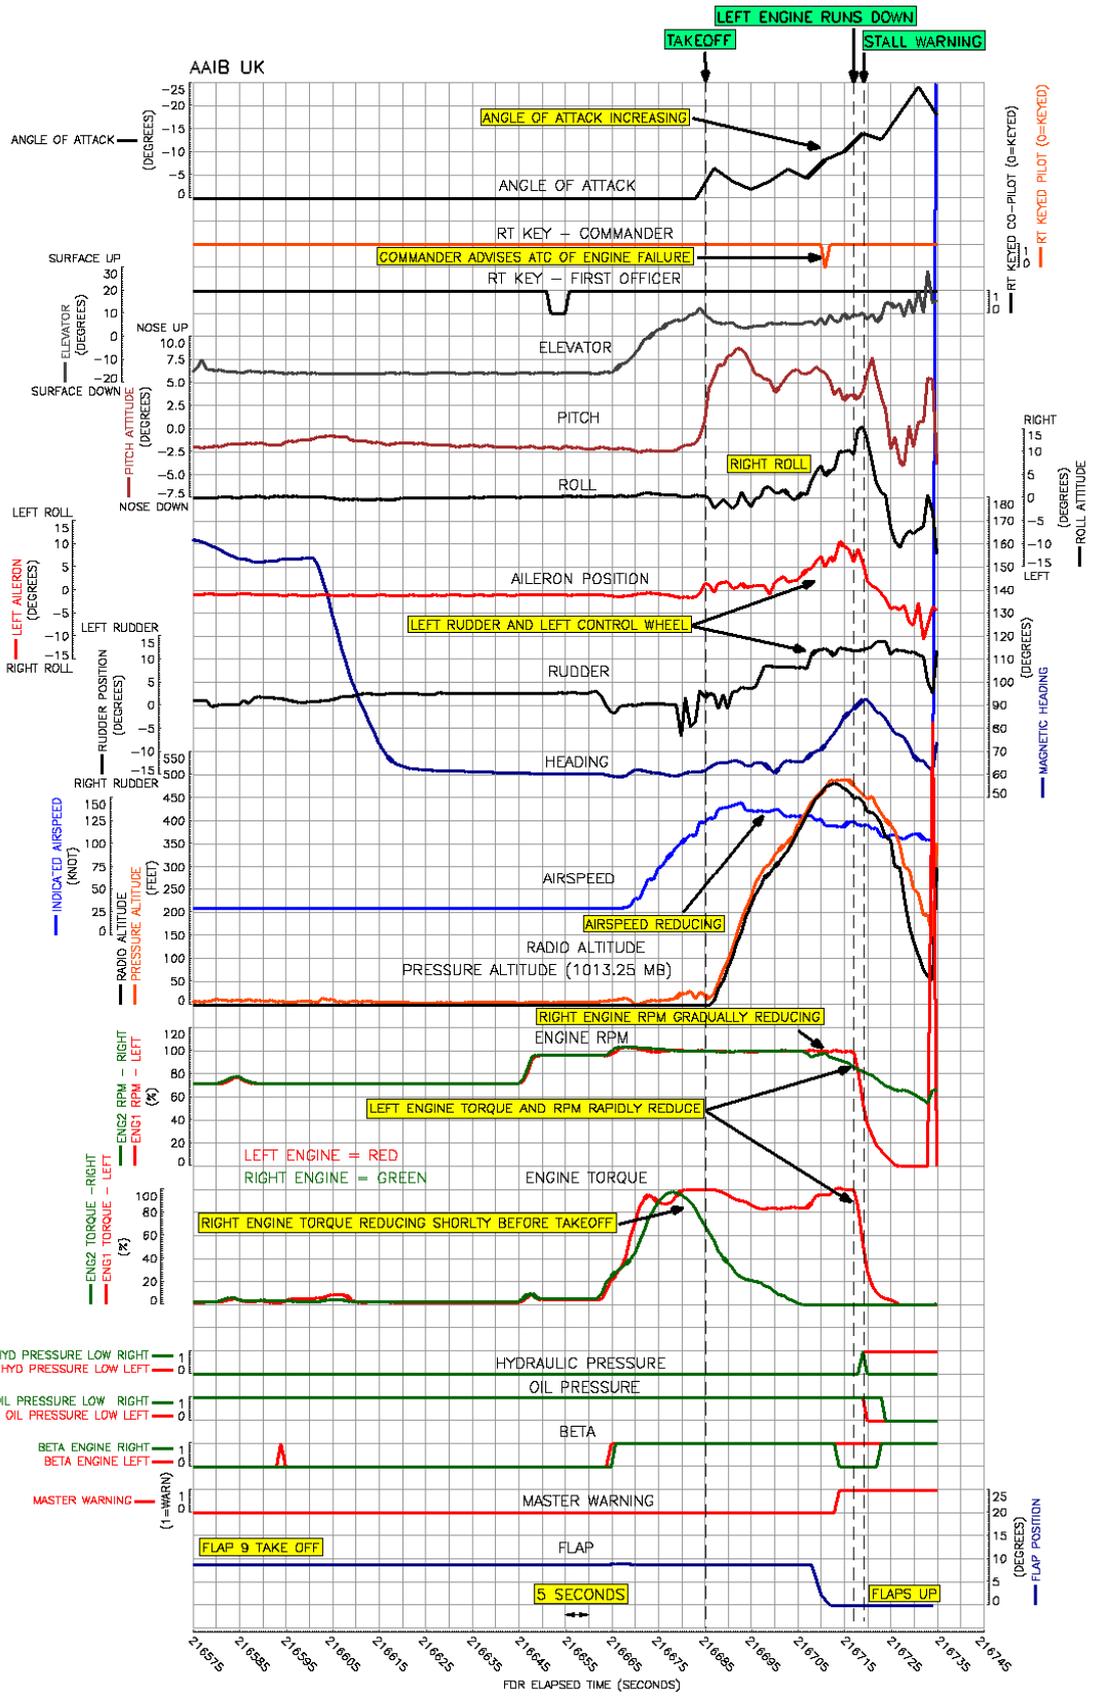
Figure 4. The FDR parameters.

- 2.7 Analysis of the FDR data (Figure 4) revealed that during take-off, at about the moment of rotation, five seconds before actually lifting off the runway, the right-hand engine failed and the thrust gradually reduced to zero in about 25 seconds. The take-off was continued. As shown by the FDR data, the dynamic effects caused by the failing engine were minimal, although the aircraft entered two small rudder pulses to the right immediately after the engine failure. The aircraft started climbing and the captain initially maintained approximate runway heading with a small, but increasing rudder input to the left. The bank angle (roll) varied slightly around wings-level; roll control power by the ailerons was adequately available. Despite the reduction of thrust from the right-hand engine, the airspeed continued to increase for about 12 seconds to approximately 135 kt, which was still much higher than the required  $V_2$  (103 kt) for this flight phase. The captain increased the rudder deflection for maintaining the heading, but allowed a small bank angle to the right, into the inoperative engine, rather than away from it. Consequently, the drag must have increased and as a result, the airspeed started to decrease. The bank angle could still be controlled using the ailerons, but was not five degrees (or less, as is preferred by the manufacturer) away from the inoperative engine, as is required for minimum drag and lowest possible minimum control speed while the thrust is asymmetrical.

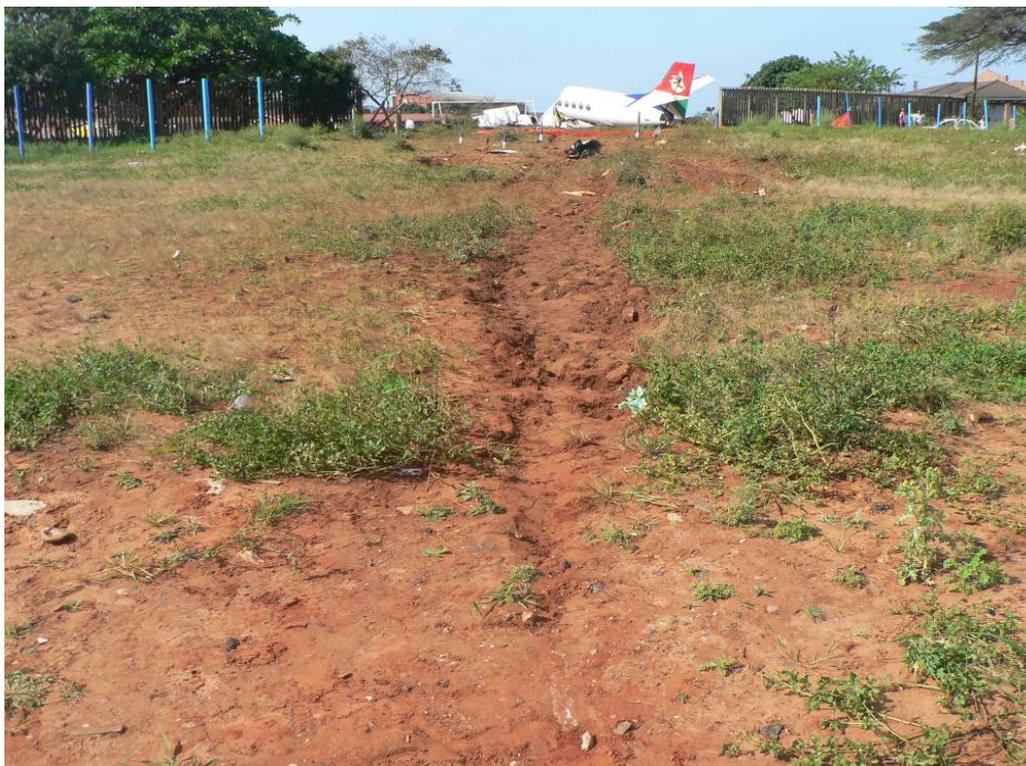
1.12.1 The ventral fin on the tail cone struck the ground first, followed by the propeller blades of both engines. The propeller ground marks indicated that the propellers hit the surface approximately 7 m before the right engine collided with the ground. The left engine then struck the ground. The aircraft skidded for approximately 25 m before hitting a power pole and skidding across a tarmac road. The bottom nose section of the aircraft then collided with a palisade fence and the fuselage broke apart above the wings. The distance from the first impact point to the main wreckage was 62 m and the main wreckage came to rest on a heading of 60°M.

**Figure 5.** The first impact mark of the tail cone.

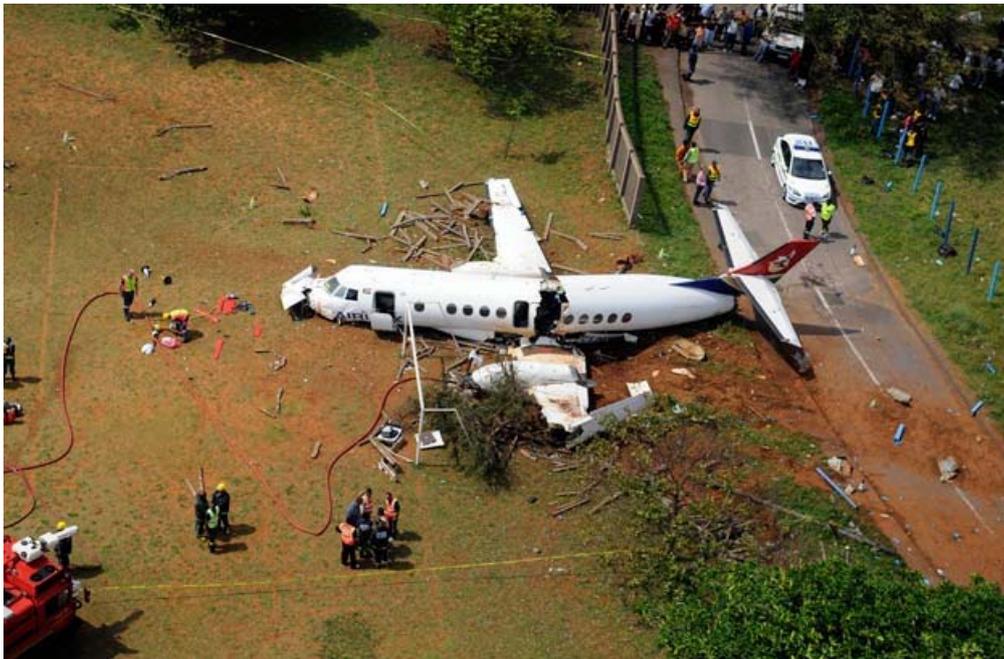
1.12.2 Both pilots' seats were bent forward by the impact deceleration. Both power levers were found in the full power position. Evidence suggests that the captain was not wearing his shoulder harness at the time of impact.

1.12.3 The No. 1 (left-hand) engine fuel condition lever was found in the cut-off position and the No. 2 (righthand) engine fuel condition lever was found in the flight position. The elevator trim pointer was within the green arc.

**Figure 6.** The main wreckage.

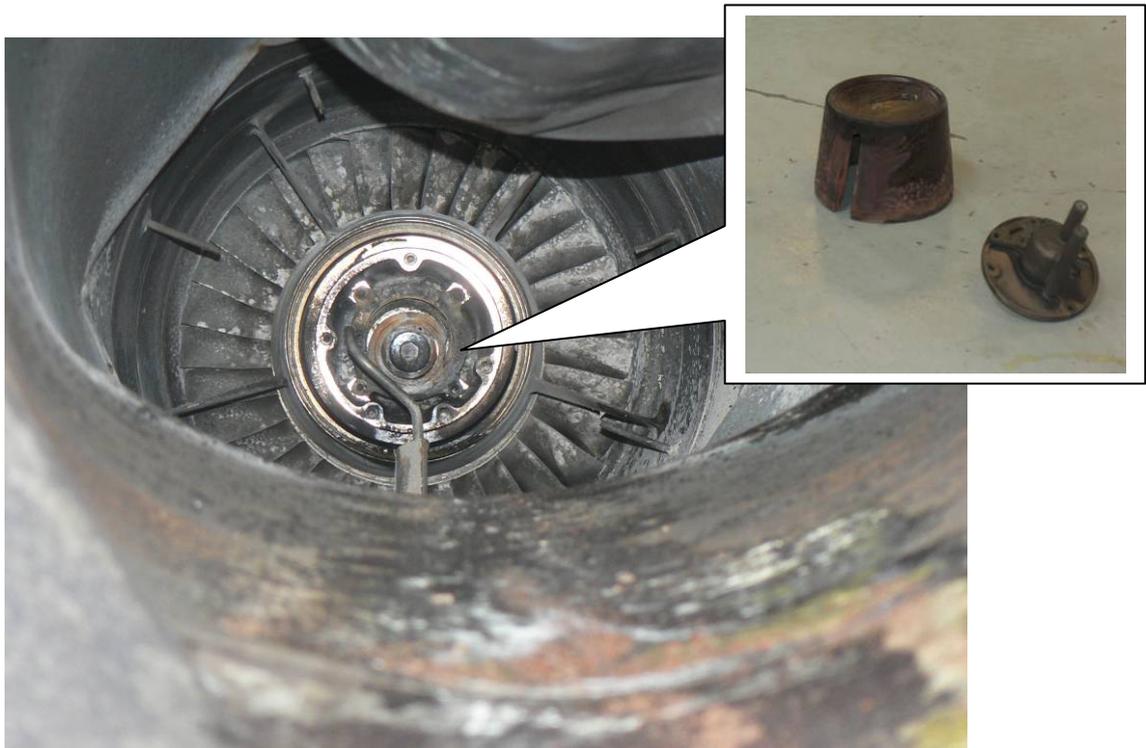
Figure 7; The right-hand engine with rear bearing cover and tail cone missing.  
The insert picture shows similar parts from another engine.

- The rotation of the propeller produced a corresponding rotation of the turbine section;
- A review of the rear turbine bearing area disclosed that the tailcone, thermal blanket, bearing cover, rear turbine bearing inner race, roller elements, bearing cage, bearing retaining nut, and lock cup to be missing;
- The bearing cover attachment portion of the turbine bearing oil supply line and oil scavenge line had separated and was missing.

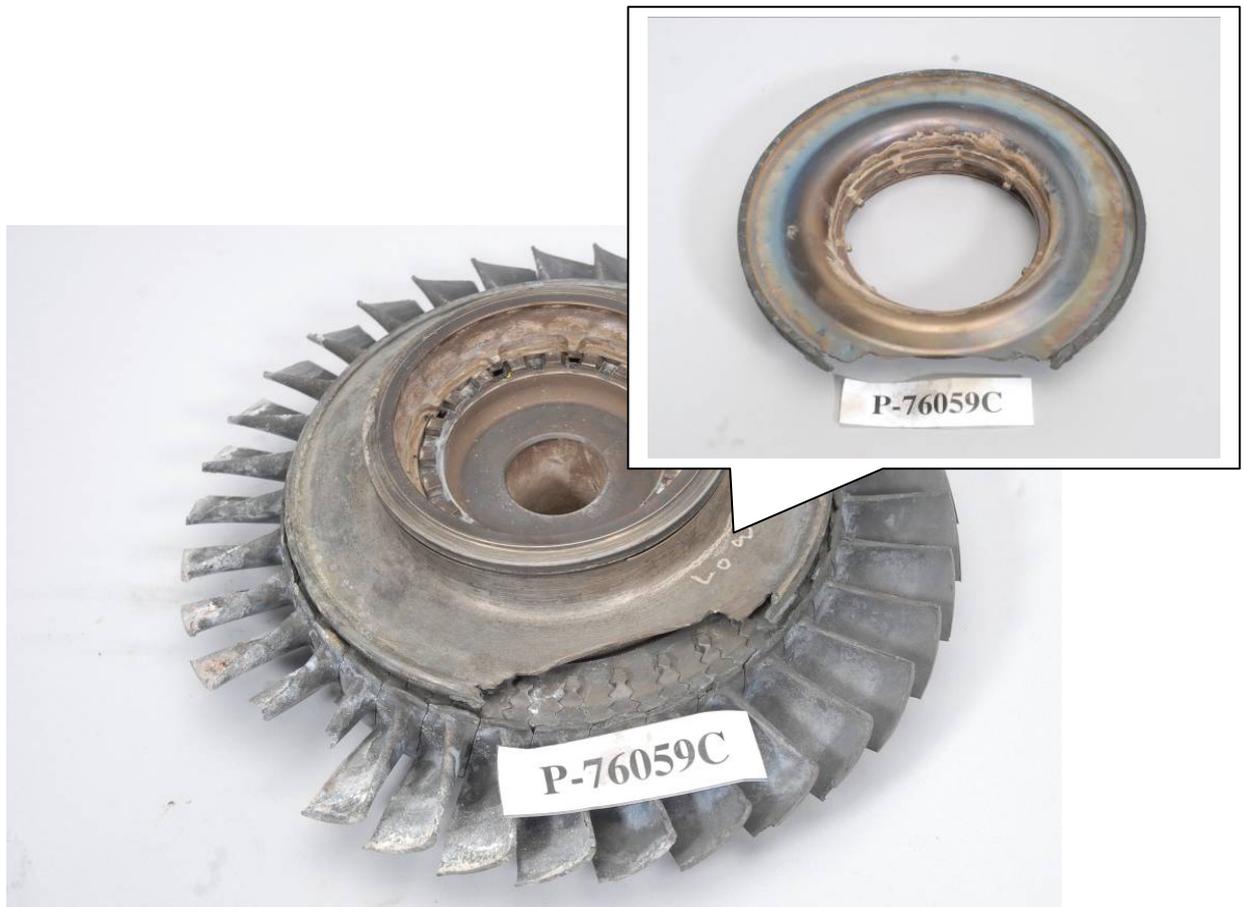
- Metal particles were found on the magnetic chip detector;
- Metal particles were found in the oil filter;
- The second-stage turbine seal plate had failed (this was considered to be the primary cause of the engine failure);
- Damage was caused to the impeller, turbine rotor blades and turbine stator.

Figure 8. The right-hand engine's second-stage turbine seal plate.

On the right engine of ZS-NRM, the seal plate had failed after 1 314 CSN, while the left engine was found with the seal plate rim worn beyond limits after only 570 CSN.

- 2.22 The event began with the separation of the second-stage turbine seal plate rim, most likely during the accident flight. The oil supply line separated in fatigue shortly after the second-stage turbine seal plate rim separation. The turbine bearing appeared to have begun to degrade because of oil starvation approximately 17 seconds after acceleration to 96% speed.

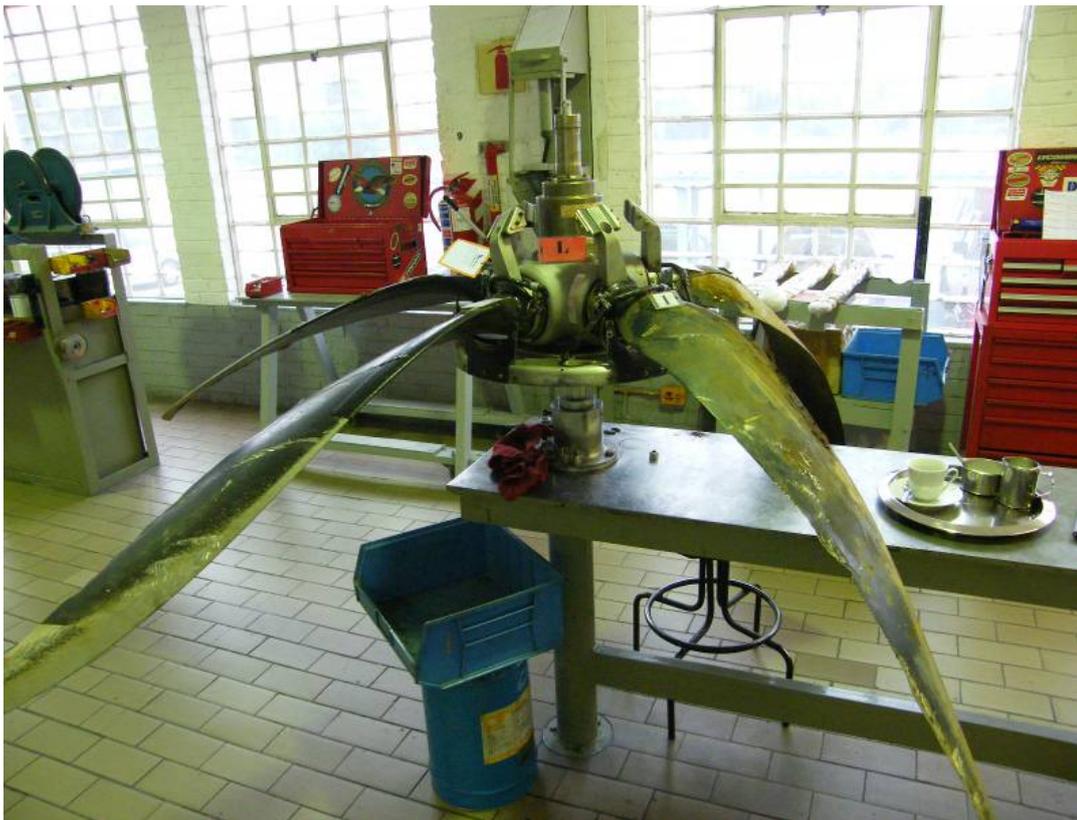
- i. As found, all the blades were on the latches with a low blade angle;
- ii. The propeller blades were bent aft and found at a low blade angle at the accident site. Examination of the pitch change mechanism found it to be fractured, allowing the propeller blades to move within the hub;
- iii. The blades did not show any significant signs of power during the impact sequence;
- iv. No visual assembly anomalies or maintenance errors were noted during the propeller teardown and examination.

**Figure 9.** Damage to No. 1 propeller.

1.16.4.1 The status of each propeller at impact was established from a combination of the physical examination and FDR data. It was concluded that the left propeller had been feathered on impact and was not rotating: the "as found" low blade angle was explained by fracture of the pitch change mechanism, which had forced the blades out of the feathered position on impact.

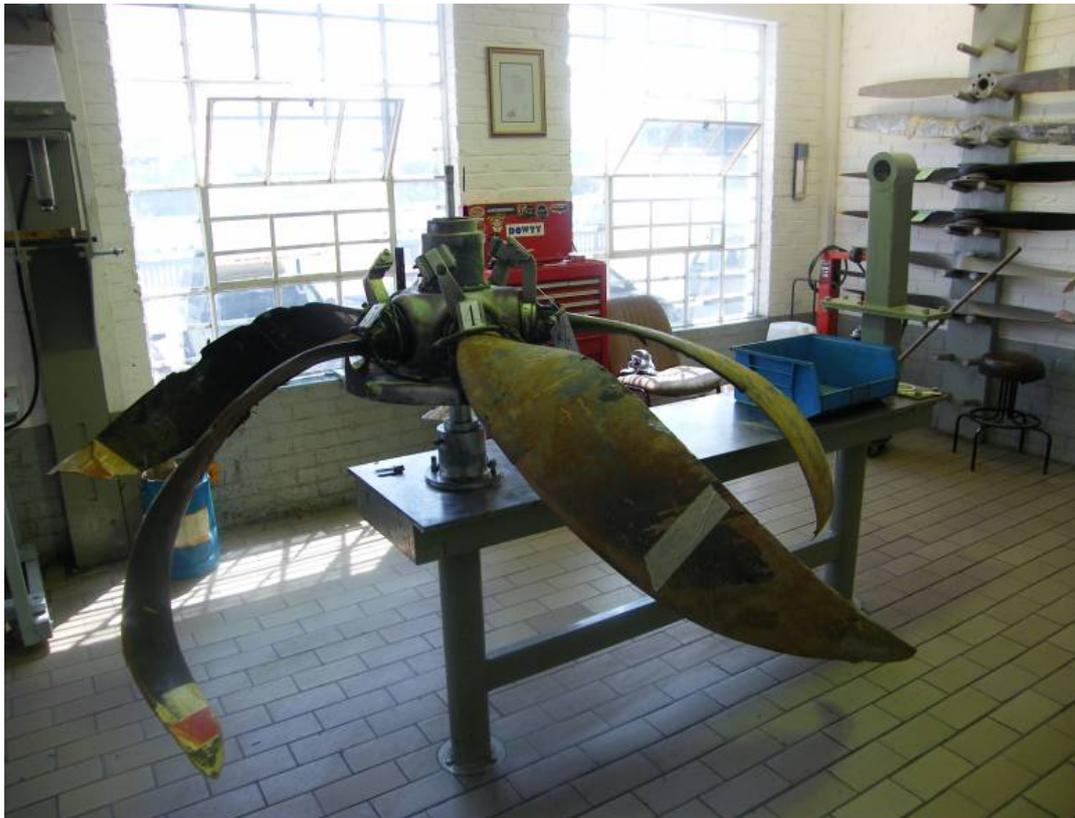
- i. All the link pins were broken and it could not be established whether the propeller blades were on the latches at the time of impact;

- ii. The propeller blades were curled in the direction opposite to rotation, consistent with the propeller blades rotating at impact. The amount of propeller blade curling is consistent with the propeller rotating at reduced speed. The propeller blades were found at the accident site in the reverse pitch position;
- iii. This is confirmed by the damage sustained to the trailing edges of all the blades as well as the twisting of the blades. According to the FDR, it would also appear that the propeller RPM at the time of impact was approximately 56%;
- iv. No visual assembly anomalies or maintenance errors were noted during the propeller teardown and examination.

**Figure 10.** Damage to No. 2 propeller.

The right propeller, despite being found in the reverse pitch condition, had been rotating at a low speed and with a low blade angle on impact. Information from the FDR indicates that the RPM was about 65%. The blades had moved after initial impact due to fracture of all five pitch link pins in the hub.
