**RAMP COLLISION, RWANDAIR FLIGHT 205, OPERATED BY JETLINK
BOMBARDIER CL-600-2B19, REGISTRATION 5Y-JLD, KIGALI INTERNATIONAL
AIRPORT,
12 NOVEMBER 2009**

EXECUTIVE SUMMARY

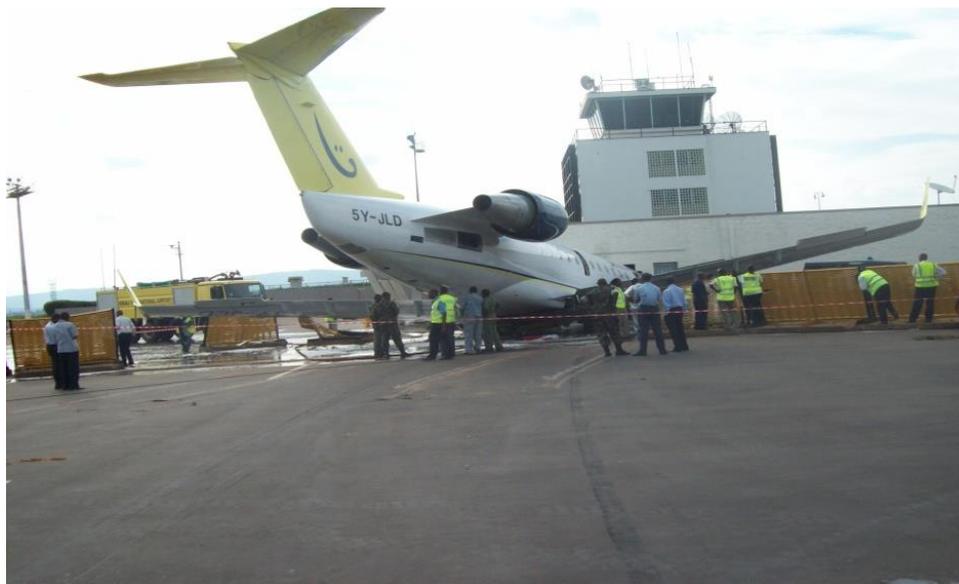
The airplane, which was generally intact, was located with its front section penetrated through the wall structure of the air traffic control tower building. Along the path on the ramp where the airplane had parked to the accident site was surface damage associated with the landing main gear wheels over a distance of 220 meters that transitioned about 80 degrees from a south to west direction (see Figure 1).

Photo 1. Left rearview of aircraft wreckage

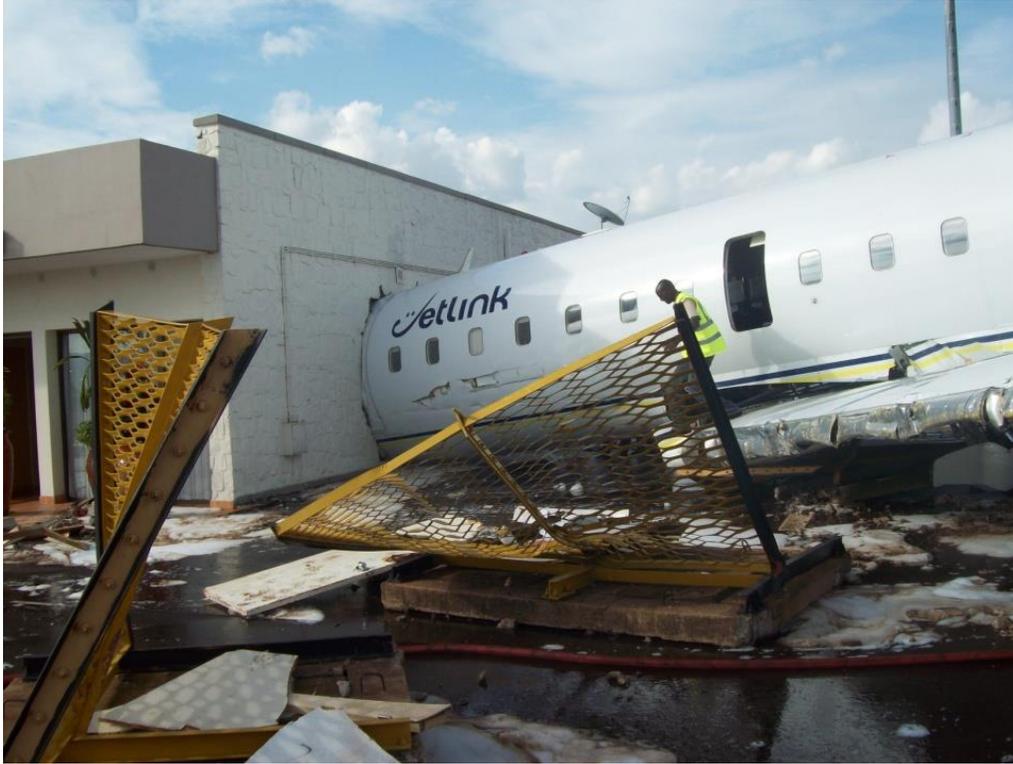
Photo 2. Left side view of aircraft wreckage (above)

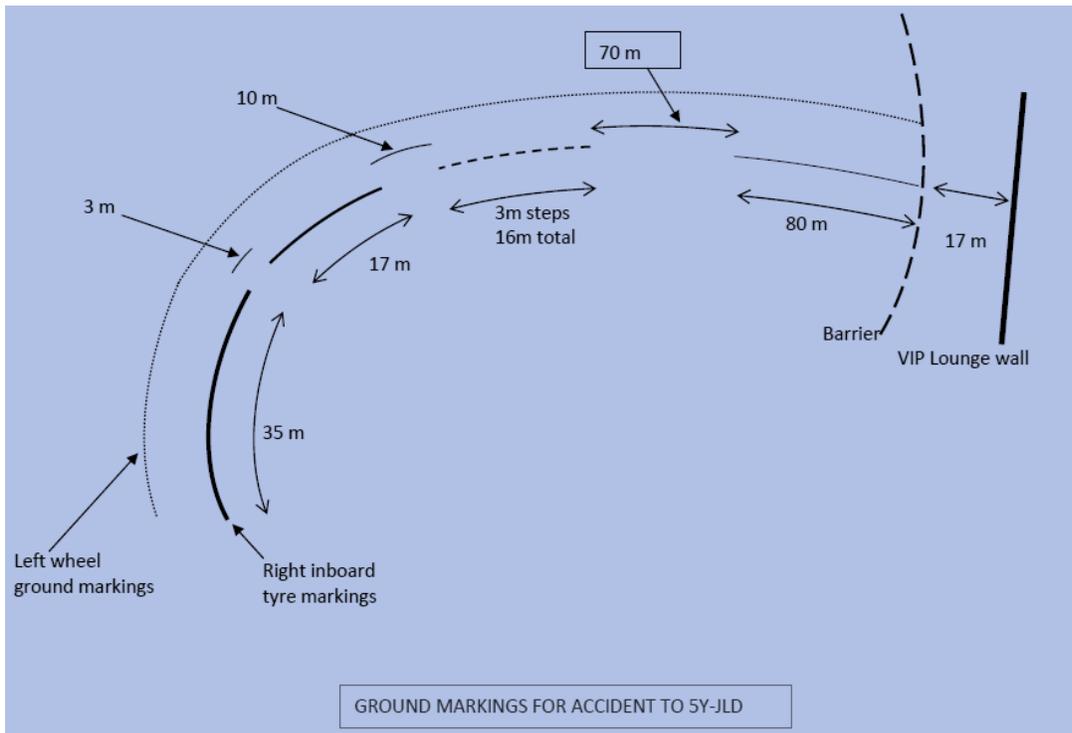
The skid marks on the ramp shows there was braking on the right tire as compared to the left tire, which appears to have caused scrapping damage to the tarmac, and it would explain why the airplane turned right during the accident sequence that followed the inadvertent movement of the airplane after it was parked.

Figure 1: Ground Markings (Below)

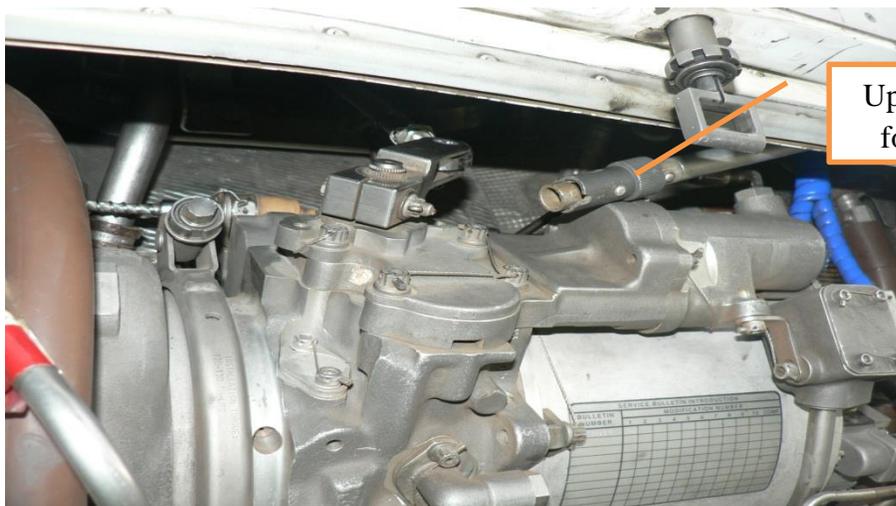
Examination of the left engine revealed the throttle mechanism was in the idle position, the upper core cowl support strut not its stowed position and the safety pin hanging from its lanyard as indicated in number 3 photo below. The strut was in a position to prevent movement of the fuel control unit actuating arm less than the 93% N1. The components of the strut stow assembly, consisting of the locking collar, spring clip, and lock pin were inspected and no evidence of mechanical malfunction was revealed. Continuity was established between the left engine thrust lever and fuel control unit

Upper core cowl support strut was found not in its stowed position

- 3.1.4** The core strut, which was found in the not stowed position, interfered with the left engine throttle lever during takeoff resulting in a jammed thrust lever.

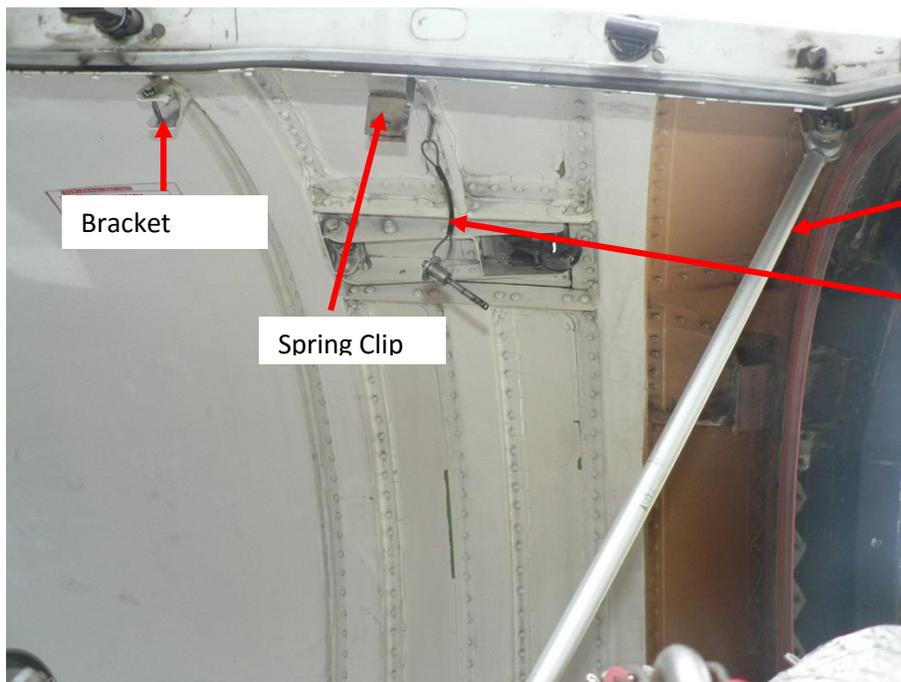
<p>investigation found the left hand engine upper core cowl stay out of place and interfering with the fuel control unit. The spring clip PIP pin holes were found to be worn and a light tapping on the cowling was enough to cause the pin to fall out. The locking mechanism at the end of the say is easily secured improperly and it is undetermined whether the PIP pin was installed in an upwards or downward direction.</p>
--	--	--

Photo 3. View of Upper Core Cowl Door Hold Open Rod found dislodged.

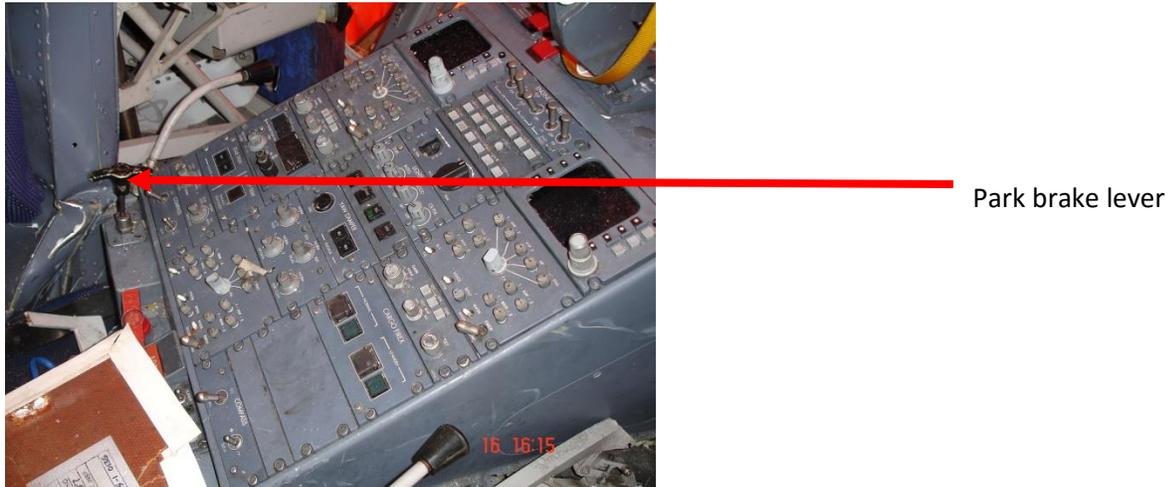
Inspection of the parking brake lever indicated that it was pulled up and engaged in the 90 degree locked position, as required for engaging the parking brake.

Photo 4. View of Parking Brake in the Park Brake Engaged Position

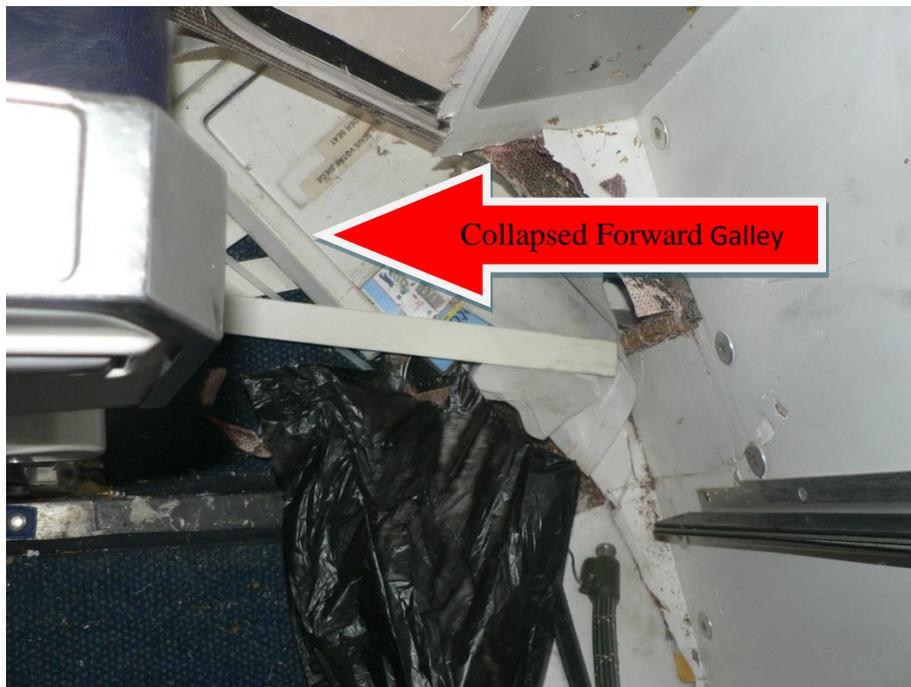
The post impact damage resulted in extensive crushing of the forward fuselage and collapse of the galley area, obstructing the use of the 1L passenger door. The passengers evacuated the airplane through the right hand over wing (RHOW) emergency exit. Several of the passengers exited the airplane with the assistance of the cabin crew.

Photo 5. View of Collapsed Forward Galley

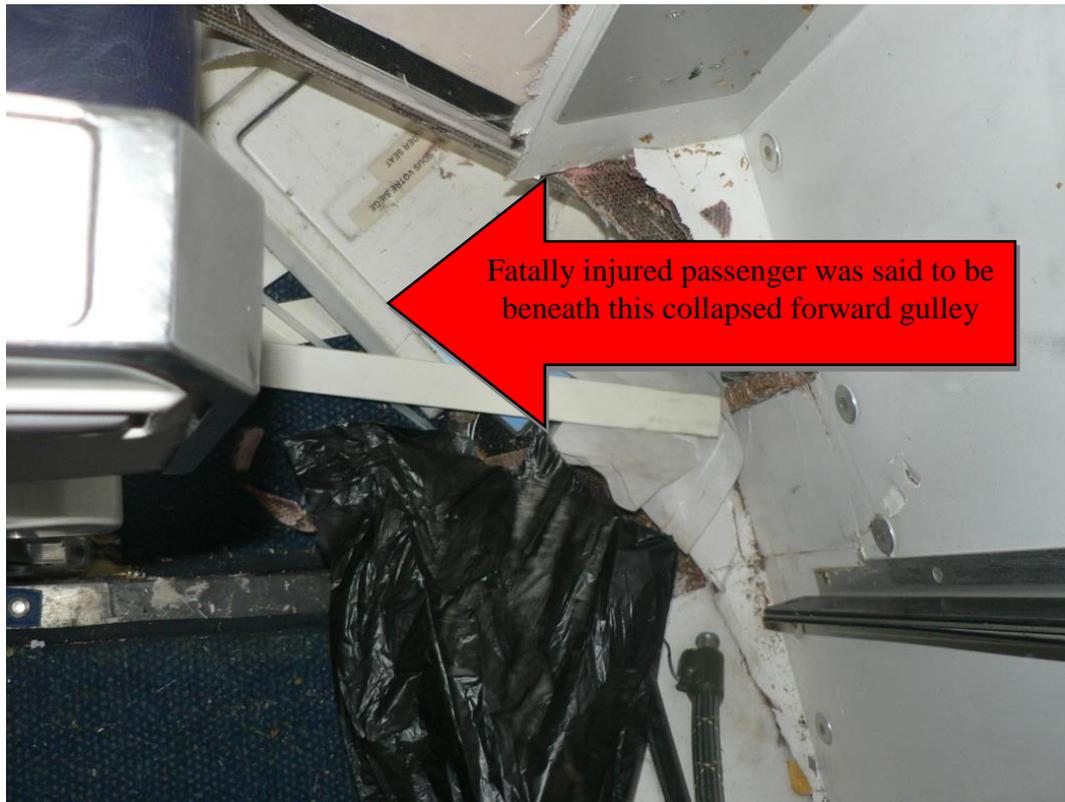
After evacuating all other passengers, rescue officers/cabin crew researched the cabin and found one more passenger (lady) lying unconscious under the collapsed forward galley. The fire officer

Photo 6. Showing place where one passenger was located.
