AAIPU# A09-01471

AIRCRAFT ACCIDENT REPORT

DASSAULT SUD FAN JET FALCON
N28RK

MATTHEW TOWN, INAGUA, BAHAMAS
DECEMBER 17, 2009

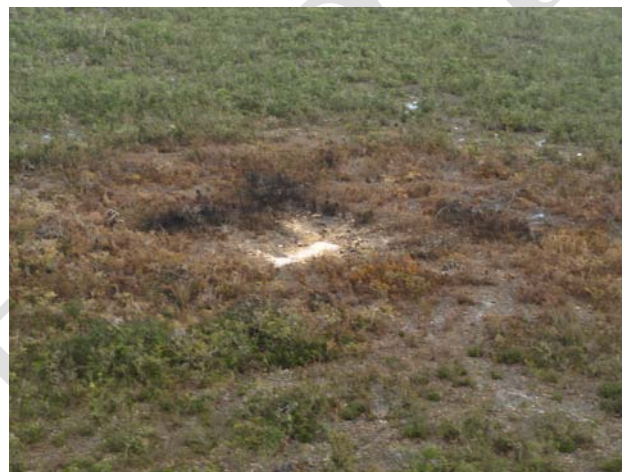
Figure 6 Post impact fire in National Park

Post impact fire destroyed approximately 5 acre section of the National Park. No other damage was reported.

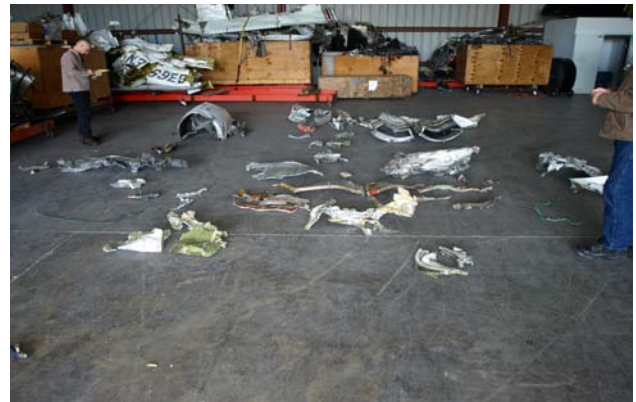
condition prior to ground impact. Less than 10% of the aircraft was recovered.

Figure 8 - Parts on the hanger floor represents the total recovered parts of the aircraft.

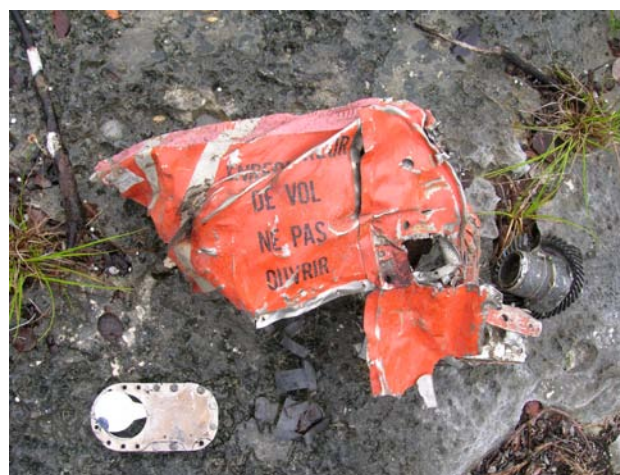
Successive searches of the area did not locate the internal parts of the CVR. The housing of the CVR was recovered; however the internal components were never recovered. Photo following showed the extent of damage sustained by the CVR.

Figure 9 and 10. Actual CVR case recovered from N28RK. Case was destroyed internal parts and recorder never recovered.

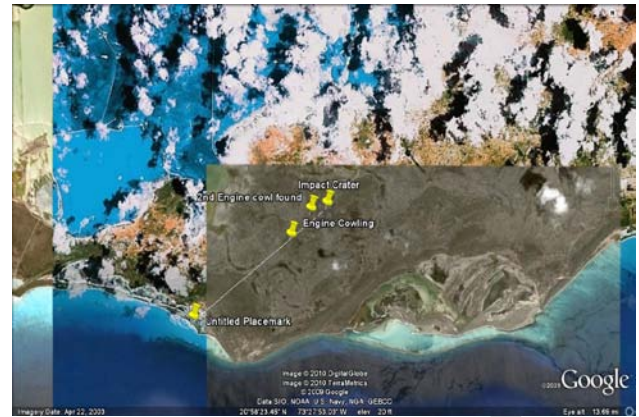
The airplane broke into many pieces, with debris spread over a large area of rough terrain. Fire from the explosion burnt the immediate area of trees and parts of the aircraft.

Figure 11 view showing aircraft break up and parts found from the ocean to the crash site.

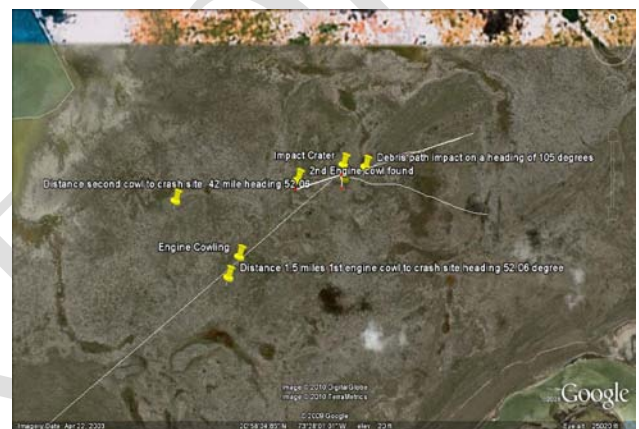
Three engine nacelle cowlings were found before the main impact site, below the flight path of the airplane from radar tracking. One was the upper cowling from the right nacelle, found .4 miles west of the crash site. The other two were lower cowlings from the left nacelle which were found 1.2 miles west southwest of the crash site.

Figure 12 view showing location of 1st and 2nd cowling found in relations to the impact and debris field

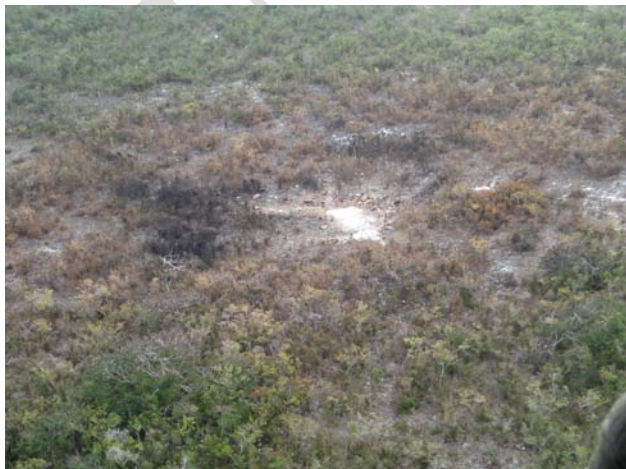
Approximately 5 acres of the national park was destroyed by the fire. Parts of the aircraft including personal effect, aircraft parts and furnishing, seat and seat cushions were also destroyed in the post impact fire.

Figure 13 show results of fire from explosion and burning that followed.
