PRELIMINARY
KNKT.10.01.01.04

Aircraft Serious Incident Investigation Report

Antonov AN-26B; 4L-IFE

Wamena Airport, Wamena, Papua

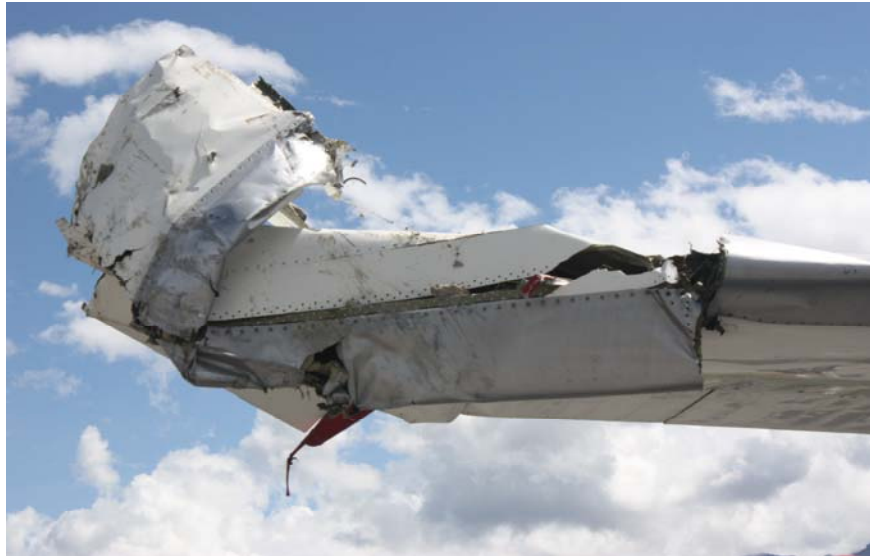
The nose landing gear, right wing tip, lower fuselage, and right propeller were extensively damaged.

Figure 1: The damaged right wing tip

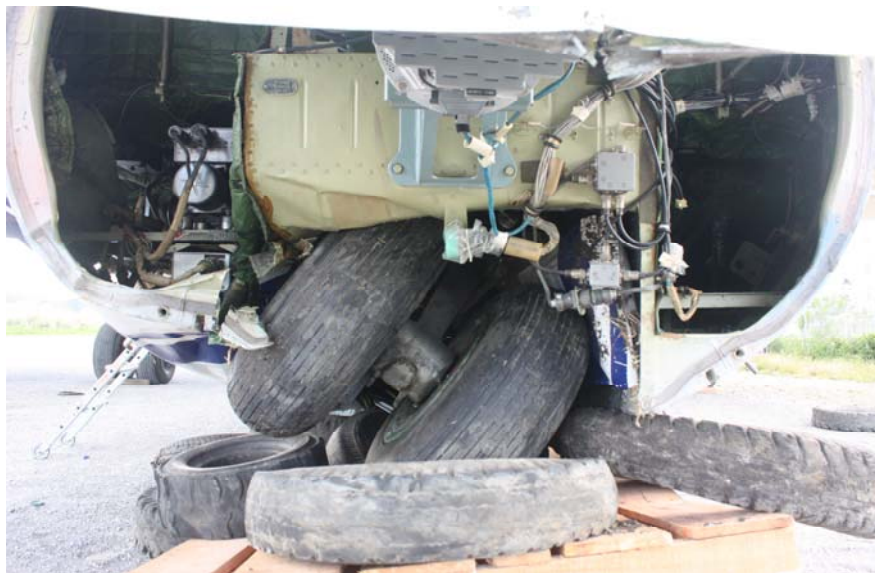
Figure 2: The nose landing gear

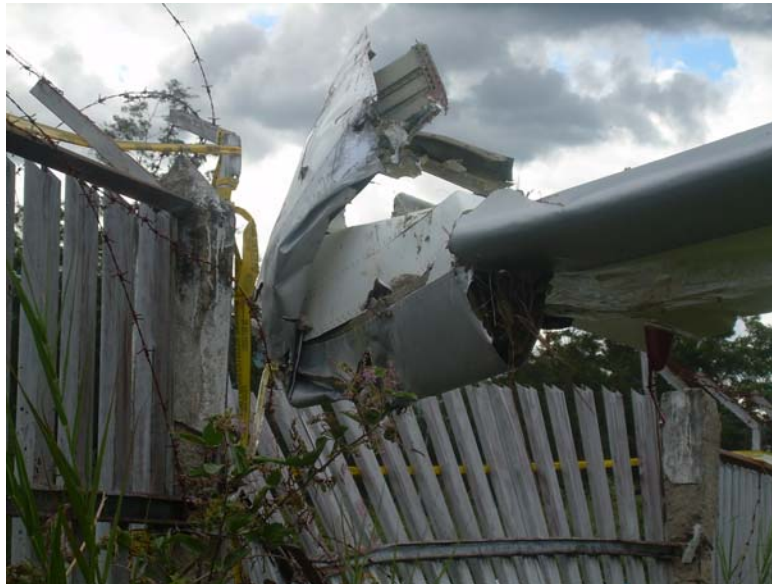
The aerodrome perimeter fence was damaged due to impact by the aircraft's right wing tip.

Figure 4: The aerodrome perimeter fence

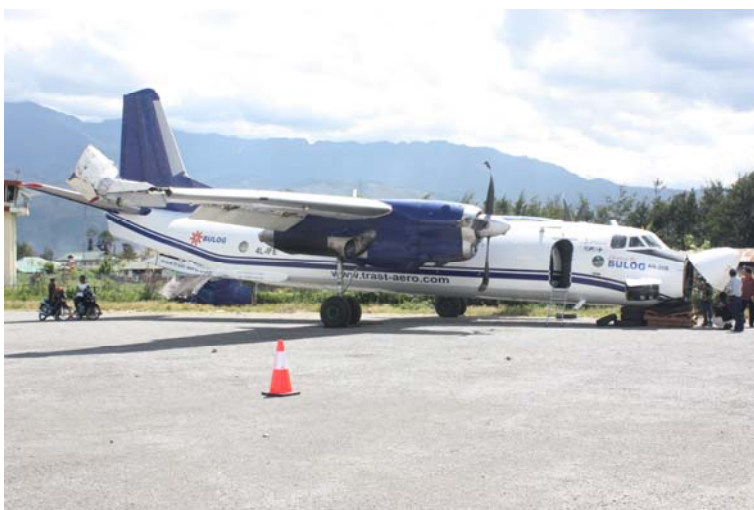
The aircraft overran the departure end of runway 15 and stopped in a ditch. It was substantially damaged.

Figure 9: The substantially damaged aircraft
